Assessing the Effectiveness of Tailings Pond Seepage Remediation Using the Four Dimensions of "Point-Line-Surface-Body": A Case Study

Shichong Yuan¹ · Guilei Han^{2,3,4}

Received: 24 May 2023 / Accepted: 12 October 2023 / Published online: 6 November 2023 © The Author(s) under exclusive licence to International Mine Water Association 2023

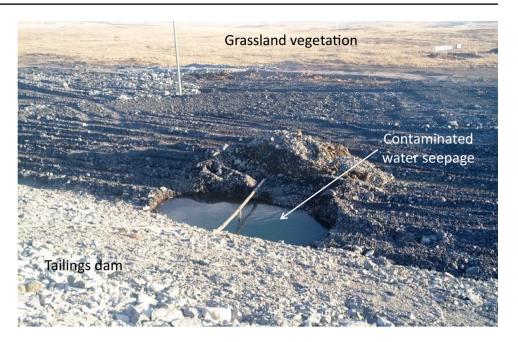
At present, for tailings pond with seepage, the conventional remediation method is to cut off the groundwater flow path by installing an underground vertical impervious body downgradient of the tailings pond (Fu et al. 2021; Yang et al. 2020; Yuan et al. 2022a, b). During the Phase II dam foundation clearing, contaminated water seepage from the mine tailings pond was found to be emerging at the foot of

the auxiliary dam (Fig. 2). Because the shallow Quaternary and strongly weathered strata have medium and strong permeability, the seepage water did not appear on the surface, but flowed downgradient through the underground aquifer (Fig. 3a). If effective engineering remediation measures are not taken in time, the metal pollutants contained in the seepage water will have an adverse impact on the fragile groundwater ecological environment downstream of the study area.

Fig. 2 Contaminated water seepage at the foot of the tailings dam

Based on a comprehensive analysis of the geological conditions and remediation requirements, we determined that the seepage problem could not be solved simply by blocking. Because the water head of the tailings pond was higher than the surface elevation of the area, water blocked by an impervious body in the flow path was bound to overflow the surface or overflow the top of the impervious body to the downstream area. To solve this problem, the system engineering scheme of interception, blocking and drainage (IBD) was designed to control the tailings pond seepage water (Fig. 3b

and c). Interception refers to the excavation of an intercepting ditch along the dam toe, which was filled with gravel to intercept the shallow seepage water. Blocking refers to the construction of an underground impervious body downgradient of the intercepting ditch at the dam toe. The bottom boundary and two shoulders of the impervious body must prevent the seepage from migrating to the downgradient area. Drainage refers to an array of liquid collection wells constructed in the low-lying and highly permeable areas to collect the seepage water along the intercepting ditch; this water can be pumped back to the tailings pond for beneficiation and utilization, to avoid the surface overflow of the seepage water.

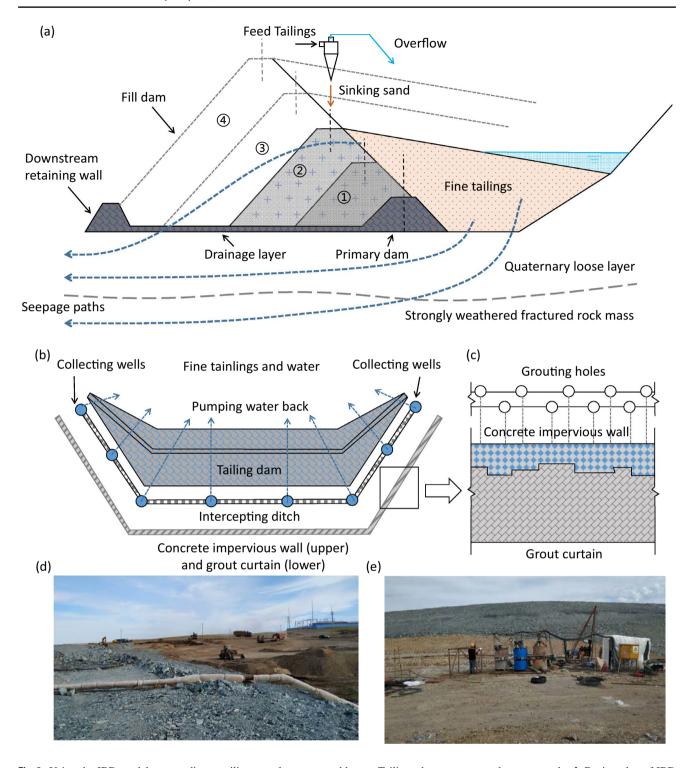
Fig. 3 Using the IBD model to remediate a tailings pond seepage problem. a Tailings dam structure and seepage paths. b Design plan of IBD model. c Design cross section of IBD model. d Construction site. e Grouting station

According to the characteristics of the rock and soil layer in the study area, the shallow loose layer and completely weathered bedrock could not be effectively grouted, but it proved suitable for incorporation into a poured concrete wall. Additionally, curtain grouting was used for the fissured bedrock to block the deep seepage pathways; the detailed design scheme is shown in Fig. 3b and c. The impervious concrete wall is 0.6 m thick, has an average depth of about 7 m, and a strength grade of C20. The curtain grouting drilling holes were arranged in two rows, distributed along both sides of the concrete wall, with a row spacing of 0.6 m and a drilling hole spacing of 1.5 m. The two rows of drilling holes are staggered (Fig. 3c). The depth of the curtain grouting bottom boundary entering the relative water-resisting layer was at least 5.0 m. The average depth of the grout curtain drilling hole was about 50 m. The designed intercepting ditch was 1.0 m wide and 2.0 m deep and was filled with pea gravel as a filter layer. A

total of eight liquid collecting wells were constructed, and the diameter of the liquid collecting well was required to be at least 0.8 m. A 426 mm diameter filter tube was placed inside, and the annular gap between the filter tube and the hole wall was filled with pea gravel as the filter layer. Photographs of the on-site construction are shown in Fig. 3d and e.

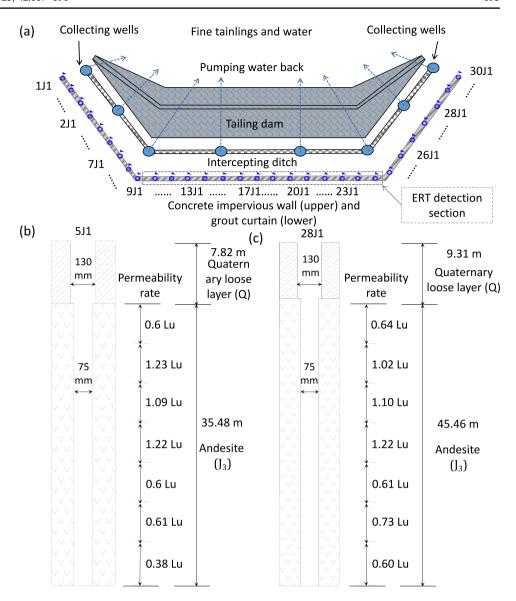
Table 1 shows the water pressure test results for inspection drilling holes 1J1–30J1. The maximum permeability

rate for these drilling holes was less than 2.0 Lu, indicating that the grouting effectiveness of the test section was good (The Industry Standard Editorial Committee of the People's Republic of China 2015). The location of inspection drilling holes 1J1–30J1 is shown in Fig. 4a, and two representative borehole histograms (5J1 and 28J1), with the lithology and permeability rate shown in Fig. 4b and c, respectively. However, the water pressure test results only reflect the permeability of a certain section of the drilling hole, and so have certain limitations.

Fig. 4 a Location of the inspection drilling holes 1J1–30J1. **b** Two representative borehole histograms (5J1 and 28J1) with lithology and permeability rate

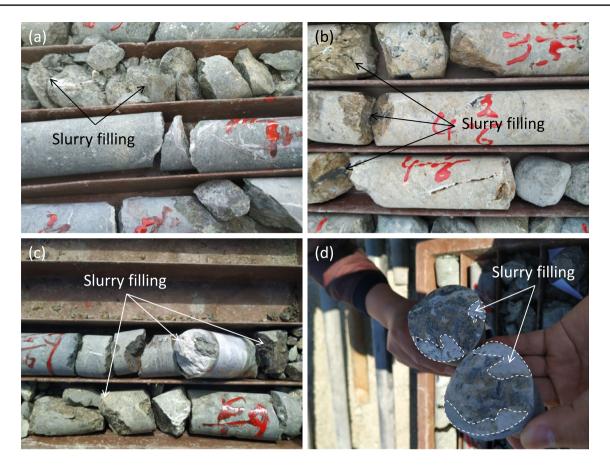
Drilling and coring surveys are an effective way to observe the development of bedrock fractures and the effect of slurry diffusion (Dou et al. 2020; Fan et al. 2016). Due to the heterogeneous diffusion of slurry in the bedrock fractures under grouting pressure, some wide and large fractures can be effectively filled by slurry, while some thin and small fractures cannot (Zhang 2022). Figure 5 shows the core specimen images of selected typical drilling holes. It can be seen from Fig. 5 that the grout slurry fully filled the bedrock joints and fissures, solidified fully, and the setting rate was high. The broken zone is fully cemented by the grout slurry, which indicates that the grout curtain is continuous and complete, and the waterproof effect is good. However, drilling and coring survey only provide a one-hole view and cannot comprehensively reflect the overall water blocking effect of grout curtain.

Fig. 5 Core specimen images of the selected typical drilling holes

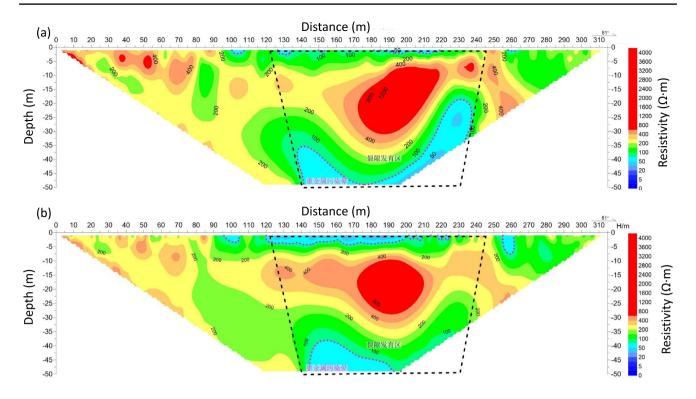
Electrical resistivity tomography (ERT) can describe geologic bodies by varying electrode spacing in detail over different scales and is widely applied in engineering geology projects (Gao et al. 2018). Figure 6a and b shows the ERT detection results before and after curtain grouting. The metal pollution halo clearly moves deeper along one pollution channel, while the shallow pollution halo is decreasing. The concrete wall (the upper part) and grout curtain (the lower part) successfully blocks the auxiliary dam seepage water, and the grouting effectiveness is relatively obvious.

Fig. 6 ERT detection results before and after curtain grouting. a Before curtain grouting. b After curtain grouting
