GEOSS Report No: 2017/04-23

Cedarberg Aqua is a bottled water company which obtains its water supply from a single borehole (KSV1). Following on from an assessment in 2008, 2010, 2012, 2014, 2015 and 2016, GEOSS was requested to complete another assessment in April 2017. The borehole is drilled into the Nardouw Sub-group quartzitic sandstones on the eastern limb of the Citrusdal syncline. The water bearing fractures are about 100 m below the ground level and the borehole is 180 m deep. The geological formations dip to the west and there are no contamination sources up-gradient of the borehole. The groundwater recharge is into the pristine geological formations in the mountains to the east of the borehole and the Nardouw Sub-group aquifer is confined.

GEOSS (2017). Cedarberg Aqua – Geohydrological Review 2017. GEOSS Report Number: 2017/04-23. GEOSS - Geohydrological & Spatial Solutions International (Pty) Ltd. Stellenbosch, South Africa

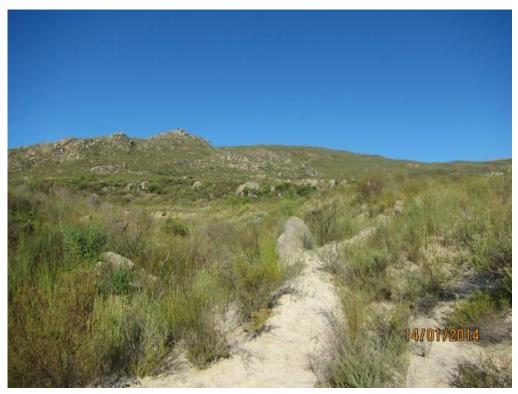
Photo 1: Regional setting up-gradient of the borehole

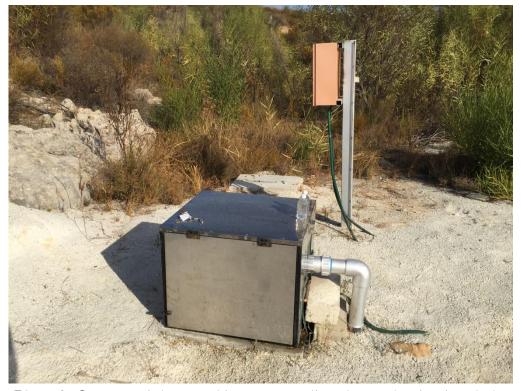
Due to the remote location of the site and the normally safe nature of the area it is not deemed a prerequisite to "house" the borehole. The security fencing around the borehole is currently being upgraded. The borehole itself is secured in a small stainless steel housing which is kept locked.

Photo 2: Secure stainless steel box surrounding the production borehole.

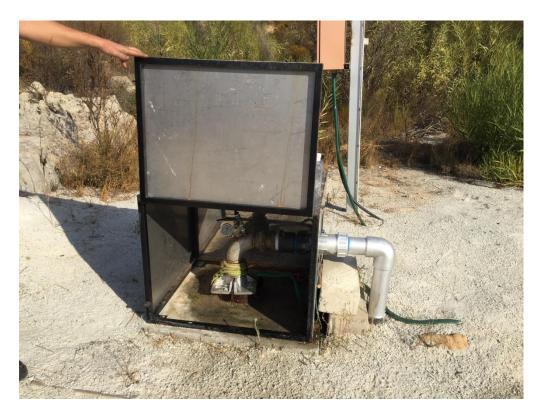
In the recent past there has been no change in the land use activities in the vicinity of the borehole. The borehole consists of an outer steel casing and an inner casing. The inner casing is sealed with a cover plate thus preventing surface based contamination (i.e. the inflow of surface based run-off or the possibility of a small creature/animal from falling into the borehole). No sources of potential contamination were identified proximal to the borehole. The general setting of the borehole is shown on an aerial photo map in **Map 2** (Appendix A).

Photo 3: Stainless steel box, which is kept locked and secured on a concrete floor, preventing anything from falling or flowing into the production borehole. Note the sampling tap.
