Dalton By-pass: site investigation in an area of abandoned haematite mine workings

E. J. Arrowsmith & P. R. Rankilor*

North Western Road Construction Unit, Department of Transport, Crystal House, Birley Street, Preston PR1 2AQ.

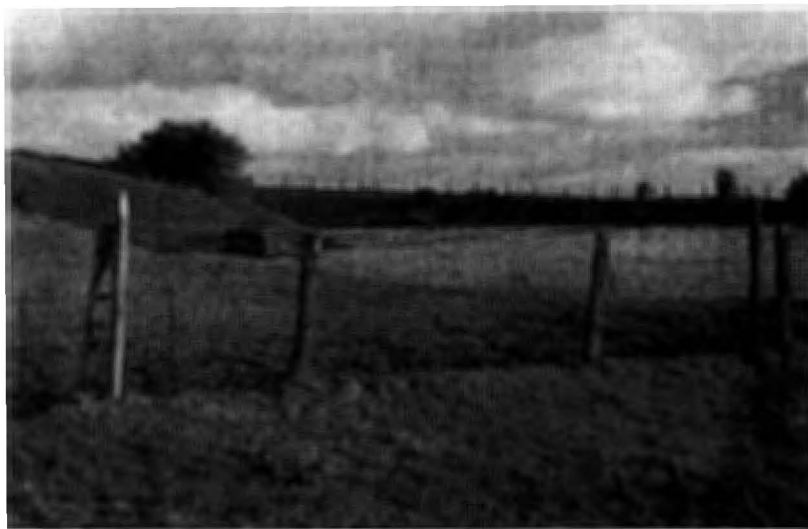
The ore was largely found in sops, bowl-shaped depressions in the Carboniferous Limestone. Where the limestone roof was absent or very thin, the overlying glacial deposits subsided as the ore was removed, creating the spectacular craters that are a feature of the district (Fig. 2). Another feature is the very large number of shafts, mostly driven to locate ore bodies and indifferently filled, or partly filled with timber staging some distance below the surface. The shafts are a continuing danger, as the timber is liable to rot

FIG. 2. Typical ponded mine sop.

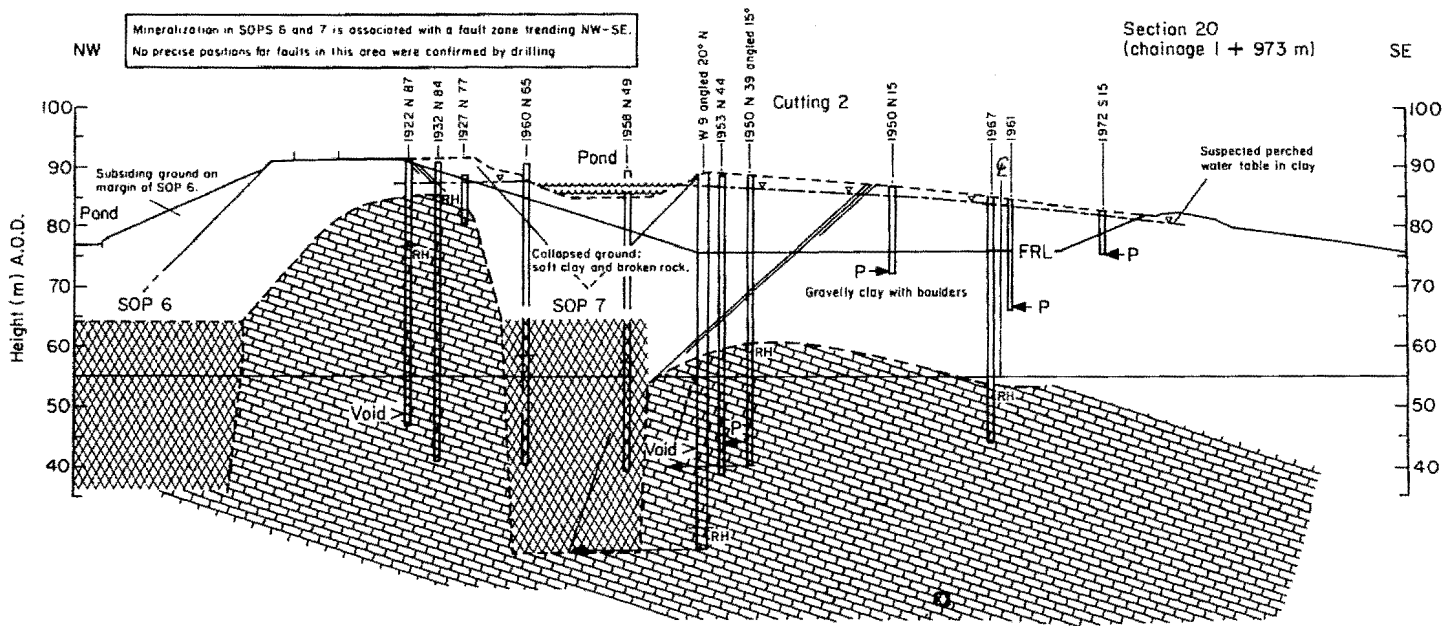
The main problem in connection with the construction of this cutting is the stabilization of Sop 7 and its two associated mine shafts. The sop itself is ponded within the collapse zone of the underlying abandoned haematite workings.

The mine workings and the shafts produce a compound zone of potential instability which adversely affects the cutting N of the proposed carriageway (Fig. 7). The main problem is to recommend a suitable construction procedure which would take account of safety requirements with respect to plant being involved in the operation of excavating the carriageway cutting. It was considered that a contractor would be unlikely to wish to allow plant to operate over the top of a sop, or within influencing distance of that sop, during the course of excavation work. It has therefore been recommended that the sop pond should be drained by pumping, and back-filled with cohesive material. Following this, light drilling rigs and grouting plant could be brought over the sop and a grouting operation conducted to stabilize the workings. The drilling operations within the sops has revealed that they are primarily rubble-filled collapse zones, with little in the way of open caverns. Consequently, a grout intake of the order of 25% of the total sop volume is to be expected. After the sop has been grouted, the cutting could be excavated by normal methods and then the back-fill material from the pond (which extends nearly down to proposed carriageway level) could be removed and replaced with granular fill and suitable land drains.

FIG. 7. Geological section across elliscales pond and cutting.

This solution is typical of the approach that will be necessary to stabilize the sops and vein workings along the length of this route.

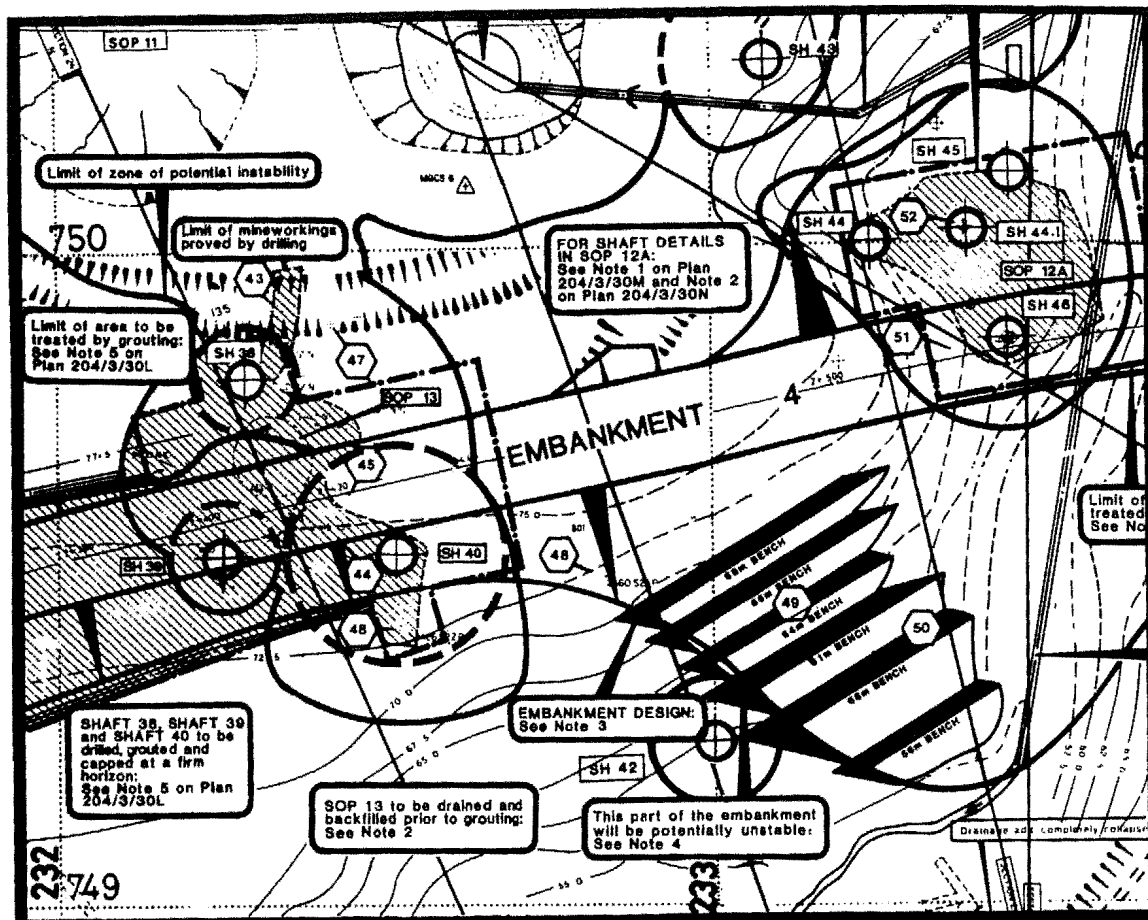
FIG. 9. Illustration of the 1/500th scale plan of Poaka Beck.

Sop 12 is another ponded sop, and will have to have its water level lowered in order to reduce the standing water table height in the higher ground above the embankment.

Site access to the floor of Poaka Beck was particularly difficult owing to the steep slopes of the valley in this vicinity. Nonetheless, the survey team prepared a detailed contour plan of the valley crossing point, and access routes were designed and constructed for the rigs. Many boreholes were drilled and trial pits excavated. The results of the borehole were difficult to analyse, since the floor of Poaka Beck at the crossing point was covered with thick superficial deposits, and yet, nearby to both N and S, bedrock limestone outcropped at valley level. The rise and fall in water table in the adjacent fissured limestone rocks, combined

the proposed embankment. It has therefore also been necessary to recommend that Shaft 43 be drilled and grouted, but not necessarily capped.

with the regular release of water from a reservoir further upstream, meant that the valley floor was sometimes dry, and sometimes contained a briskly running stream. Sink holes could be seen further N where the river disappeared into the bedrock. In view of the rapidly-fluctuating water table at this locality, it is recommended that any embankment base be constructed on a granular drainage blanket protected from contamination by a fabric filter membrane.

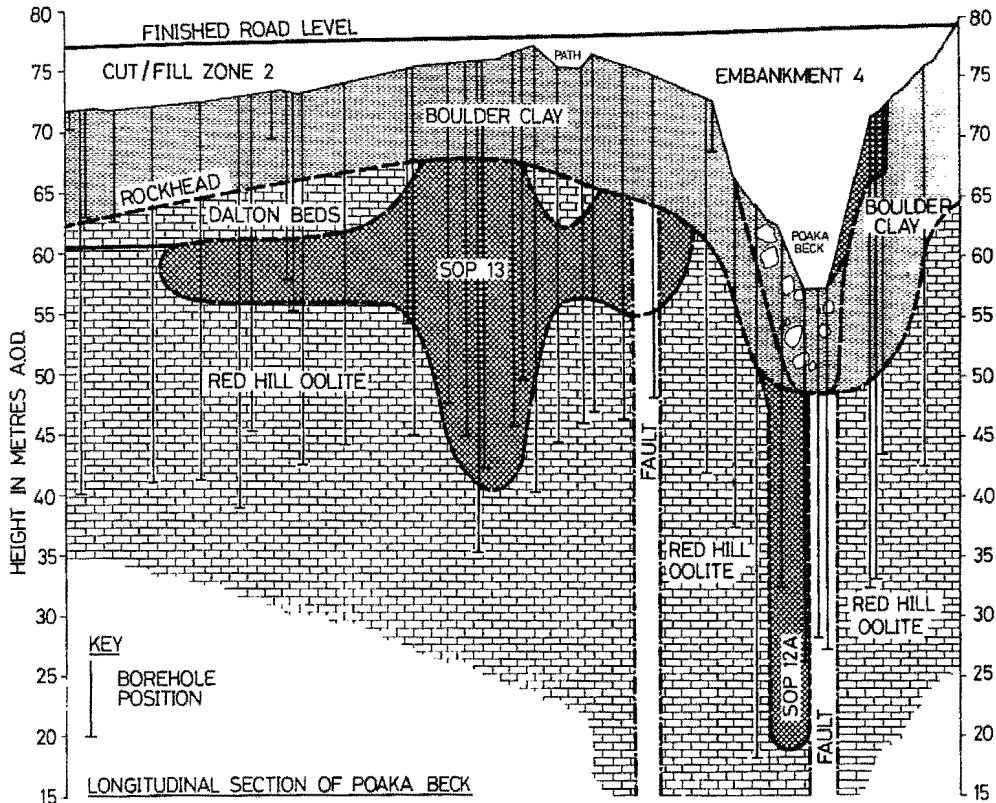
FIG. 10. Geological longitudinal section of Poaka Beck valley, showing sop.

Of course, decisions of this kind never tend to be easy and, as can be seen in Fig. 10, the deep superficial deposits in the floor of Poaka Beck at the crossing point, and the irregularity of rock-head determined by the boreholes, lead to the conclusions that the crossing is being proposed at the point of a collapsed limestone cavern. Since a river disappears into swallow holes just to the N of the proposed crossing, and in the context of the general problems posed by limestone river valleys it can be anticipated that the valley floor will not be stable in the long-term. In the event of minor movements owing to settlement, an embankment would certainly be a more flexible structure than a bridge and in pure engineering terms, as opposed to environmental and aesthetic terms, it might be the better alternative.

In view of this possibility and of a possible fill short-fall for the route as a whole, it was considered sensible to assess the cost-effectiveness of an elevated structure across the valley. Normally, such a structure would be much more expensive than the equivalent earth embankment, but in these special circumstances, where considerable extra works relating to the stabilisation of mining shafts and mine sops are concerned, there seemed a good possibility of financial economy.

When the expense of stabilizing mine shafts and mine workings is taken into account, together with the cost of the imported fill, then the cost for the two structures becomes virtually the same. This allows the aesthetic aspects of the valley environment to be considered and makes the proposition of an elevated structure very attractive. It is interesting to compare this with the cost balance in Goldmire Valley where, despite taking into account the stabilization of the mine working and the high cost of excavating 3 m of peat an elevated viaduct still transpired to be some 20% or so more expensive than the equivalent fill
