How to Prevent Flow Failures in Tailings Dams

Roberto Rodríguez¹ · Alejandro Muñoz-Moreno^{1,2} · Ana Vanessa Caparrós³ · Cristóbal García-García⁴ · Ángel Brime-Barrios⁵ · Julio César Arranz-González¹ · Virginia Rodríguez-Gómez¹ · Francisco Javier Fernández-Naranjo¹ · Alberto Alcolea³

Abstract

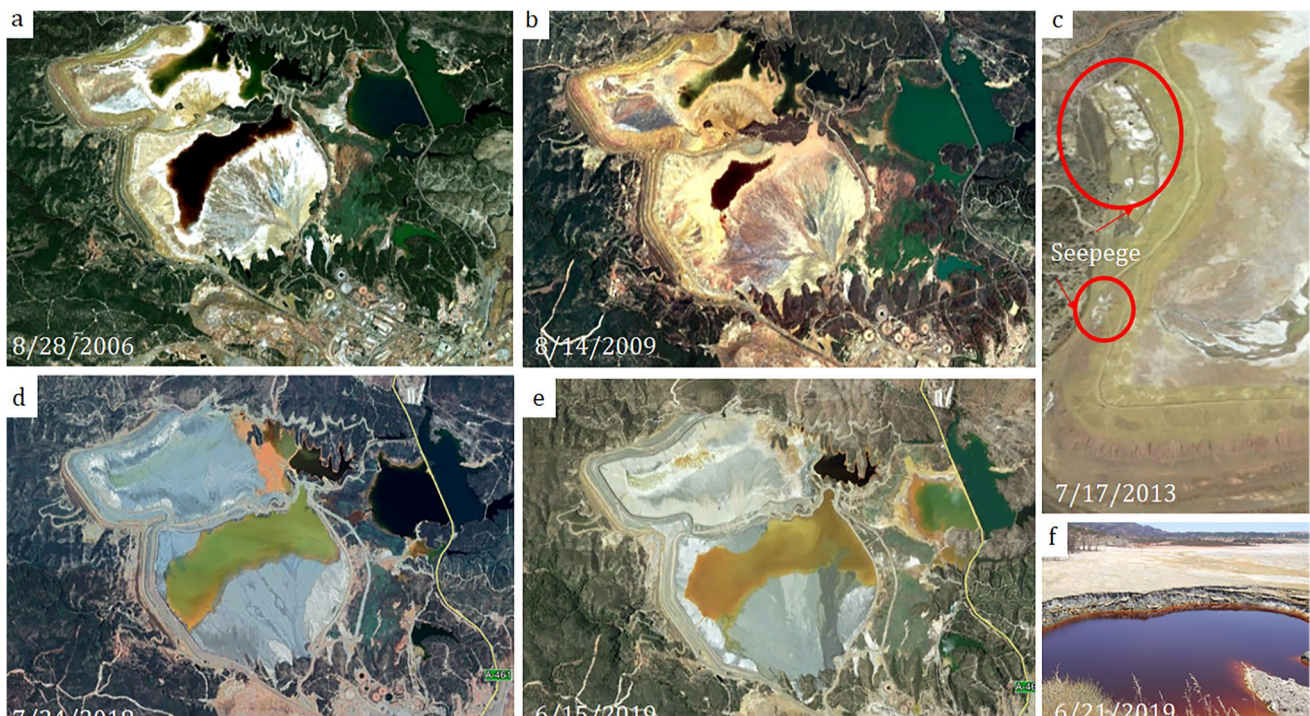
efflorescence. Leaks are shown in Fig. 3e. Figure 3f shows the existence of a water table 1.4 m from the surface. This shows that the TD basin is completely saturated. In addition, the existence of thin stratification layers can be observed (Fig. 3f).

Fig. 3 Spatial–temporal evolution of an active TD with important concentration of efflorescence on surface. Storage tailings due to flotation process for extraction of Cu, Minas de Rio Tinto, Spain

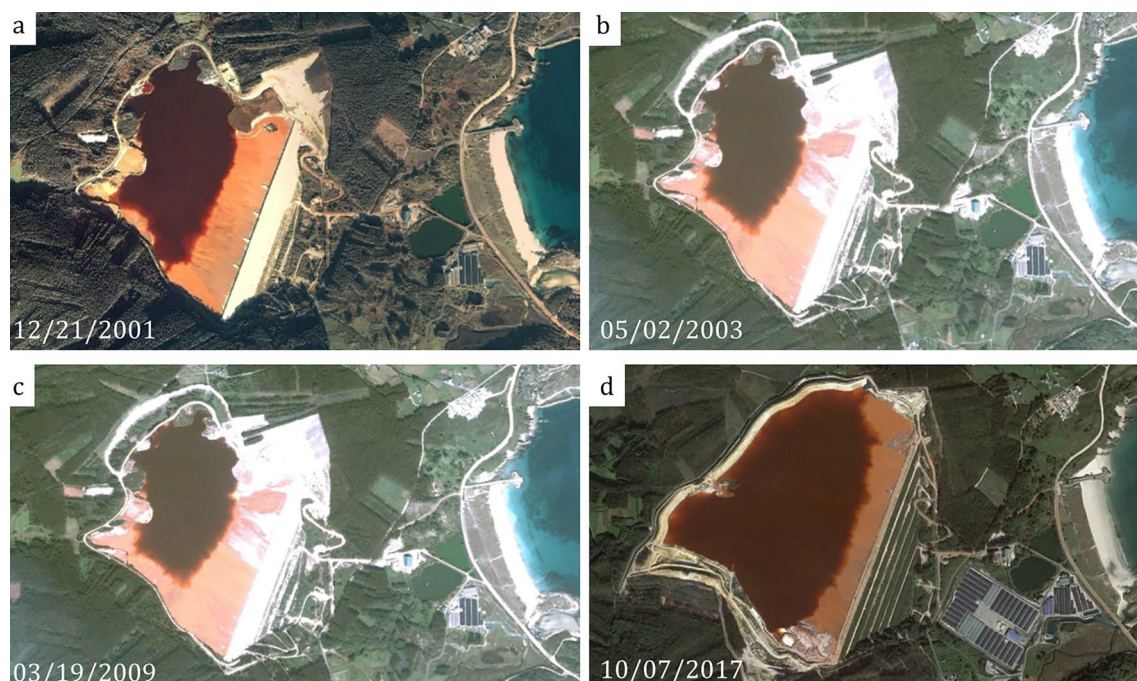
The TD in Fig. 4 stores tailings derived from aluminium extraction. It shows how the position of the lagoon and the evaporation area have frequently changed (Fig. 4a–d). In 2017, a water lagoon covered more than 80% of the surface of the TD basin. We observed that the efflorescence dissolved when the humidity increased. The green colour of the vegetation was due to restoration of the dam (Fig. 4d).

Fig. 4 Spatial–temporal evolution of an active TD with important concentration of efflorescences on the surface. Storage tailings due to the Bayer process of extraction of Al, San Ciprian, Galicia, Spain

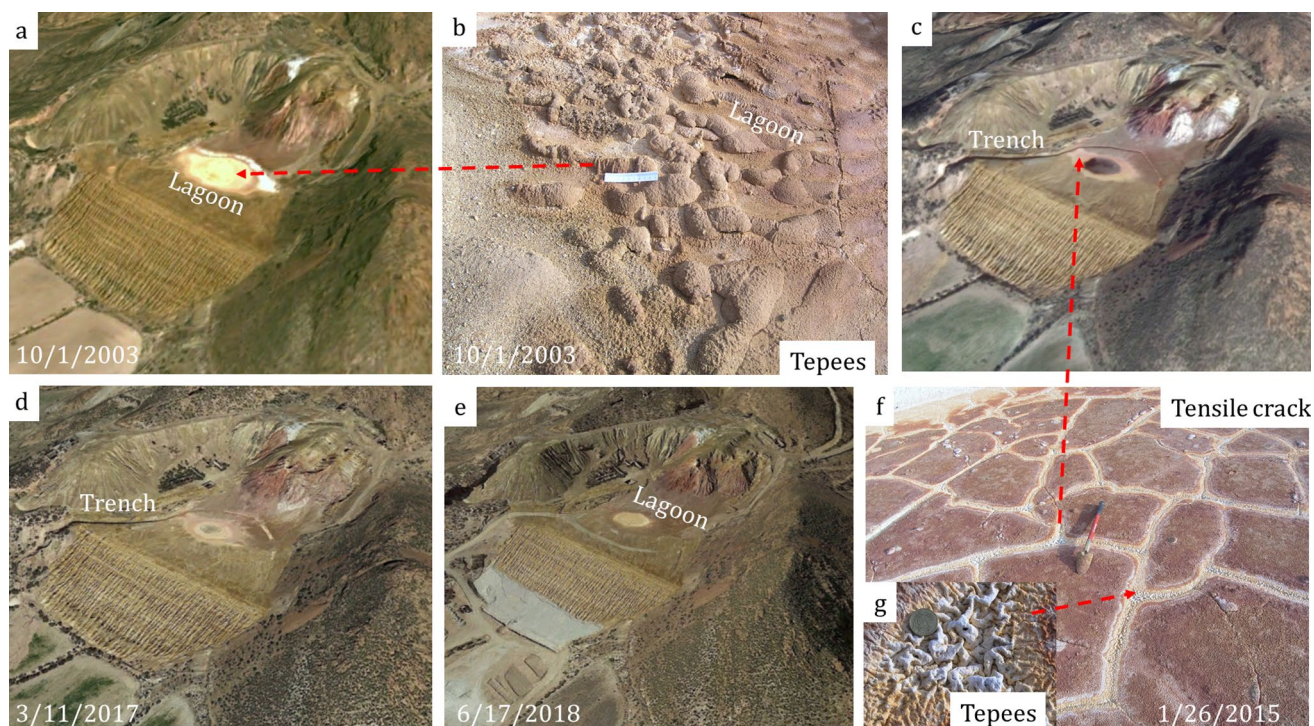
Figure 5 shows a TD abandoned more than 50 years ago, which stores Pb–Zn tailings from a sulphide-rich deposit (Table S-1). Its geotechnical stability has been affected by actions such as the construction of a drainage trench inside the basin and in the dam (Fig. 5b–d). Actions that fail to consider the proper conceptual model of operation must be amended, which entails an additional expense to restore the TD (Fig. 5d). Disharmonic sedimentary structures, consisting of a fold that resembles an inverted depressed V in cross-section, can be seen (Fig. 7g).

Fig. 5 Spatial–temporal evolution of an abandoned tailings dam with important concentration of efflorescences on the surface **a** dry lagoon and efflorescence, **b** construction of a drainage trench, **c** the drainage trench caused the development of tensile cracks and important hydric

erosion process, **d** sealing of the drainage ditch and construction of a wall at the base of the dam **e** detail of crust efflorescence, **f** detail of tensile cracks, **g** detail of efflorescent crust. Cerro de San Cristóbal. Mine district Mazarrón, Murcia, Spain

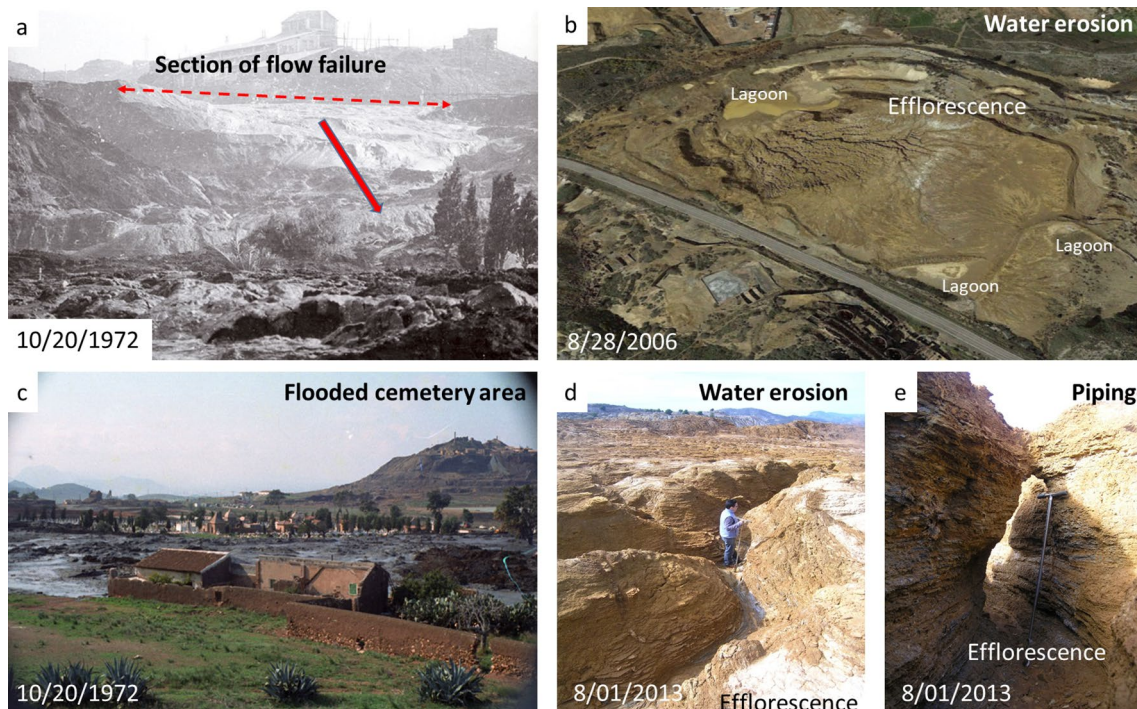
Fig. 6 Spatial-temporal evolution of an abandoned tailings dam with different processes: **a** liquefy and flow failure, **b** cemetery area affected by flow failure, **c** panoramic view of the drainage network due to water erosion, **d** gullies due to hydric erosion, **e** piping. It can

be observed an important concentration of efflorescence on surface (**b**, **d**, **e**). Tailings dam Brunita. Mine district Sierra de Cartagena-La Unión, Murcia, Spain

surface (Fig. 6b–e) can be observed. Figure 8b shows three zones of water accumulation during rainy periods.

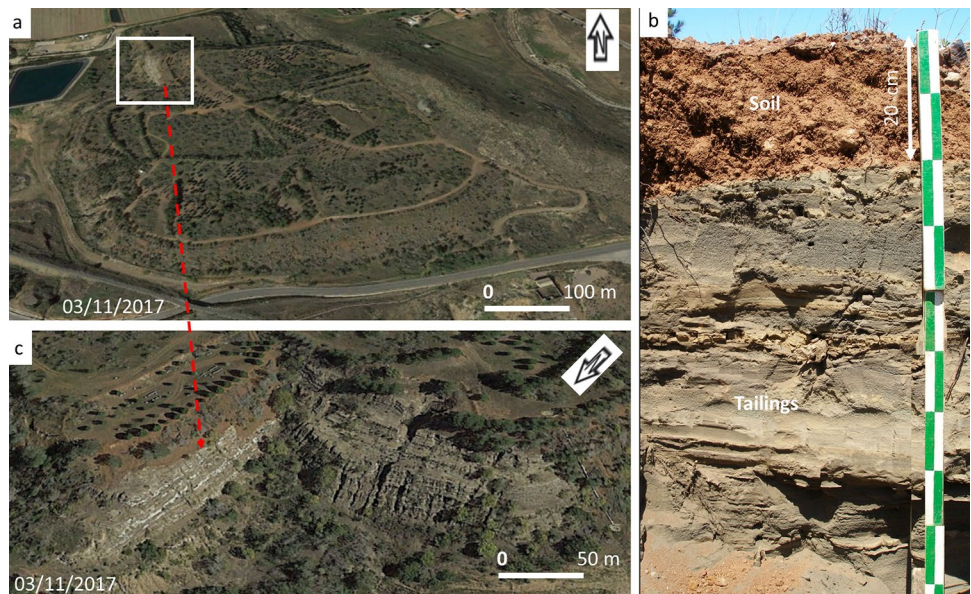
Fig. 7 **a** Restored tailings dam with storage-release covered with soil, **b** efflorescence on surface of the dam due to seepage, **c** detail of the vertical profile. Tailings dam Llano del Beal, Mine District Sierra de Cartagena-La Unión, Murcia, Spain

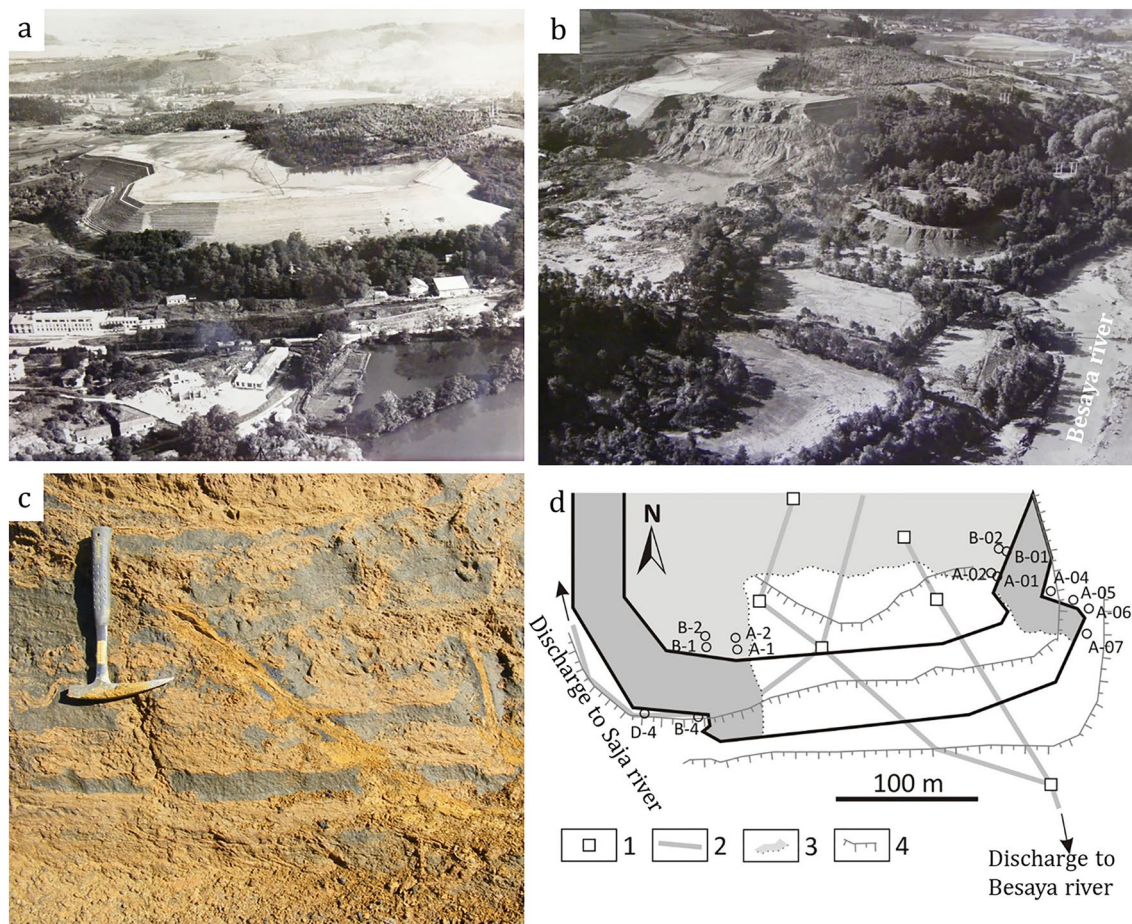
Fig. 22 **a** Tailings dam "La Luciana" before flow failure due to static liquefaction, **b** after the flow failure, **c** sand dykes due to static liquefaction, **d** location of the CPT boreholes and drainage system. 1 is tower of decantation. 2. Drainage system. 3. Slide surface. 4. Dump

Again, this is only a simplified model of the TD, based on data from the area that did not fail. A great deal of information is available on the geotechnical properties of the La Luciana TD, both in situ and in the laboratory (Berzal 1976; Cruz 2019; Fernández-Naranjo et al. 2015, 2019), there are high-quality images before and after the failure, and the
