HYDROLOGIC INVESTIGATION AND REMEDIATION OF A POST-REMINING ACIDIC SEEP¹

William W. Aljoe²

Nile A. Linberg³

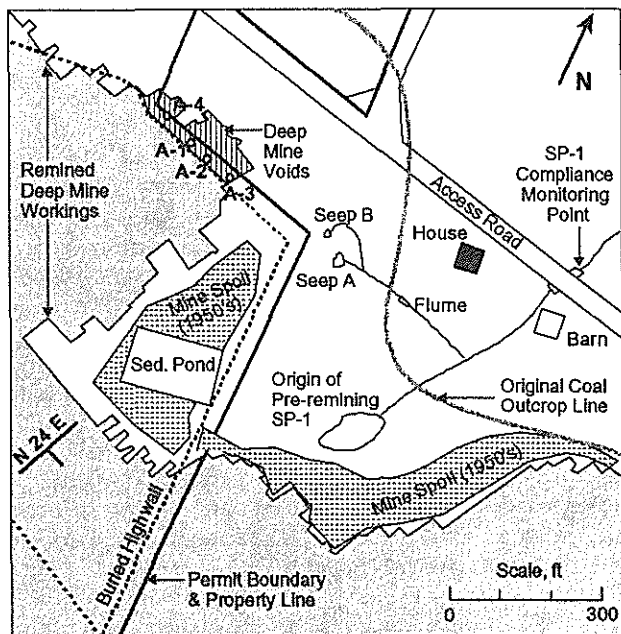
Figure 3. Post-remining Discharge Area

However, the mine operator pointed out that another factor besides the surface mine may have been controlling the degradation of SP-1. At some time shortly after the cessation of surface mining, the landowner to the east of the permitted area made several excavations that began to discharge acidic water at a rate that was greater than that of the original SP-1. Flow from the original SP-1 decreased concurrently. As shown in Figure 3, these post-remining discharges (Seeps A and B) eventually passed through the SP-1 compliance monitoring point. The mine operator contended that the excavations were tapping a portion of the deep mine pool that had not been impacted by surface mining, and that the mining company should not be held responsible for treatment of the discharge.

placing sodium carbonate briquettes in the contaminated stream; however, this was not viewed as a viable long-term solution by either the company or the regulatory agency. To supplement this treatment, the mining company injected a large quantity of anhydrous ammonia into the abandoned mine voids which were believed to be the source of the discharge. The injection wells, labeled A-1 through A-4 in Figure 3, were located between the surface mine highwall and the mine permit boundary, and penetrated the mine voids within 300 ft of the post-remining seeps. It was expected that the alkalinity and aeration introduced via the ammonia injection would eliminate the acidity of the seeps and cause precipitation of metals to occur within the mine voids. However, the water quality of the discharges showed no appreciable change after ammonia injection, thus causing the mining company to review its approach toward remediation.

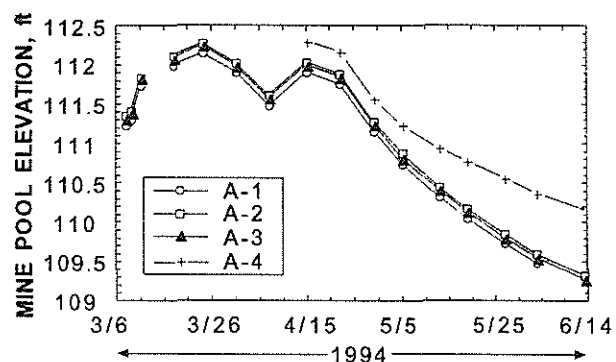
Figure 4. Water Elevations in Mine Void Wells (arbitrary reference datum).

Water Elevations and Flow Rates. Water elevations in wells A-1, A-2, and A-3 were almost identical (Figure 4), suggesting that these wells penetrated the same mine pool. The mine voids were only partially flooded, with about 2 ft. of water in a void height of about 7 ft. By June 14, the mine void at Well A-1 became dry. It was inferred that a small mine pool existed in the voids penetrated by these three wells, and that the pool was drained by a consistent discharge source.

The water elevation in Well A-4 was consistently higher than in the other three mine void wells by 0.5 to 1.0 ft; this difference was considerably greater than the error that could be attributed to surveying and level measurement. Also, the decline in the water elevation at Well A-4 was less steep than in the other three wells during May and June 1994. From these data, it was inferred that another small mine pool existed in the portion of the deep mine penetrated by well A-4. The degree of hydrologic connection between the two pools could not be confirmed; however, the behavior of Well A-4 during May and June suggested that this pool was not directly connected to the same discharge source as the pool penetrated by the other three wells.

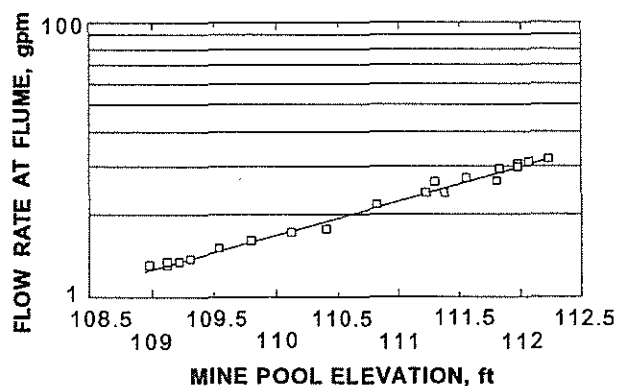
Figure 5. Mine Pool Elevation vs. Discharge Rate.

The combined flow rate from seeps A and B was directly related to the elevation of the mine pool at wells A-1, A-2, and A-3 (Figure 5). This relationship was not surprising, given that both the pool elevation and flow rate would be similarly influenced by precipitation. Figure 5 shows that the mathematical relationship at this site was exponential (linear plot on log scale); however, mine pool elevation-discharge plots at other sites had exhibited a direct linear relationship (Aljoe, 1994).

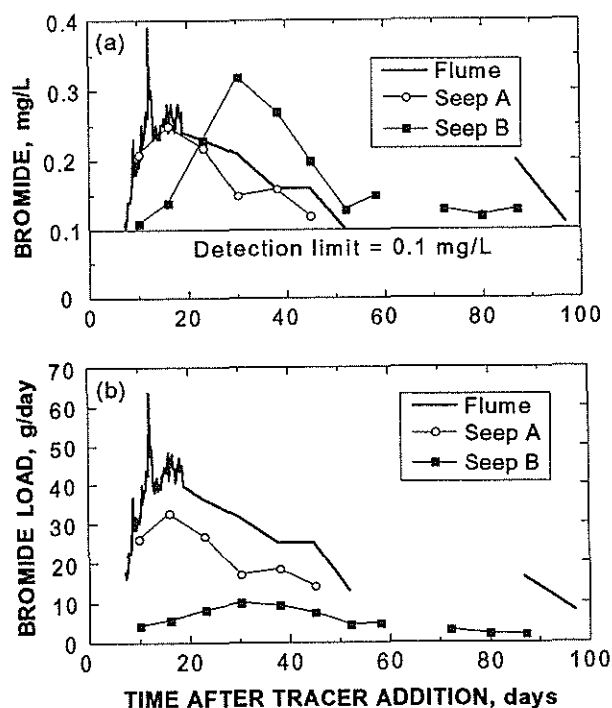
Figure 6. Results of Bromide Tracer Test (a) concentrations; (b) loads.

In general, the results of the tracer test showed that there was a distinct hydrologic connection between the mine pool and the seeps, but that the connection was not as direct or exclusive as first anticipated. Figure 6 shows the bromide concentrations (a) and loads (b) at the three discharge locations. If the mine pool were indeed the only source of water to the seeps, the high discharge rate would result in a pool turnover time (complete passage of the tracer cloud

From the peak bromide concentration and load shown in Figure 6, the average flow velocity from the bromide injection wells to the seeps was estimated to be 12 to 27 ft/day. This velocity is more than an order of magnitude lower than found by Aldous and Smart (1988) for underground mine workings with pure conduit-type flow. Instead, the velocity is closer to those for sealed underground mine workings (Aljoe and Hawkins, 1993), mine spoil (Hawkins and Aljoe, 1992), or glacial sediments (Grisak, et al., 1977). These results suggested that the tracer cloud moved through

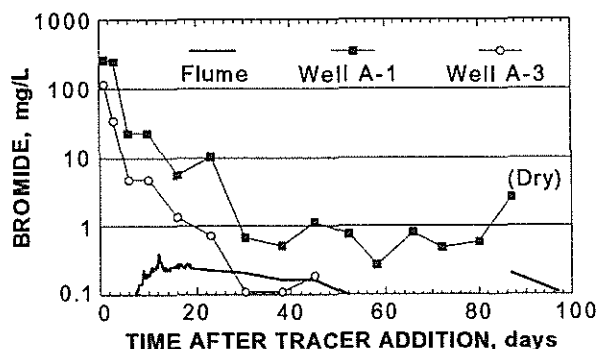
Figure 7. Tracer concentrations in Mine Pool and Discharge.

Figure 7 shows the bromide concentrations in the injection wells over the sampling period, along with the flume concentration curve. The consistently lower concentrations in Well A-3 were attributed to the greater amount of flushing water that had been used in this well. The rates of concentration decline in the two wells were very similar, but the higher initial concentration in Well A-1 allowed bromide to remain detectable until the mine void became dry.

The fact that bromide concentrations in part of the mine pool were on the order of 1 mg/L while seep concentrations were undetectable indicated that dilution was occurring between the mine voids and the seeps.

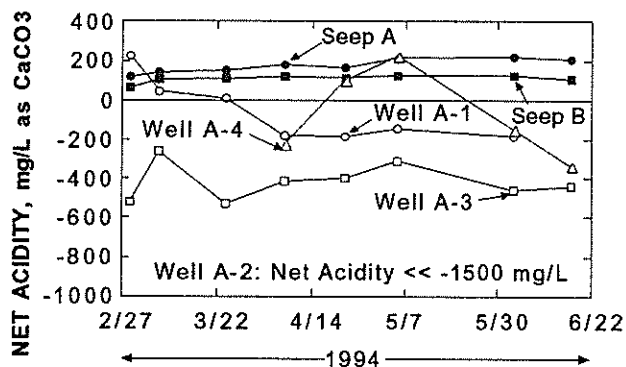
Figure 8. Net Acidity in Mine Pool and Seeps.

Net acidity at the seeps was very stable at 100 - 200 mg/L over the study period; conversely, the mine voids generally possessed strongly alkaline water (negative net acidity = net alkalinity). Although wells A-1 and A-4 were acidic on several occasions, they showed temporal fluctuations that contrasted markedly with the stable pattern of the seeps. Furthermore, Well A-3, which was closest to the seeps and was shown to be hydrologically connected to the seeps via the tracer test, was consistently net alkaline by more than

400 mg/L. In order for the seeps to be net acidic, while still receiving recharge from the alkaline mine pool (as verified in the tracer test), one or both of the following must have been occurring: (1) significant geochemical changes were occurring along the flow path; or (2) another source of recharge that was more acidic and probably larger in volume than the mine pool was present.

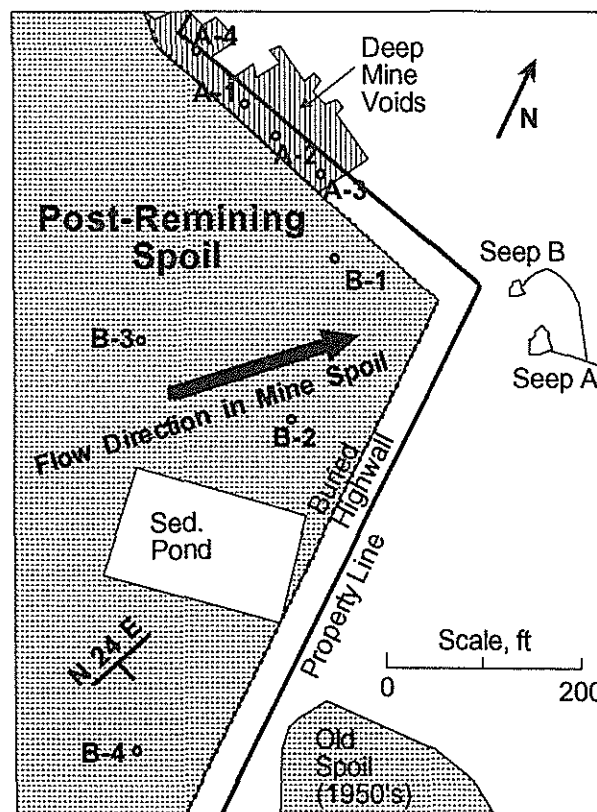
Figure 9. Mine Spoil Well Locations.

The water level in the monitored mine pool was about the same as that of Well B-3, and about 0.5 to 1.0 ft above the levels in wells B-2 and B-1. The water elevation in Well B-4 was 3 to 4 ft below those of the other wells; however, because of its physical separation from the other wells and the seep areas, and the tendency of mine spoil to have multiple flow paths, Well B-4 was considered to be relatively unimportant to the flow system in the seep area. Figure 9 shows the local ground water flow direction as determined from the water levels in wells B-1, B-2, and B-3. Note that the flow direction did not parallel the dip of the pit floor, but was directed toward the seeps.
