A STUDY OF GEOHYDROLOGICAL AND ROCK ENGINEERING
ENVIRONMENT AT LAPPVATTNET EXPERIMENTAL MINE

Jan-Åke Åkesson
Senior Engineering Geologist
BERGAB - Berggeologiska Undersökningar AB
St Pauligatan 33 A
S-416 60 Gothenburg
Sweden

The paper describes a hydrogeological and geotechnical study of rock mass at an experimental nickel mine at Lappvattnet, Sweden. The mine is situated 30 km south-west of the township of Skelleftea and was mainly developed for the exploration purposes. The mine consists of 1000 m of underground roadways from where a number of diamond cored boreholes were drilled for geotechnical studies and mine valuation. The main problem encountered during the development stage of the mine was very high quantities of ground water inflows at relatively high hydraulic pressures. The geological and hydrogeological conditions along the length of the drifts are described together with the methods used for ground-water inflow control. The study shows that there is a strong need for modifying the grouting methods to suit the rock conditions in order to control the ground-water inflows. A discussion regarding the need for a detailed geotechnical investigation prior to the planning

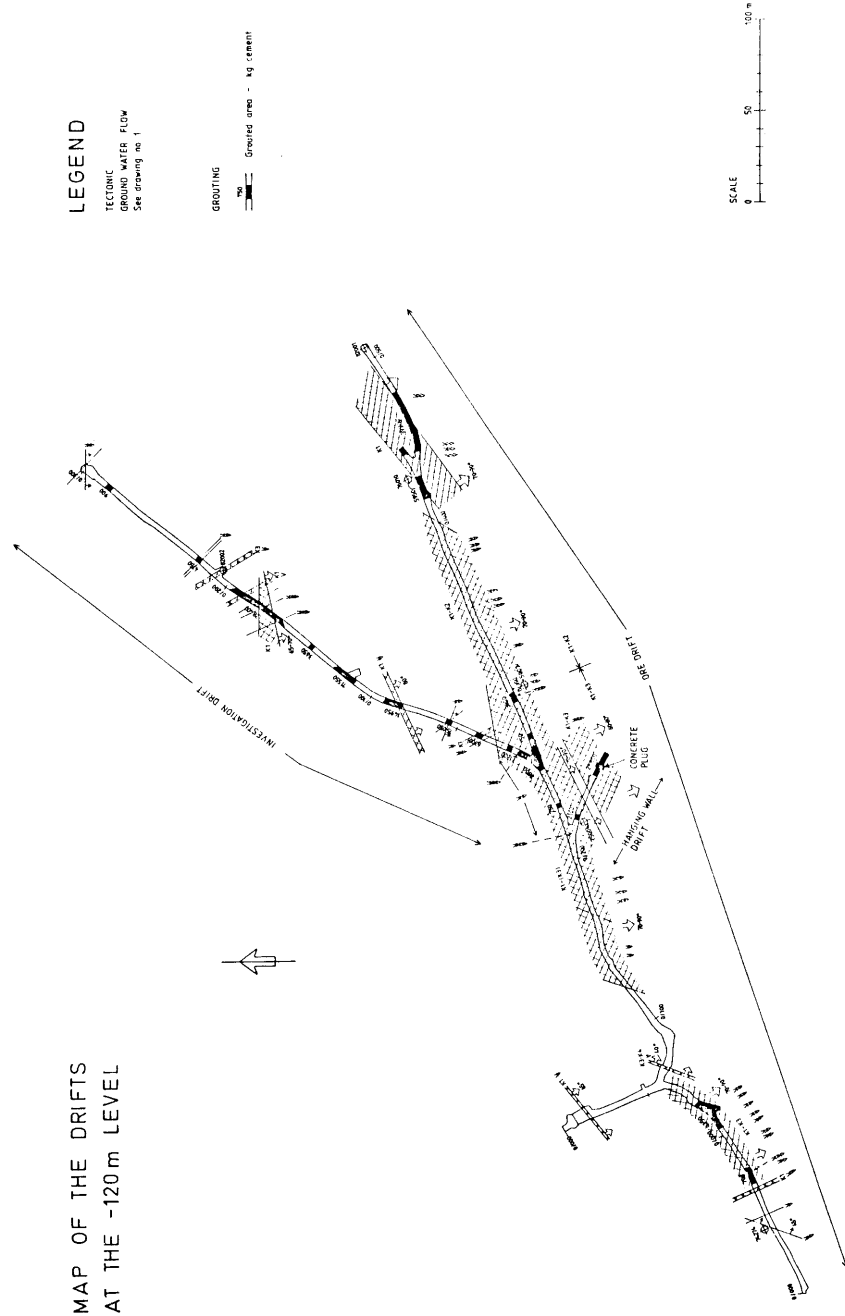
Figure 2 Layout of site of investigation

about 15 years in a large number of projects, both at the planning and development stages. The structure plan of the drifts is given in Fig. 2 which show the fissures and water bearing zones at the time of the geological mapping.

Figure 2 shows the area of drifts grouted by cement together with the information about used quantity of cement, as marked for every grouted section. The majority of the grouted sections are to be found in the parts of the drifts, where the fissure frequency is high and the ground-water flow strong. Despite occasional high quantities of cement the still leaking parts often have strong water inflows. However, there are some grouted sections in the investigation drift which do not correspond to water bearing fissures or zones (Fig. 2). Only the fissures and zones which were leaking at the time of the survey are represented in Fig. 2. If on the other hand the grouted sections were compared to a detailed drawing of the investigation drift, where all information is available, the following would appear:

- in the grouted sections there were especially vertical fissures striking about N30-35°W
- in the grouted section around O/190 there is a zone about 2 m wide, striking N35°W. In this zone the grouting cement can be seen along the previous open fissures
- the fissures still leaking within the grouted sections had small leakage (v).

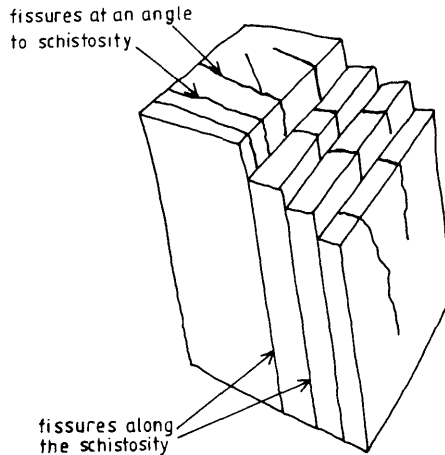
Figure 3 Principle type of fissure formation

In the ruptural deformation after consolidation of the bedrock to a rigid mass, it had been exposed again to deformation. Older schistose veins and planes formed during the plastic deformation have then controlled the new movements along the schistosity/graphite veins. Further movements had also occurred along the earlier tension cracks. The experience from areas of similar geological structure shows that fissures/schistosity zones often limit the extent of other types of fissures. Fissures at an angle to the schistosity terminate in many cases, just to fissures along the schistosity zones or continue to diffuse (see Fig. 3).

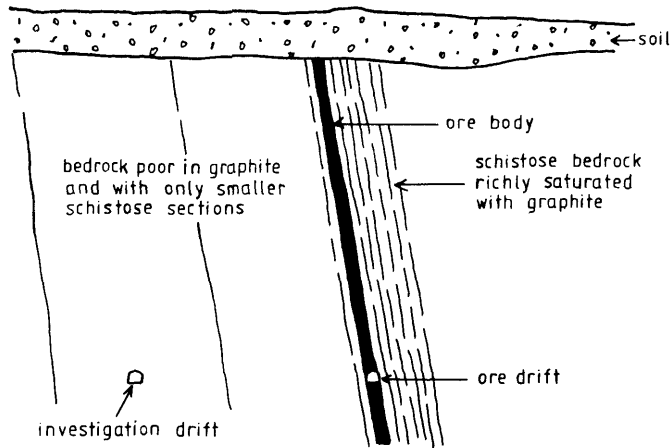
Figure 4 Diagrammatic presentation of the bedrock around the ore drift and investigation drift

The ore drift is situated in the bedrock containing a high percentage of graphite and is characterized by the presence of slaty cleavages and minor types of fissures. The investigation drift is located in the rock mass containing a low percentage of graphite and predominantly characterized by structural features such as fissures intersecting the schistosity at an angle and to a lesser extent by the slaty cleavages. (Fig. 2 and 4).

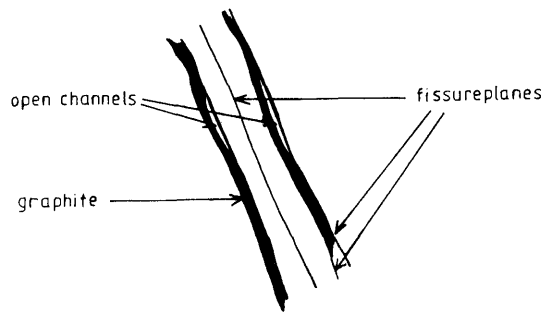
The ground-water flow was strong in both the graphite poor and graphite rich parts. In the graphite rich part the water flow is almost completely linked to the fissures flow along the schistosity and sometimes to "channels" along the graphite veins (see Fig. 5). The tension cracks formed perpendicularly to the schistosity are open and water bearing. This has been possible to verify within some grouted parts of the investigation drift where the grout was seen to have filled open fissures of this type.

In the structure mapping by borehole cores, the water bearing open fissures are normally identified by the presence of a layer of rust on the fissure surfaces. However, in the present study these direct indications of the presence of water were very rare. The absence of rust in itself is natural in the parts where the graphite veins in contact with the water bearing fissures along the whole surface or in open channels. No natural rust occurs in such an environment. (Fig. 5).

Figure 5 Diagrammatic presentation of open "channels" along graphite veins

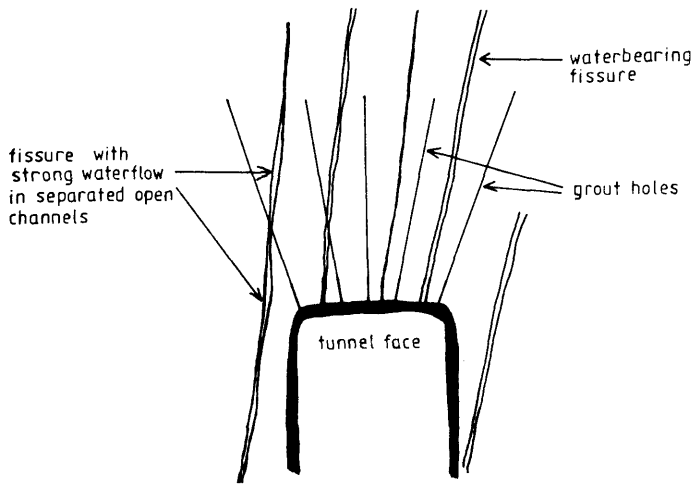
Figure 6a Conventional grouting with fissures parallel to the drift. When the grout holes are conventionally placed and directed the chances to obtain a good sealing of the fissures are small

When the drifts were mapped some substantial leakages were also observed in sections where extensive groutings had been done. An explanation could be, that the drifts, especially the ore drifts, were driven parallel to a large number of fissures which had a bad communication with each other, due to lack of transverse fissures. The forward drilling, which is almost parallel to the drift in this type of pre-grouting, could not intersect all the fissures. Many of these are therefore left ungrouted because of the lack of transverse fissures. An aggravating circumstance for the grouting can also be the water bearing channels along the fissure planes which were observed during the survey (see Fig. 6). It is difficult to achieve good grouting results under the circumstances where bad communication prevailed between the fissures together with a relatively high ground-water pressure (about 1,2 MPa). Good sealing calls for good knowledge, technical imagination and good equipment.

This clearly stresses the need for a grouting method which is adjusted to the rock condition, if the ground-water inflow is to be reduced.

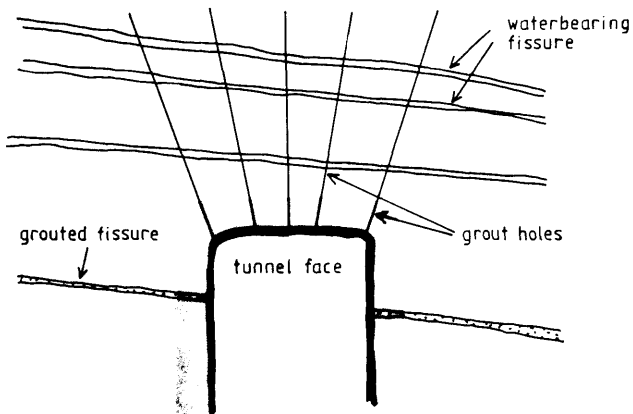
Figure 6b Conventional grouting with fissures perpendicular to the drift. Good conditions to attain a good sealing result. Each grout hole intersects several fissures and the same fissures are intersected in several places

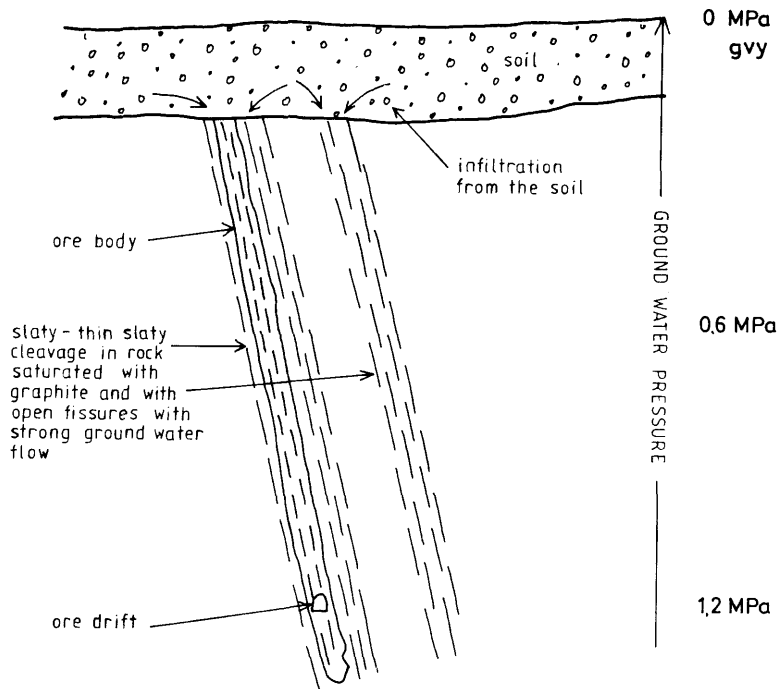
Figure 7 Bedrock and ground water condition around the ore mineralisation

Considering the high frequency of water bearing fissures, the ground-water conditions along the ore mineralisation are very important. It is estimated that the ore drifts are representative of other parts of the ore mineralisation, at least when it comes to the width opening of fissures. The change of ground-water pressure on different levels from the ore drifts are however, very essential.

This study indicated that the strong ground-water flow combined with the high ground water pressure has been the main problem when driving the drifts. Since the water pressure is lower on higher levels the problems with the water inflow will be reduced higher up in the ore mineralisation. The ground-water conditions in the ore mineralisation can be summed up as follows:

The bedrock and ground-water situation around the ore mineralisation is shown in Fig. 7.
