VENTILATION SHAFT WATER INFLOW CONTROL

ROSSARDEN TIN MINE, TASMANIA, AUSTRALIA

Mr Stephen Hancock
B.Sc. (Melb), Cert. E.H. (NSW), M. Aus IMM, FAIG, MIWES
Principal Consultant

Australian Groundwater Consultant Pty Ltd,
Melbourne Victoria Australia

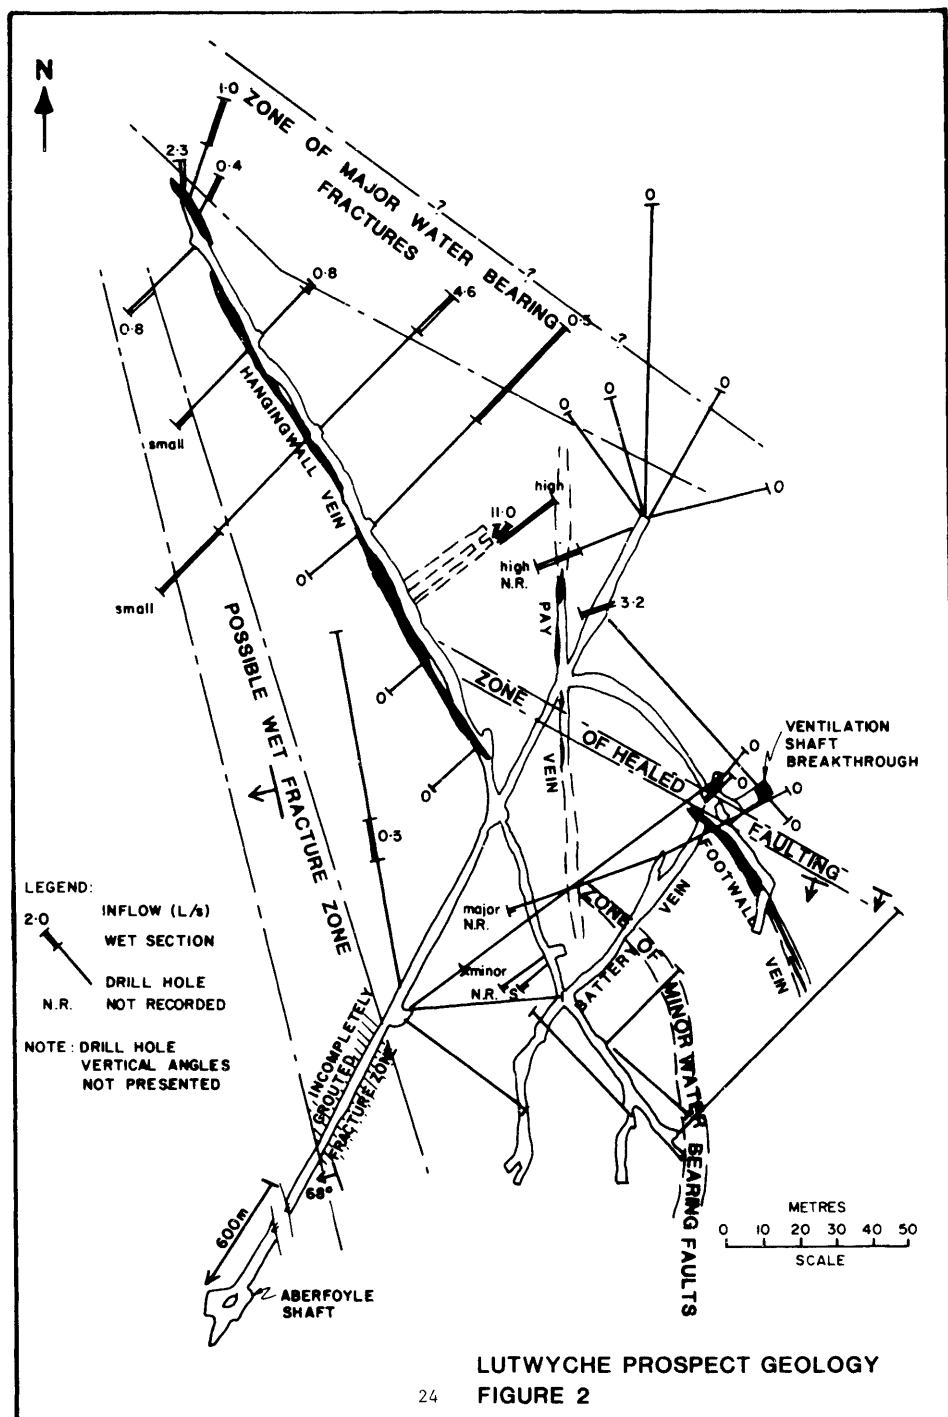
It has been concluded that, even though the faulting and fracturing post dates the mineralization, the Hanging Wall Vein and the Zone of Healed Faulting (Figure 2) have affected the persistence of the fractures as hydrological conduits and fractures east of these structures generally exhibit high sustained flows while those to the south and west only show high initial burst flows.

The Hanging Well Vein and Zone of Healed Faulting dip SW to WSW at 55 - 60°, thus fracturing to the west overlies the present mine workings, while those to the east under lie these structures. This matches observed evidence from workings that flows east of the structures emerge from the lower side. For pressure, hydraulic continuity and storage continuity to be maintained from the surface to depth below the Hanging Well Vein and Zone of Healed Faulting, another structure must exist. This structure has not been identified.

The ventilation shaft was proposed to intersect the Lutwyche Project level immediately adjacent to the zone of Healed Faulting (Figure 2). No geological information existed on the section to be intersected by the shaft. No investigation holes had been drilled for reason of economics.

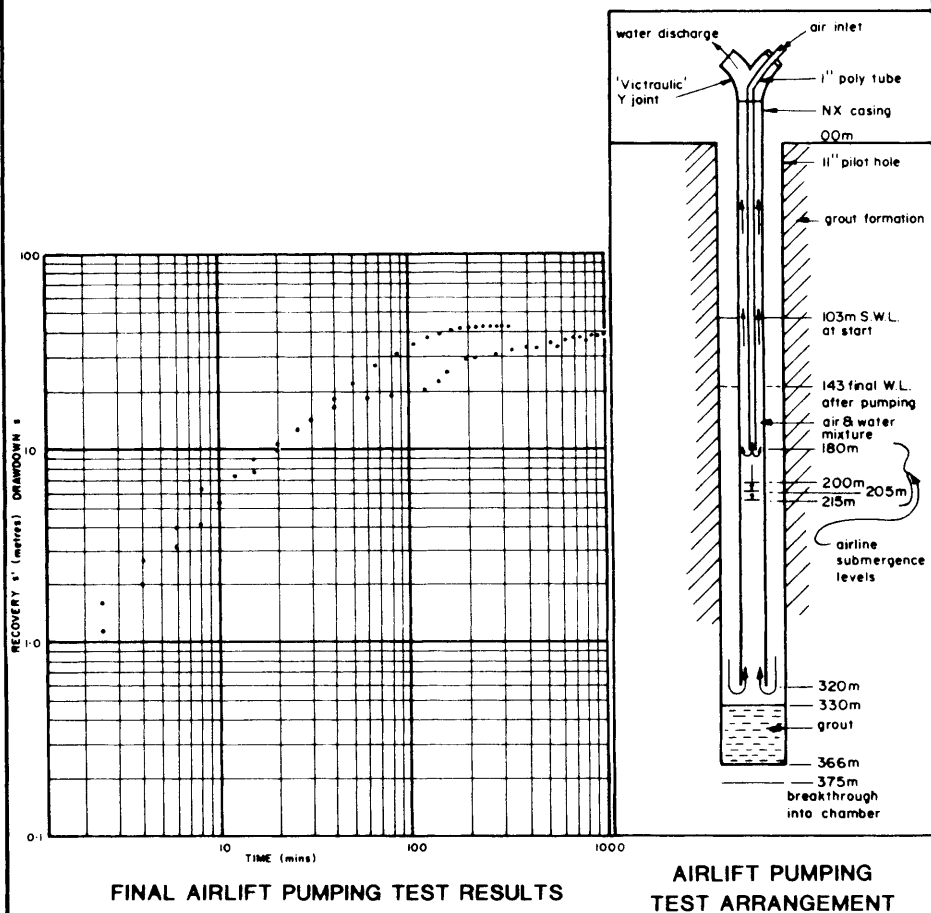
FIGURE 4

An air lift pumping test was conducted with an eductor pipe as shown in (Figure 4) on completion of drilling and in advance of break through. The test was run for 1,060 minutes with the air inductor line being progressively lowered to ensure constant submergence, constant hydraulic efficiency and thereby, constant discharge. The pumping test curve shows the impact of the hole volume in the test results. The pumping test data both for drawdown and recovery were analysed using the techniques of Papadopoulos and Cooper (1967). This analysis indicated a residual fractured rock transmissivity to the hole of 0.5m²/d. Estimating storativity at 1×10^{-1} , the inflow to the shaft at full diameter was estimated at less than 3.8 L/s. The actual inflow recorded on completion of reaming was 3.75 L/s. This inflow falls within the tolerable limit for the shaft and mine operation.
