# **Mine Inundation-Case Histories**

V.S. Vutukuri \* and R.N. Singh\*\*

Department of Civil and Mining Engineering,  
University of Wollongong,  
Northfields Avenue,  
Wollongong,  
NSW 2522  
Australia

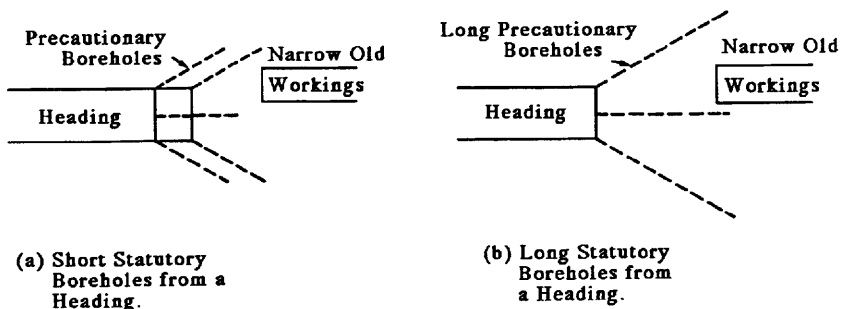
- (i) Short advanced bore holes may leave an inadequate barrier between the blind end of the bore holes and the old workings which may subsequently fail (Figure 1).
- (ii) Long advanced bore holes may completely miss a narrow old workings containing an accumulation of water.
- (iii) An advanced bore hole through highly stressed ground or an outburst prone ground may completely close due to strata pressure thus giving wrong impression that the old mine workings are free of water.
- (iv) There are no statutory provisions for controlling the inflow of water through precautionary bore holes once they have intersected the old workings.

Figure 1 Statutory bore holes when current workings approach water logged workings

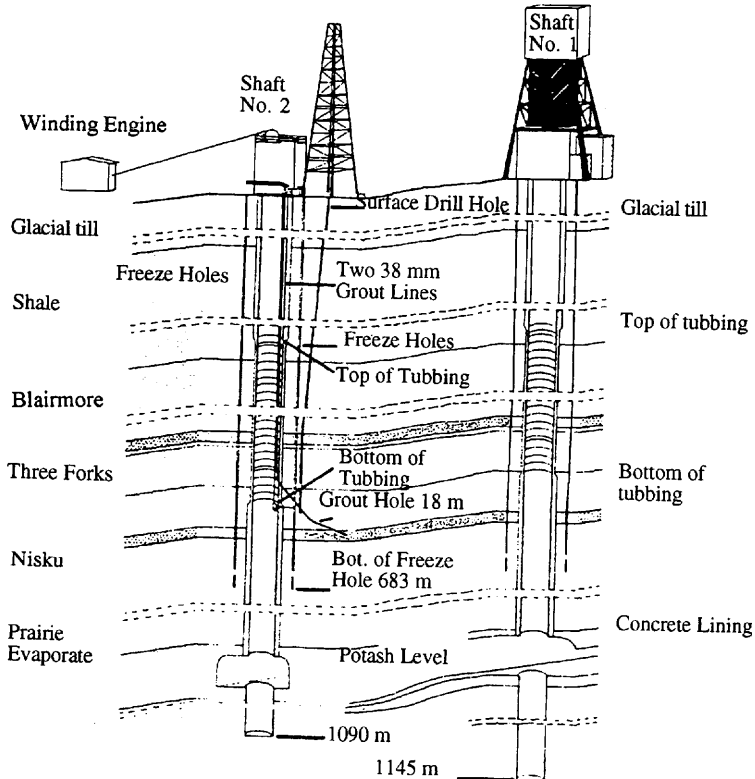
Figure 4 Section through No.1 and No.2 Shafts, Cominco Potash Mine (Prugger, 1979)

On 2nd August, 1970, during routine shaft grouting, a major water feeder was intersected at the bottom of the tubing column. Water and quicksand under very high pressure entered the shaft at a rate of 65 m<sup>3</sup>/min (1083 l/s, Prugger, 1979) and flooded the mine including both shafts. Figures 4 shows the cross section through both shaft showing stratigraphical column and the point of intersection.

The breach was sealed with cement grout simultaneously from and within the shaft through a relief hole drilled from the surface. The mine was dewatered, rehabilitated and the equipment was restored and the production resumed two years after the accident. A total of 515,130 m<sup>3</sup> of brine had to be removed before clean-up and rehabilitation of underground mine openings and equipment could begin. To provide access to the mine, 15,000 m<sup>3</sup> of fine quartz sand and mud had to be removed. One low-lying area was not dewatered, but was abandoned.

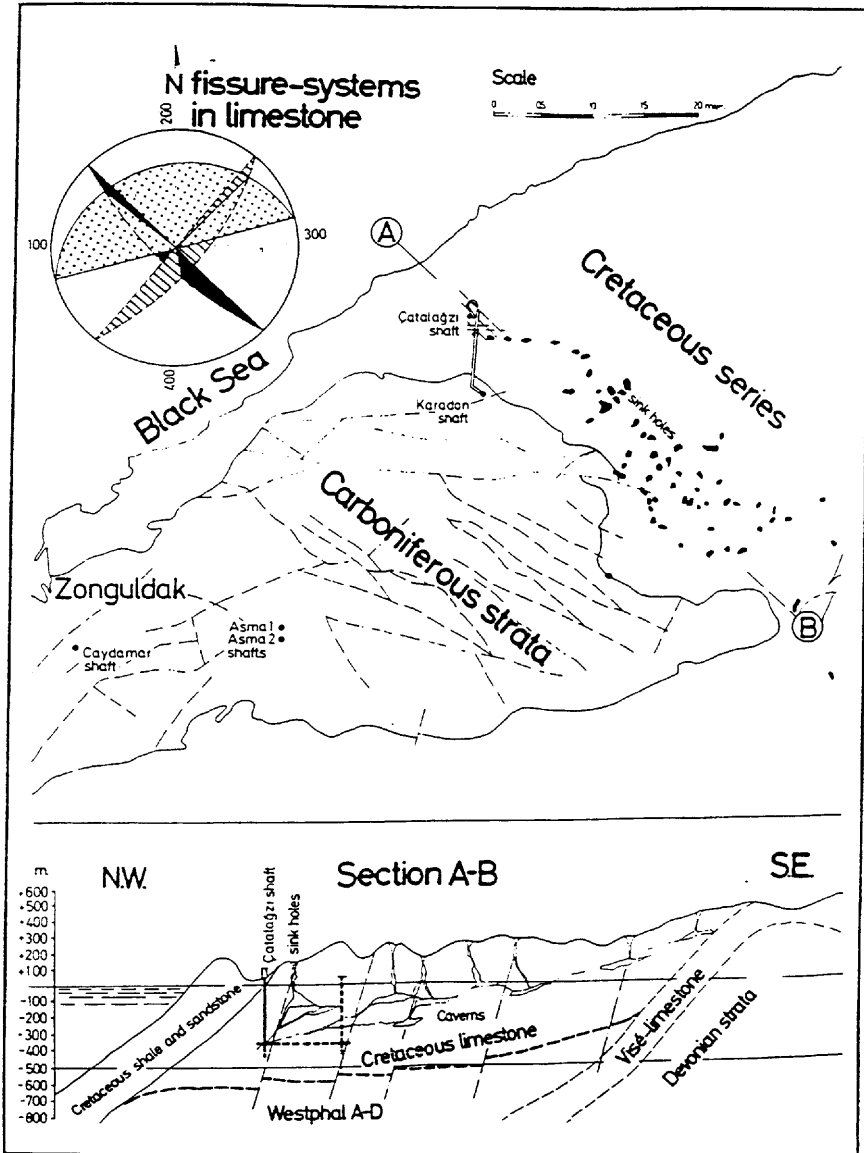
The Catalagzi shaft had an inside diameter of 6.5 m and was concrete lined. As the shaft was sunk through the karstic limestone, extensive grouting work had already caused a delay of 18 months during the sinking due to constant water problems. After sinking was completed the underground loading station loop had to be driven through the vuggy, water bearing limestone and the shaft station had to be connected with the existing mine workings by a main haulage roadway through limestone which dipped at about 30 °. The development work was carried out observing all precautions. Pilot holes were kept in advance of the face and the rock mass was grouted where necessary. After 300 m of drifting through the karst limestone in the loading station loop, a major water inflow occurred. It can be seen in Figure 5 that the karstic limestone forming the basin has many solution caverns and is intersected with major faults. It may also be noted that in spite of these hydrogeological features there were no test holes drilled in the vicinity and at the centre line of the shaft at the time of shaft sinking. During the drivage of the loading station hoop, water rushed in at a rate of 32.5 m<sup>3</sup> per minute. As a consequence, the drift was completely flooded and had to be abandoned.

Figure 5 Geological structure of site 2 in the vicinity of Karadon and Catalagzi shafts (Mattes, 1975)

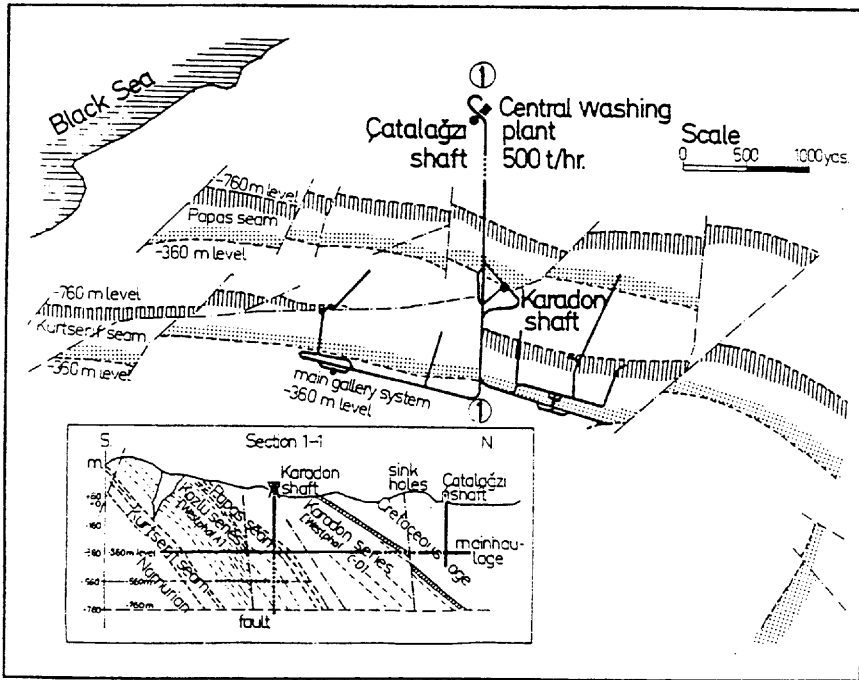
Figure 6 Plan and section of Karadon and Catalagzi section (Mattes, 1975)

The Catalagzi shaft subsequently filled up with water to a level of 16 m below the shaft collar. The shaft was then dewatered by using 11 stage submersible electric pumps with a capacity of  $7.2 \text{ m}^3/\text{min}$ . It may be noted that the help of a diver was needed to remove shaft debris. After two and a half years and four major floods the shaft was secured by a water dam 120 m north of the shaft. In order to isolate the major feeder intersecting the karst aquifer concrete water dams with watertight welded steel doors were required to seal the water feeder. A second water dam was also built on the south side of the shaft and equipped with a water tight door. Only after the shaft had been protected by these dams, the mining of the main haulage to the Karadon mine started. It required  $2\frac{1}{2}$  years using 11-stage submersible pumps and at a cost of \$1.6 million to dewater the mine.

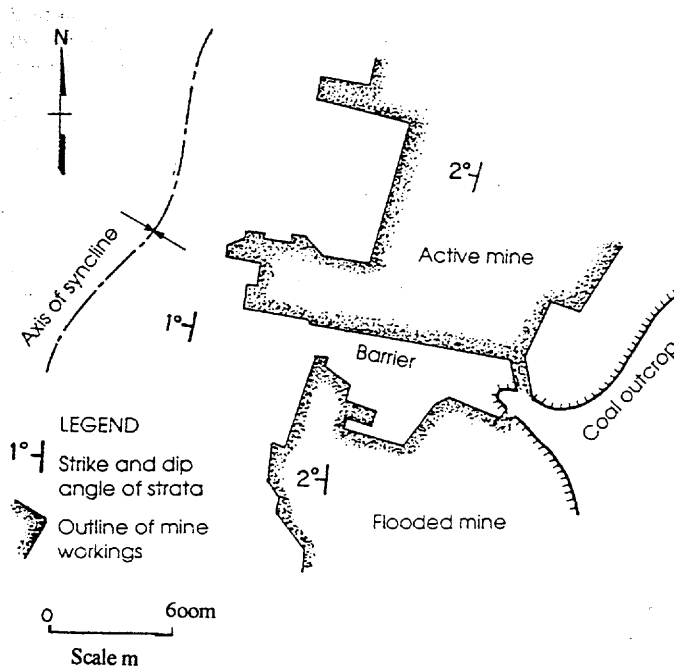
In this mine a barrier of apparently more than adequate dimensions failed to prevent a substantial influx of water from the adjacent flooded mine. Water first entered through roof-bolt holes and slickensides in the roof with only minor seepage through the coal seam. Analysis confirmed that the seepage was mine water rather than ground water. Dewatering the flooded mine was estimated to take a minimum of 180 days continuous pumping at a rate of (63 l/s) without allowing for any recharge.

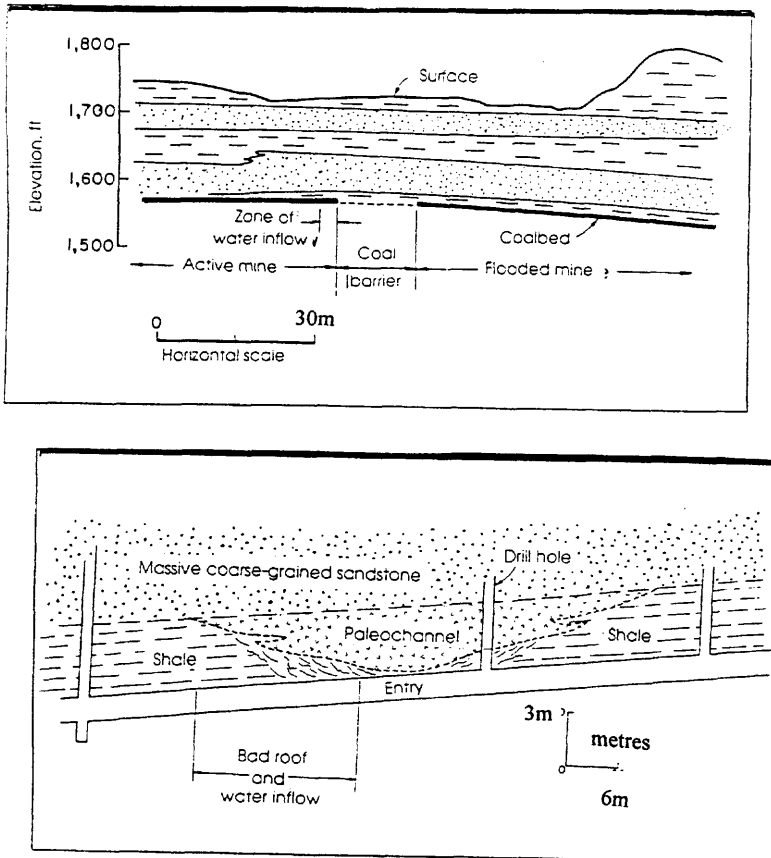
Three bore holes drilled in the mine roof and one from surface revealed a sandstone-filled paleochannel (Figure 8a and b) adjacent to the zone of heavy water inflow. Pathways for the water lay along the margin of the channel where deformation of the roof strata had occurred. Although no evidence was obtained which could confirm the

Figure 8 (a) Transverse profile of the barrier zone (b) Paleochannels in the roof strata of the active mine.

continuity of the paleochannel across the entire width of the barrier, no explanation other than an anomalous, permeable geological structure seemed warranted.

This case example demonstrated that the barrier pillars between the water logged workings and the active working should be free of geological structures and anomalies.

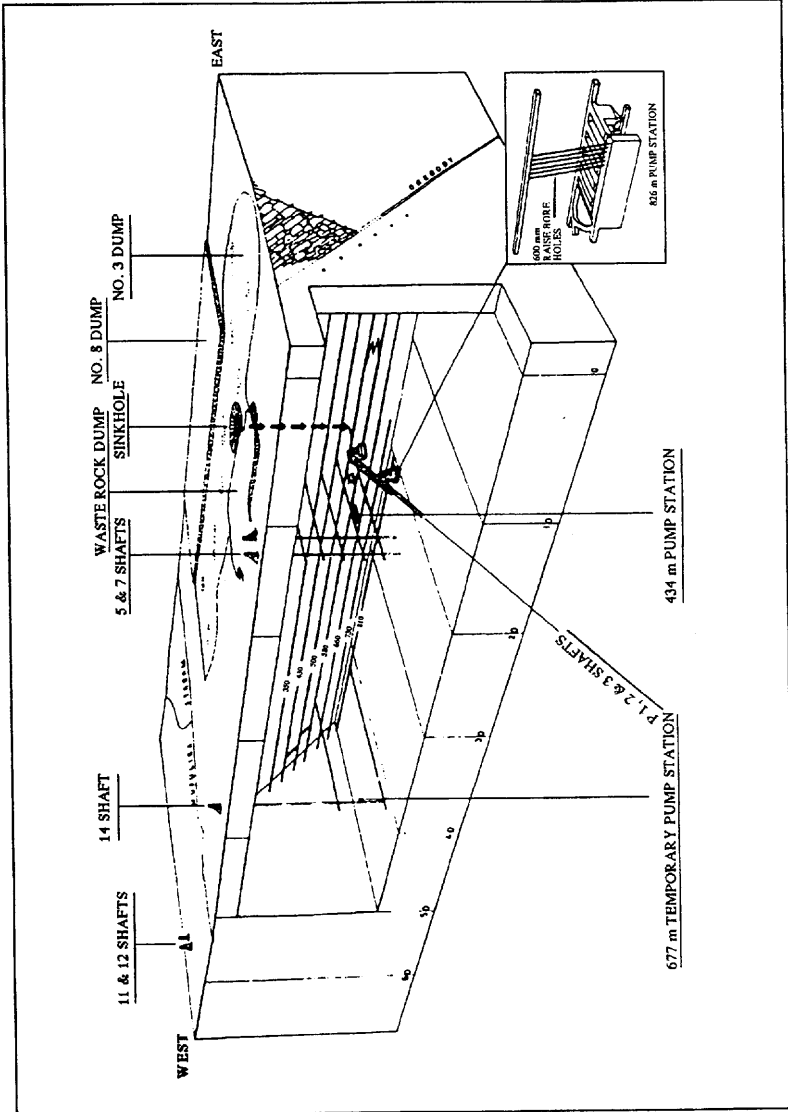
On September 30, 1970, a sink hole appeared on the surface through which a mud flow, composed essentially of concentrator tailings, poured into the mine, killing some 89 miners and causing serious damage to the mine. Within a 15-minute span in the early-morning hours of 25th September, 1970, an inrush of about 453,070 m<sup>3</sup> of mud from the surface flooded much of the Peterson section of the mine, trapping and killing miners and wreaking extensive damage to the mine itself (Figure 9). The bulk of this mud originated from a large accumulation of saturated tailings from the concentrator, which had been impounded on subsiding ground above the mine workings. A sinkhole with an associated collapse chimney developed beneath this accumulation, creating channels leading to the underground workings; through these channels, tailings flowed into the mine through several major ingress points between the 500m and 580m levels, and thence to lower levels via ore passes, raises, and the Peterson shaft system. As a result, the Peterson section filled with mud and water from the 500m level downwards.

Figure 9. Mutulira inrush area showing position of shafts, main levels, pump stations, and the sinkhole on the surface with the probable entry point of the mud and tailing into the mine workings. The inset shows the arrangement for introducing submersible pumps into the sumps (after Neller et al., 1973)

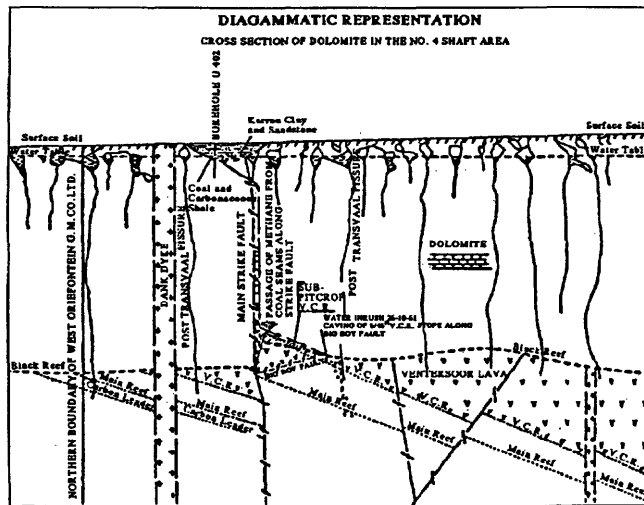
Figure 10 Diagrammatic representation of solution cavities and fissure formation (Cousens and Garret, 1969)

On the morning of 26th October, 1968, an examination of the hanging wall in a stope between 4 and 6 level, No. 4 shaft (Figure 10) at a depth of 863m below surface,

indicated some movement and a small amount of water inflow. At 9.30 a.m. a fissure opened in the stope and large quantities of water rushed into the mine.

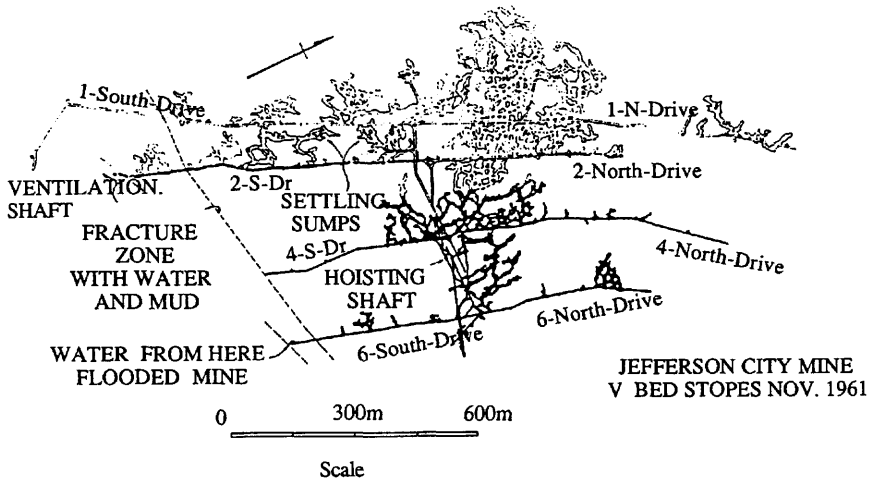
Figure 11 Cross section through Jefferson City Mine ( Miller and Jolley, 1964)

On the south western part of the mine a highly fractured water bearing zone comprising steeply dipping fractures and faults with minor displacements was known to be present. Examination of the exposed fracture zone reveals a series of lenticular voids up to 152 mm in width with the rest of the zone water tight. The pattern of the voids in the plane of the fault resembled a lacy structure. Water, heavily charged with mud and sand, had been encountered within this zone by drill holes during driveage of 1-S, 2-S, and 4-S drifts. Each time the water was controlled by placing packers in the holes. Drilling of precautionary pilot holes in advance of the drift face was, therefore, unreliable. It was believed that at greater depth this zone would be comparatively dry because the fractures and voids would have tightened with depth.

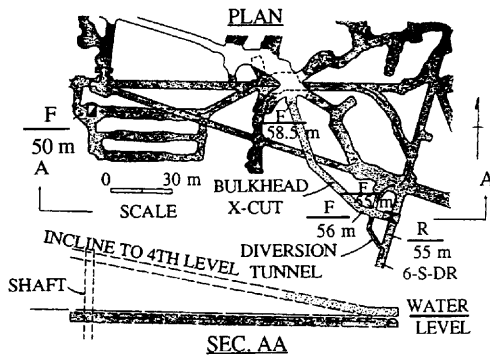
A: Development (stippled area) for 6-S plug required driving a 81 m cross-cut an 25 m diversion tunnel that connected with 6-S drift. Shaded areas represent working full mud

At this point of time, it was decided to build a friction type plug at 6-level South to seal the inflow. To achieve this end, a plan was devised for plugging off the 6-S drift without the need to lower the water level below a 55m datum viz. 6 m above the 6th level station. This plan involved building a large concrete plug in the 6 level south drift from the top of the drift and a small concrete plug with valved pipes in an adjacent diversion tunnel. Both plugs were the friction type with no hitches or reinforcing steels except for some steel pins in the diversion plug. A crosscut 82 m long was driven from a stope which had been cleaned of mud at elevation of 57m, to a point 1.5 m above the back of 6 level south drift. At the elevation of 55m, a 1.8m by 2.4m diversion tunnel 25 m long was then driven both north and south to within one round of connecting with the 6 level south drift. The elevation of the bottom of the diversion tunnel was 54m, the same as the back of 6-level south drift. The detail of the diversion tunnel and the 6-S concrete plug is shown in Figure 12. This operation virtually stopped the inflow and the mine was ultimately dewatered and restored after interruption of production for a period of 10 months.

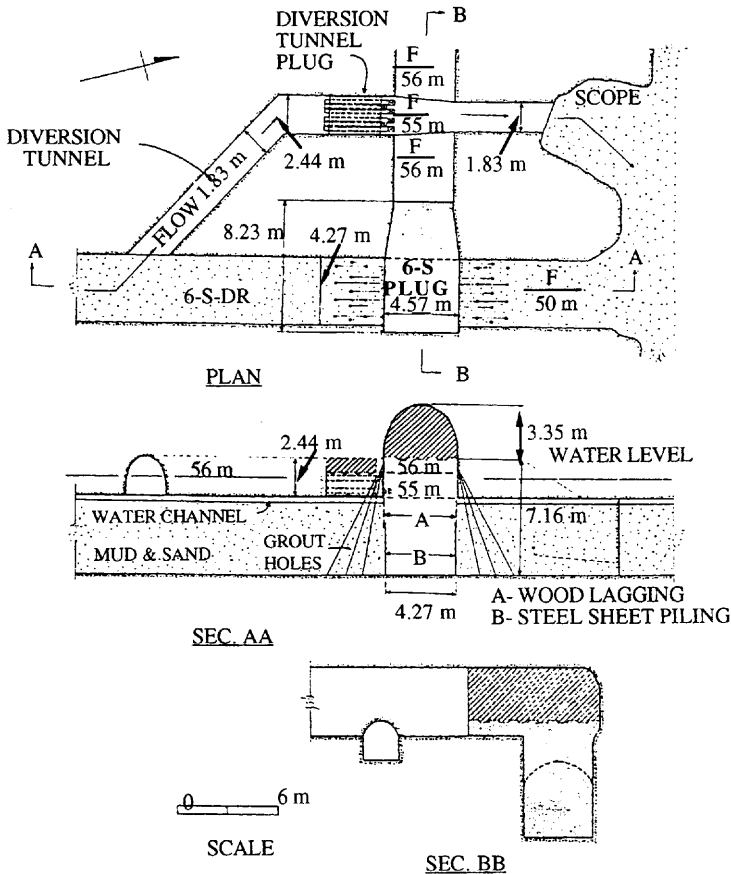
B: Details of the diversion tunnel and 6-S concrete plug
