Identification of Flow Zones Inside and at the Base of a Uranium Mine Tailings Dam Using Geophysics

Erika Juliana Aldana Arcila¹ · César Augusto Moreira¹ · Pedro Lemos Camarero² ·
Matheus Felipe Stanfoca Casagrande¹

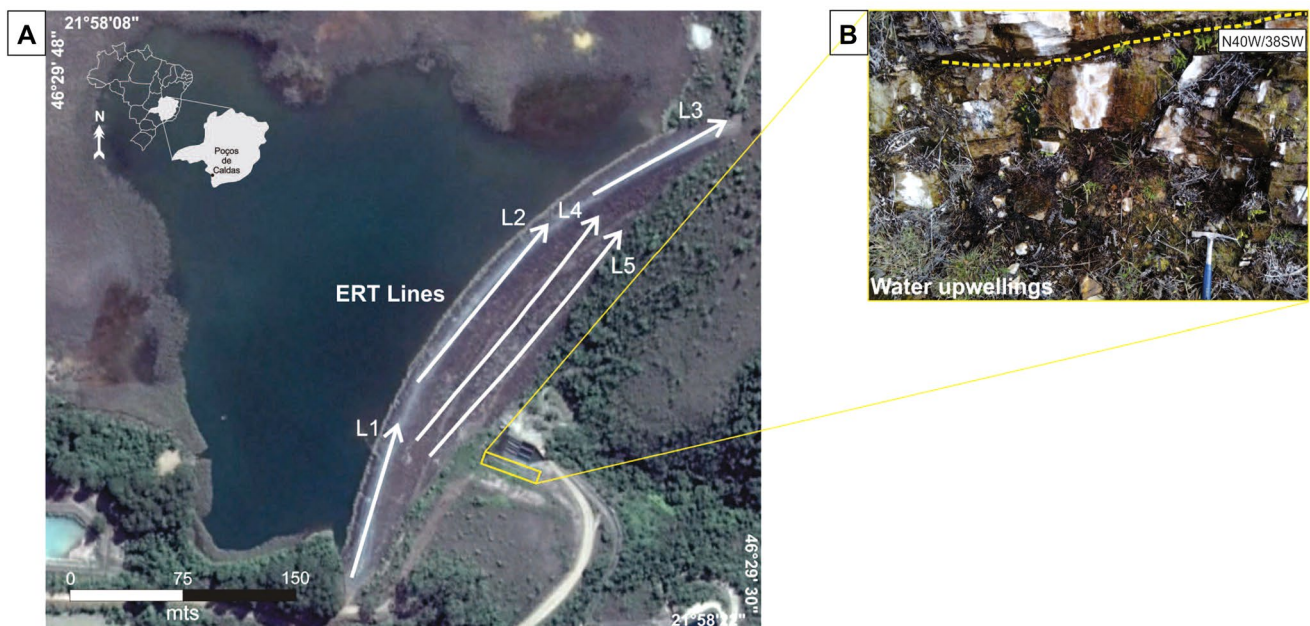
Note that the dam is 42 m high at its central point. Lines 1 and 3 were located close to the dam's embankment, where the original relief of the valley contacts the dam's abutment and the rock massif is variable, and less than 42 m in height. The gap between electrodes was 6 m, based on the estimated dimensions of the body and the desired depth of investigation; the lines were oriented in the SW direction towards the NE. These lines intercept the massif major geologic fracture, where it was possible to identify water upwelling (Fig. 4b).

Fig. 4 **a** Arrangement of geophysical lines in the study area; **b** water upwellings at the rock massif in the dam's foundation

Note that the largest volume of water flows inside the rock massif below the dam and on its left side, and a rocky basement occurs at an elevation of 1290 m (30 m deep) on the sides of the dam. These facts are extremely important for the research, considering that the infiltration occurs on the same side of the fractured massif that presents the water upwellings (Fig. 4b).

As for the upwelling area, chemical analysis of the local water is recommended to establish its possible relationship with the water in the dam, in addition to the planning of a waterproofing system based on the structural pattern and geophysical results.

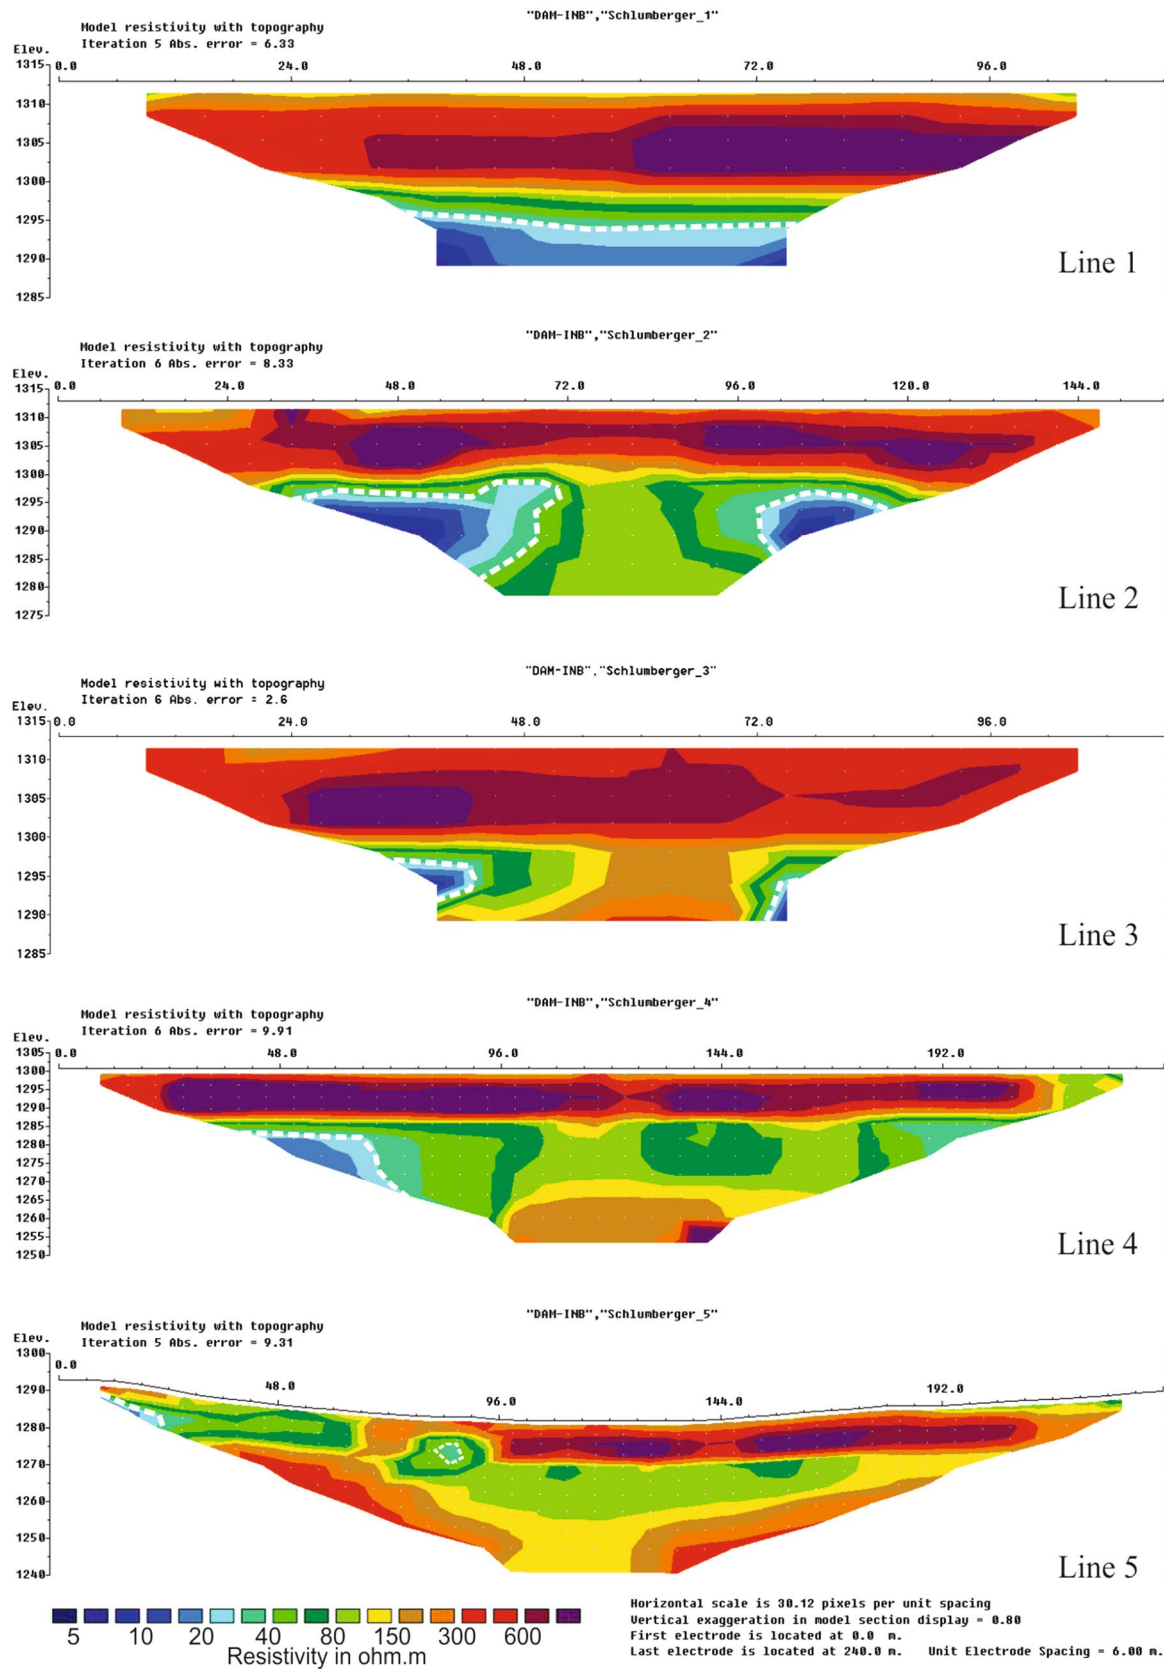
The models showed high resistivity patterns in the upper sections (Fig. 5). Lines 1, 2, and 3 show a thicker upper resistive horizon with values between 300 and 600 Ωm . In the deeper sections, the resistivity decreases considerably with the lowest resistivity values (5 Ωm) downstream and laterally, as indicated in the highlighted areas. The blue colored areas in lines 1, 2, and 3 represent the most significant water flow zones; one can observe the continuity of water flow laterally from an elevation of 1290 m, from line 1 to line 2 and from line 2 to line 3.

Line 4 has a superior area characterized by high resistivity, although it is thinner than lines 1, 2, and 3. From ≈ 15 m deep, it shows a low resistivity area and a zone between 45 and 60 m with less than 20 Ωm of resistivity associated with the presence of water; however, it does not show the significant resistivities associated with large volumes of water flow. Line 5 shows greater lateral variations of low resistivity, with two 20 Ωm areas between 9 and 30 m and 84 and 90 m.

However, all of the profiles had a region with resistivities between 39 and 300 Ωm , between the elevation of 1310 and 1280 m, which could be related to the construction materials of the dam, such as the compacted clay core and the transition system (sand and gravel) connected to

Lines 1, 2, and 3 were at the top of the dam, upgradient of the filter system, while lines 4 and 5 were downgradient of the filter system. In line 5, there are two infiltration zones. The first is round and located at the 1270 m level; it is interpreted as a wet zone resulting from the drainage mat, since it occurs at the contact between the dam's embankment and the massif. The second, on the upper left, is interpreted as an infiltration area in the massif, due to its depth of occurrence and the dam's geometry; this zone is also identifiable on line 4.

Fig. 5 The ERTs inversion with highlight in low resistivity areas

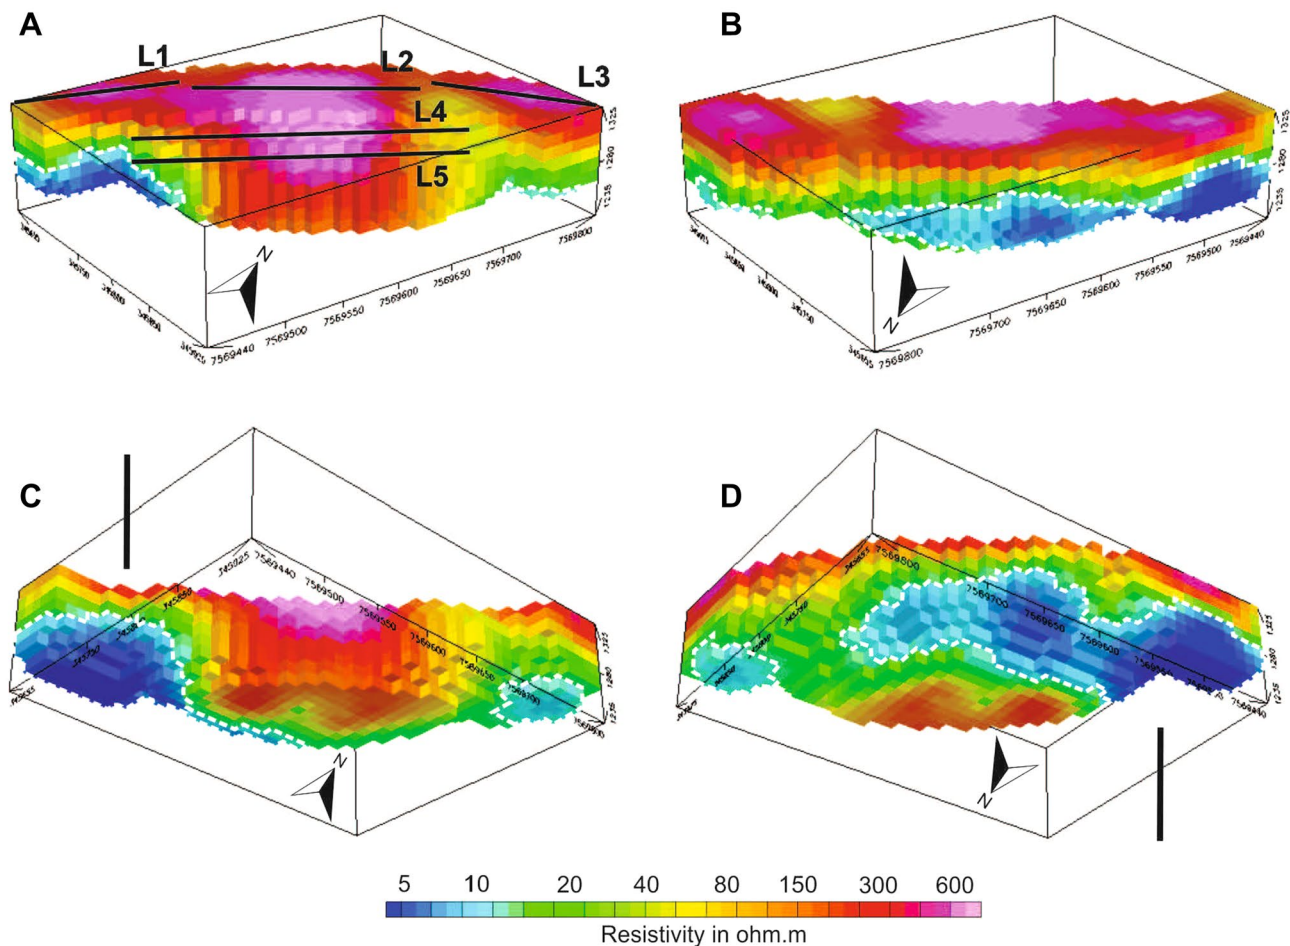
In the frontal view (Fig. 6a), it is possible to observe high resistivity areas (300–600 Ωm) in the upper sections that belong to the rockfill, following the design of the structure. The areas of low resistivity (between 15 and 35 Ωm) on the sides stand out; these indicates the prevalence of water-saturated rock at the ends of the dam. The raised points represent the lowest resistivities (5–9 Ωm) or wet regions. On the left side, there is a significant volume of water compared to the right side. However, the rear view (Fig. 6b) clearly shows two points of low resistivity in the middle portion associated with water flow from 1290 m in elevation. The views of the front and rear base (Fig. 6c and d) suggest that this flow occurs from NW to SE, as indicated by the arrows.

In the same set of images, another significant resistivity zone between 70 and 20 Ωm was identified, on the right side of the dam (Fig. 6a). Although it does not point to the presence and continuity of water flow in the upper sections, it is possible to identify a less resistive zone on the dam's surface

Fig. 6 Model of 3D blocks of electrical tomography: **a** front view; **b** back view; **c** base view; and **d** rear base view

In the view of the front and rear base (Fig. 6c and d), a 9 Ω m point is also observed, indicating the presence of water on this side of the dam. However, according to the elevation, this water is inside the rock massif, below the dam. This flow is probably related to the low resistivities located in the upper sections due to the phenomenon of capillarity; this aspect was analyzed through the multilevel map model generated by the 3D interpolation model (Fig. 7), in which a more detailed model of the dam was produced, where layers of resistivity were selected every 10 m of depth, in order to study the interior of the dam.

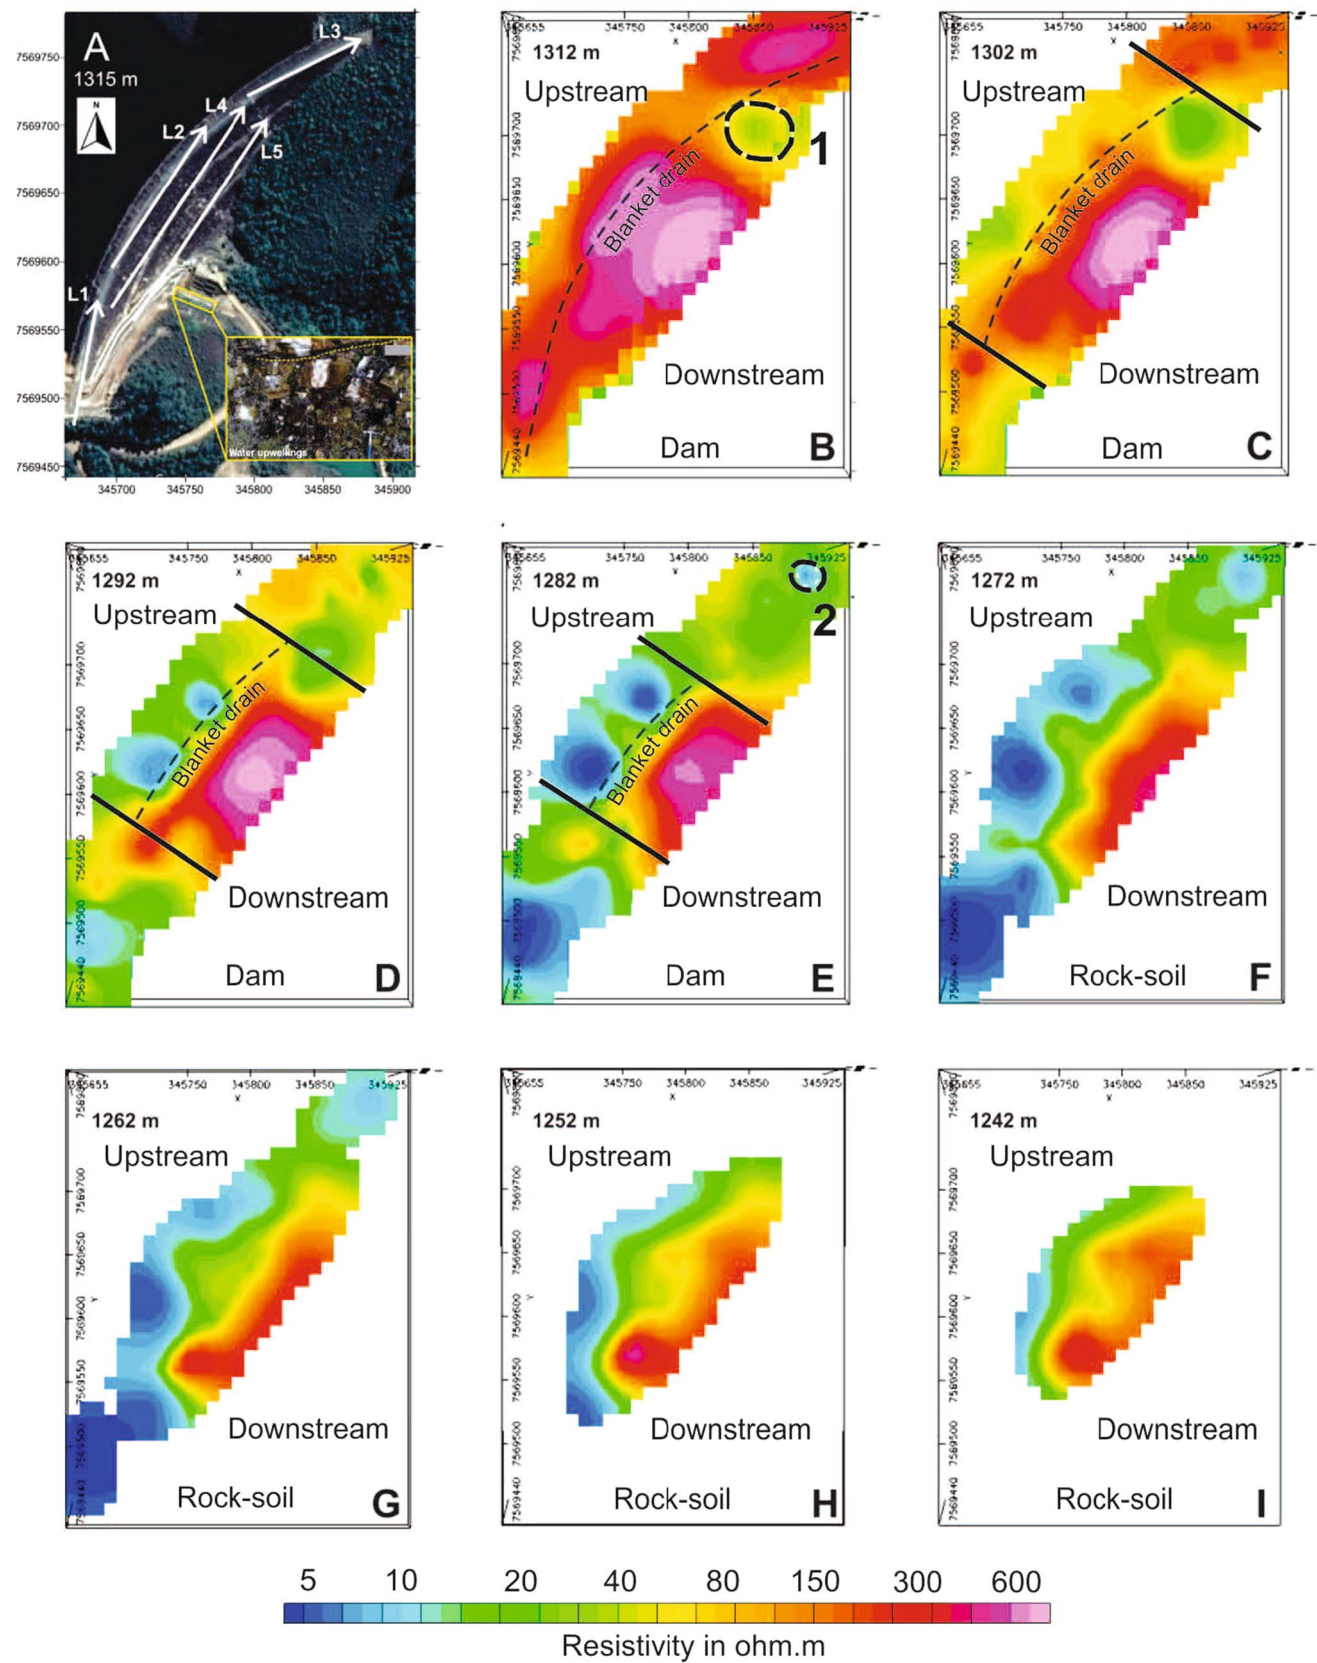
According to Fig. 7d, the dam has zones of low resistivity that indicate the presence of water at four relevant points,

two of which are located inside the dam. However, the function of the drainage mat is to retain the flow of percolated water through the dam and the foundation, and prevent water from passing through the dam body. Figure 7d and e show that the water flow is blocked midway, exactly where the drainage mat is located, demonstrating that the system is functioning properly.

As previously mentioned, the right side of the dam has a less resistive region in the upper sections of the dam, with values up to 20 Ω m in the front region of the drainage mat, as highlighted in Fig. 7b; this increases with depth (Fig. 7c and g). In Fig. 7e, f and a second region is also indicated, which has resistivity values of 6–10 Ω m, indicating the presence of water. An analysis of Fig. 7f and g indicates that the water flows laterally, descending from NE to SW.

The least resistive section (5–9 Ω m) is on the left side of the dam, where there is a significant volume of water. Figure 7d and e show three low resistivity locations in the central and left side, and a significant increase in depth in the NW to SE direction. The presence of such anomalies,

Fig. 7 3D interpolation model, with 10 m depth increments: **a** Arrangement of geophysical lines in the study area; **b** 3D interpolation model at 1312 m; **c** 3D interpolation model at 1302 m; **d** 3D interpolation model at 1292 m; **e** 3D interpolation model at 1282 m; **f** 3D interpolation model at 1272 m; **g** 3D interpolation model at 1262 m; **h** 3d interpolation model at 1252 m; **i** 3D interpolation model at 1242 m
