# Interpretation of the Failure of the Aznalcóllar (Spain) Tailings Dam

Joaquín Martí<sup>1,2</sup> · Francisco Riera<sup>2</sup> · Francisco Martínez<sup>2</sup>

## Abstract

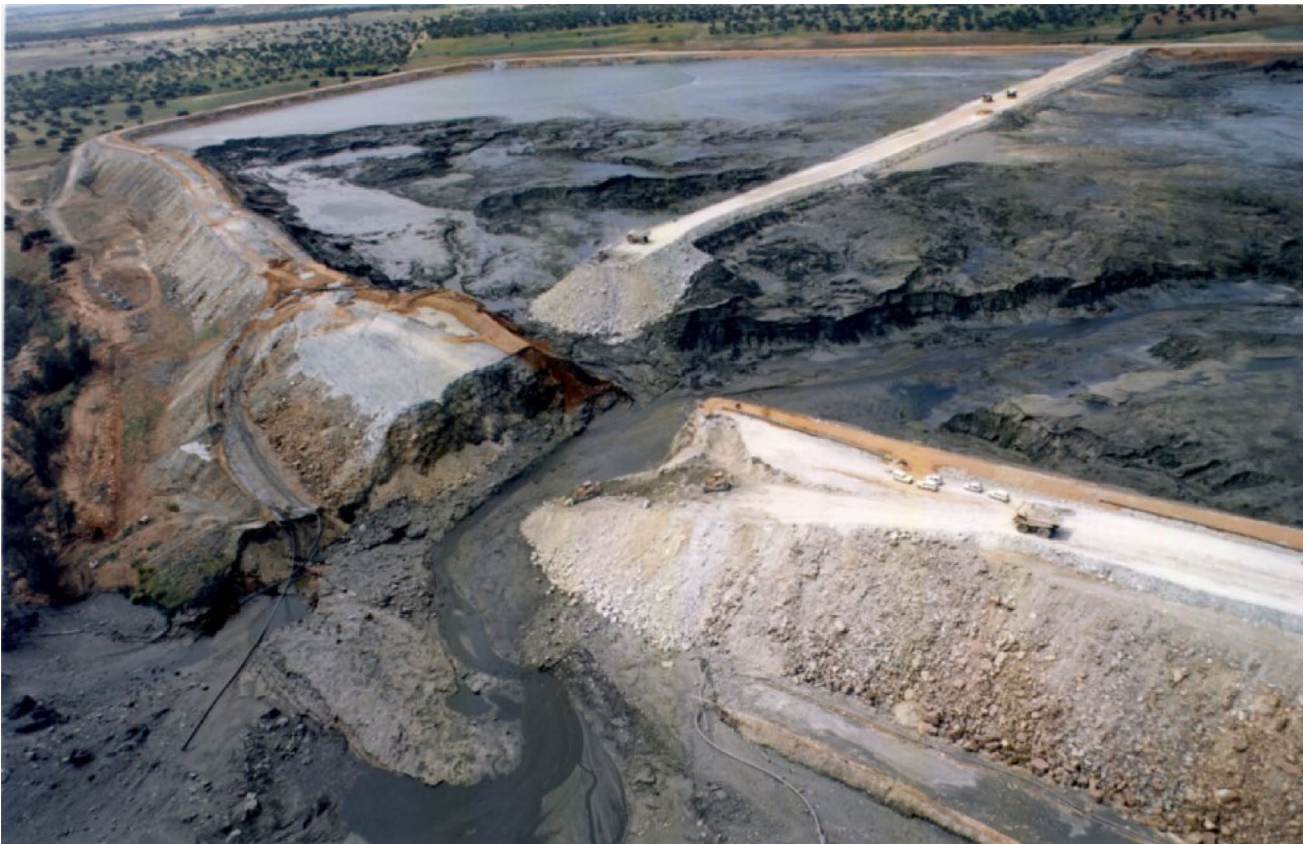
The dam failed during the morning of April 25, 1998, causing a large spill into the nearby the River Agrio; the spilled volumes of tailings and water are estimated at 1.3 and 5.5 million  $\text{m}^3$ , respectively. Failure probably occurred shortly before 01:00, when the power line near the dam toe failed. The maximum outflow took place sometime between 01:00 and 03:00, as evidenced by the peak water level recorded at 03:30 by the staff-gage located 13 km downstream. The outflow discharge ceased around 08:00, when the river flow at the staff-gage started to decline, returning to normal by 18:00. Figure 6 presents a photograph of the breach.

**Fig. 6** Breach produced by the failure

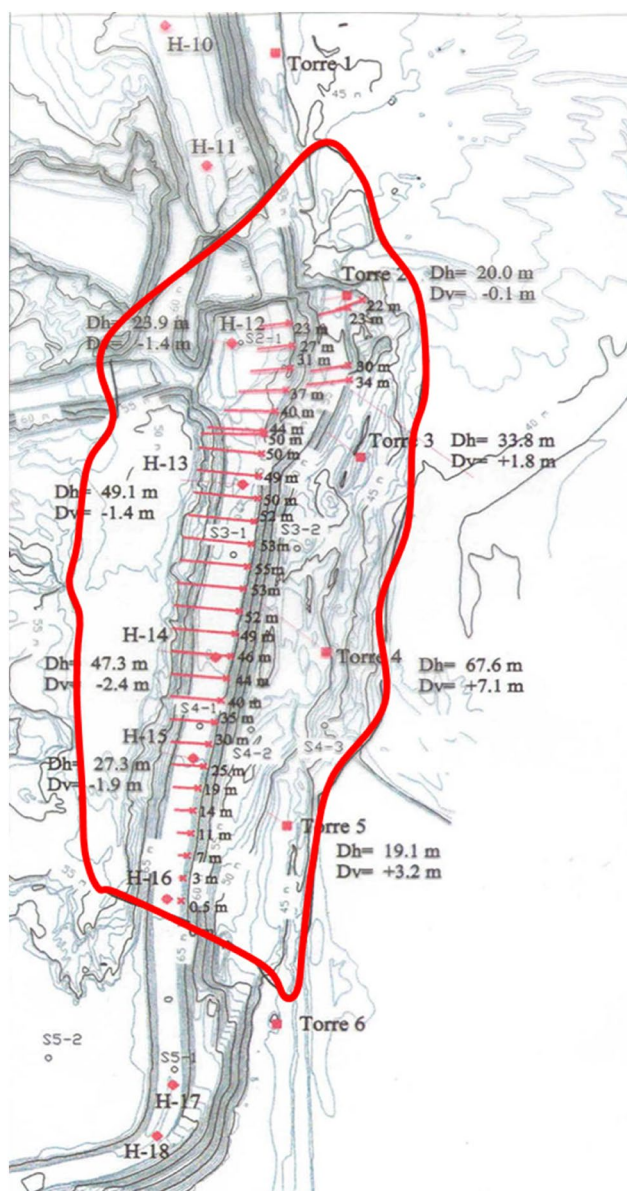
During the failure, the dam experienced up to 55 m of lateral displacement, with few distortions, along a 700 m long segment of the east dam of the pyrite pond (Fig. 7). The dam, together with the alluvium layer and the upper 10 m of clays below the alluvium, formed a block that slid along a near-horizontal surface in a direction approximately perpendicular to the dam. Figure 8 shows the cross-section of the dam before and after the failure. These two figures are adapted from Alonso and Gens (2006a).

**Fig. 7** Plan view of the failure indicating dam displacements (adapted from Alonso and Gens 2006a)

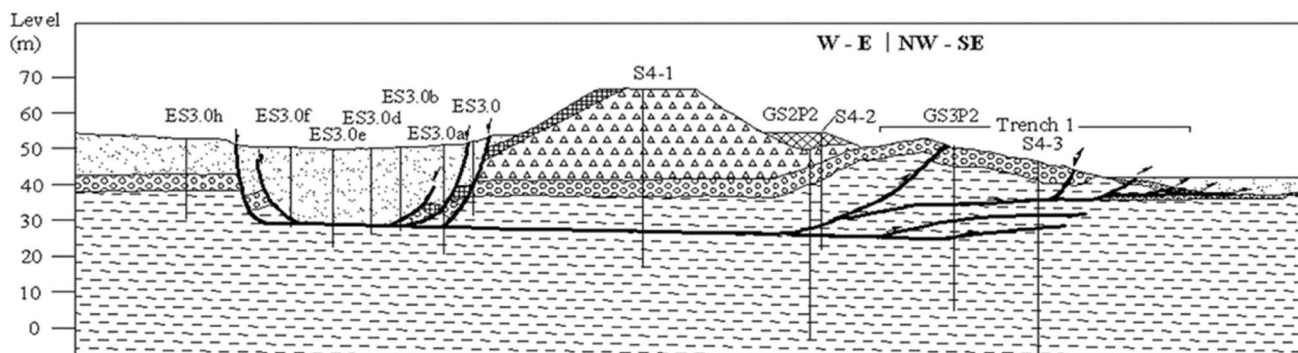
**Fig. 8** Final geometry of the observed failure and initial position (adapted from Alonso and Gens 2006a)

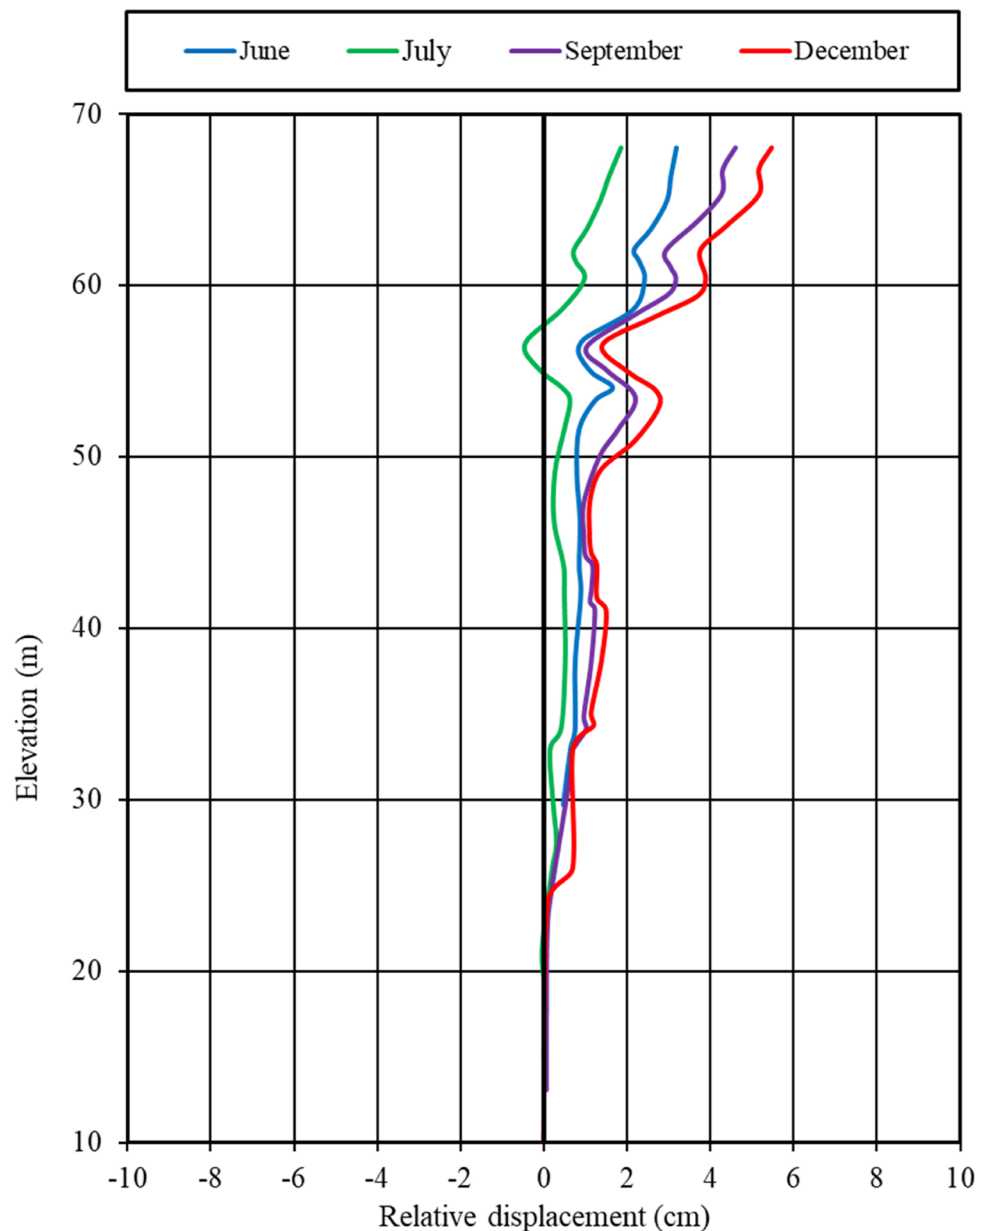
Of greater interest was inclinometer I-3, since it was located in the area that suffered the largest displacements. Figure 9 shows its traces during the monitoring period, starting in December 1996. Unfortunately, inclinometer

**Fig. 9** Traces from inclinometer I-3

I-3 was damaged at a depth of about 5 m shortly after January 1998 and provided no data thereafter. At the end of 1997, I-3 was experiencing a uniform displacement of 1 cm from elevation 25–50 masl; above 50 m, the displacement grew, with some oscillations, to reach about 5 cm at the top of the dam (i.e. at an elevation of 68 m).

The shallower feature of the inclinometer trace consisted of gradually increasing displacements, starting at about elevation 50 m. This point is about 8 m inside the body of the dam, which suffered no disruptions, even in the course of the large failure displacement. The most likely origin was a local disturbance, produced by the ongoing construction, perhaps involving rearrangement of schist blocks and buckling of the inclinometer tube.

The deeper feature was a displacement of about 1 cm at an elevation of 25 m, about 3–4 m deeper than the plane where the sliding occurred. This discontinuity, although small, is more suggestive of a failure mechanism being activated within the clay. Interpreting this feature presents some problems, though, as any calculations must be based on the local increase of the levels of the tailings and water. Over this period, the level of water increased 0.95 m, from 65.50 m to 66.45 m. It seems that no tailings were placed in the failure area over this period; hence, for quantitative comparisons, it will be assumed that the displacements recorded were caused by a 0.95 m increase in the water elevation in the pond; while the increase in water level was taking place, tailings elevations were between 24 and 26 m. Although potentially useful in the context of a forensic investigation, the impending character of the failure would have been difficult to infer at the time from the readings of inclinometer I-3.

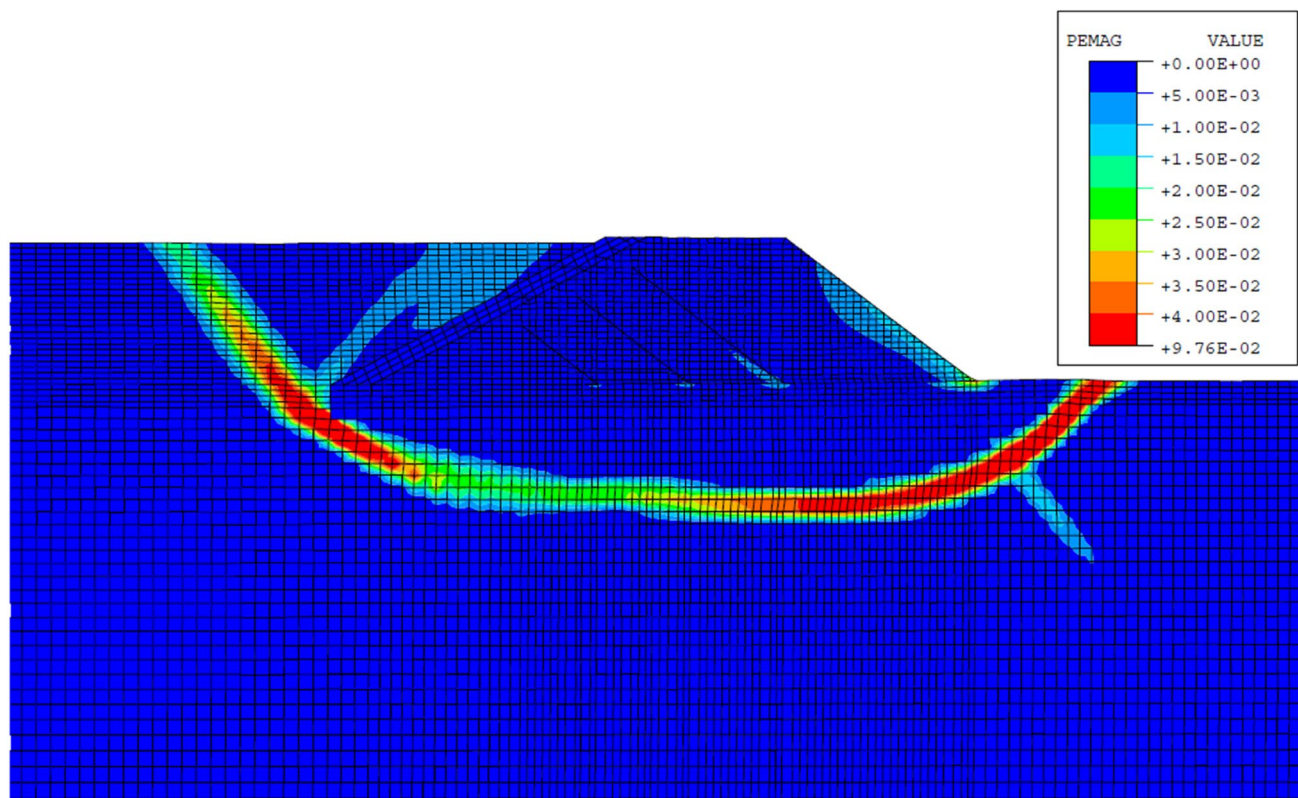
Figure 11 shows a typical result, using in this case a peak cohesion of 65 kPa. It depicts the levels of plastic strains immediately before failure, which occurred when the dam was 25 m high. The coefficient of consolidation was  $0.001\text{ cm}^2/\text{s}$ , residual friction was reached for 0.02 strains, and residual cohesion for 0.001 strains. As the figure shows, the strain levels are such that the strength has already decreased to its residual value at all points of the failure surface.

From the upstream toe, the failure is very well developed and curves rapidly to become more horizontal within the clays. Around the downstream toe, the failure surface is a typical deep surface under the toe which, rather than continuing its curvature upwards through the dam, finds it easier to link up with the incipient failure surface going through

Fig. 11 Plastic strains at about 25 m ( $C_v = 0.001\text{ cm}^2/\text{s}$ ;  $\epsilon_c = 0.001$ ;  $\epsilon_\phi = 0.02$ )

the upstream toe. The central part of the failure is the last one to develop. The linkage of the two, initially independent, failure surfaces results in a rather planar surface, which in this case extends about 16 m below the top of the clays.

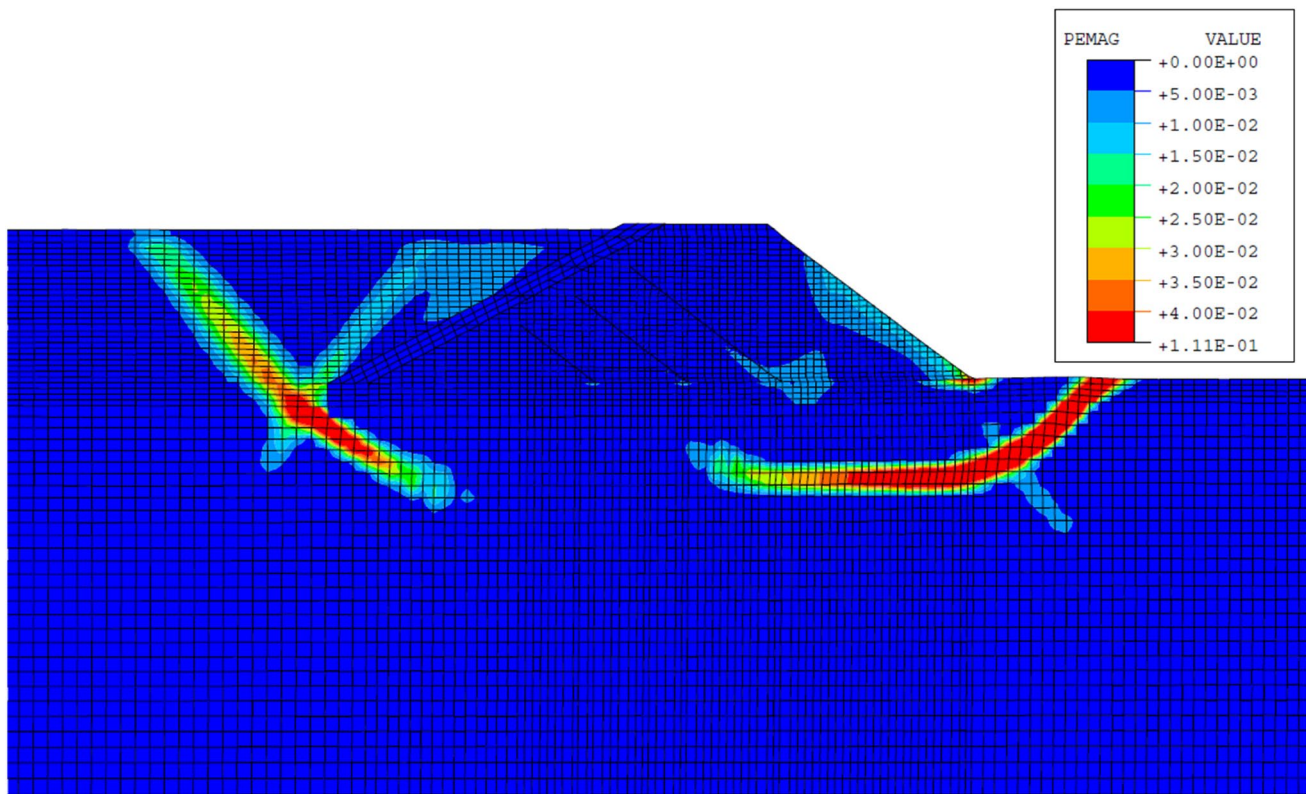
Minor variations in the above parameters maintain the timing and approximate geometry of the failure. However, if the material is sufficiently ductile, failure does not occur, even when the dam reaches 27 m in April 1998. Figure 12 shows the plastic strains at that time when cohesion vanishes only for 0.005 strains and the residual friction is attained after reaching 0.1 strains. The failure surface is already developing and only the central upstream region remains intact. The dam is very close to failure and only the residual strengths can be mobilised over a large region of an eventual failure surface. Also, the progressive failure is clear in this figure: a small additional increment in dam height (and in the associated forces exerted by the tailings) will complete the progressively extending failure surface. When this happens, the failure will be essentially planar and will traverse the clays some 12–14 m below the contact with the alluvium.

**Fig. 12** Plastic strains at about 27 m ( $C_v = 0.001 \text{ cm}^2/\text{s}$ ;  $\epsilon_c = 0.005$ ;  $\epsilon_\phi = 0.10$ )

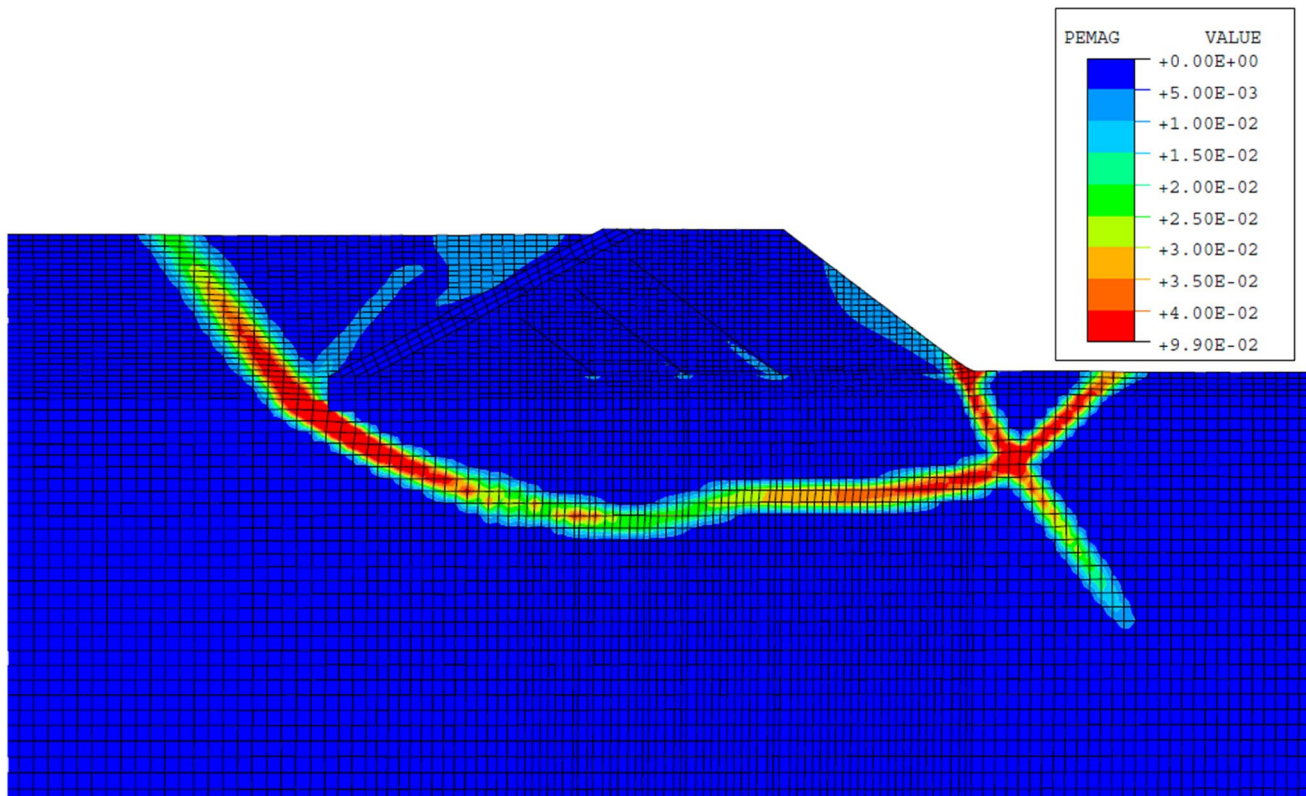
If a marked brittleness is maintained (0.001 strains for the cohesion and 0.02 for the residual friction), avoiding the failure at elevation 27 m requires increasing the coefficient of consolidation to about  $0.00175 \text{ cm}^2/\text{s}$ . At a value of

$0.00150 \text{ cm}^2/\text{s}$ , failure still occurs before reaching the height of 27 m (Fig. 13).

**Fig. 13** Plastic strains at about 25 m ( $C_v = 0.0015 \text{ cm}^2/\text{s}$ ;  $\epsilon_c = 0.001$ ;  $\epsilon_\varphi = 0.02$ )

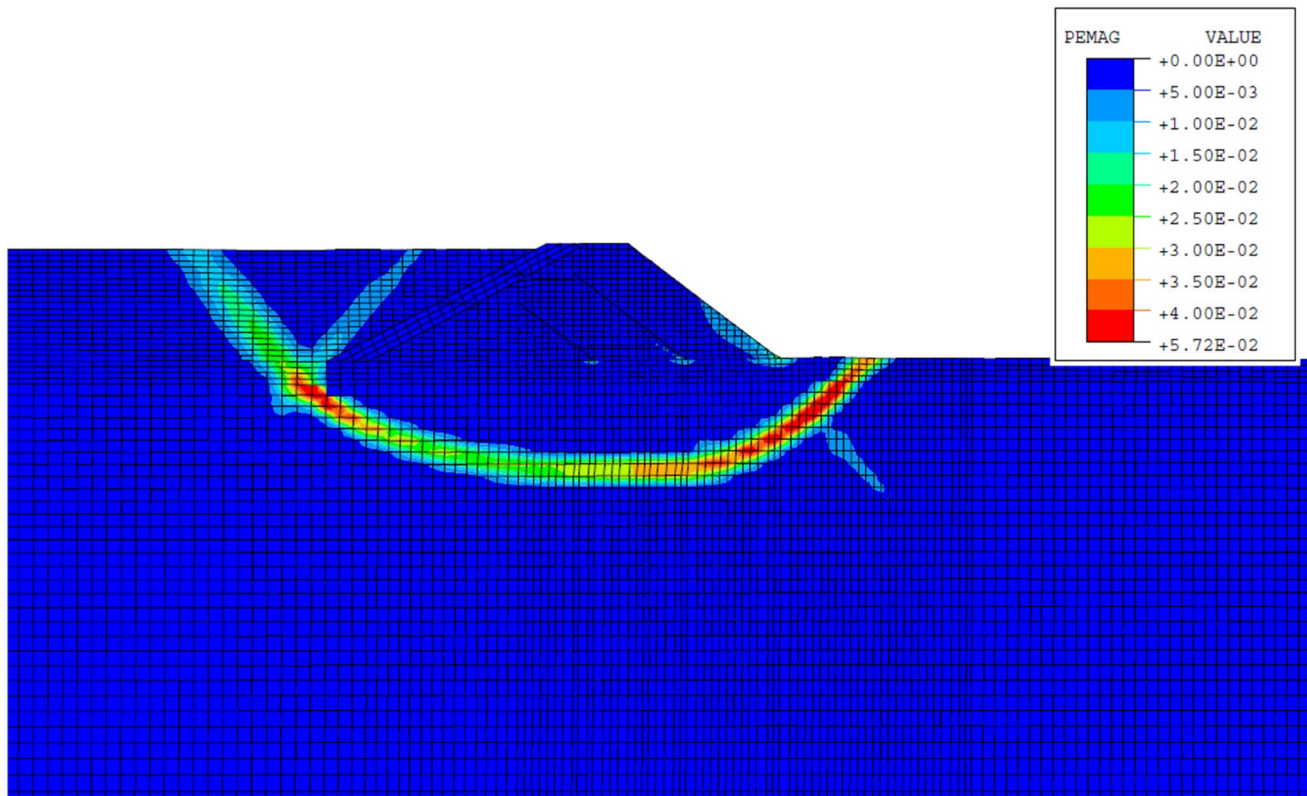
As a final observation, the dam was very near failure in 1987, when it reached a height of 20 m. An analysis was carried out using the values employed by Geocisa (1996a, 1996b), that is,  $\phi' = 22^\circ$  and  $c'_p = 20 \text{ kPa}$ , for the peak strength of the clays. The rest of the parameters were identical to those used for producing Fig. 11. The calculations predict failure in 1987, shortly before reaching the height of 20 m (Fig. 14).

**Fig. 14** Plastic strains at failure in 1987. Peak strengths from Geocisa (1996a, b)

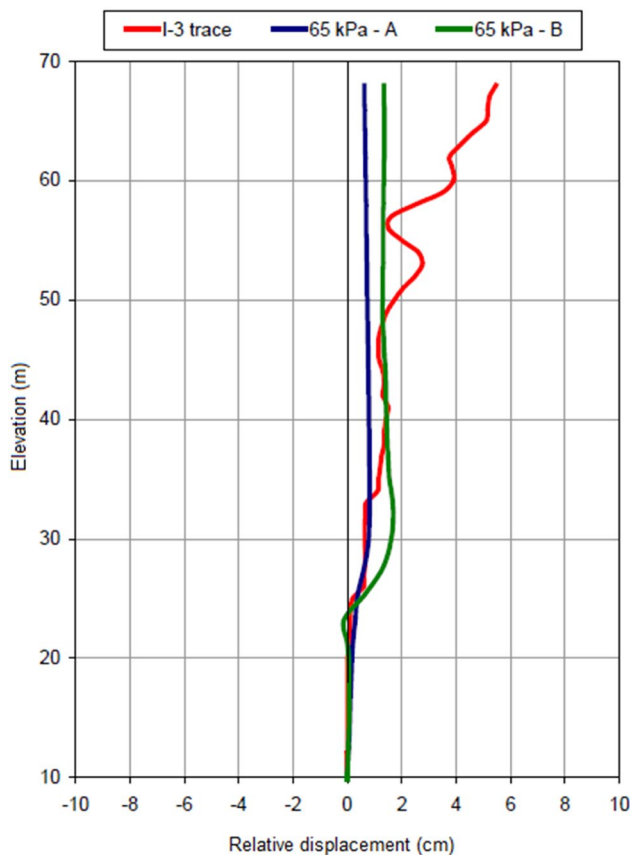
An independent piece of information tends to confirm this conclusion: the displacements recorded by inclinometer I-3 during its 12 months of operation (during 1997). Figure 18 depicts the inclinometer trace, together with two

other traces, which are the expected displacements for a case with very brittle cohesion ( $c'_p = 65$  kPa,  $\epsilon_c = 0.005$ ) when the level of water inside the pond increases by 0.95 m: in one case, this event is assumed to be the first that occurs with the addition of the final 2 m of tailings and water, while in the other case, it is the last one. Both the location and size of the displacement discontinuity are reproduced fairly well. However, a smaller and more

ductile cohesion (even if able to match the timing of the failure) does not yield the discontinuity at the correct depth.

**Fig. 18** Trace of inclinometer I-3 compared to those calculated with local tailings elevations of 24 m (a) and 26 m (b)

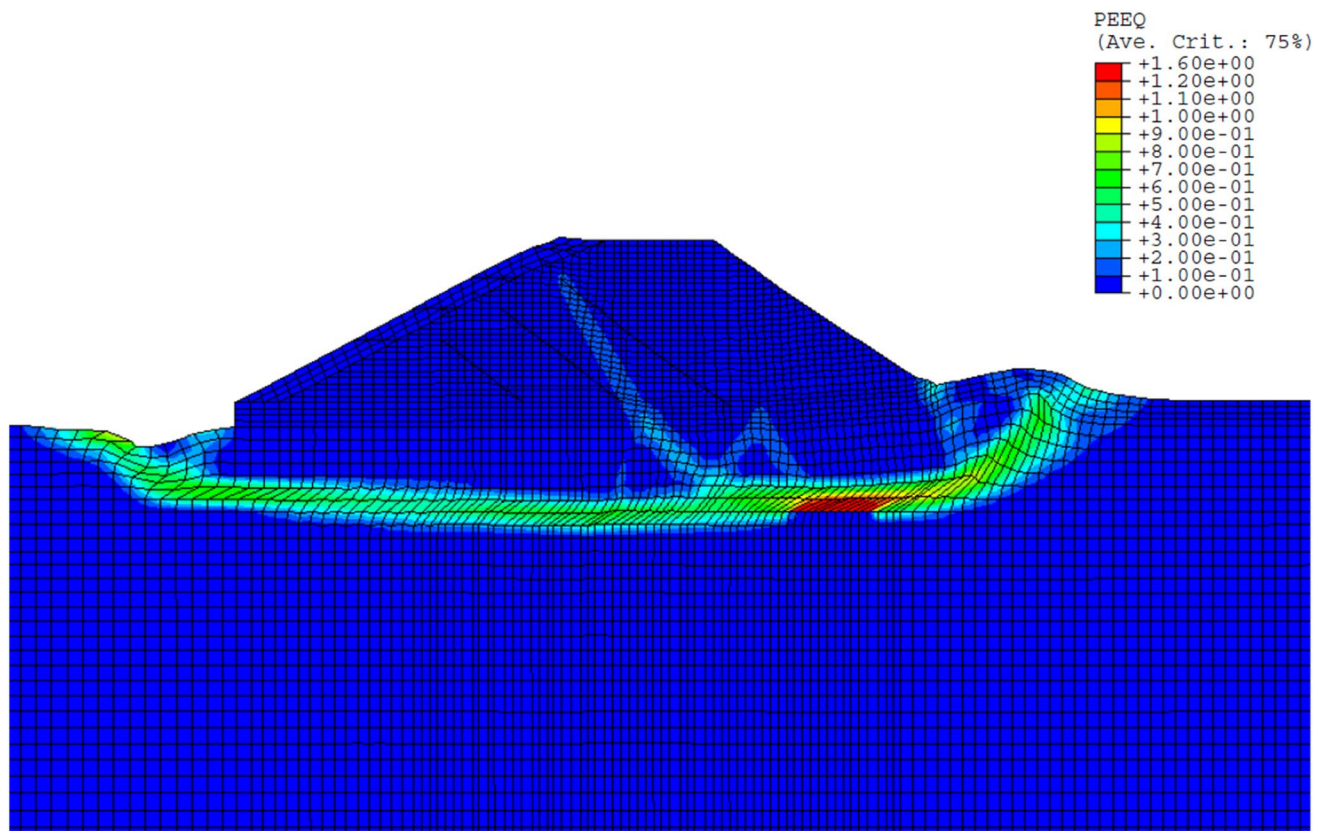
For each of the pre-liquefaction calculations conducted, the tailings were assumed to liquefy providing failure was expected at or around a dam height of 27 m. Then, with the new forces generated by the liquefaction, the evolution of the dam was calculated for the first 5 s. Figure 20 is a typical example of the results obtained. It shows the plastic strains and the displaced dam after 5 s for a case when the coefficient of consolidation was  $0.001 \text{ cm}^2/\text{s}$ ; cohesion disappeared with strains of 0.005 and friction became residual over 0.1 strains. By then, the dam has already moved some 7 m and a passive wedge of materials was building up ahead of the dam. Behind it, a cavity was growing, which would take advantage of any pre-existing subvertical N-S fissures

**Fig. 20** Displaced dam with plastic strains after 5 s ( $C_v = 0.001 \text{ cm}^2/\text{s}$ ;  $\epsilon_c = 0.005$ ;  $\epsilon_\phi = 0.1$ )

to localize the incipient trench. The geometry of the failure is clearly consistent with the observations, even though nothing specific has been done to account for the structure of the clays.

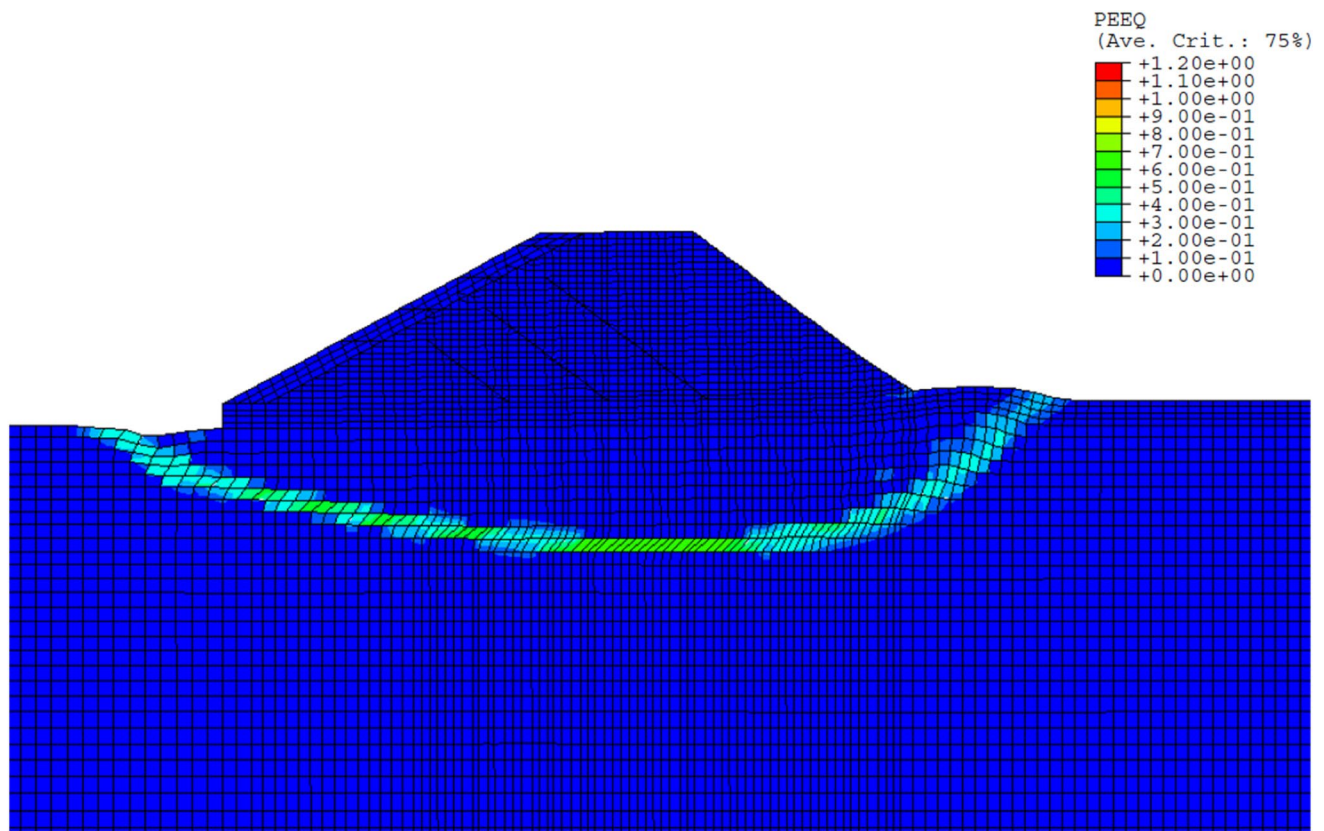
The role of progressive deterioration of the clays was also investigated. To this end, the analysis that gave the results presented in Fig. 11 was repeated, but without accounting for any deterioration that might have occurred prior to liquefaction of the tailings. In other words, the clays were still able to develop their peak strength with liquefaction (Fig. 21). As can be seen, the differences are not very large, but the failure surface is now deeper and more smoothly curved: instead of a plane at 10–12 m, it reaches a depth of about 18 m.

This observation clarifies the role of brittleness relative to the failure surface. Brittleness, progressively activated during the construction, was responsible for the shallow,

planar character of the failure surface. If the same material had somehow been protected from weakening during construction, the failure surface would have been deeper and more smoothly curved. The failure configuration developed from liquefaction of the tailings is partly inherited from the construction history, due to the brittleness of the clays. It is therefore not surprising that models that do not account explicitly for the brittleness of the clays predict failure surfaces that are deeper and more smoothly curved and hence need to assign a greater role to the clays' structure (Alonso and Gens 2000; EPTISA 1998).

**Fig. 21** Displaced dam assuming no deterioration during construction

pressures under the dam. This assumption was in fact wrong and should have been verified. The obvious method would have been to install piezometers that reached into the clays. These would have shown the very slow pace of consolidation and caused a redesign, essentially a wider dam base: since the dam weight did not contribute frictional strength, the only way to improve the sliding stability was to spread the demands over a greater area.
