# Mechanism and Remediation of Water and Sand Inrush Induced in an Inclined Shaft by Large-Tonnage Vehicles

In August 2016, multiple large-tonnage transport vehicles passed through the inclined shaft of the Jinjitian coal mine, Yulin, China, over a short period of time, resulting in fracturing of the floor, bearing capacity reduction, liquefaction of the underlying sand layer, and a serious water and sand inrush. The inrush and its sand content increased rapidly, with flows up to 72 m<sup>3</sup>/h, with up to 16% sand. Fractures appeared in the walls of the shaft and nine subsidence pits formed on the ground surface. As the distance between the shaft roof and floor continued to shorten, the mine faced the risk of flooding. Four remedial measures were rapidly taken. First, where the roof and floor was seriously fractured, cribs were constructed to effectively stop the convergence of the roof and floor. Second, grouting was carried out on the periphery of the shaft sides to seal and block the inrush ducts, reducing the inrush by 52% and eliminating the sand content. Then, the cribs were replaced with arched steel supports for permanent support. Finally, the shaft wall behind the sa

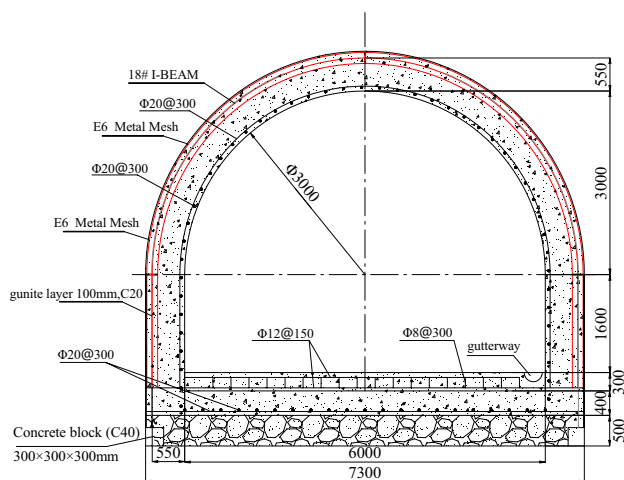
The sub-shaft of the Jinjitian coal mine was completed and put into operation in July 2014. The first 60 m of the sand layer of the inclined shaft was constructed as an open trench, while the deeper (60–350 m) portion of the sand layer was developed using freezing. The sub-shaft had a 5° inclination. The cross section of the 60–350 m section was a straight, semi-circular arch, with a net width  $\times$  net height of 6.0 m  $\times$  4.6 m (Fig. 1). Its roof and sides were supported

Fig. 1 Schematic of the 60–350 m section of the inclined subshaft

using no.18 I-beam steel stands plus a hang net and 100 mm of shotcrete plus a single layer of 550 mm thick, reinforced C40 concrete. The floor was covered in turn with 500 mm of rubble mortar, 400 mm of single-layer reinforced concrete, and 300 mm of doubly reinforced C40 concrete. The continuous transportation of materials and equipment from the surface were realized using trackless rubber-tire vehicles. In addition, the sub-shaft was also used as an air inlet and safety exit.

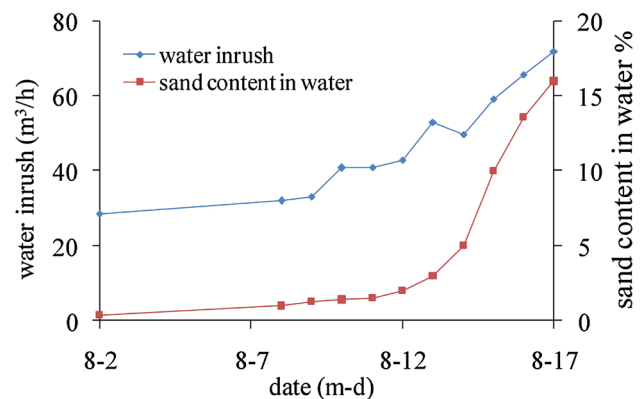
In the early August 2016, a water and sand inrush from the floor developed at the water trench along the 230–300 m section of the shaft as all of the coal-mining equipment was being transported to the working face. Both water inrush and the amount of sand increased over time (Fig. 2). Consequently, the floor developed cracks, the roof fractured, and a water–sand mixture flowed into the mine at rates up to 72 m<sup>3</sup>/h, containing up to 16% sand and multiple fractures developed in the shaft wall. By August 17, nine subsidence pits, with a total volume of 650 m<sup>3</sup>, had developed on the land surface above the 240–290 m section of the inclines shaft (Fig. 3) and the distance between the shaft roof and floor had decreased to 4.0 m.

Fig. 2 Relationships of the measured water inrush and in-water sand-bearing volume to time in the inclined subshaft

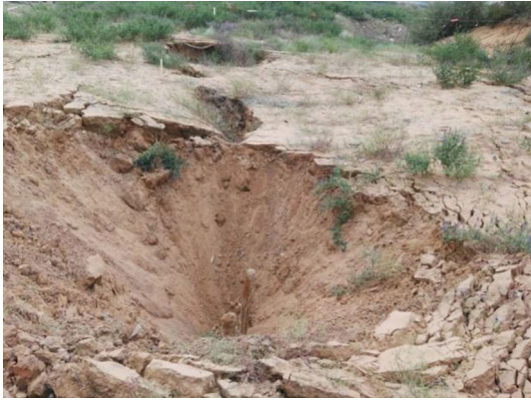
The water and sand inrush sites were located over a wide area at multiple, dispersed sites, but mostly at floor water ditches and fractures. Field observations found that the 300 mm thick concrete bottom and 400 mm thick concrete top had separated, by as much as 50 mm at the ditch of the inclined floor.

**Fig. 3** Site image of ground subsidence due to water and sand inrush from the inclined shaft

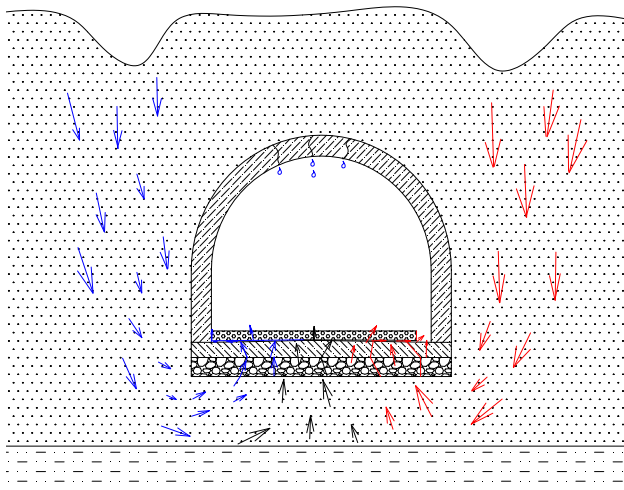
Water and sand inrush developed as multiple large-tonnage vehicles passed through the inclined subshaft in a short time. This suggests that the inrush was induced by the

heavy vehicles, which apparently first caused the inclined floor to fracture, lowering its bearing capacity. As more vehicles passed through the shaft, the underlying sand floor began to lose stability; pore water pressure increased, causing the sand to layer to liquify. All of this led to sand-carrying groundwater to spurt first through the cracks in the floor, and then through the sides of the shaft and then the roof, eventually resulting in surface subsidence. Meanwhile, the cracks gradually widened, further increasing the amount of water and sand flowing into the mine. Figure 4 illustrates the mechanism.

**Fig. 4** Schematic of the mechanism of water and sand inrush from the inclined subshaft

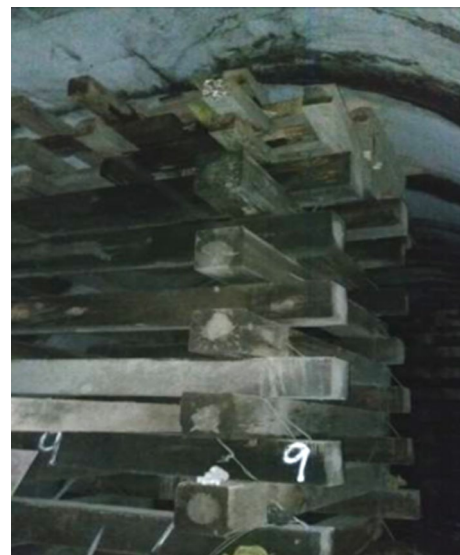
**Fig. 5** Image of the crib construction field

Pine timbers 300 mm wide and 300 mm thick were used to build cribs that were 2.5 m long and 2.5 m wide. The top of the stack were connected the roof of the shaft using wooden wedges (Fig. 5). Ten stacks were constructed on August 17–18, 2006 in the seriously fractured areas of the roof and floor, along the 220–300 m section. Figure 6 shows the measured closing distance of the shaft roof and floor over time at the 260 m section. The convergence of the shaft roof and floor obviously slowed down after completion of the cribbing, indicating that the stack provided good internal support.

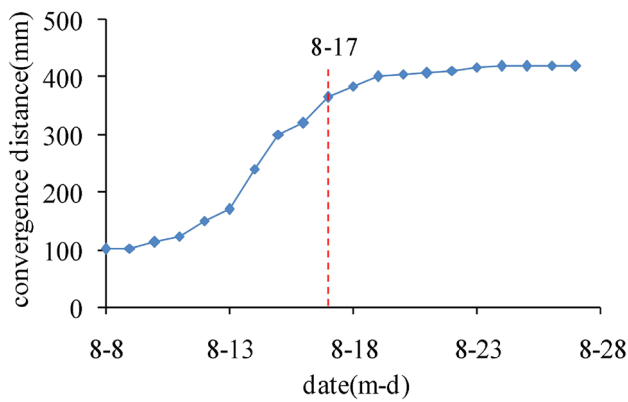
**Fig. 6** Relationship of the measured convergence distance of roof and floor to time at 260 m of the inclined subshaft due to water and sand inrush

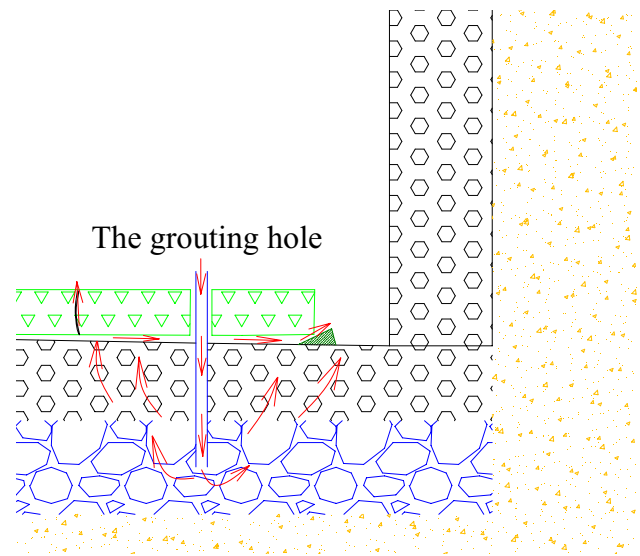
The initial grouting was conducted into the shaft floor near the water and sand inrush sites, followed by the installation of orifice tubes deep into the 500 mm gravel and sand slurry layer. Because the grouting sites were very close to the water and sand inrush sites, the floor was seriously broken and had poor pressure-bearing capacity, resulting in a serious slurry return, obvious floor heave, poor sealing, and blocking of the water and sand inrush sites during grouting, along with newly-produced water and sand inrush sites near the grouting boreholes. Figure 7 shows a schematic of this grouting. During the 24 h of continuous grouting, a total of 20 grouting boreholes were drilled, consuming 36 t of cement and 12 t of water glass slurry. It soon became clear that water inrush and sand content had increased rather than being reduced, indicating that the floor grouting measure was not successful. In hindsight, this could have been predicted. In 2010, at the Yushujing coal mine, 180 km away from the Jinjitian mine, grouting of the floor to seal and block water and sand inrush sites in the main inclined shaft resulted in floor fractures, more water and sand inrush, and the shaft being made useless. Similarly, in 2014, at the Caojiatang coal mine, 15 km from the Jinjitian mine, grouting of the floor to block water inrush sites of its inclined shaft also led to increased floor fracturing and water flow.

**Fig. 7** Illustration of remediation of the inclined shaft floor

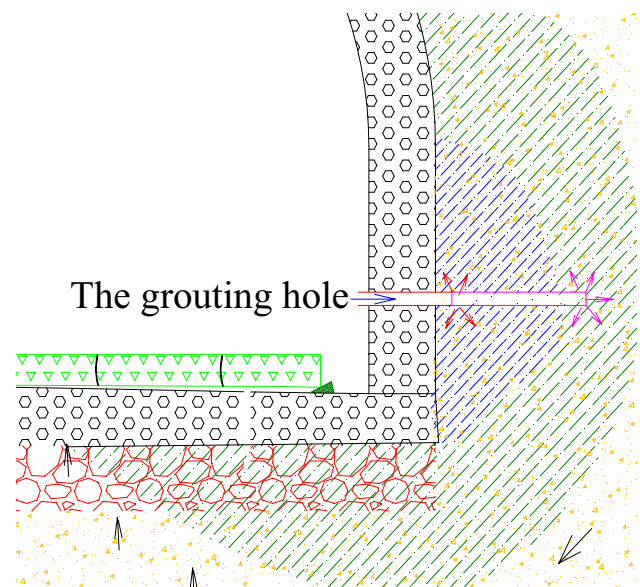
**Fig. 8** Illustration of grouting the sides of the inclined shaft

Since the floor grouting method did not achieve the desired effect, a second grouting effort was initiated on August 18 at the sides of the inclined shaft in the 225–320 m section, with the boreholes 0.5 m away from the shaft floor and spaced every 2.0 m, with priority given to most severe

water and sand inrush sites. Analysis of the water and sand inrush sites showed that water and sands coming through the floor originated from the sides and roof of the shaft. Thus, grouting through the wall into the sides of the shaft using instant hardening mortar could seal and block water and sand passageways. Figure 8 shows the schematic of grouting into the sides of the inclined shaft. A total of 194 grouting boreholes were drilled and a total of 700 t of cement, 180 t of water glass slurry, and 124 t of urea–formaldehyde resin slurry were consumed. Figure 9 shows how both the water inrush and the in-water sand content continuously decreased over time as a result. During the first day of grouting, water

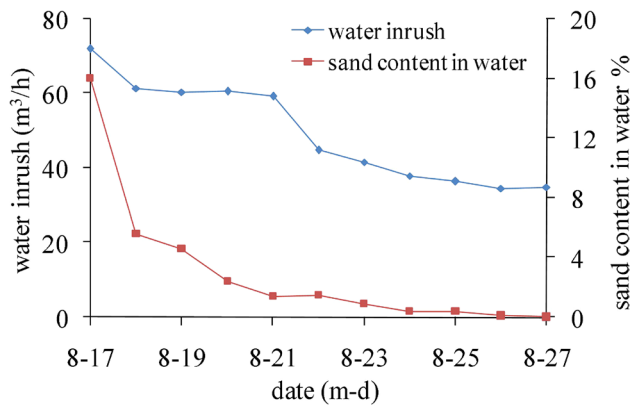
**Fig. 9** Relationships of both water inrush and sand content to time in the inclined subshaft after side grouting

inrush was reduced by 10.5 m³/h and the sand content fell from 16 to 5.6%. On August 27, the water inrush was 34.8 m³/h, and the in-water sand content was undetectable. Because the grouting was so effective, construction of the concrete wall was not necessary.

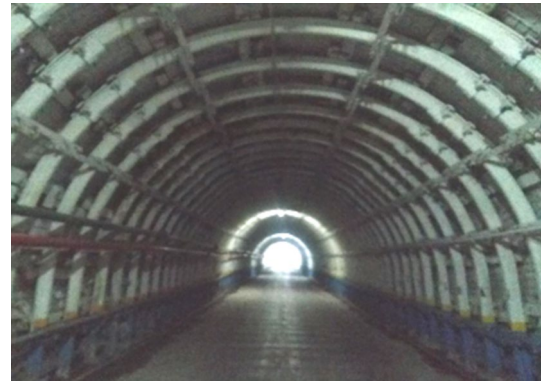
**Fig. 10** Site image of the U-shaped steel supports after construction

The wooden cribbing served as a temporary support and reinforcement. After the sand component of the inrush was stopped, 220 m long U-shaped steel supports, composed of leg, arch, and ground beams, were installed along the 130–350 m section of the shaft as a more permanent means of reinforcement. The leg and arch were made of no. 36 U-shaped steel with lengths of 4.0 and 5.2 m, respectively. The ground beam was made of no.12 U-shaped steel with length of 6.0 m. The U-shaped steel supports were emplaced every 0.7 m of roadway along the 130–240 m section and 300–350 m section of the subshaft, and every 0.5 m of roadway along the 240–300 m section. Figure 10 shows the in-field picture of the U-shaped steel supports after construction.

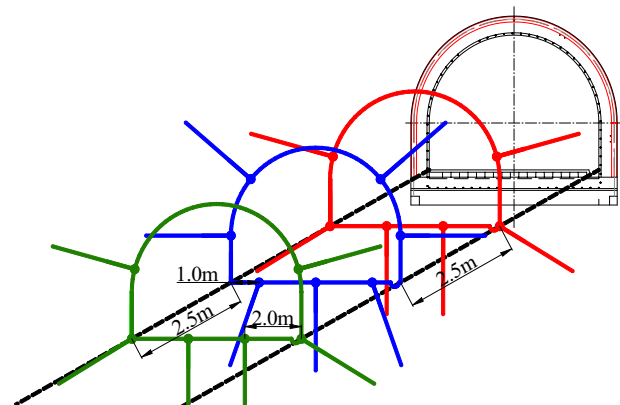
**Fig. 11** Schematic of post-wall sand layer grouting hole

The steel supports made it possible to safely seal and reinforce the floor in the 130–350 m section. Figure 11 shows the schematic of the post-wall sand layer grouting in this section. This phase of grouting work was finished January 2, 2017. A total of 572 boreholes were grouted in the construction section, consuming 3500 m³ of cement–water glass slurry, 2265 t of cement, and 220 t of water glass

slurry. Each borehole was grouted twice: first, when the drilling passed through the shaft wall and second, after the drilling had passed 2.0 m through the in-situ borehole into the post-wall sand layer, with the grouting pressure controlled within 1.0 MPa. No new shaft wall fractures were observed during or after grouting, and the water inrush volume dropped from the previous 34.8 to 2.5 m³/h.

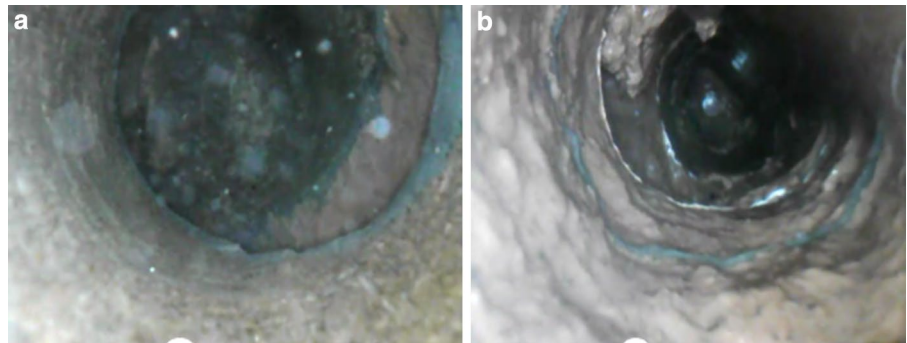
After grouting was completed, 14 detection boreholes were bored into the shaft walls and floor every 3 m along the grouted section and no sand inrush was observed. Furthermore, a borehole camera was used to videotape the interior of the boreholes. Figure 12 shows the hardened grayish vein-like cement slurry as well as the white vein-like urea–formaldehyde resin slurry.

**Fig. 12** Development of slurry veins at the shaft floor and wall at 240 m section of the shaft.

**a** Image shot at the bottom of borehole into floor; **b** Image shot at the 2.5 m depth of borehole into the shaft wall
