SNIP MINE: SEVEN YEARS AFTER CLOSURE

S.J. Sibbick, P.Geo. AMEC Earth & Environmental
R. MacGillivray, P.Geo, Barrick Gold Inc.

ABSTRACT

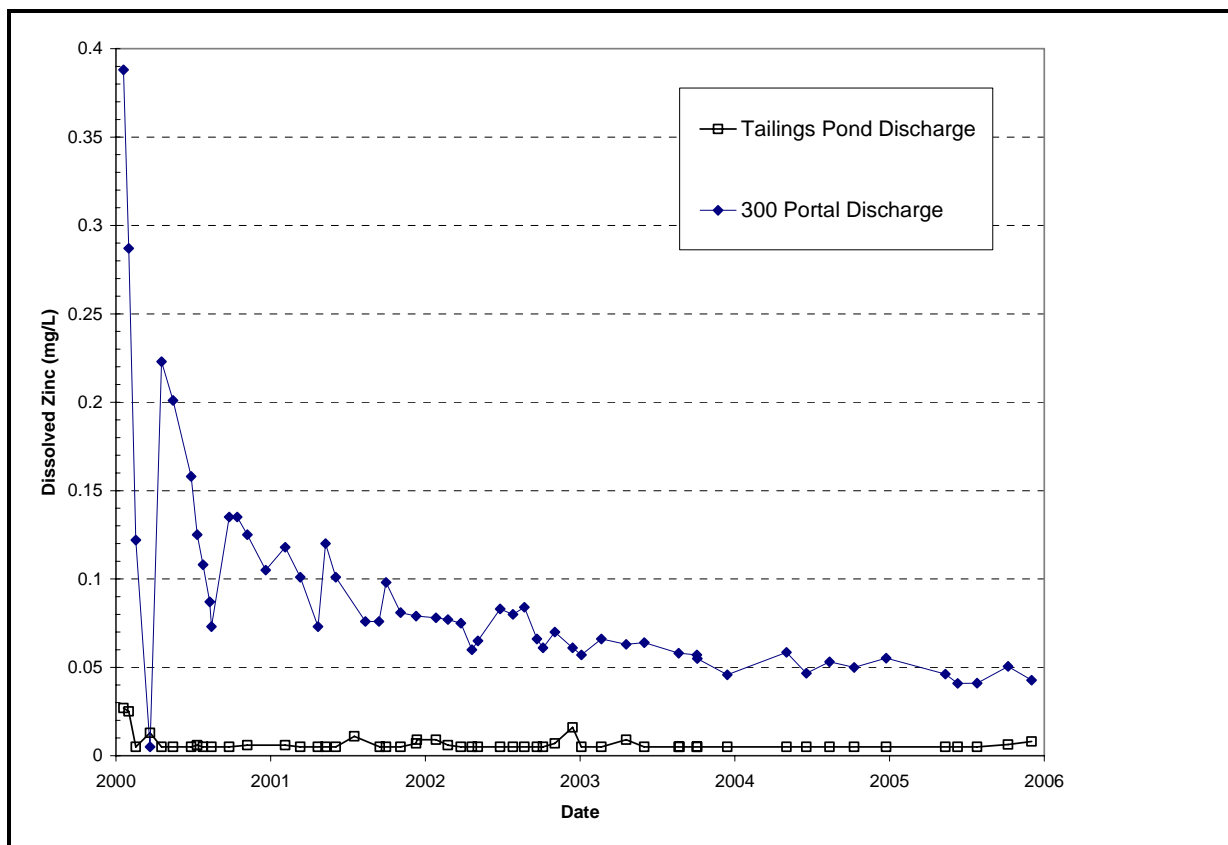
Figure 1 - Dissolved zinc concentrations, 300 Portal and Tailings Pond discharges, 2000 to 2005

Initial discharges from the 300 Portal reported elevated levels of metals, most notably zinc (Figure 1). A peak concentration of 0.388 mg/L was measured in January 2000 from the 300 Portal discharge. Since that time, zinc concentrations have shown a pattern of near-continuous decrease. Concentrations measured in 2005 were approximately 0.05 mg/L or less, representing an almost ten-fold decrease since mine water began to discharge from the mine. Conversely, zinc concentrations measured at the TPD have remained very low, generally at or below the detection limit of 0.005 mg/L.

A notable distinction between zinc and sulphate are the differences in the concentrations found between the 300 Portal and the tailings pond discharge (TPD). As noted, sulphate concentrations at the TPD are as little as one-half the 300 Portal discharge concentration. However, zinc concentrations in the TPD have remained near or below detection limit (0.005 mg/L) since closure. Zinc concentrations of the 300 Portal water have been reduced by at least an order of magnitude during flow through the tailings impoundment. Based on the available flow monitoring data, the estimated monthly flows from the TPD are twice that of the 300 Portal (Table 3), suggesting that dilution can account for approximately a 50% reduction in concentrations at the TPD. Therefore the zinc concentration reduction appears to be the result of both dilution and the attenuation of zinc within the impoundment, possibly by the absorption onto organic materials.

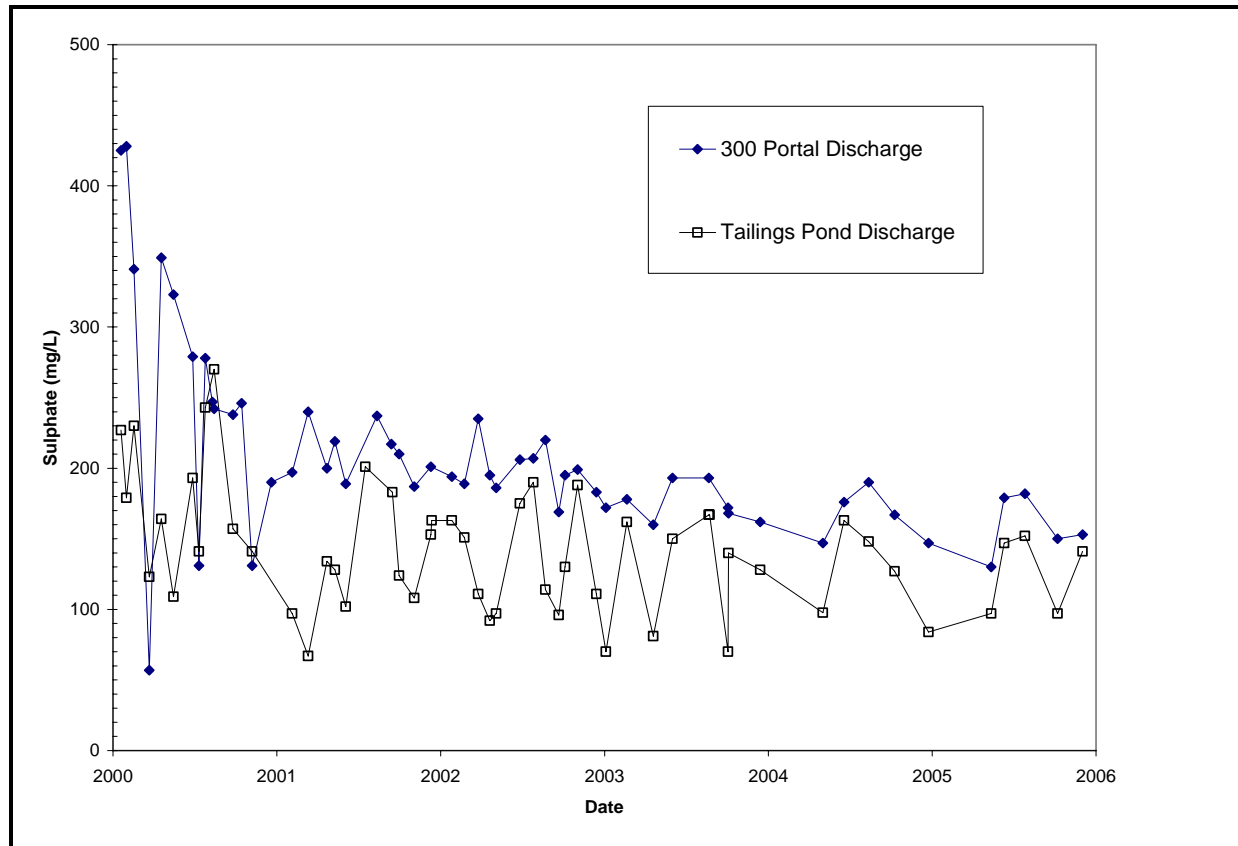
Figure 2 – Sulphate concentrations, 300 Portal and Tailings Pond discharges, 2000 to 2005

Sulphate concentrations in mine drainage are an indicator of sulphide oxidation and/or the dissolution of secondary sulphate minerals produced from the oxidation of sulphides. Sulphate tends to be a conservative parameter; unless saturated, sulphate concentrations will be unaffected by interactions with other metals or compounds. Therefore, sulphate concentrations in mine water discharges can be used to gauge the ongoing oxidation of sulphides and the release of oxidation products that have accumulated within the mine. Initial sulphate concentrations discharging from the mine had elevated concentrations (~425 mg/L) in the 300 Portal drainage (Figure 2). Sulphate concentrations have gradually decreased in the portal flow since mine flooding. Flows from the TPD have reported lower sulphate concentrations than the portal discharge (Figure 2) that show a pattern of variable, but gradually decreasing

concentrations over time. In general, the TPD flows have sulphate concentrations that range from equivalent to approximately one-half of the 300 Portal concentrations.

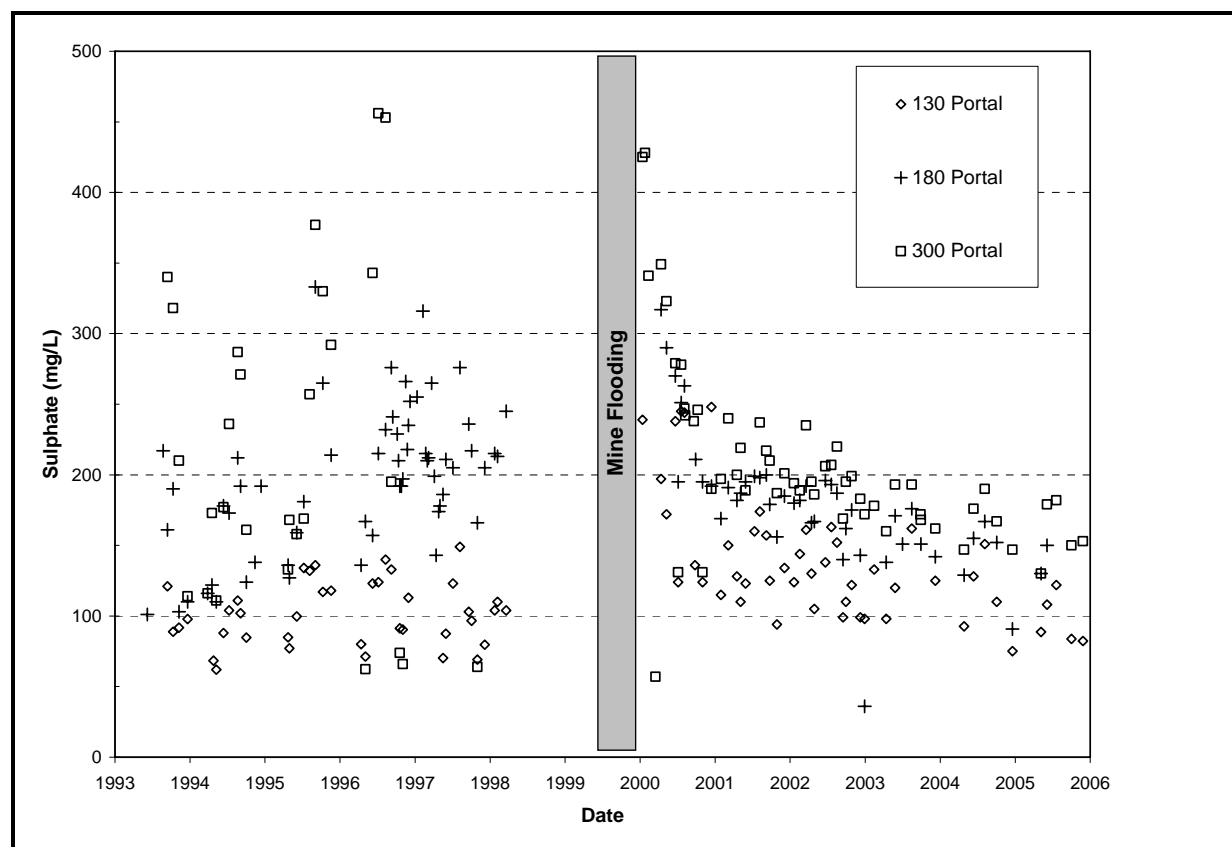
Figure 3 – Mine water sulphate concentrations, Pre and Post flooding

Figure 3 presents concentration data for sulphate collected from mine water discharge at the 130, 180 and 300 portals before and after closure of the mine. Mine water discharge at these portals was regularly collected between 1993 and 1998 and from 2000 to 2005. Mine water quality during operations showed an overall wide range of concentrations but similar concentration ranges for each of the three portals. The mine water represented a combination of groundwater, surface infiltration from areas such as the Crown Pillar, and mine process water. Process water primarily constituted water used in the placement of hydraulic backfill in stopes; other lesser sources included water used in the operation of machinery such as drills.

The 130 Portal discharges generally had the lowest concentrations, followed by the 180 Portal and finally the 300 Portal with the highest overall concentrations. This likely reflects the use of the 180 and 300 portals for active discharge of mine water to the tailings pond. Lower concentrations in the 130 Portal discharges may also represent dilution by groundwater seepage along the longer flowpath from the mine workings to the portal entrance.

During the operation of the mine prior to flooding, mine water from all three portals showed a similar overall pattern of increasing concentration with time. Concentrations of the discharges were commonly in the range of 50 to 300 mg/L sulphate, with some values in the 300 to 450 mg/L range. These concentration increases over time likely reflect both the increasing volume of backfill placed in the mine during operations, and oxidation of sulphides within the backfill and possibly on mine surfaces.

Following flooding of the mine to the 300 Portal level, discharge concentrations showed initial maximum concentrations (up to 425 mg/L) which decreased rapidly over a few months. By early 2003, sulphate concentrations in the mine water discharges were below 200 mg/L. Like the water quality data during mine operations, sulphate levels in the 130 Portal discharges had lower concentrations than the 180 and 300 Portal flows. Discharges from the 180 and 130 portals have been relatively insignificant since closure; these flows consist of minor seepage flows that emanate from bedrock downgradient of the plugs. Inspections during 2005 observed no flows from these two locations. It is not clear what the source of the post-closure flows from the 130 and 180 portals; however, the similarity in the concentrations and patterns of decrease suggest that these waters are at least partially derived from mine water.

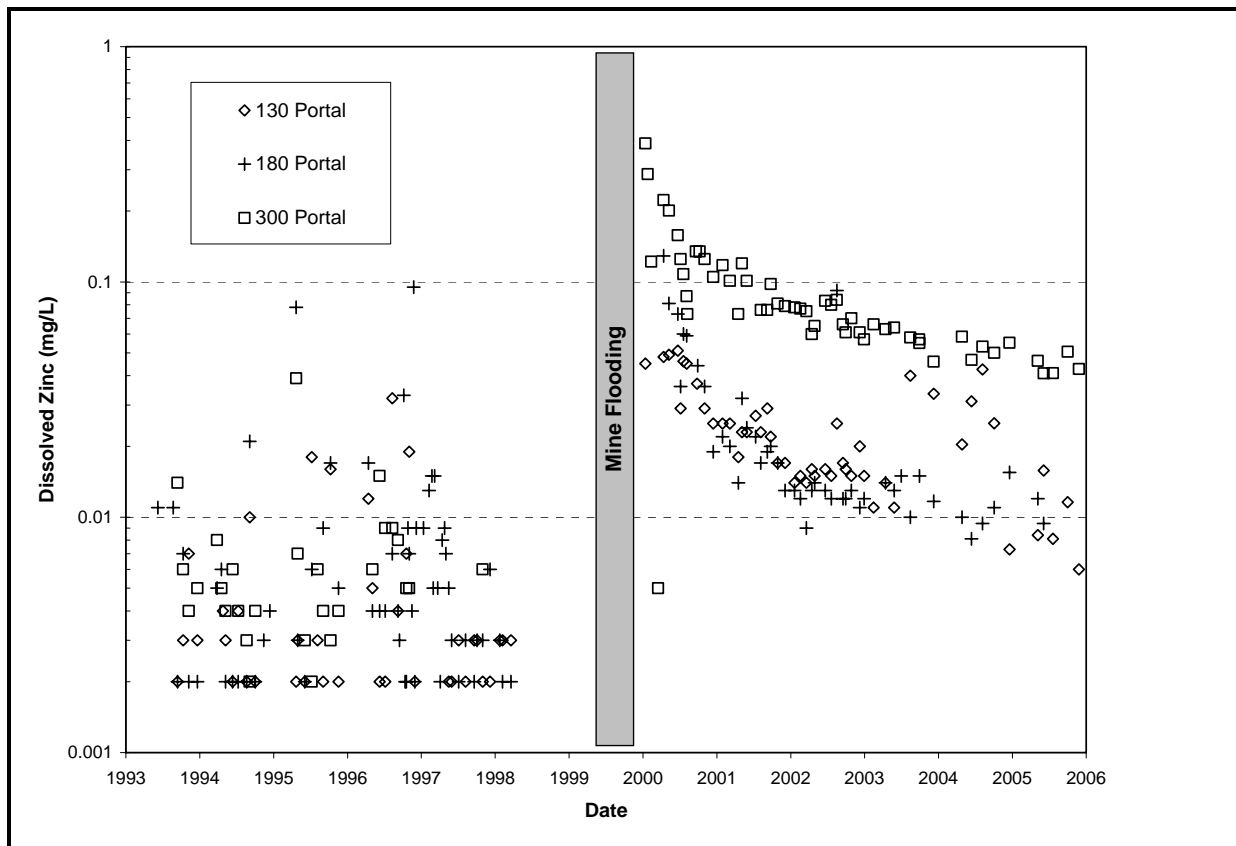
Figure 4 – Mine water zinc concentrations, Pre and Post flooding

Dissolved zinc concentrations for pre- and post-closure water quality are shown in Figure 4. Concentrations during mine operations generally ranged from at or below detection limit (0.005 mg/L) to

0.01 mg/L, with infrequent concentrations between 0.01 and 0.1 mg/L. No relationship appears to exist between dissolved zinc concentrations and discharge location in the mine.

Following flooding, zinc discharge concentrations from all three portals increased significantly over their pre-closure concentrations; values greater than 0.1 mg/L were measured in flows from the 300 and 180 portals. Concentrations in the 130 portal discharges reached 0.05 mg/L. Since mine flooding, dissolved zinc levels in flows from the 300 Portal have decreased steadily to concentrations below 0.05 mg/L. Concentrations from the 130 and 180 portals have also decreased steadily, reaching concentrations of approximately 0.01 mg/L. Dissolved zinc concentrations in the 300 Portal flows have been significantly higher than those measured for the 130 and 180 portals. The patterns of decrease followed a very similar pattern to that observed for the 300 Portal concentrations. As well, these patterns of decrease are also very similar to that observed for sulphate (Figure 3). However, like sulphate, the dissolved zinc concentrations decreased rapidly from their peak concentrations immediately following onset of discharge from the 300 Portal. The pattern of mine water concentrations suggest that steady-state concentrations may be reached in the near future.

The observed increases in the sulphate and dissolved zinc concentrations in mine water immediately following closure of the mine indicate that a mass of soluble metals were released into the mine water during flooding. These metals accumulated on the mine surfaces during the operational phase of the mine due to the oxidation of sulphides on surfaces such as mine walls and backfill. During the mine operation these soluble metals remained in place as there was no mechanism to remove them in significant quantities from the mine surfaces. However, as the mine flooded these accumulated oxidation products were released into the mine water.

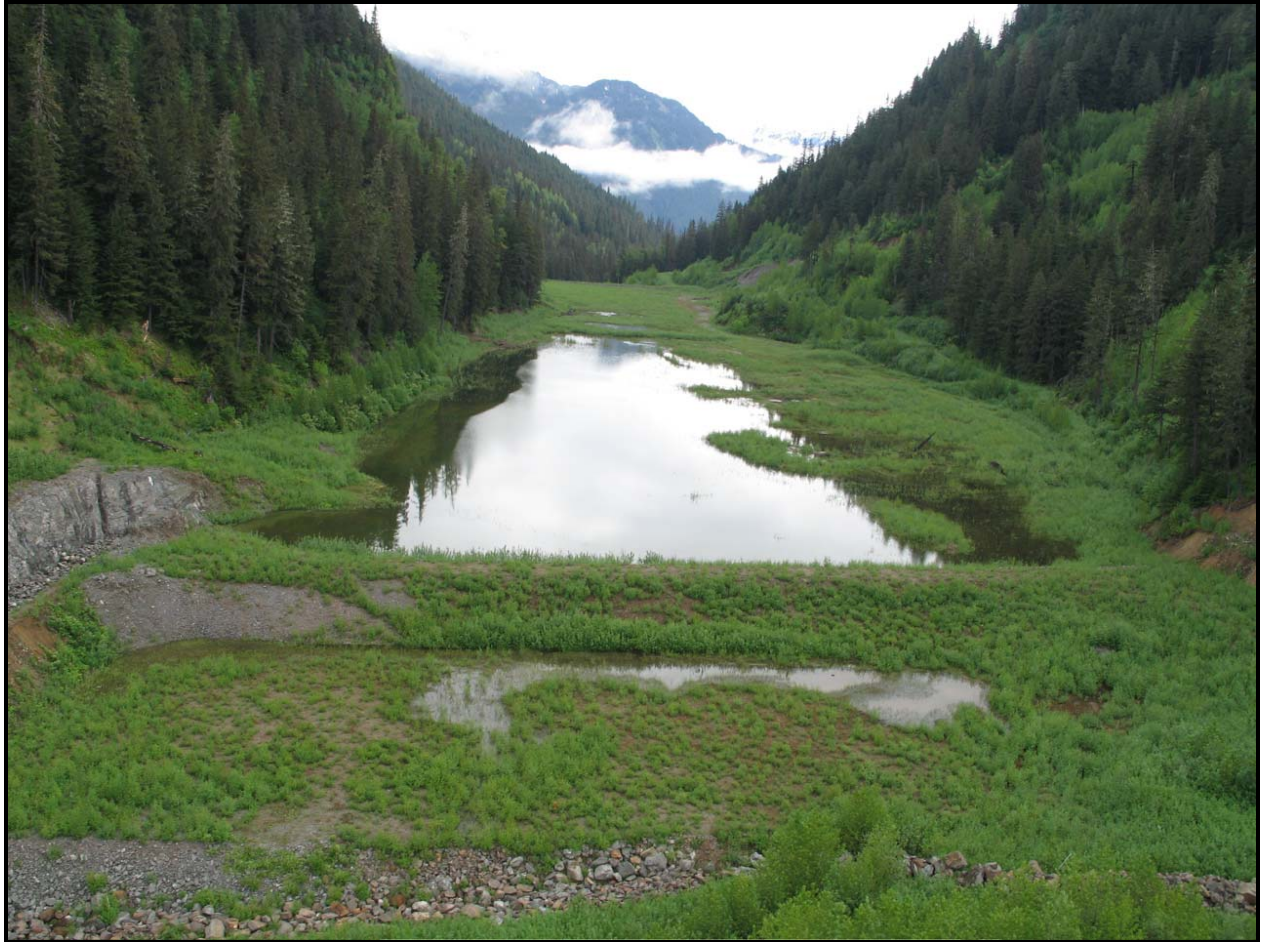
Tailings were identified as potentially acid generating, requiring an oxygen-limiting cover to ensure that ARD/ML conditions could not occur. Construction of a suitable dry cover was ruled out as it would have required a volume of material greater than the volume of the entire mine. The final design resulted in the construction of a saturated cover that would maintain water-saturated conditions within the tailings. To achieve this, the tailings were regraded to promote drainage towards Sky Creek, and then capped with a layer of non-acid generating waste rock from the 150 dump and 180 dump. A spillway was built at the south end of the impoundment to allow discharge into Sky Creek. The spillway elevation was constructed to maintain the water level within the waste rock layer capping the tailings. A coarse rock blanket was placed in the spillway to prevent potential damming as a result of beaver dam construction. Subsequent settlement of the tailings has resulted in the formation of shallow ponding behind the embankment which ensures saturation during drier periods. Consolidation of the tailings and the migration of vegetation onto the cap have resulted in the development of a naturally formed wetland as shown in Photo 1.

Photo 1 - Snip tailings pond, looking north, May 2005
