## Technical Evaluation of the Gold King Mine Incident

San Juan County, Colorado

U.S. Department of the Interior  
Bureau of Reclamation  
Technical Service Center  
Denver, Colorado

October 2015

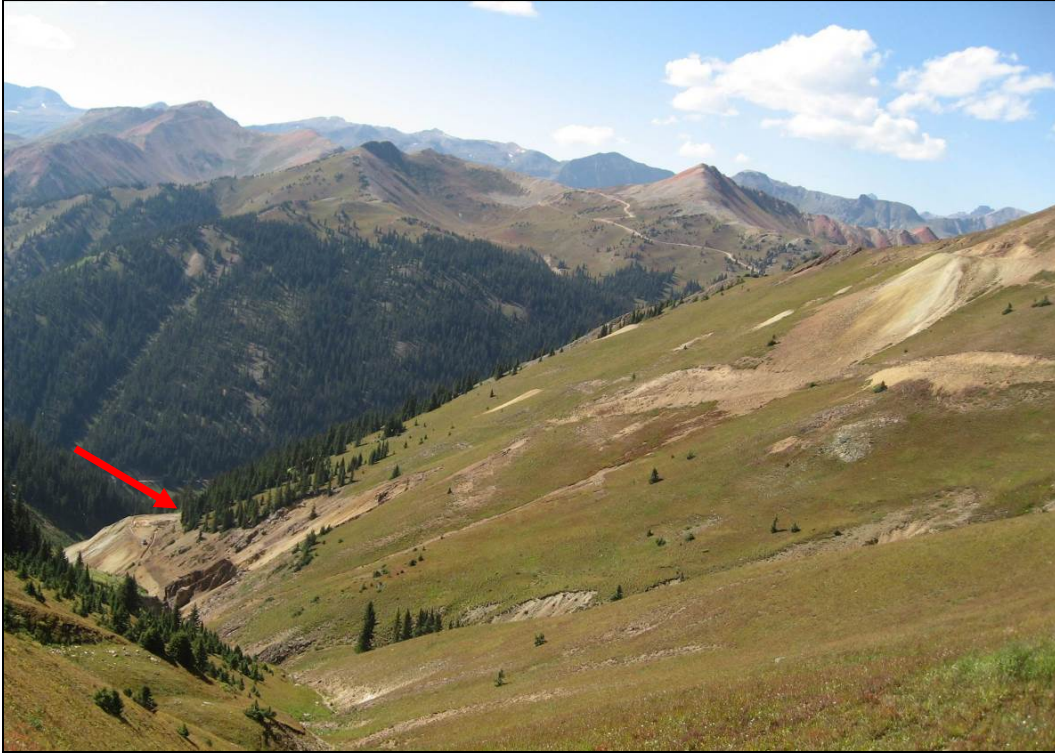
Figure 1.—Photograph of the Gold King Mine looking west. The red arrow points to the location of the mine blowout, which occurred on August 5, 2015.

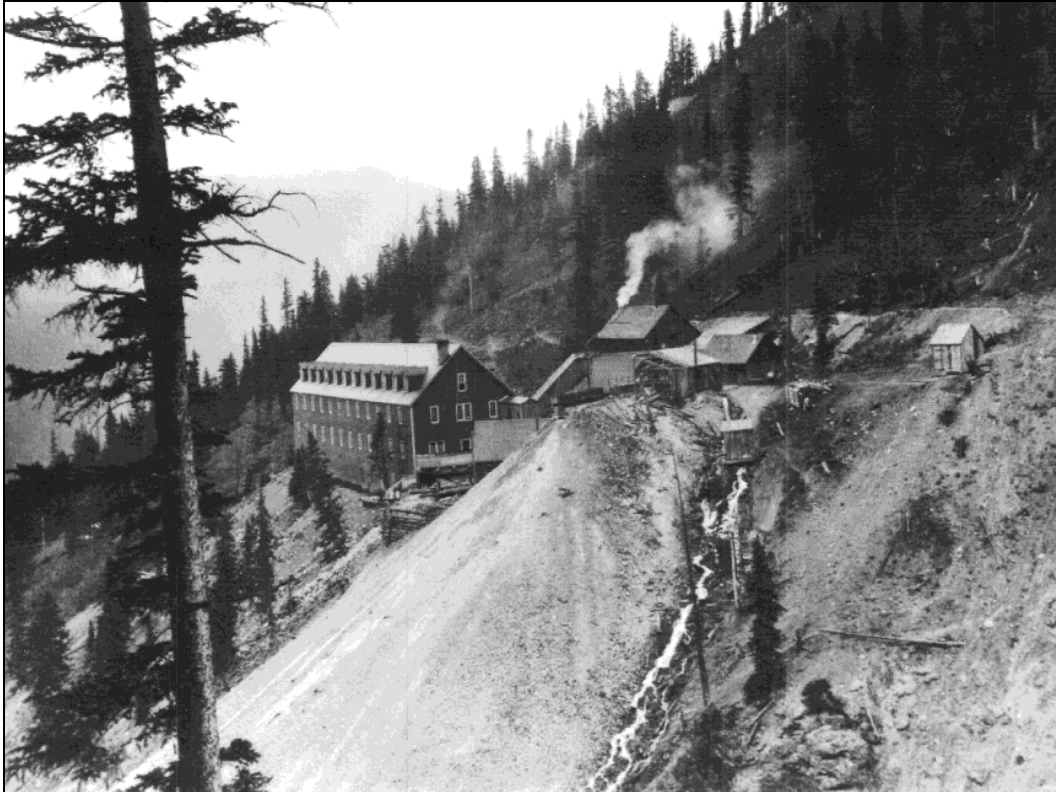
Figure 5.—Historical photograph of the Gold King Mine Level 7 taken prior to the mine closing in 1923. Note the drainage flow down the side of the waste-rock dump.

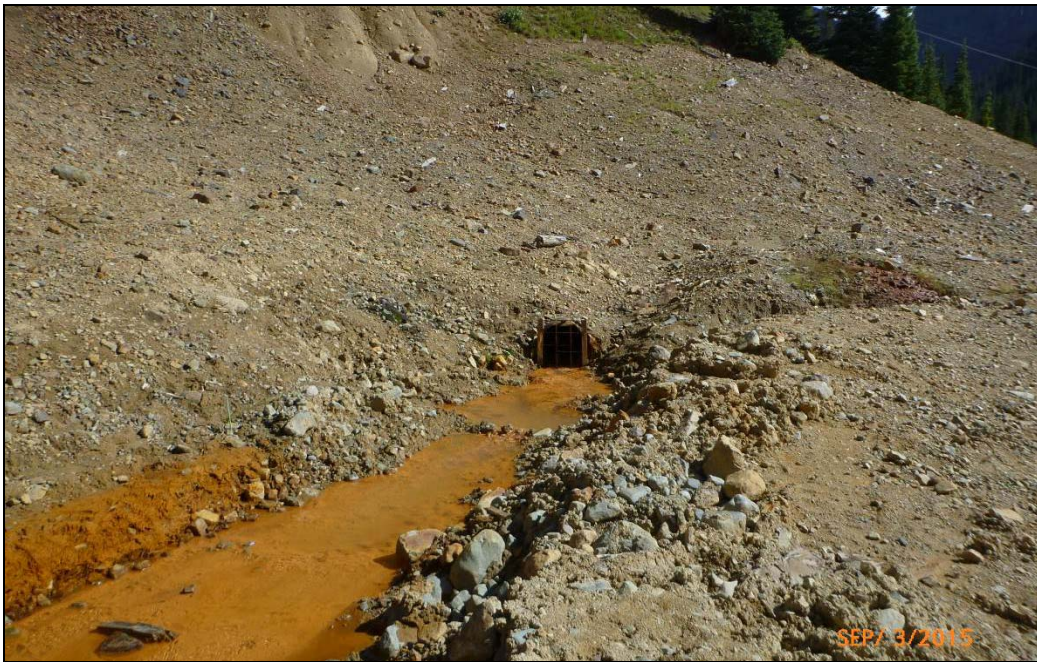
Figure 7.—Photograph showing the seepage outflow from the drain pipe at the American Tunnel at Gladstone, Colorado, as it appeared on September 3, 2015, with about 100 gpm of acid water flowing out.

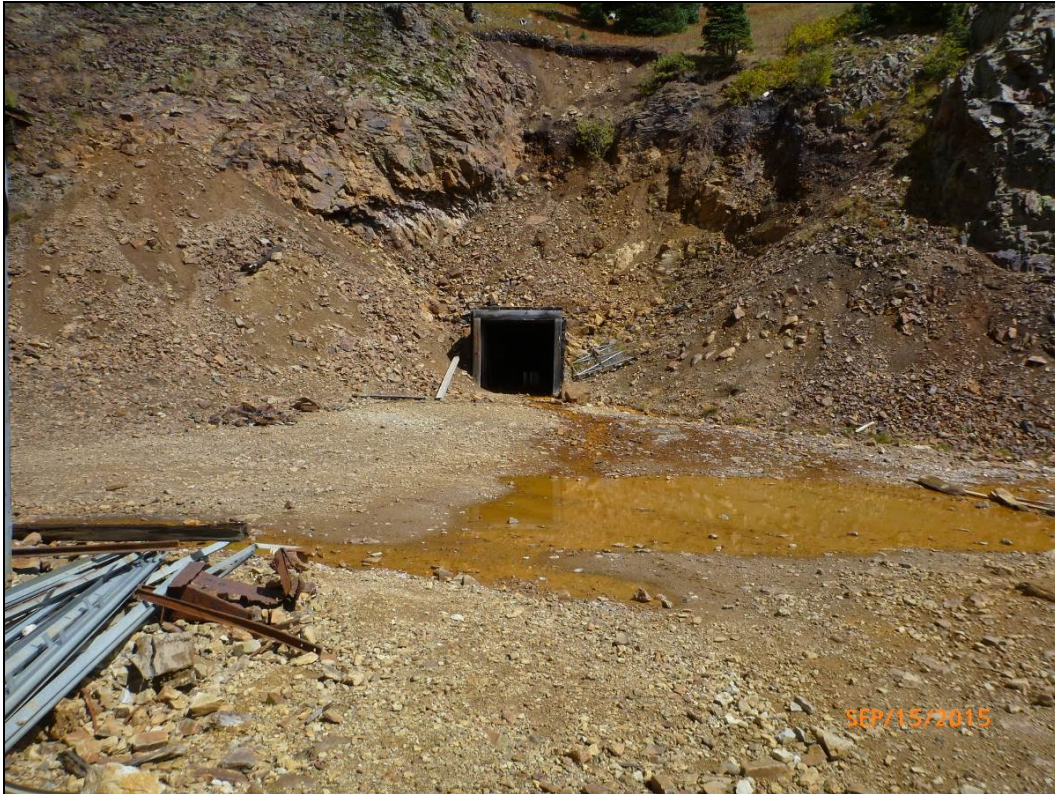
Figure 10.—Photograph showing seepage from the Mogul Mine on September 15, 2015. This mine has hydraulic bulkheads to limit the outflow of water from the Sunnyside Mine.

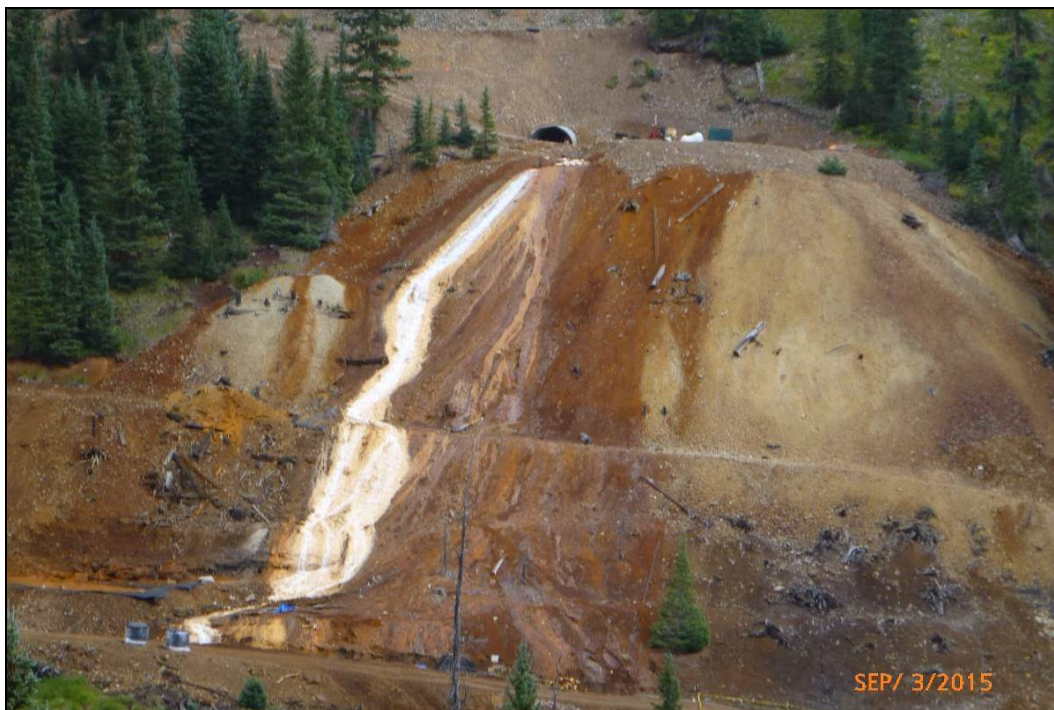
Figure 11.—Photograph showing acid drainage flowing out of the Red and Bonita Mine on September 3, 2015.

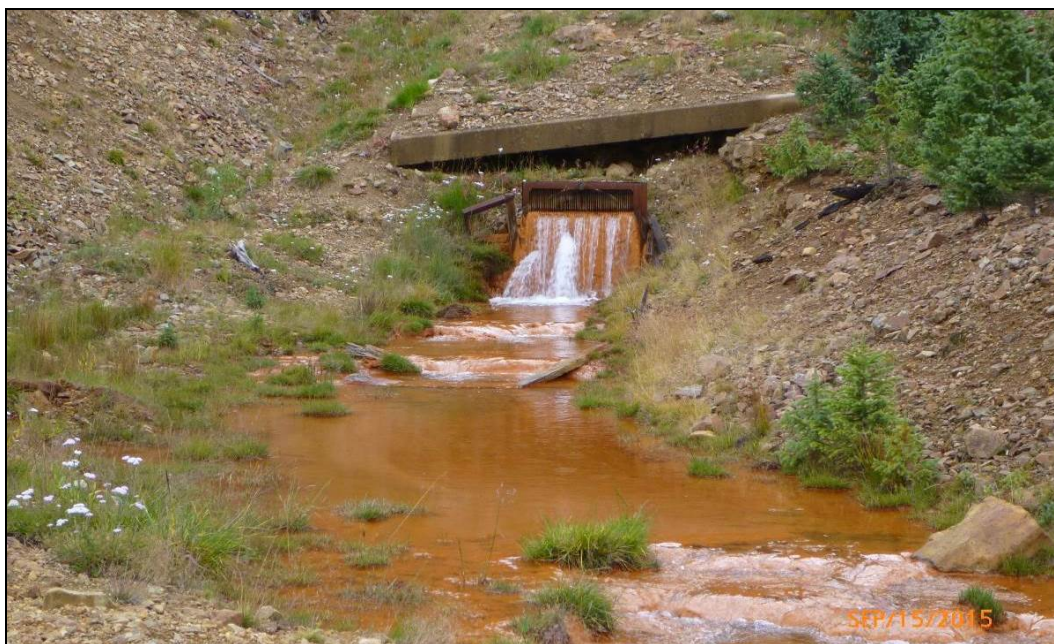
Figure 12.—Photograph taken on September 15, 2015, of drainage from the Silver Ledge Mine, which is located south of the Gold King Mine.

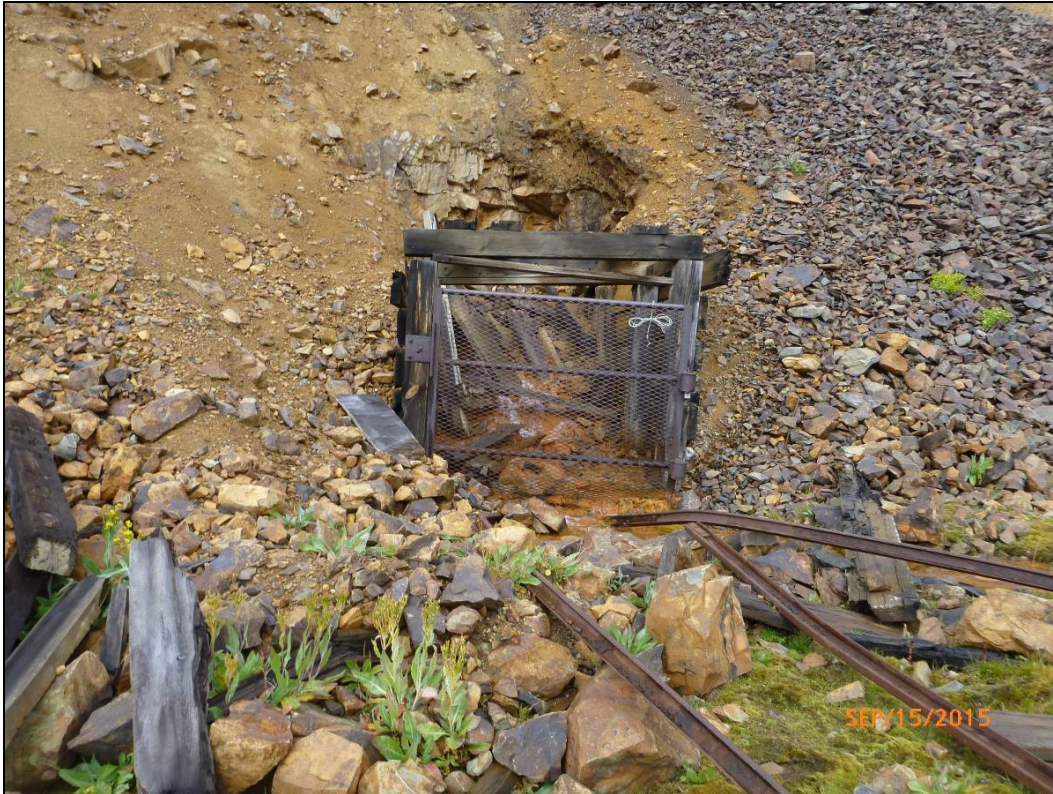
Figure 13. Photograph taken on September 15, 2015, showing acid seepage from the Blackhawk Mine located south of the Gold King Mine.

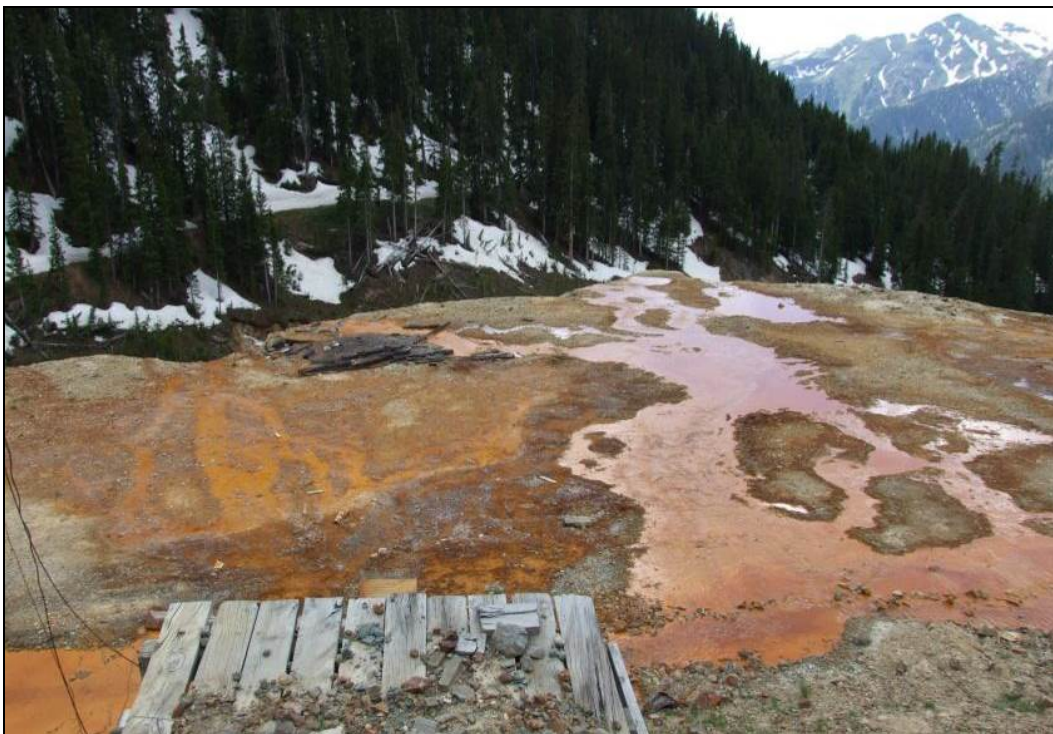
Figure 14.—Photograph showing adit seepage infiltrating into the Gold King Mine Level 7 waste-rock dump in 2007 (from DRMS project files).

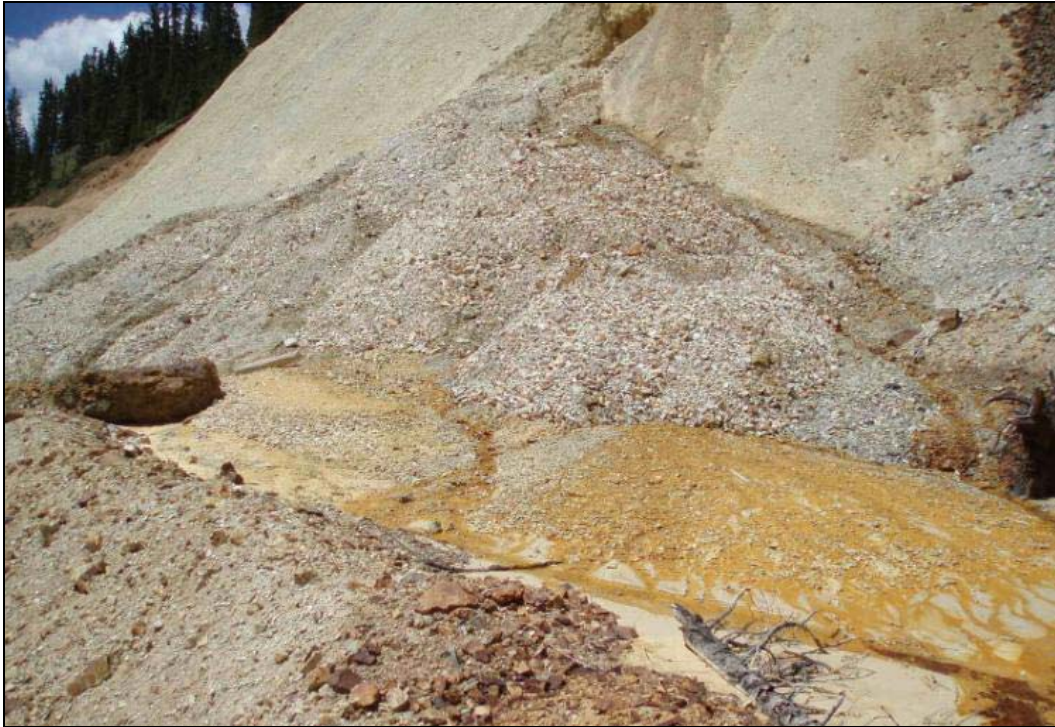
Figure 15.—Photograph showing deposition of landslide material in 2007 blocking a portion of the access road near the base of the waste-rock dump (from DRMS project files).

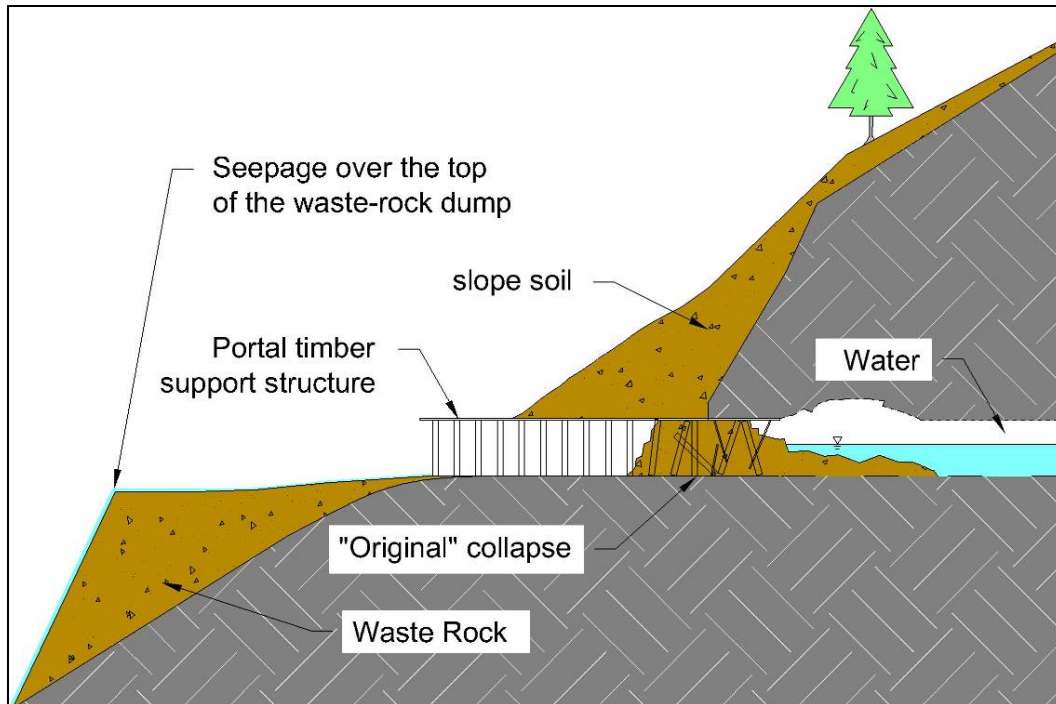
Figure 16.—Cross-section showing the condition of the Gold King Mine Level 7 New Adit in 2007 (not to scale). This shows the water level assumed by DRMS, but it may have been full of water at this time, as was later discovered.

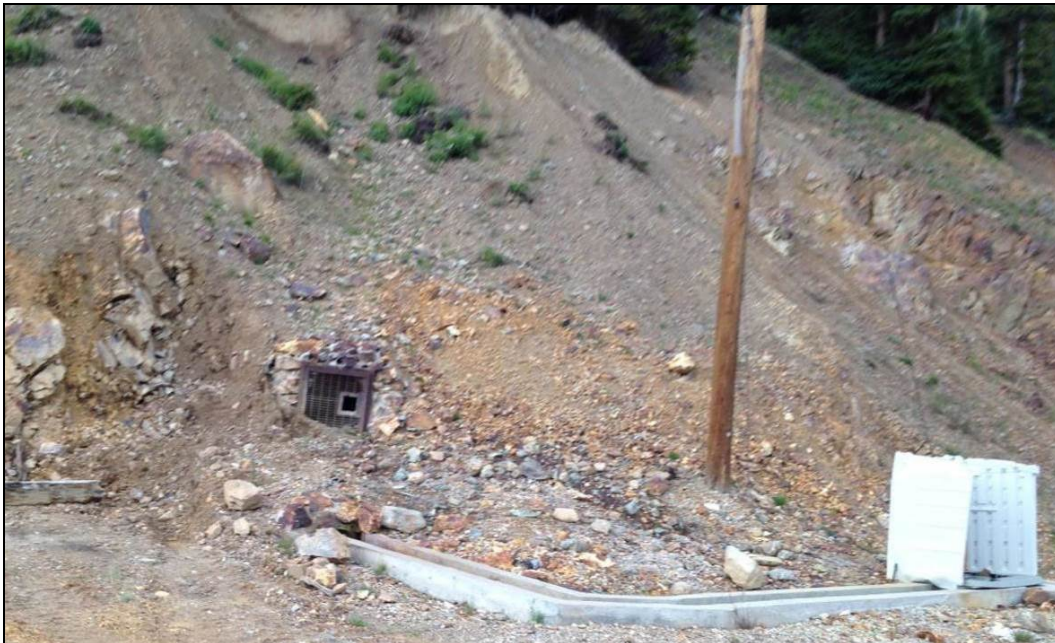
Figure 22.—Photograph showing the condition of the Gold King Level 7 New Adit portal on August 27, 2014, prior to any EPA modifications. Soil and rock debris have migrated downslope and covered a portion of the drain installed in 2009 (photograph from EPA project files).

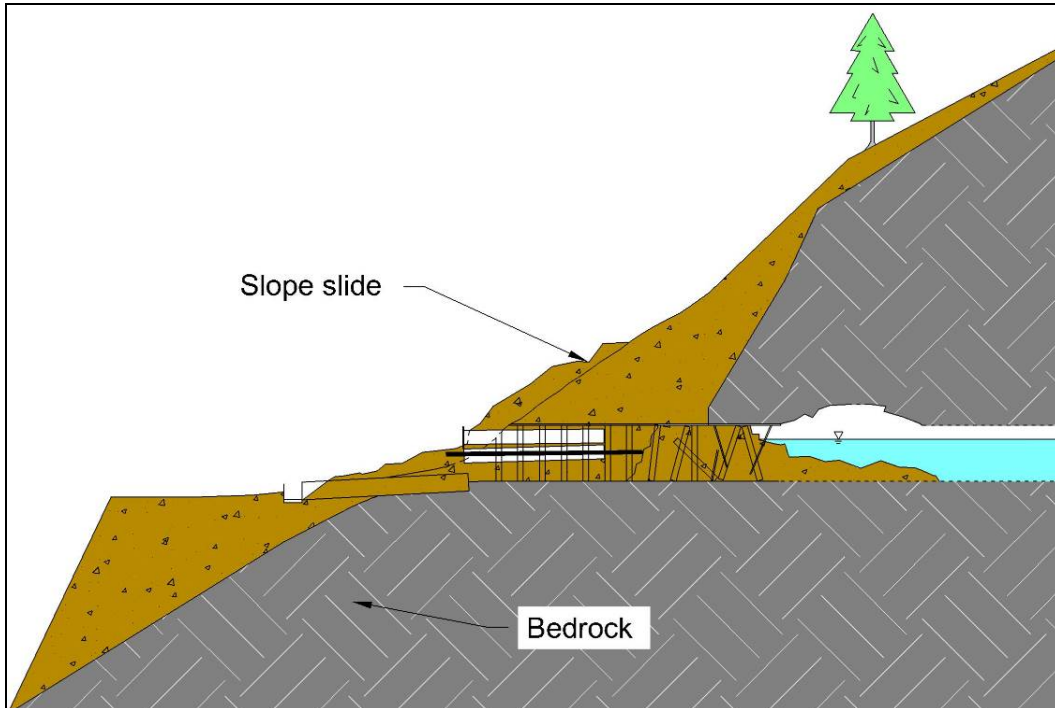
Figure 23.—Cross-section showing the condition of the Gold King Mine Level 7 New Adit in 2014 (water level as assumed by EPA and DRMS), more rock and soil had come down off the slope and were partially blocking the drain, which indicates a lack of maintenance (not to scale).

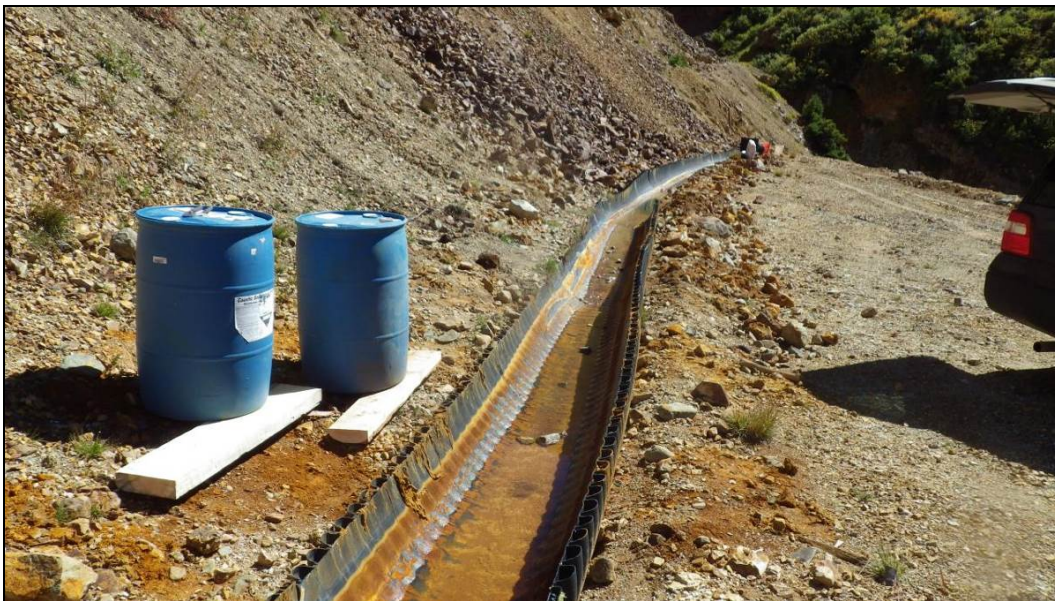
Figure 24.—Photograph showing seepage flow in the half-pipe channel at the Gold King Mine Level 7 New Adit area on September 11, 2014. Flow of approximately 12.6 gpm was recorded (photograph from EPA project files).

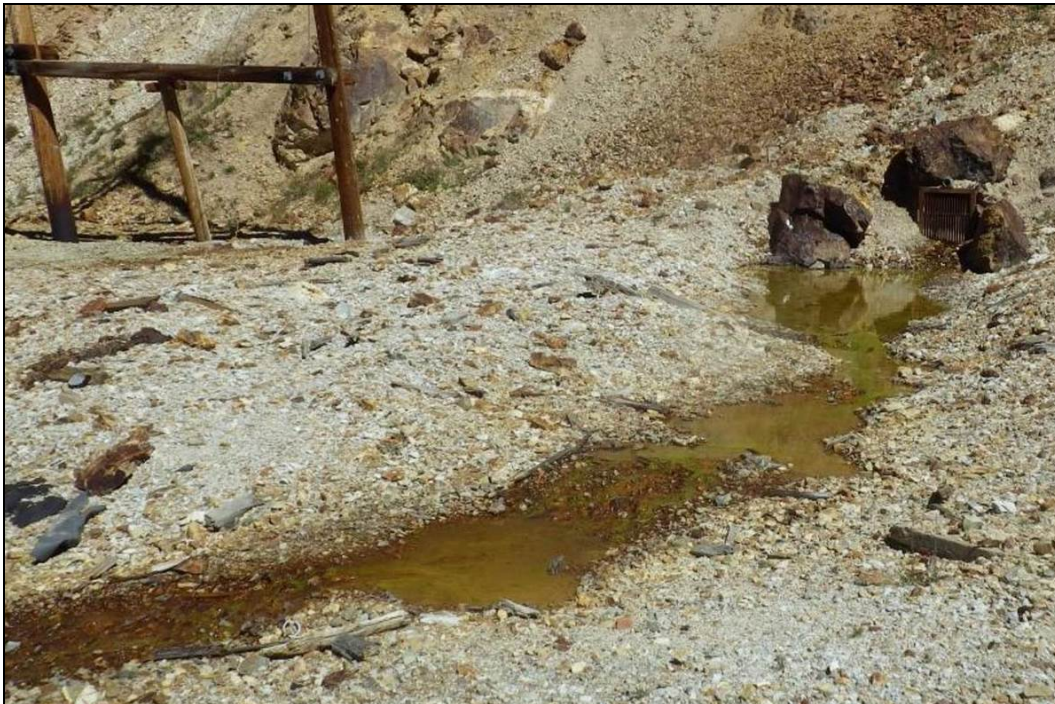
Figure 31.—Gold King Mine Level 7 OLD Adit (upper right) showing a small amount of seepage flow on September 11, 2014. At the portal, the floor of the old adit is approximately 2 feet higher than the floor of the old adit portal (photograph from EPA project files).

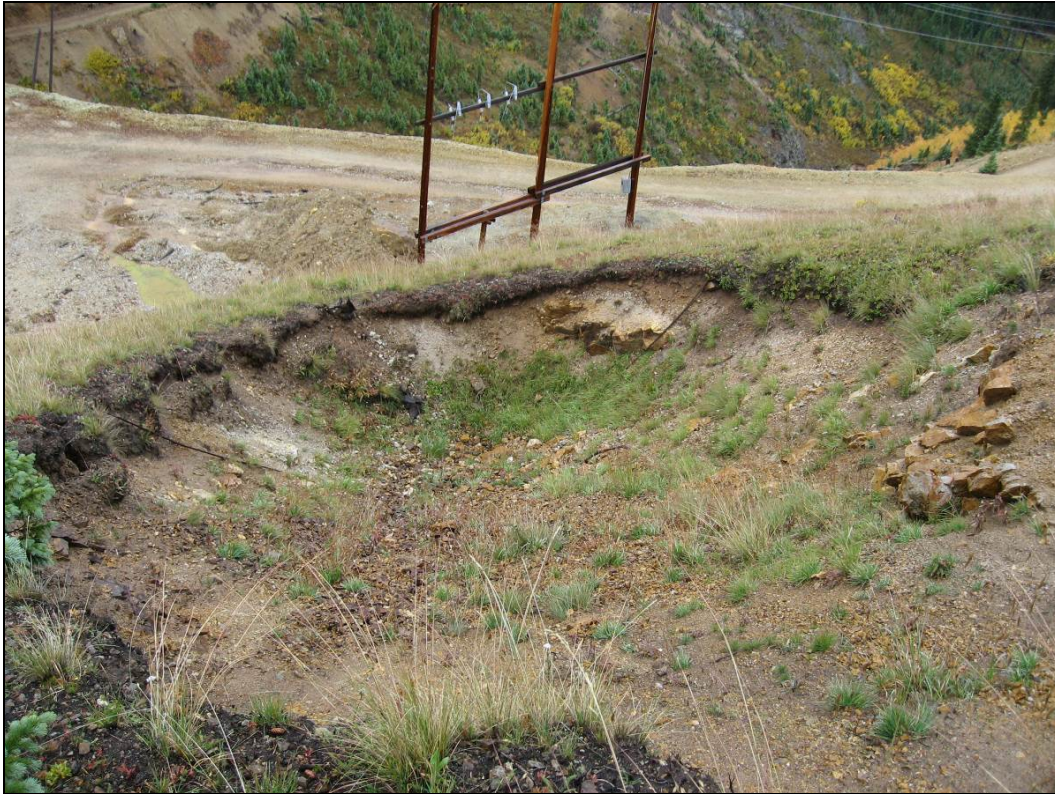
Figure 32.—Photograph taken on September 22, 2014, looking downhill at the subsidence pit located above the Gold King Mine Level 7 Old Adit.

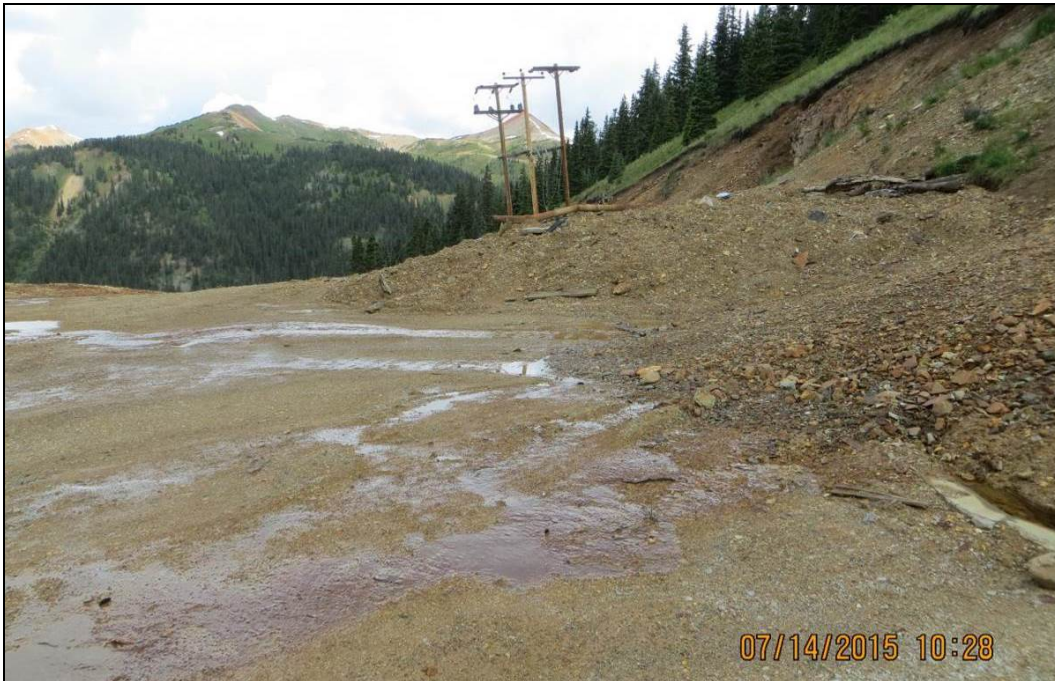
Figure 33.—Photograph showing the condition of the Gold King Mine Level 7 Old Adit portal area on July 14, 2015. Note that more soil and rock had slid from the slope area and had buried a portion of the concrete diversion channel including the ends of the two drain pipes (photograph from EPA project files).

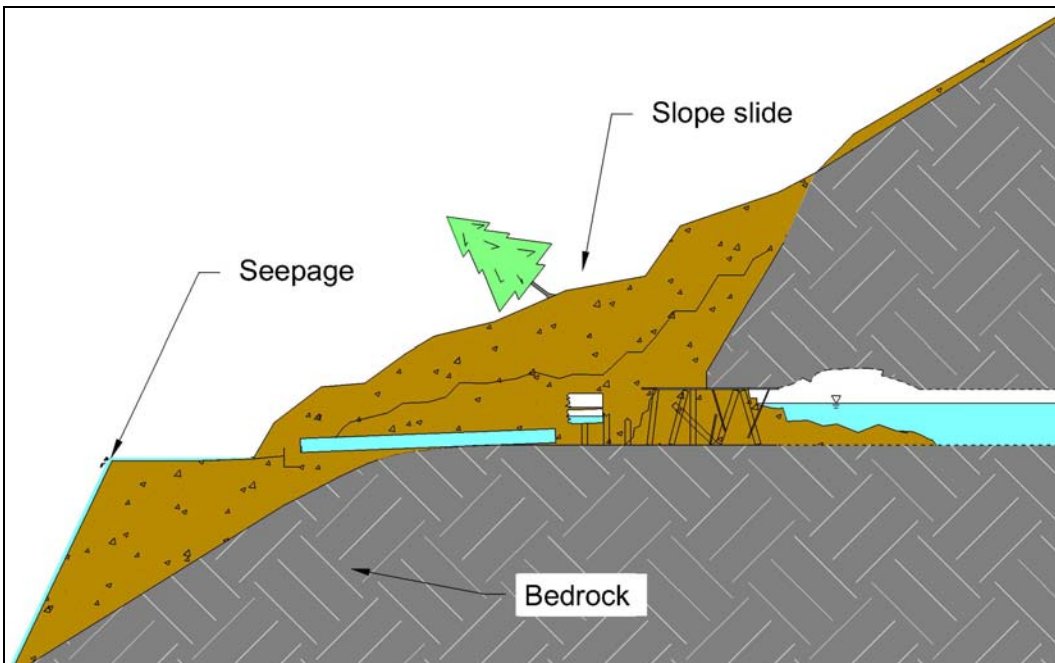
Figure 34.—Cross-section showing the condition of the Gold King Mine Old Adit on July 14, 2015 (water level as assumed by EPA and DRMS), when EPA returned to the site to begin work. More rock and soil and a tree had slid down onto the drains, and seepage was again saturating part of the waste-rock dump (not to scale).

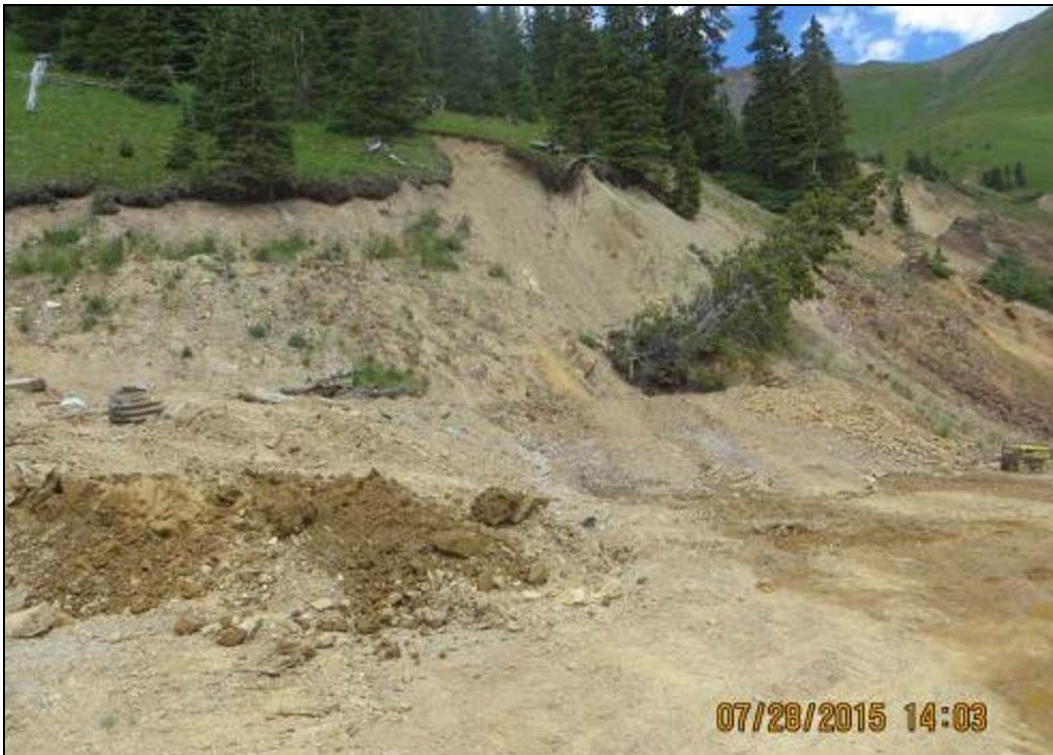
Figure 35.—Photograph showing the condition of the Gold King Mine Level 7 New Adit portal area on July 28, 2015. Note the soil and a tree that has slid downslope onto the portal area; at this time the seepage had been returned to the concrete trough, and the dump was drying out (photograph from EPA project files).

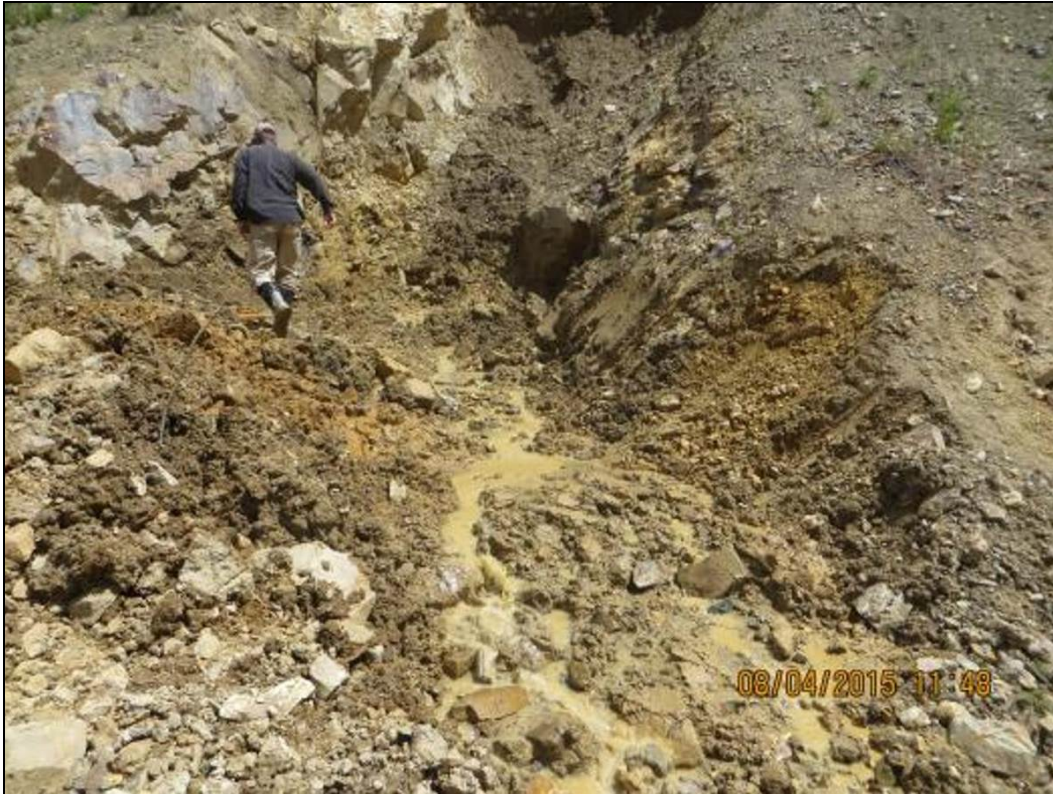
Figure 38.—Photograph showing seepage flow from the excavation at the Gold King Mine new portal at 11:48 a.m. on August 4, 2015. The flow is emerging approximately 5 to 6 feet above the floor of the adit (photograph from EPA project files).

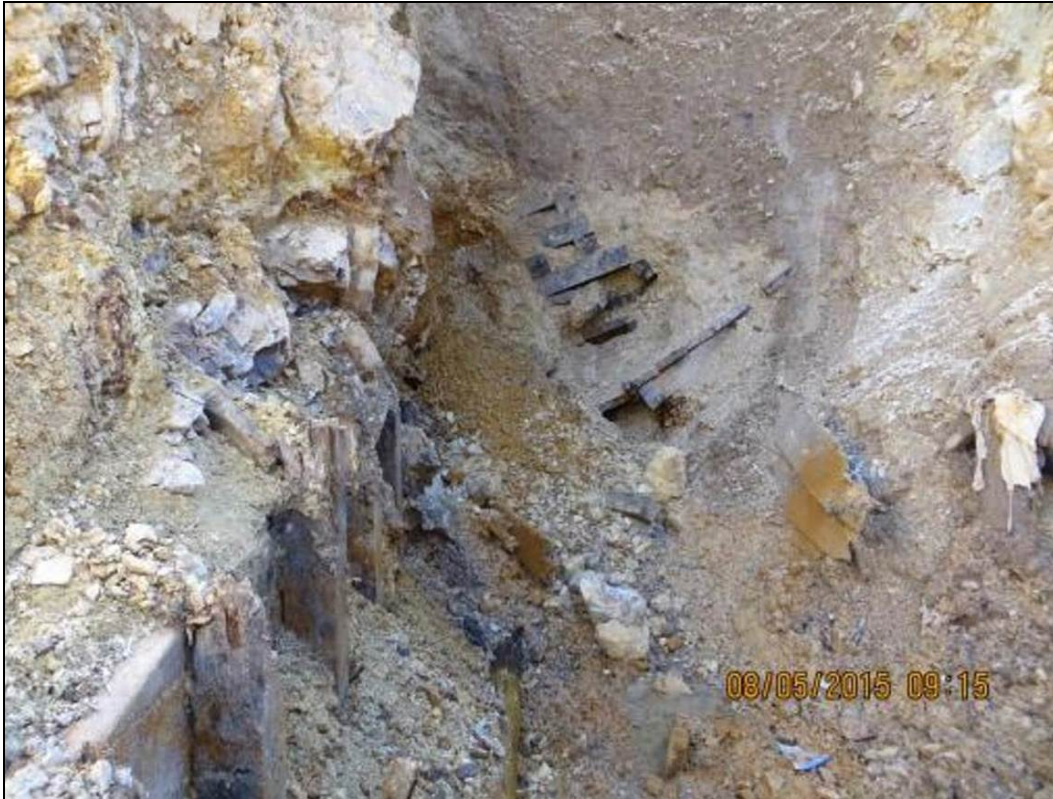
Figure 46.—Photograph taken at 9:15 a.m. August 5, 2015, showing the Gold King Mine Level 7 New Adit excavation uncovering mine timbers and lagging (photograph from EPA project files). Minor seepage is visible just to the left of the date stamp where a small puddle has formed. Note the soil in the upper end of the excavation above the timber lagging.

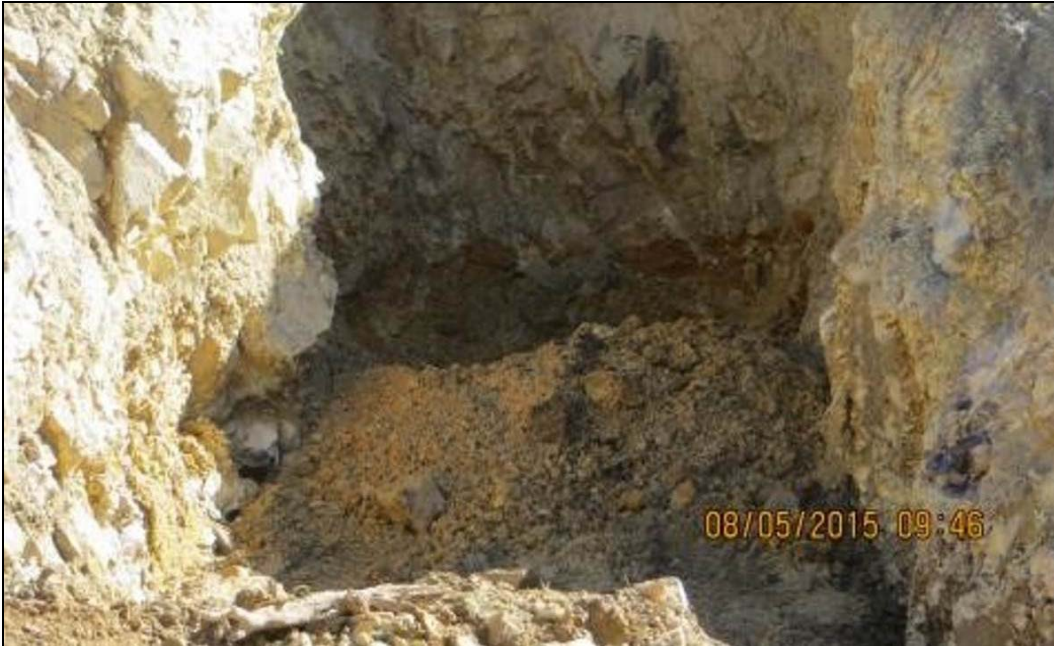
Figure 47.—Photograph taken at 9:46 a.m. August 5, 2015, showing that the loose soil from the upper end of the excavation had been removed exposing fractured and crumbly rock (photograph from EPA project files). The fill derived from the excavation had now covered the timbers, lagging, and seep visible in the previous photograph (figure 46). This indicates that the bottom of the excavation was about 10 feet above the level of the floor of the adit; this corroborates reports that they were digging high, trying to stay above the assumed water level in the adit.

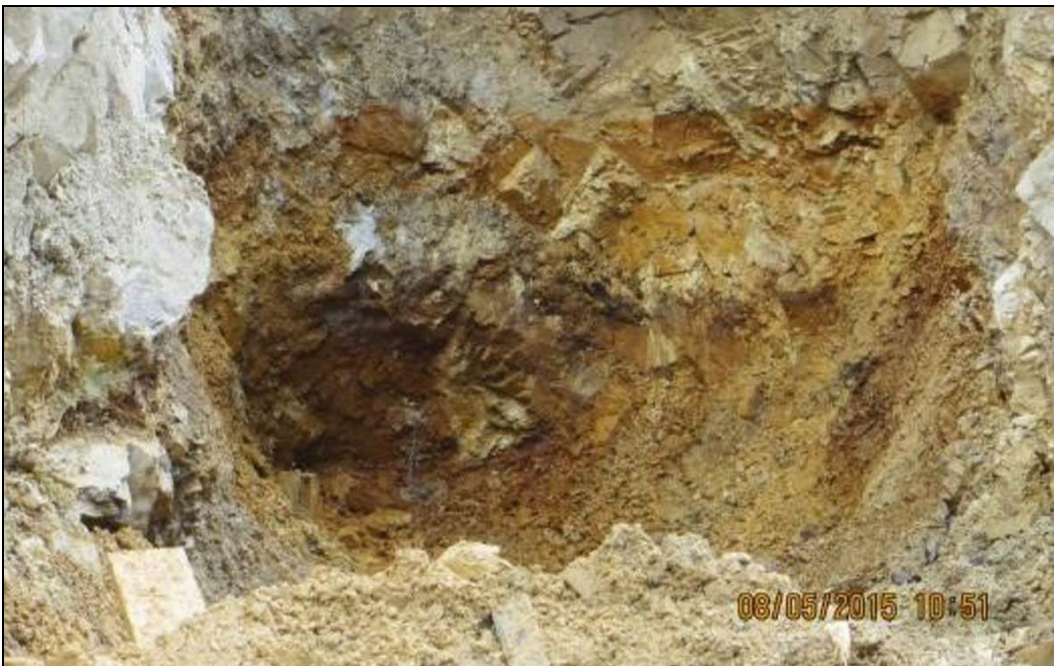
Figure 48.—Photograph taken at 10:51 a.m. on August 5, 2015, showing the initial spurt of clear water (photograph from EPA project files). The center of this photograph is shown enlarged in figure 49.

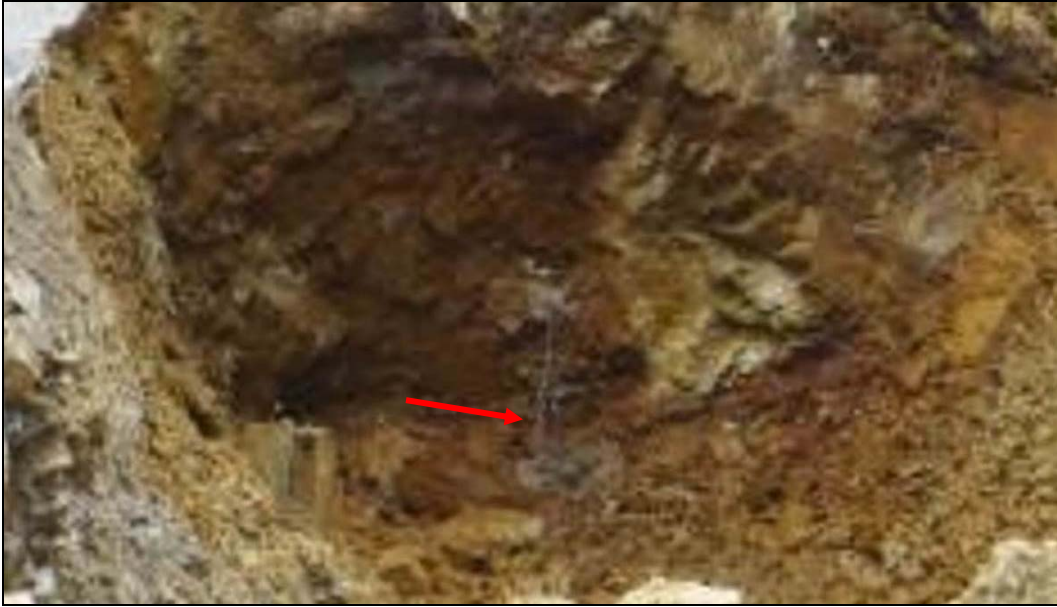
Figure 49.—A cropped and enlarged version of a portion of the photograph taken at 10:51 a.m. on August 5, 2015 (figure 48). Red arrow points to the initial vertical spurt of clear water shooting up about 1.5 to 2 feet as described by the EPA OSC (photograph from EPA project files).

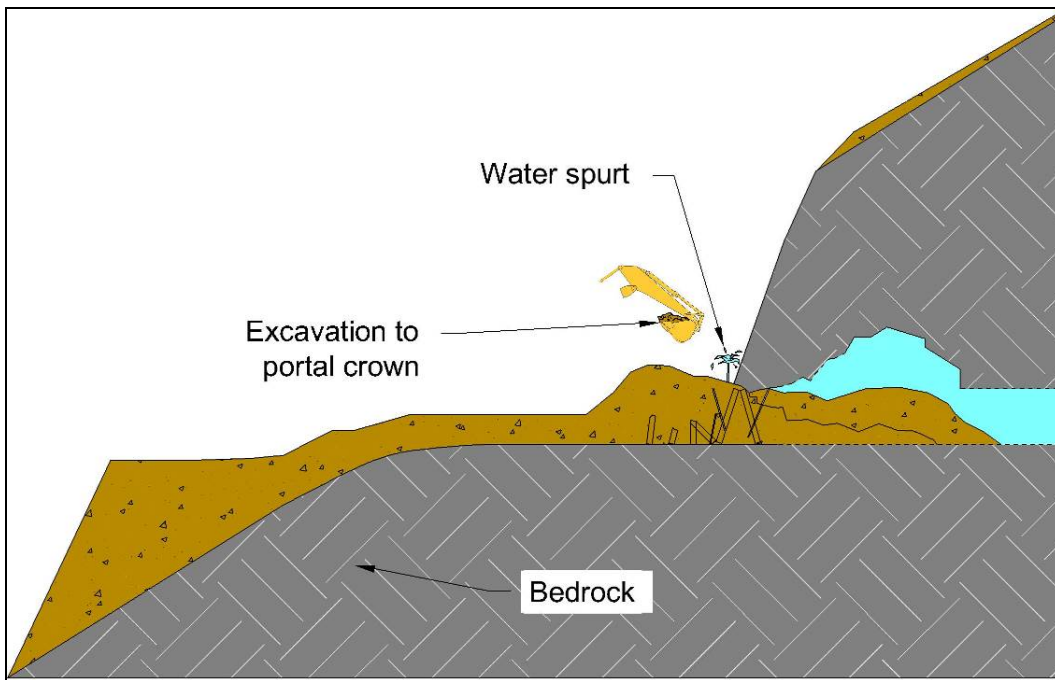
Figure 50.—Cross-section showing BOR's interpretation of the conditions immediately before the blowout as the spurt of water appeared indicating the adit was full and under pressure (not to scale).

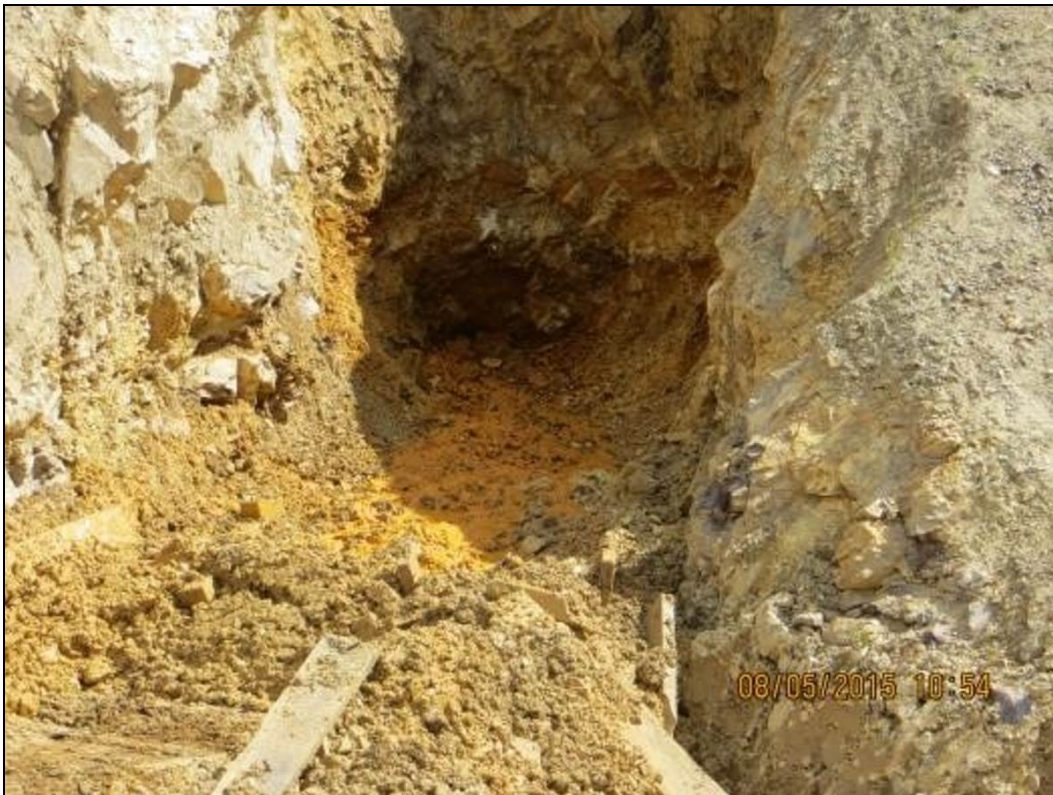
Figure 51.—Photograph of the uncontrolled flow taken at 10:54 a.m. on August 5, 2015. In 3 minutes, the flow progressed from a vertical spurt of water to the flow erosion evident in this photograph. The EPA OSC then made a decision to evacuate the portal opening to safeguard personnel onsite. A few moments later the flow erupted in an uncontrolled release (photograph from EPA project files).

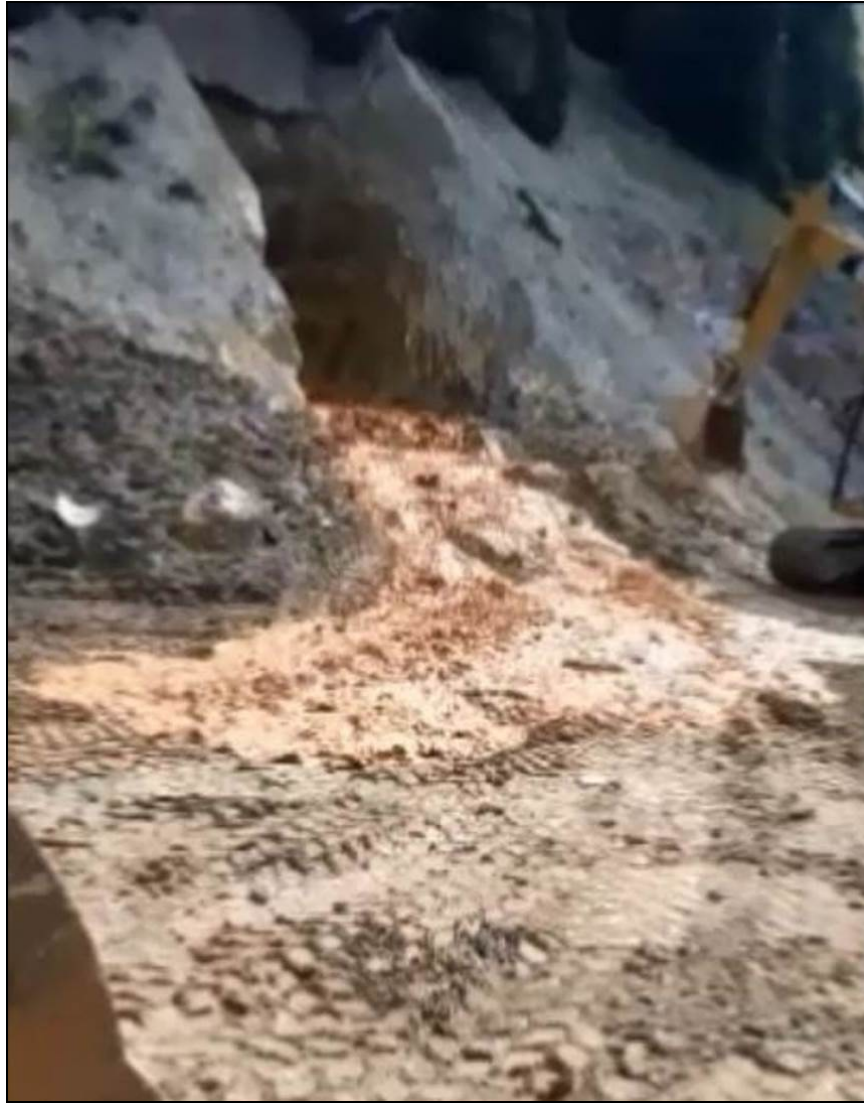
Figure 52.—Photograph showing the initial blowout from the adit. At this point, the flow is surging up over the backfill that was present in the portal area (still frame extracted from a video taken on August 5, 2015, at approximately 10:55 a.m.).

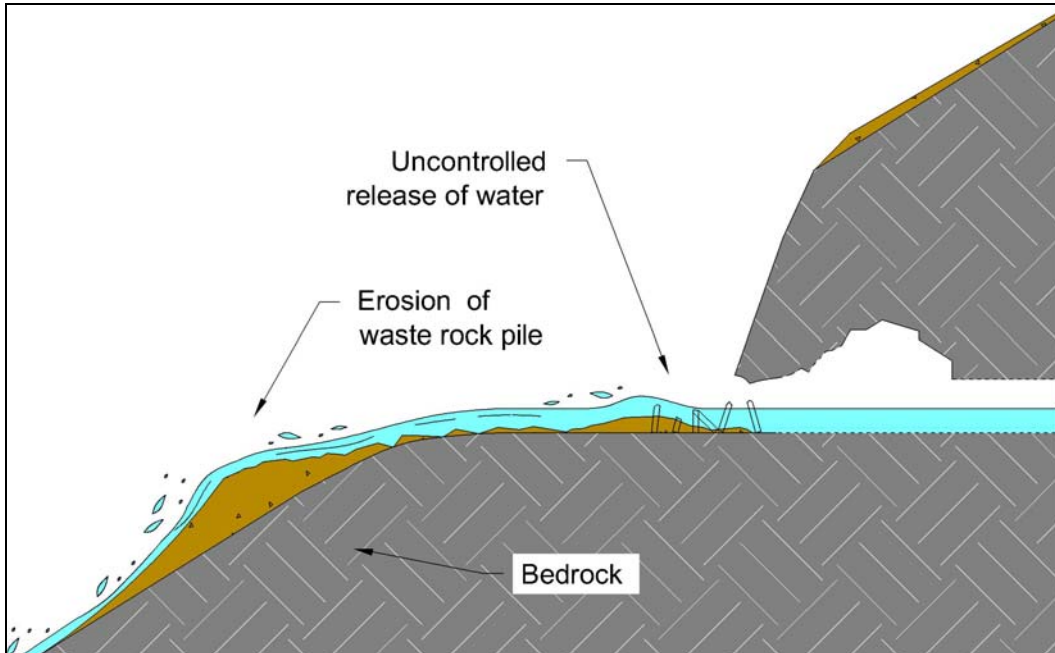
Figure 55.—Cross-section showing the blowout as it eroded the blockage and eroded fill from the waste-rock dump (not to scale).

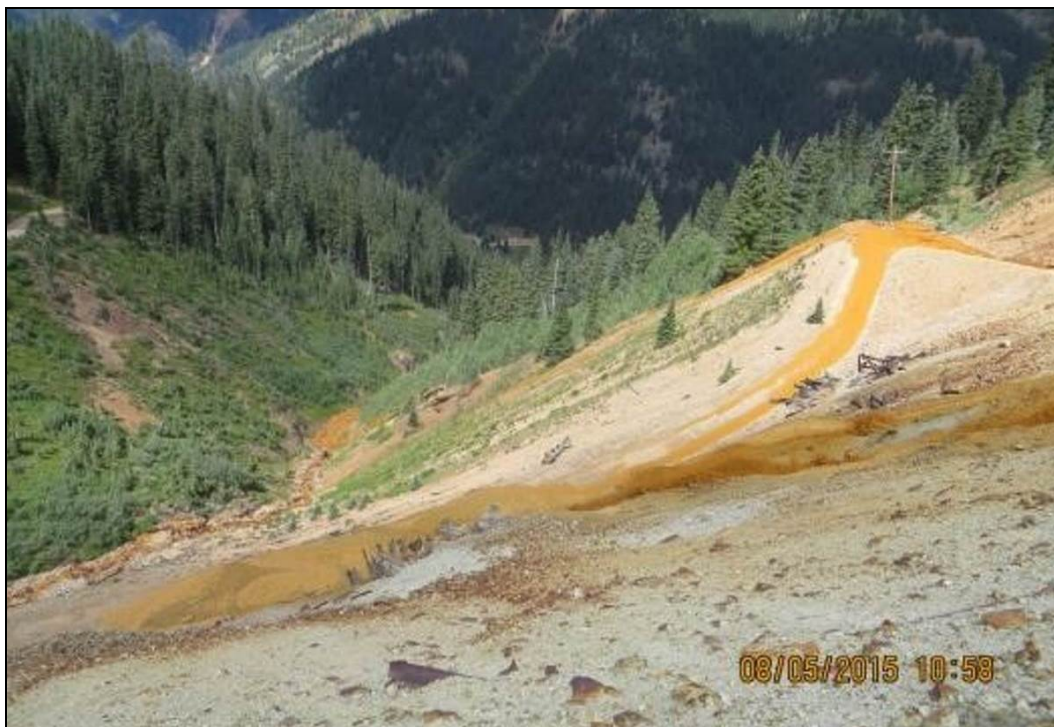
Figure 57.—Photograph showing a portion of the mine water flowing down the access road at 10:58 a.m. on August 5, 2015 (photograph from EPA project files).
