## Technical Evaluation of the Gold King Mine Incident

San Juan County, Colorado

U.S. Department of the Interior  
Bureau of Reclamation  
Technical Service Center  
Denver, Colorado

October 2015

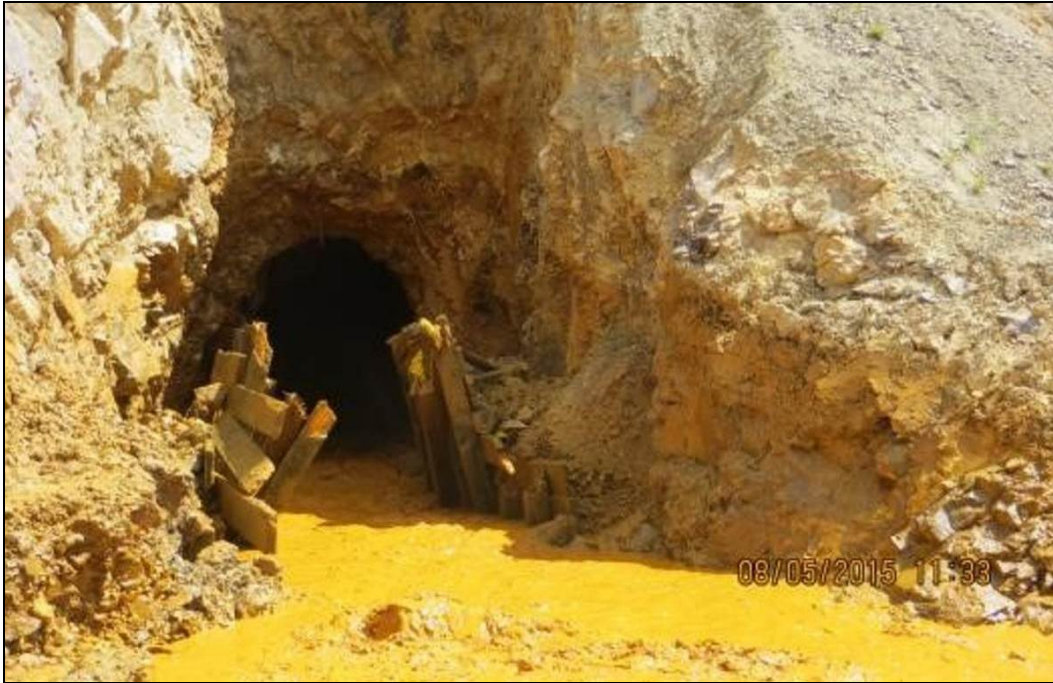
Figure 59.—Photograph showing the condition of the adit at 11:33 a.m., August 5, 2015; the peak flow of the uncontrolled release had passed and the flow rate was decreasing (photograph from EPA project files).

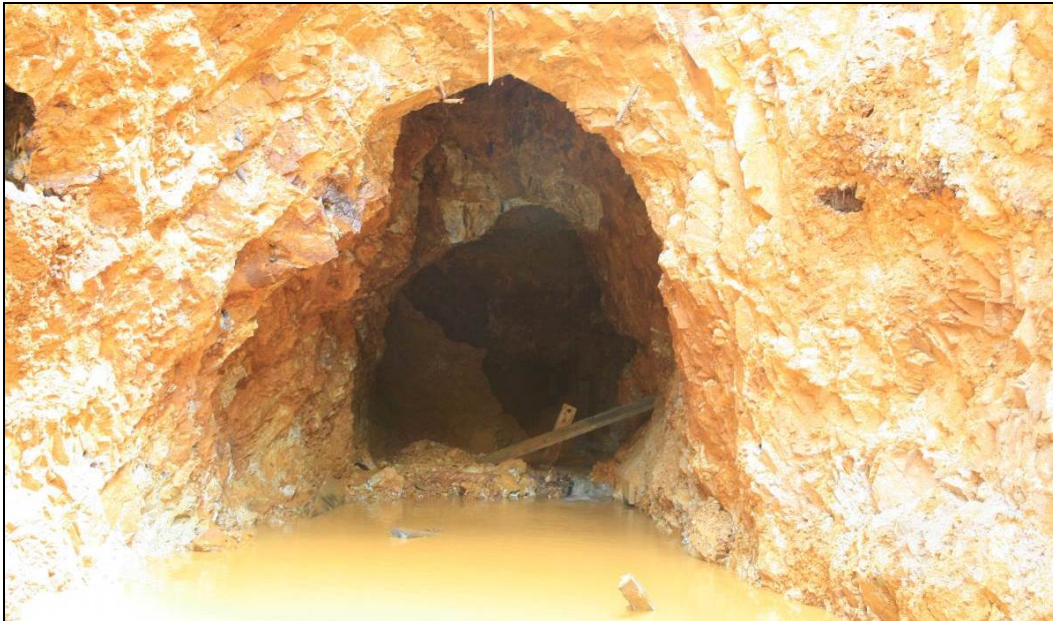
Figure 62.—Photograph showing the Gold King Mine Level 7 New Adit on August 16, 2015, after an excavator was used to reach inside the mine opening and remove the timbers. Note piles of debris from partial roof collapses inside the adit.

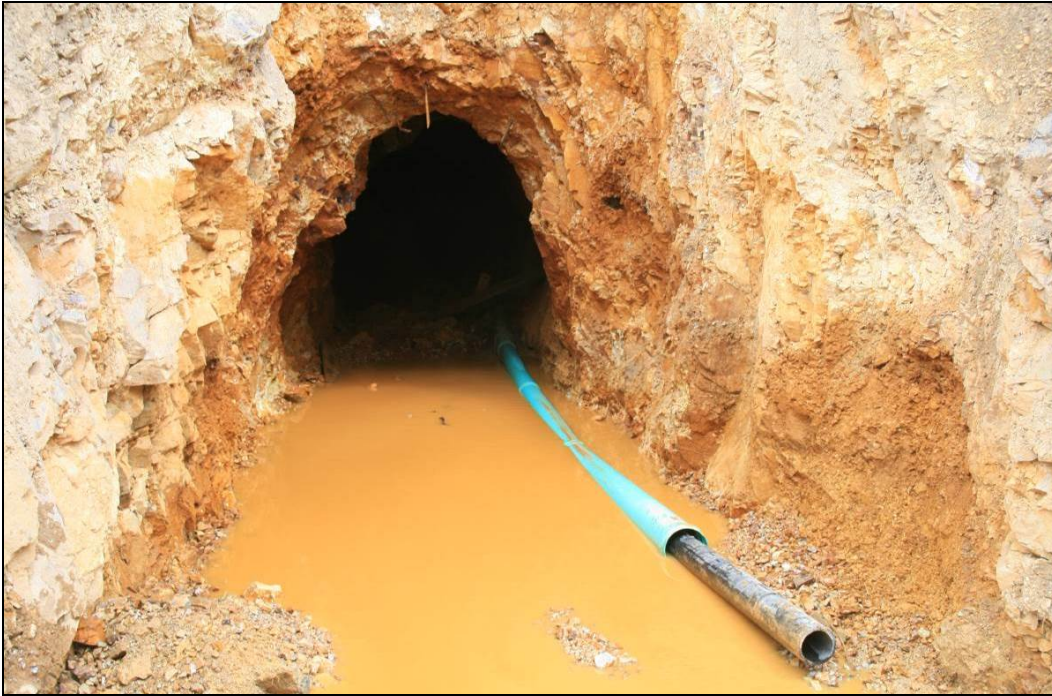
Figure 63.—Photograph showing the adit on August 16, 2015, with an 80-ft long (four 20-foot segments) turquoise-colored 24-inch outside-diameter drain pipe inserted into the adit opening. An 8-inch inside-diameter black HDPE pipe has been inserted into the 24-inch diameter pipe.

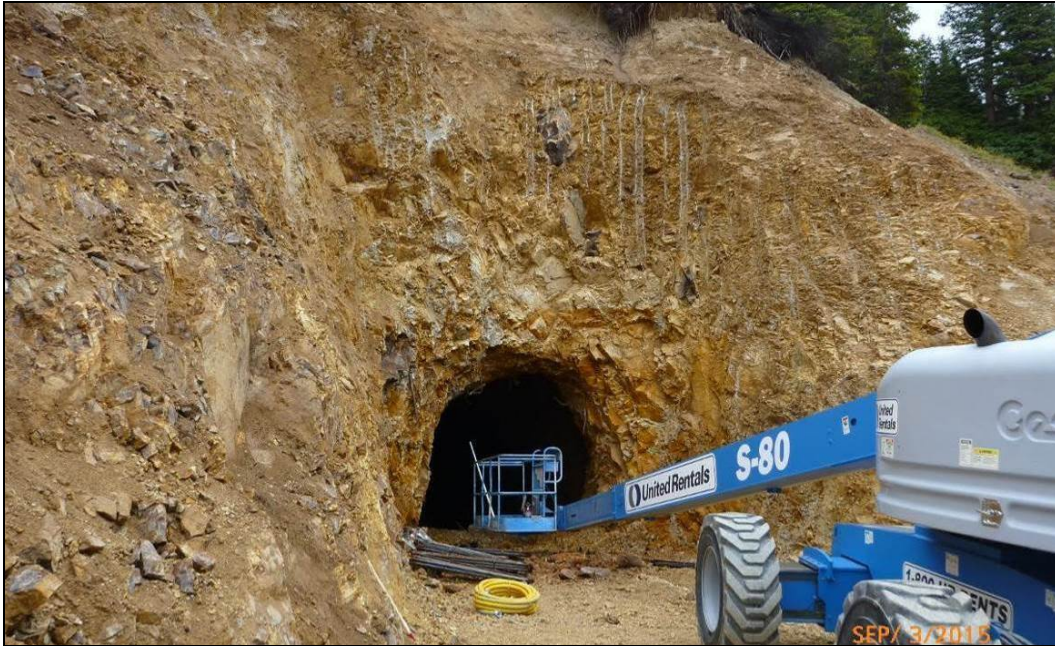
Figure 64.—Photograph showing the adit on September 3, 2015, at the initiation of rock bolting. The rock had been excavated to provide a larger work area. Note the excavator teeth marks left in the rock, an indication that the rock is altered and contains a significant amount of clay.
