The Failure of the Aznalcóllar Tailings Dam in SW Spain

Eduardo E. Alonso¹

Abstract

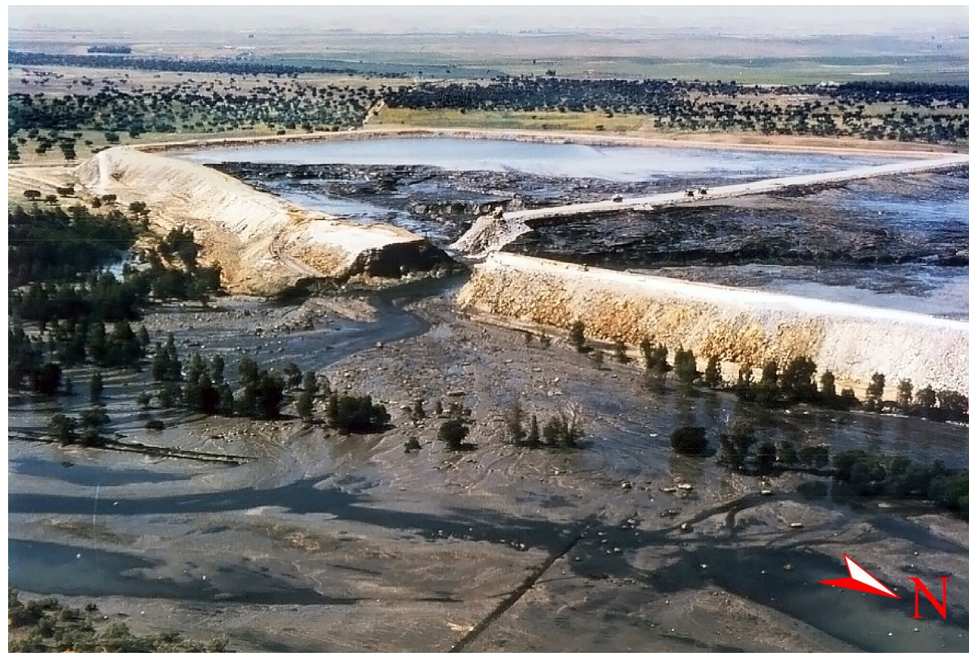
Figure 3 is an aerial picture of the breach opened on the east side of the dam after the main flooding event. The tailings deposit was divided into two ponds (north and south) separated by a transversal dyke shown in the photograph. The southern pond (left part of the photo) stored the finest tailings (fine sand and silt sizes) whereas the northern one received coarser material (medium to fine sands). The deposition of tailings in the pond used a spigotting technique. The deposit remained always saturated under a shallow (≈ 1 m) water layer. The failure affected the southern deposit.

Fig. 3 April 25, 1998; early morning. On the left, the displaced stretch of the dam and the opening allowed a fraction of the stored tailings and water to spill out, north and south of the transversal dyke. The original breach was estimated at about 14 m wide. Subsequent erosion increased the gap to about 25 m

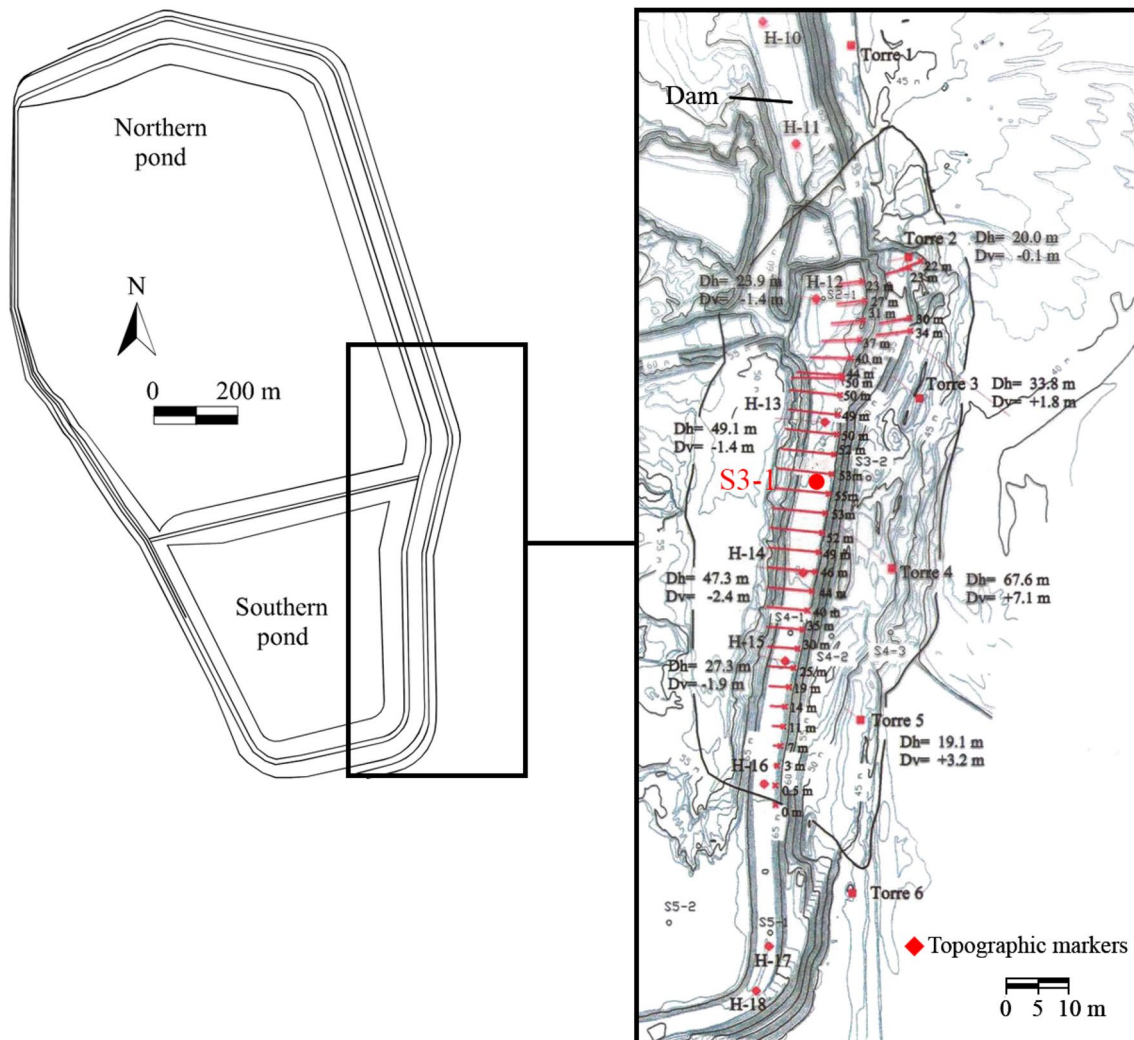
Aerial photographs taken before and after the accident provided a precise description of the failure. A 600 m long stretch of the southern dyke moved to the east (Fig. 5). The displacement vectors represented in Fig. 5 reached maximum values of 45–55 m in the central part of the displaced dyke. Towards the north and south, the displacements decreased gradually. The breach occurred at a place where the dyke's orientation changed. In fact, the dyke limiting the northern pond of the deposit remained essentially still, as explained below. In some locations, the horizontal (D_h) and vertical (D_v) displacements of the displaced points could be determined. The spatial direction of the displacement vectors at these points followed the dip direction of the stratification planes. The vertical jointing of the clay substratum explains some aspects of the slide geometry. The northern limit was a plane separating the stable dyke from the displaced one. The forward sliding motion opened a “window”,

Figure 5 shows the contour of the landslide responsible for the displacement of the dyke. Figure 6 shows the central cross-section of the landslide after failure. The geometry of the failure surfaces were established by the numerous borings shown in the figure; clear indication of shearing bands were found in the cores. Trenches excavated in the downstream passive zone also helped detail the shearing of the mobilized clay mass.

Fig. 5 Landslide contour line and displacement vectors of the southeastern dyke

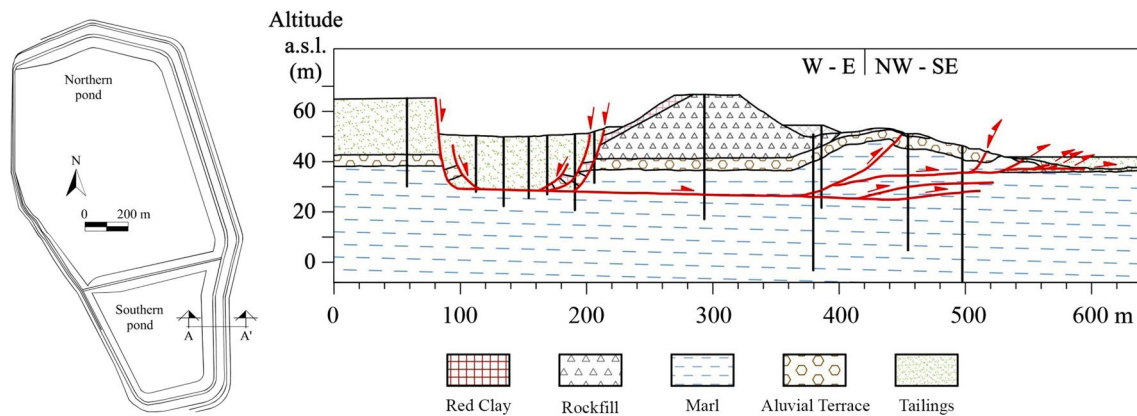
Fig. 6 The central zone of the failure, showing the displaced dam and the pattern of shearing surfaces within the blue clay

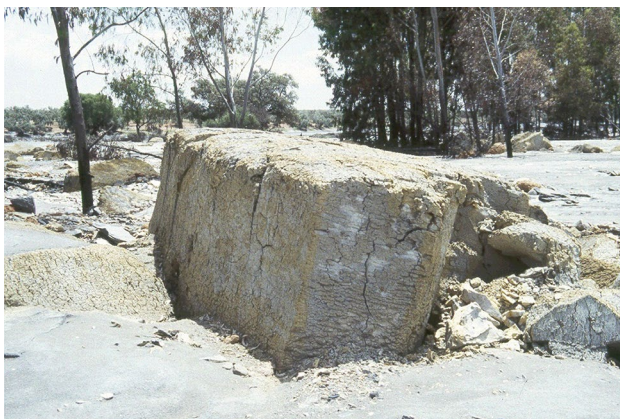
The violent flow of liquefied tailings out of the pond carried with it large blocks of marine clay, which “floated” on the underlying tailings (Fig. 7), due to the high specific

Fig. 7 Clay blocks ‘floating’ on the tailings flow. Note the parallelepipedic shape, sharp edges, and the joints covered by oxidation coatings

weight of the saturated pyritic tailings (around 31 kN/m³) and the natural saturated specific weight of the blue clay (18–20 kN/m³). These blocks exhibited a parallelepipedal geometry, consistent with the set of main discontinuities: sub horizontal sedimentary planes and two families of vertical jointing. These large bodies of blue clay allowed us to extract undisturbed block samples for laboratory testing; Alonso and Gens 2006a).

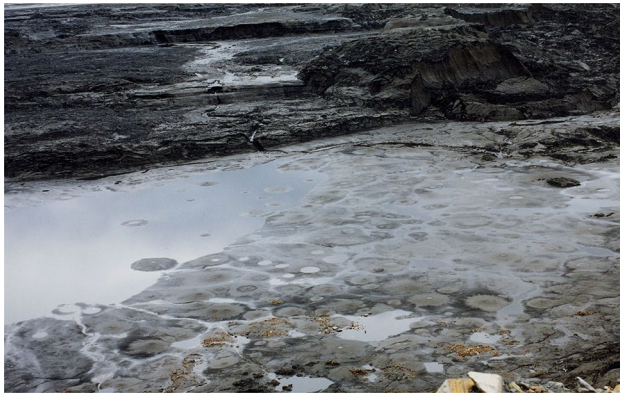
Fig. 14 Mud “volcanoes” observed a few hours after the failure on the surface of the depressed basin, upstream of the slid dam (Courtesy of J. M. Rodríguez Ortiz)

- Figure 14 is a photograph in the direction of the pond, taken from the crest of the displaced dyke. The presence of mud “volcanoes” everywhere is a clear indication of liquefaction;
- The distance travelled by the dyke (45–55 m) is difficult to explain without the propulsion provided by the liquefied tailings.

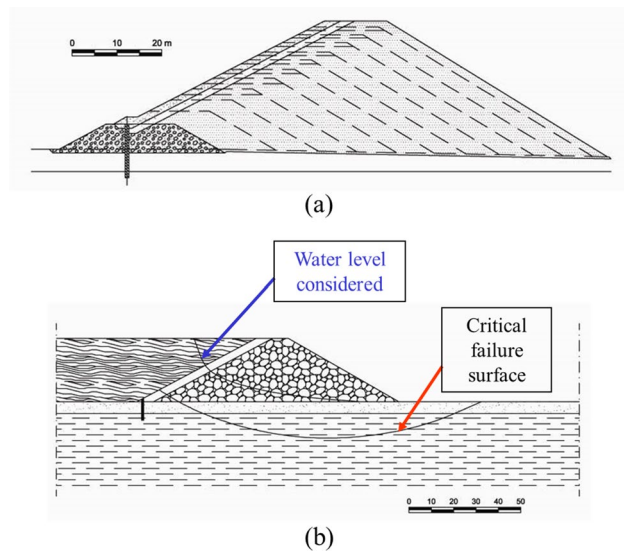
Fig. 25 Stability calculations during the design phase of the original project

- Tailings could liquefy;
- Pseudo-static vertical and horizontal accelerations $a_v = 0.776 \text{ g}$; $a_h = 0.048 \text{ g}$ (for a design earthquake of magnitude $\text{MSK} = 7$);
- Water level given in Fig. 25b under stationary conditions;
- M-C strength parameters for the blue clay: $c' = 0$; $\phi' = 20^\circ$.

The calculated safety factor in the original project, using the Morgenstern-Price method, was 1.3. Figure 25b shows the critical failure surface for the final height of the dam.

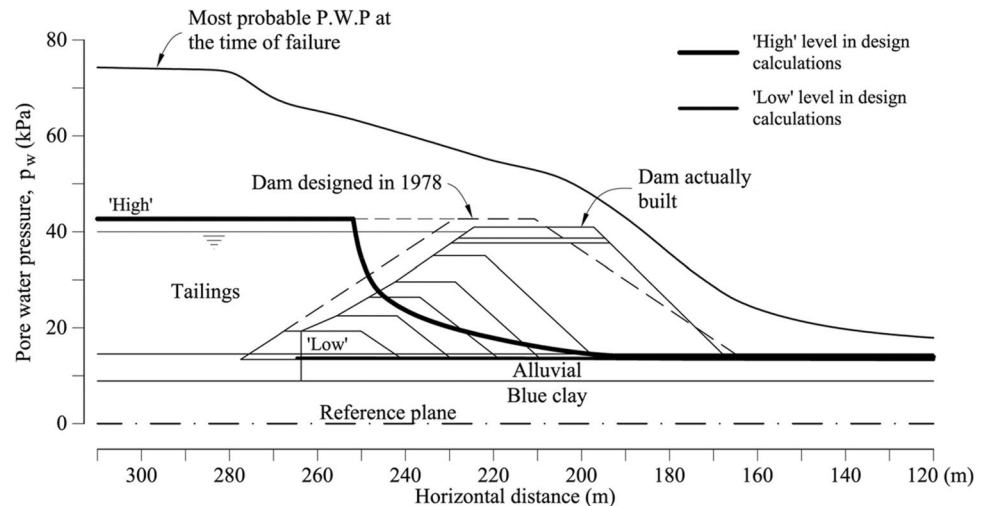
Fig. 26 Water pressures on the failure plane (“reference plane”)

Despite the precautions adopted in some of the assumptions (liquefaction of tailings; earthquake loading) and the absence of any effective cohesion, the dyke failed. Figure 26

- The most probable pore water pressure in the sliding surface (“reference plane” in the figure) at the time of failure was much larger than the pressures assumed in the original project. The figure shows the two alternatives assumed: either a “high” pressure or a “low” pressure, which was given by the free horizontal water level on the alluvial permeable layer. The “high” pressure profile was an interpretation of the condition of steady state percolation flow through the dam;

- No consideration of the progressive failure mechanism induced by the downstream dyke construction. In fact, the brittleness of the plastic blue clay was not recognized. The average friction selected (20°) is far higher than the residual friction (11°). However, the mentioned average operating friction on the failure surface (18°) does not differ much from the constant value assumed when designing the dyke.
