**THE LOCATION, HAZARD ASSESSMENT AND SEALING OF  
UNSAFE MINE OPENINGS IN THE CENTRAL  
WITWATERSRAND GOLD MINING BASIN**

A dissertation submitted to the Faculty of Engineering and the Built Environment, University of the Witwatersrand, in fulfilment of the requirements for the degree of Master of Science in Engineering by research only

Johannesburg, 2009

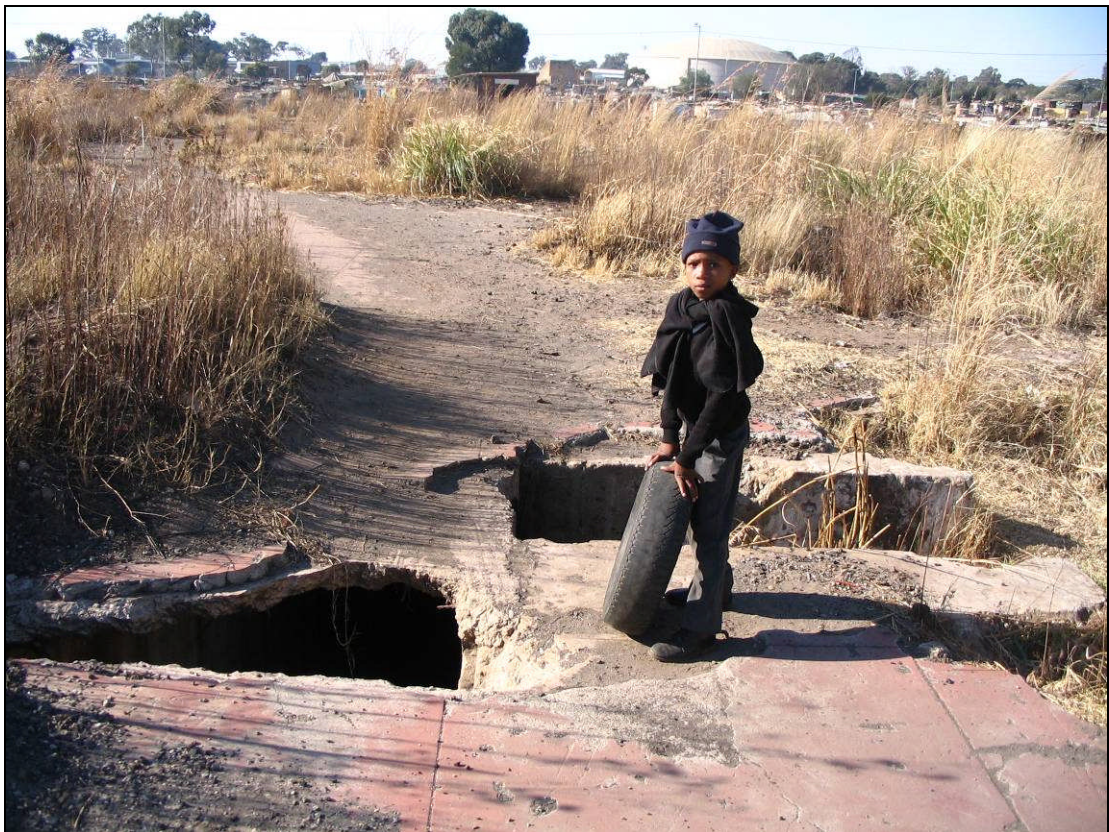
Figure 1.1 Local inhabitant dangerously close to two abandoned mine shafts, Johannesburg. Each of these openings is believed to be approximately 500m deep.

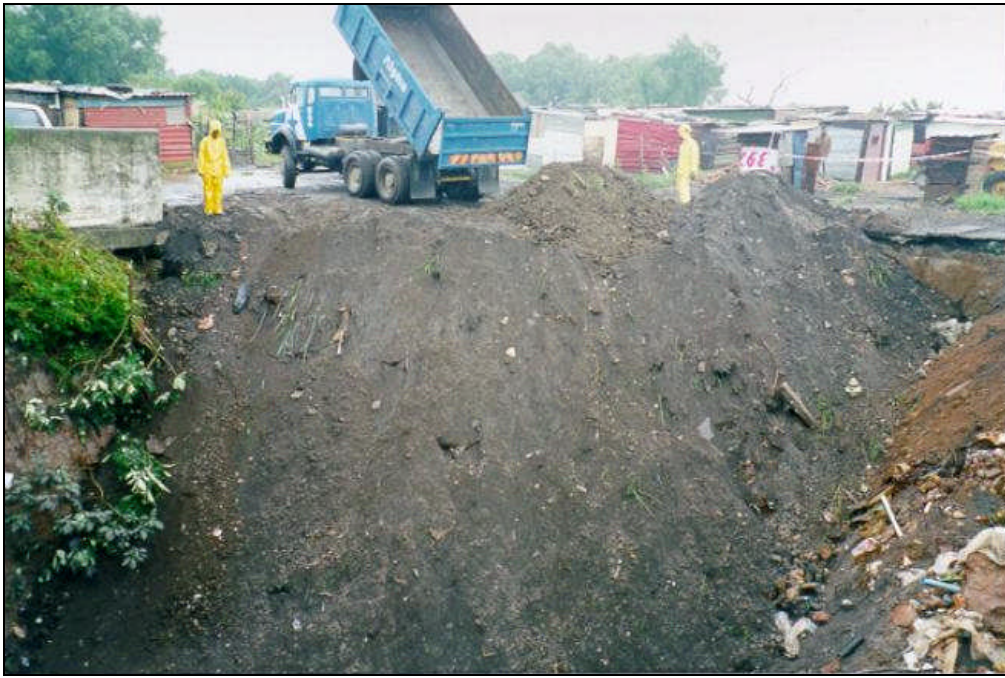
Figure 1.11: Uncontrolled backfilling, Boksburg (circa 2004)

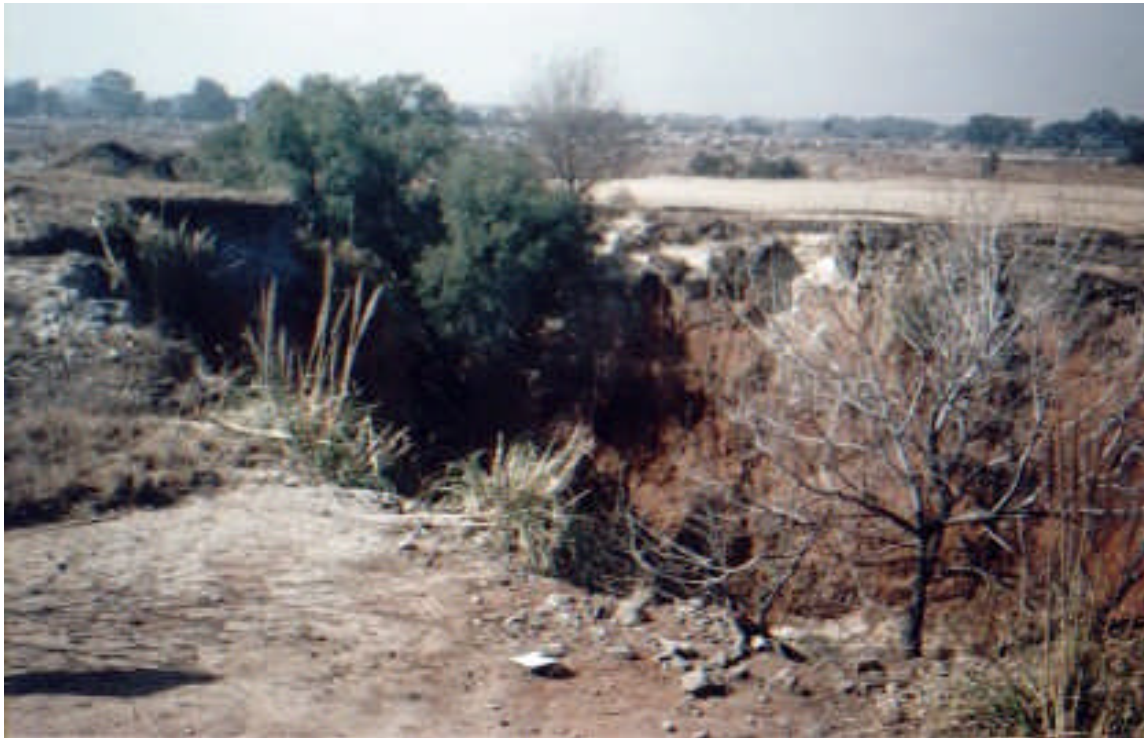
Figure 3.5. Largest subsidence in study area, ERPM 17, Ekurhuleni

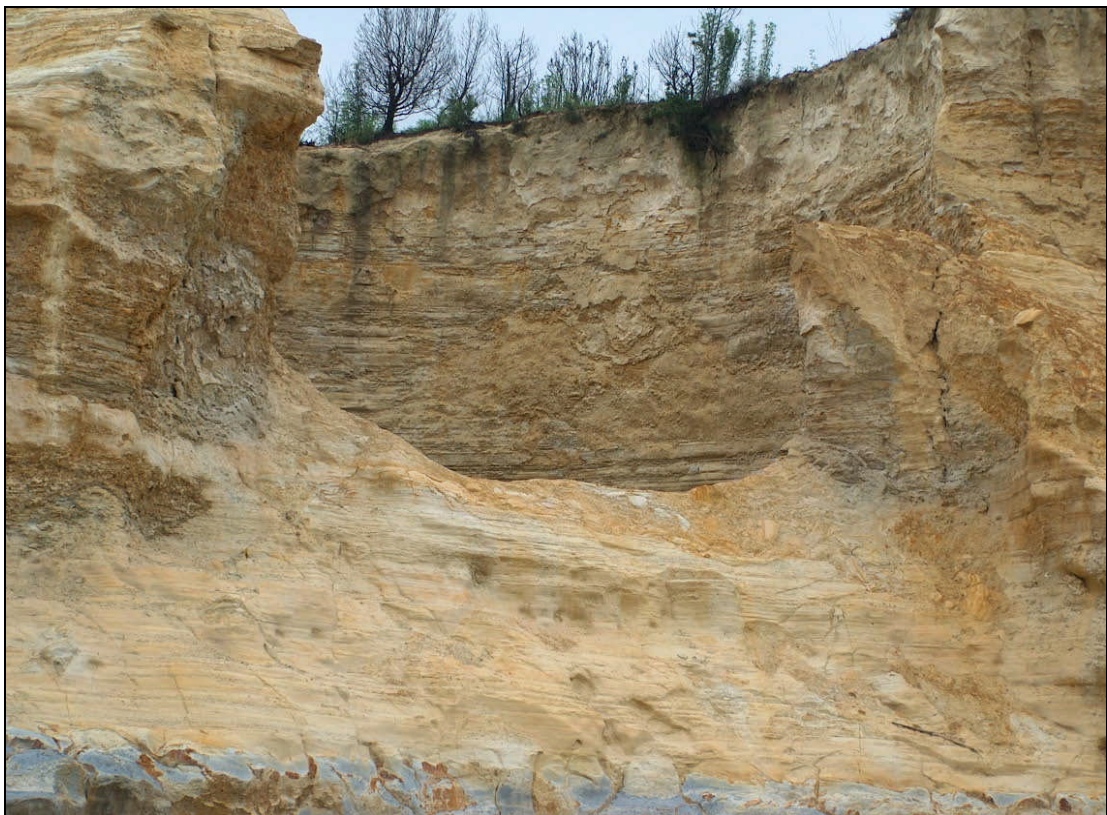
Figure 3.6. ERPM24x, collapse of a slimes dam into an underlying mine opening, Ekurhuleni

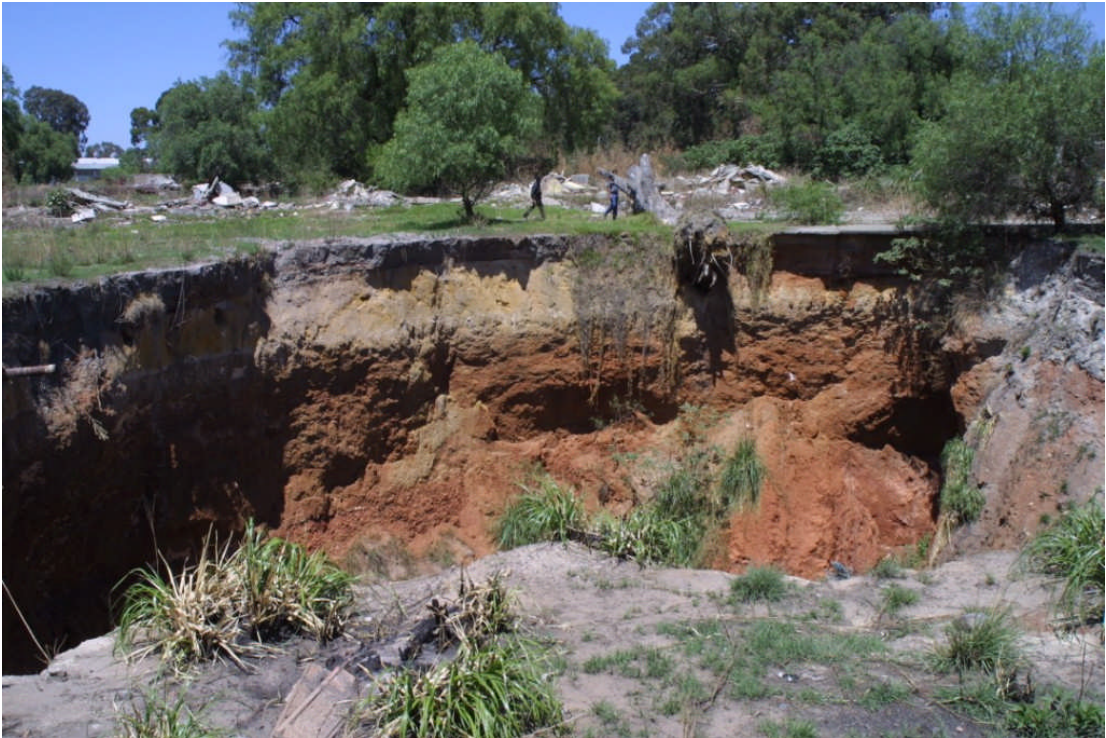
Besides its size, approximately 27 000m<sup>3</sup>, S&J15 (Figure 3.7) on the former Primrose Gold Mine property also illustrates how quickly subsidence can occur. Up until 1999 this area was a working gold mine, with a working headgear positioned over an inclined shaft. Yet by 23 October 2002, the date of a site visit by L. Croukamp (pers. com), a massive subsidence was present which presumably had developed sometime within this period i.e three years. This appears to be indicative of the illegal removal of steel supports from the abandoned shaft which led to collapse of the hanging wall and eventually surface collapse, Figure 5.16.

Figure 3.7: S & J 15, the old Primrose No.9 shaft, one of the largest known subsidences in the study area

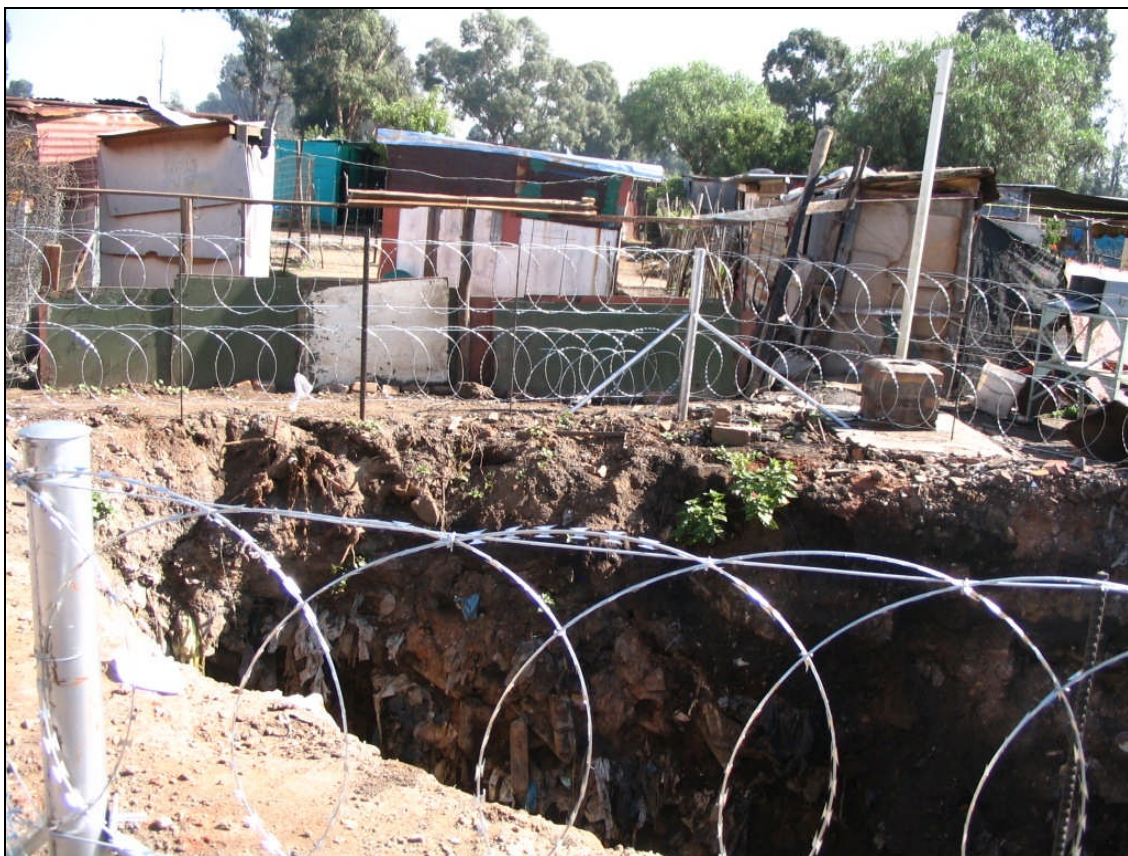
Figure 3.11. Informal settlement situated close to dangerous mine opening  
(Balmoral Vertical), Balmoral Informal Settlement, Ekurhuleni

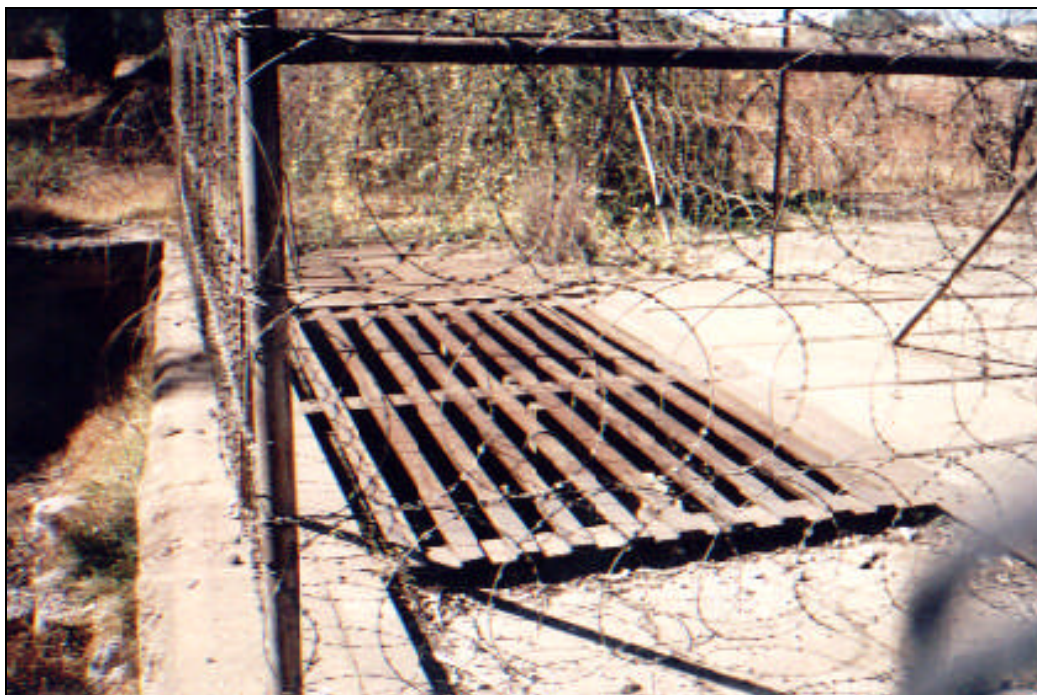
Figure 4.10: Mine opening (S & J 8) sealed with a metal grate and barbed wire fencing, Johannesburg

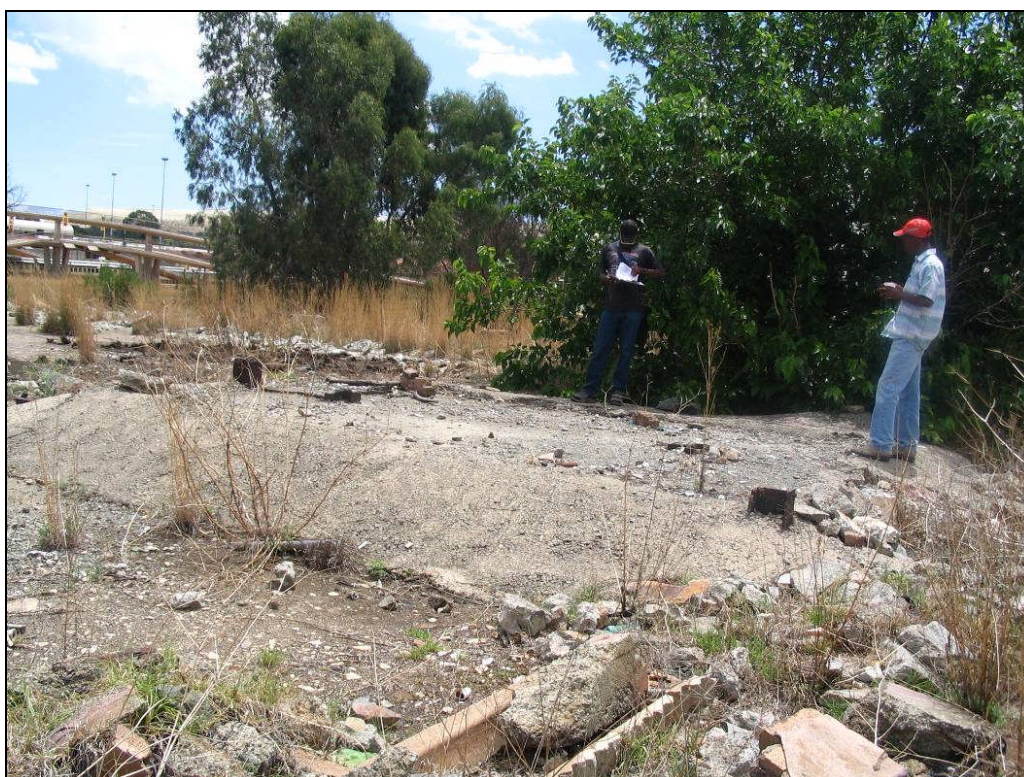
Concrete seals, where a layer of concrete was placed across the top of the shaft, were also commonly found, (Figure 4.11). No information could generally be found regarding the nature or age of such seals. However, in general, most observed seals seem not to have been tampered with. This can probably be ascribed the effort required to remove the reinforcing from the concrete matrix. There were exceptions however such as at the Kleinfontein Mine (outside the study area), Ekurhuleni, where evidence was seen (Figure 4.12) that the concrete layer covering the shaft was removed by force, the reinforcing bar cut and access to the shaft gained.

Figure 4.11: Typical shaft sealed with concrete seal (Crown Mine 8 Shaft A, Johannesburg)

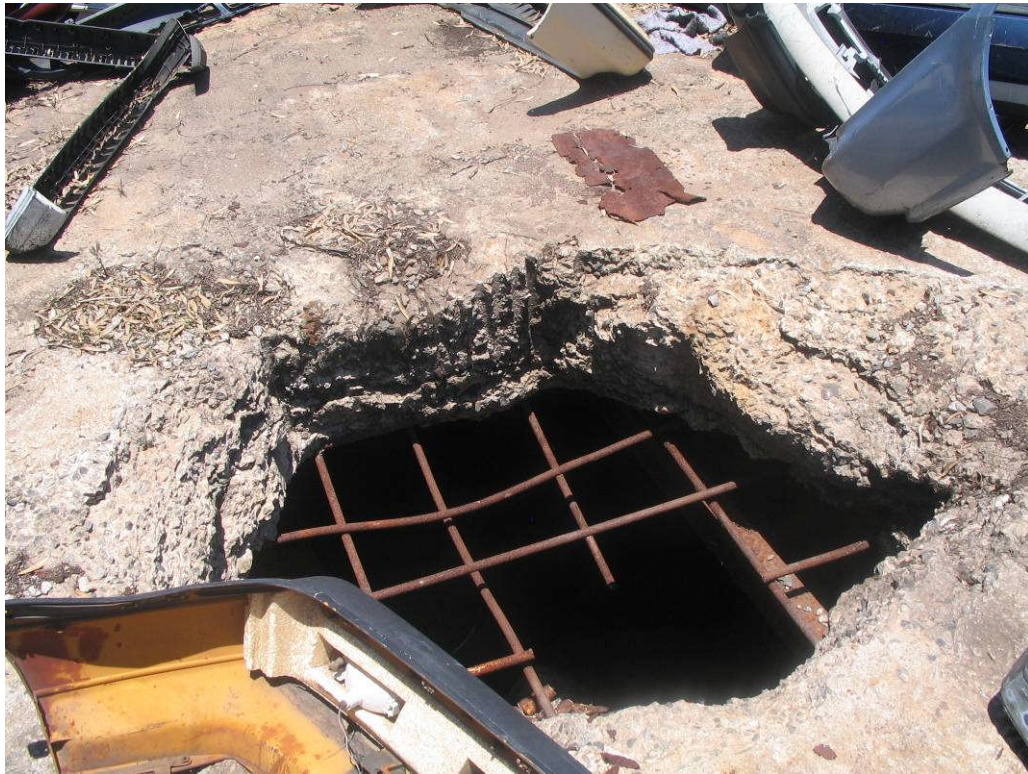
Figure 4.12. Access attempt through reinforced concrete seal, Kleinfontein Mine (Ekurhuleni)

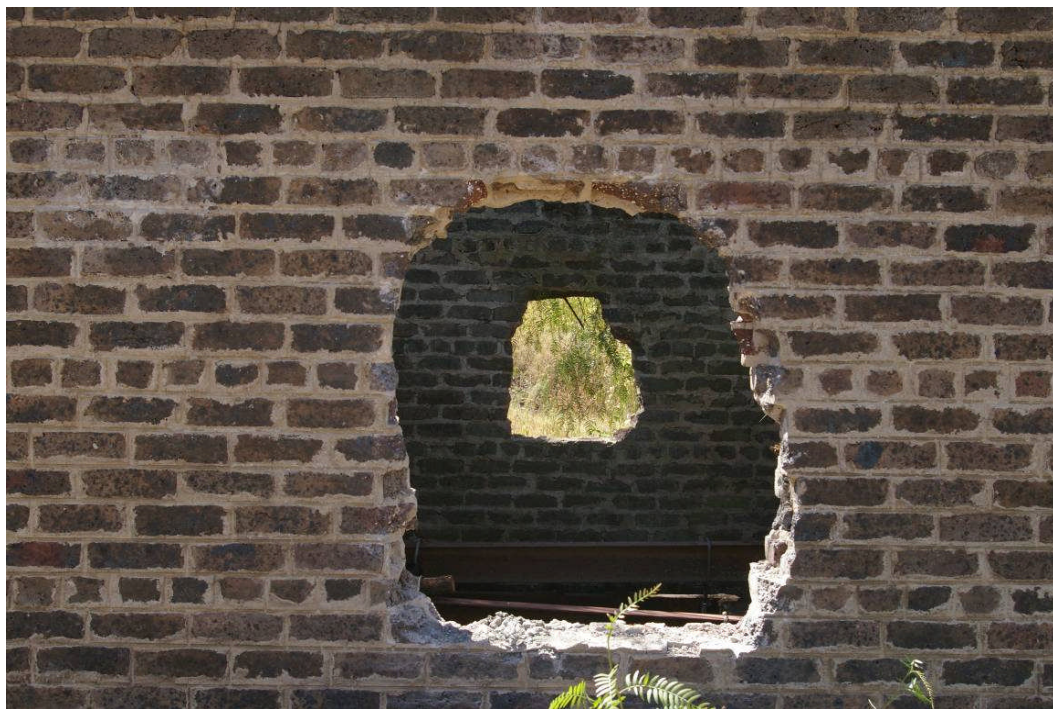
Figure 4.13. Access attempts through perimeter wall in Mine Opening Roode 5, Johannesburg

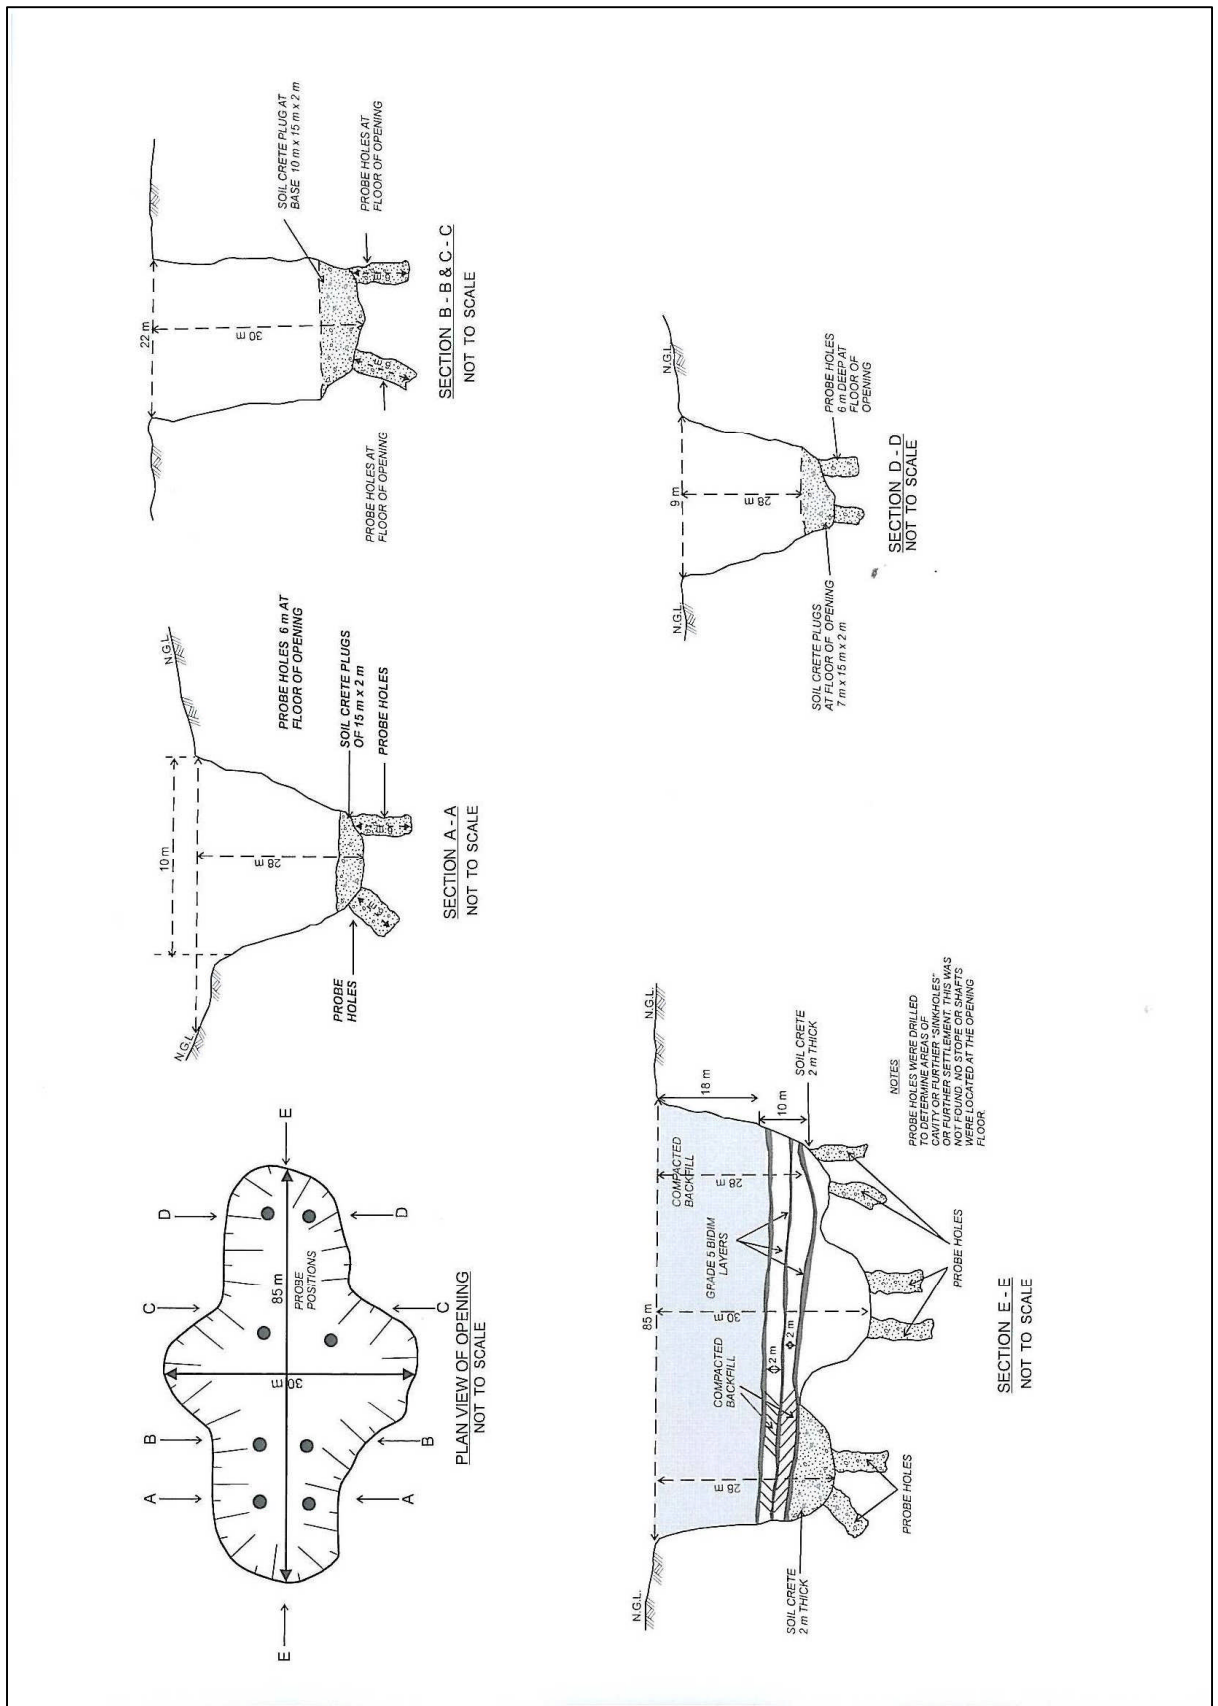
Figure 5.15. Investigation and sealing solution for ERPM 17, Ekurhuleni

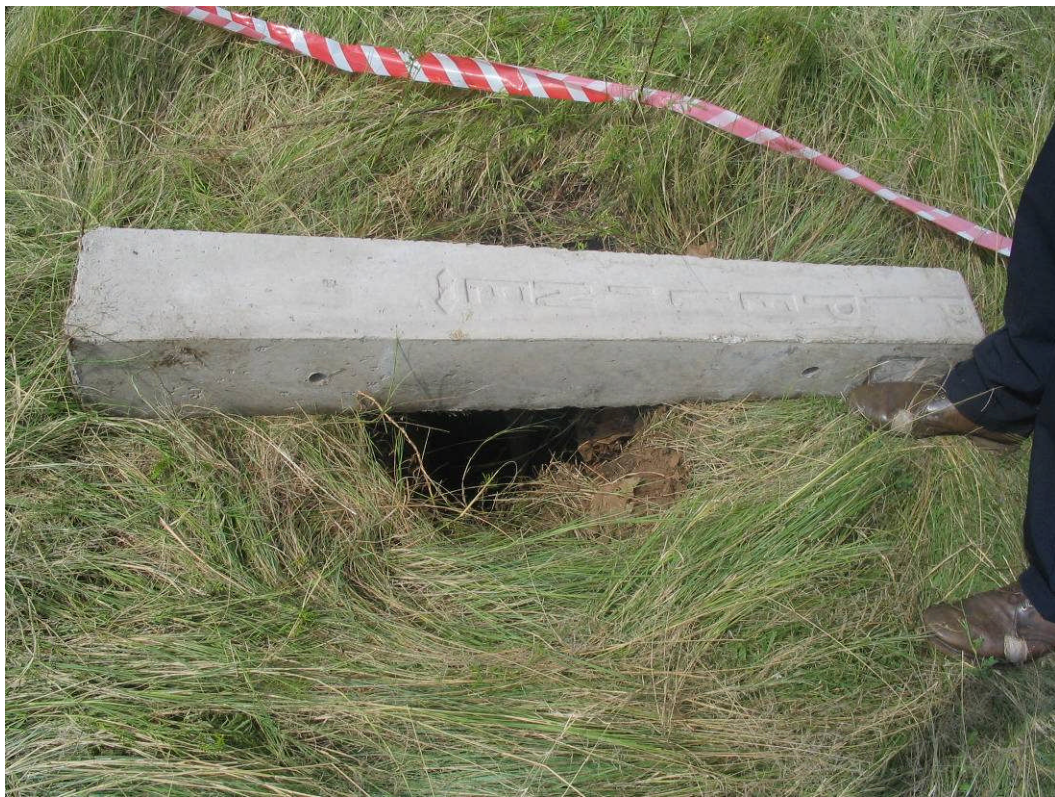
Figure 1: Ekurhuleni, small subsidence into which a woman fell on the 17/3/2005.
