# Institute of Geological Sciences

Report No. 75/10

THE ROCKFALLS OF JAMES VALLEY, ST HELENA.

A PRELIMINARY REPORT GIVING A SUMMARY OF RECOMMENDATIONS.

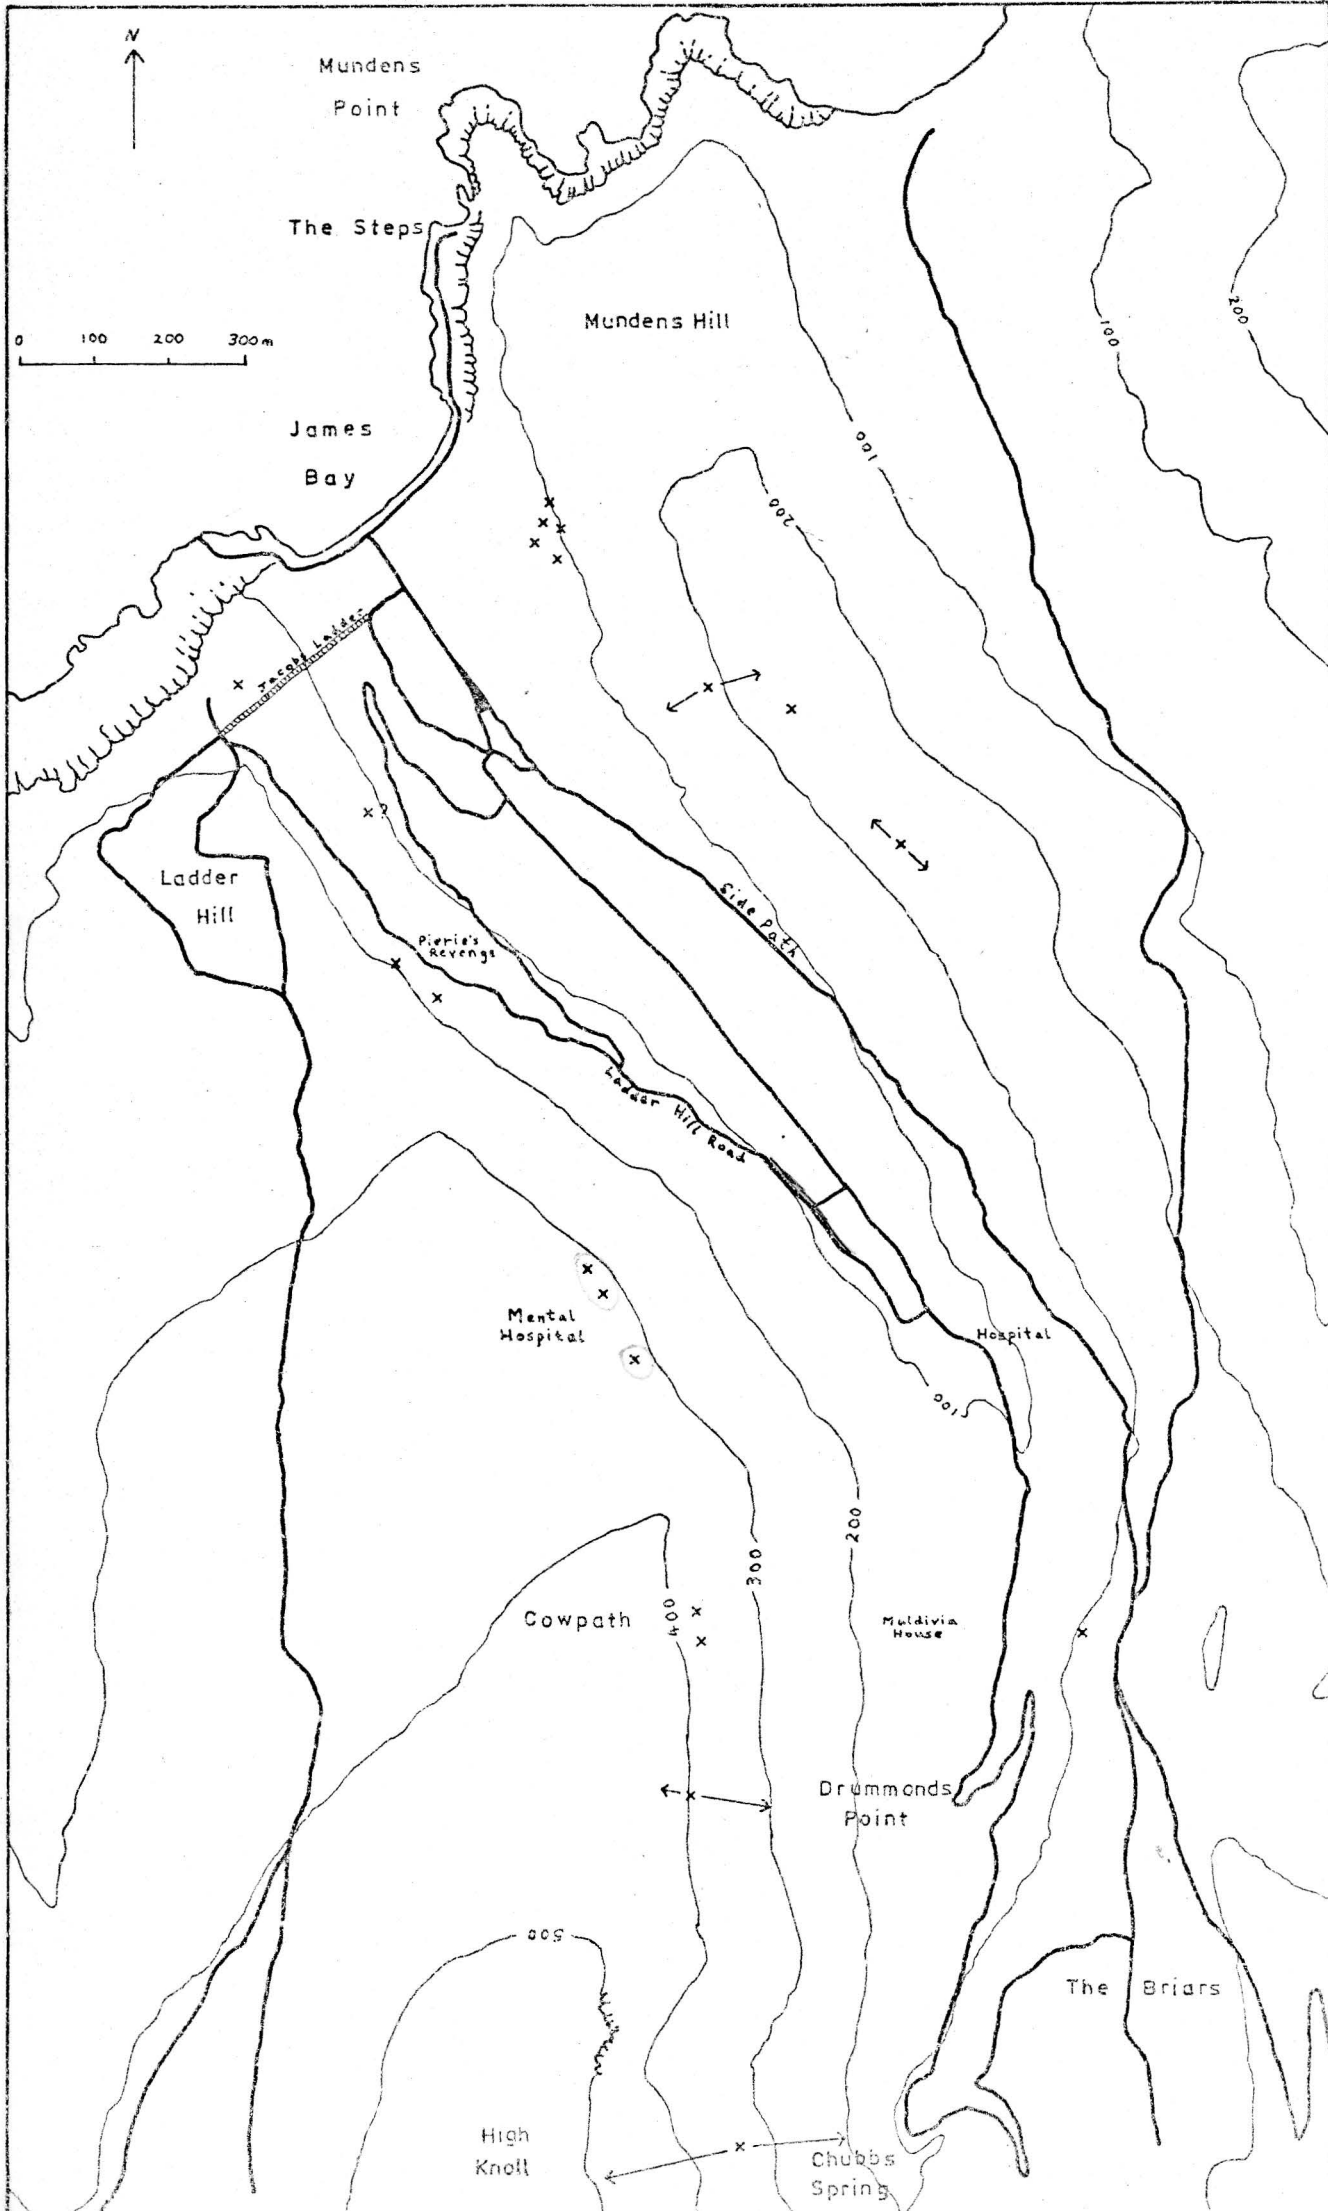
FIGURE 2 The Location of Recorded Rockfalls  
in James Valley

No systematic records of the occurrence of rockfalls have been kept on St Helena by any of the Government Departments. However between 1860 and 1923 a number of weekly newspapers were produced and these contained some references to the rockfalls that took place between these years. Table 1 gives the date, location (where given), size, preceding weather conditions and casualties for all falls recorded, and their locations are plotted on Figure 2.

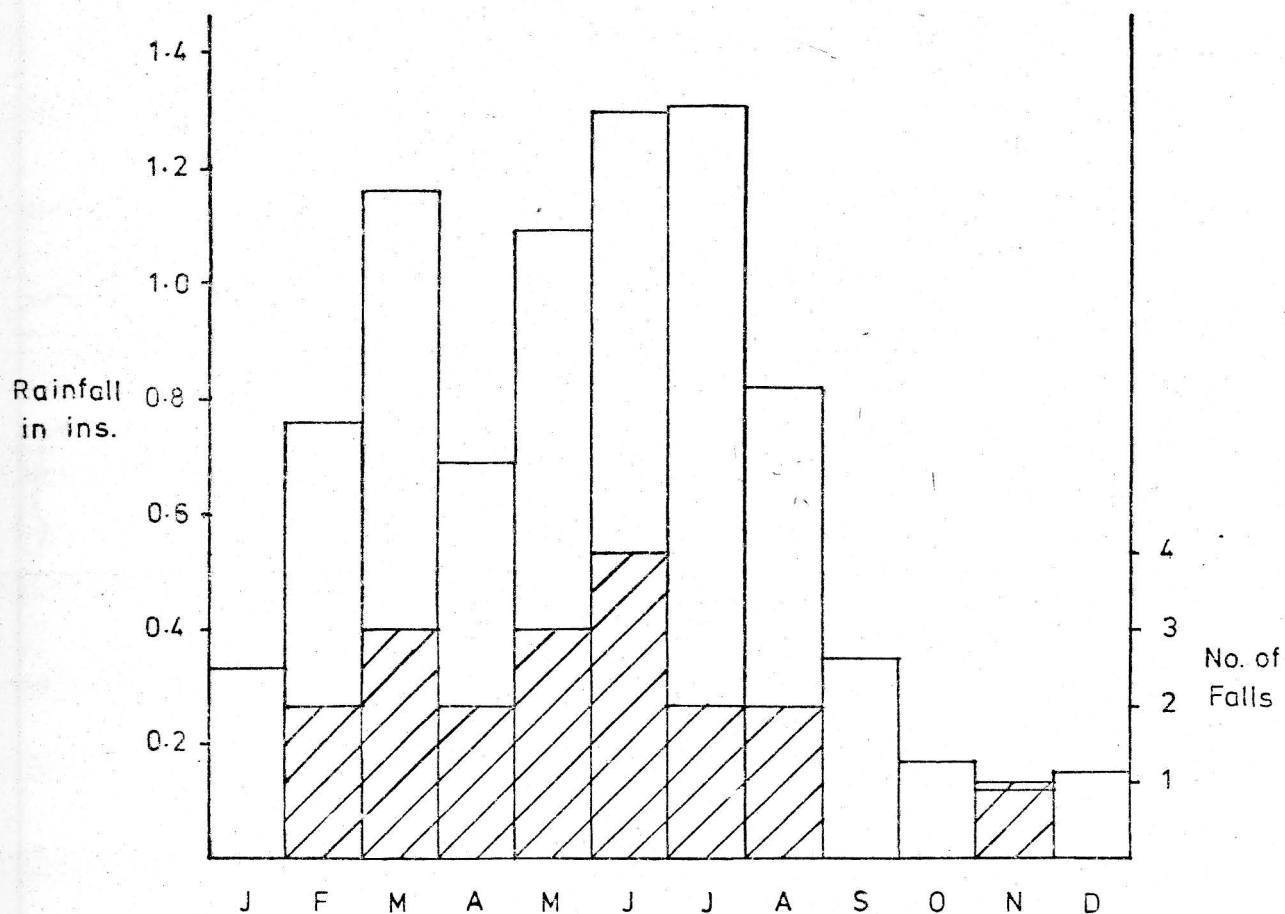
FIGURE 3 Histogram showing average monthly rainfall at Jamestown between 1932 and 1973 and monthly distribution of rockfalls between 1861 and 1923, and including the fall of August 1973.

Figure 3. show a histogram of the number of rockfalls recorded as having occurred during each calendar month. This clearly shows that the vast majority of rockfalls have occurred during the seven month period from February to August. This part of the year is also the wettest time of year on St Helena. Figure 3. also shows average monthly rainfall plotted for Jamestown. This is taken from records for the period 1922 to 1973.

Clearly, there is a correlation between rainfall and rockfalls.

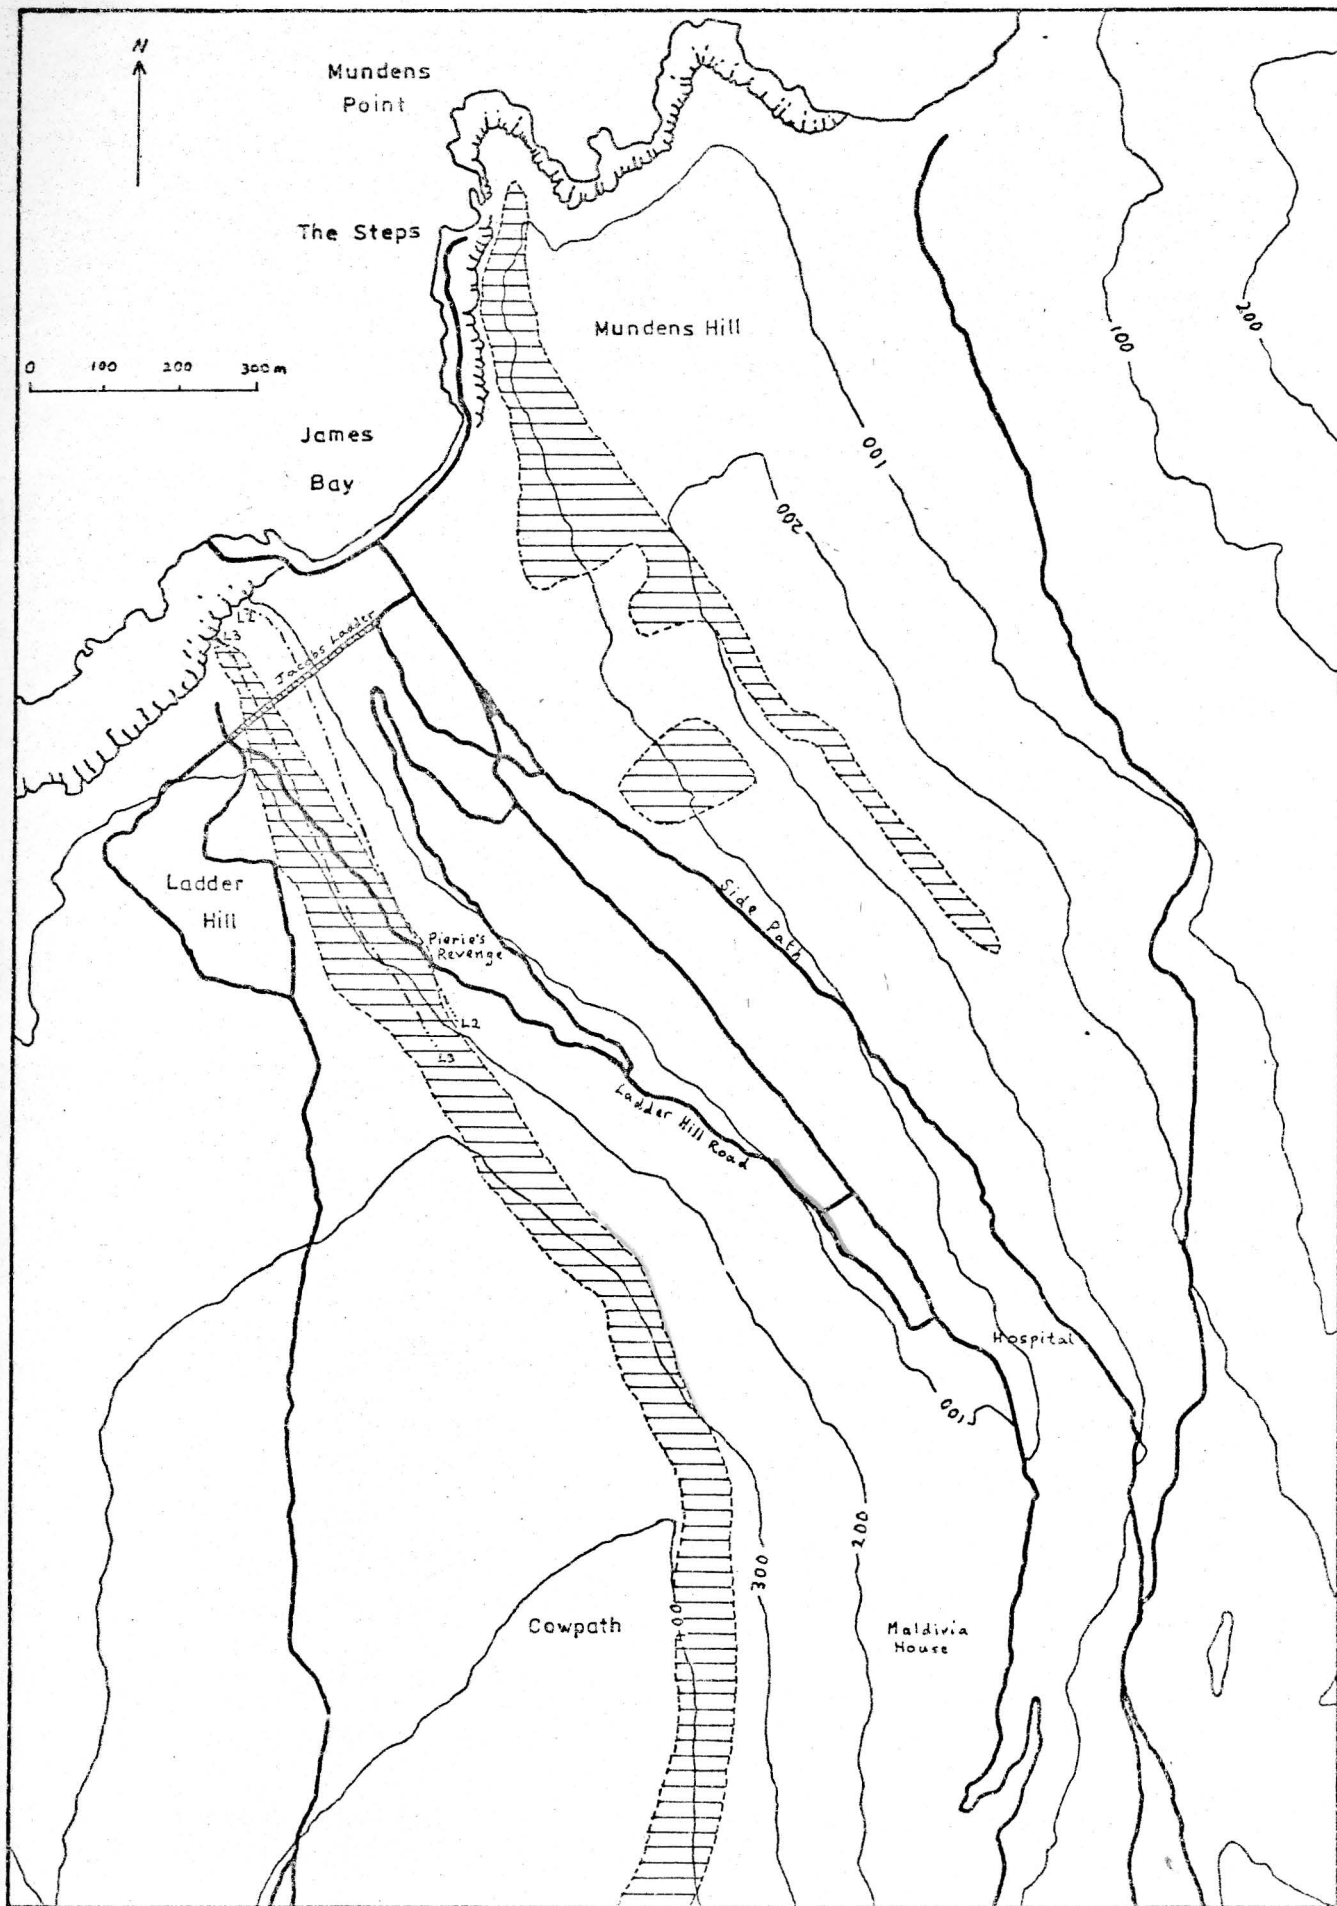
FIGURE 4 Map of James Valley showing areas of greatest potential instability and the outcrop of the northern end of flow groups L2 and L3.

The fieldwork together with the knowledge of the location of some old falls revealed that the majority of falls have been and are likely to be restricted to certain parts of the hillside (see Figure 4). On the east (Side Path) side of the valley falls are likely to originate in one of three areas, namely:

- a) The crest of the valley side (that is approximately the upper 30 m. of the slope) between the navigation triangle (Marked as a 'tower' on the 1:10,000 map) and Mundens Point.
- b) The upper part of the gulleys which are situated above Napoleon Street.
- c) The whole of the valley side above the track to Ruperts Bay between the Botanical Gardens and Mundens Point (i.e. between the up-valley end of Sisters Walk and The Steps). This area continues upwards to area a).

On the west side of the valley areas are less clearly defined being more related to individual flows or small groups of flows. Two flow groups, in particular, stand out on the valley side and have been labelled L2 and L3. Flow group L2 runs from the seaward side of Jacobs Ladder as far as Picrie's Revenge which is part of the flow group and includes a number of precipitous, overhanging and dangerous crags including the locally wellknown 'Emily's Jump'.

Flow L3 occurs higher in the succession at a height of 160 m. seaward of Jacobs Ladder and rising to about 220 m. above Pierie's Revenge where it was the source of the terrible fall of 1890. This flow group also contains a number of potentially dangerous outcrops particularly seaward of Jacobs Ladder and in the vicinity of the 1890 fall.

Apart from these two flow groups the whole of the slope above flow L3 is a likely source of rockfalls. This is particularly true of the upper group of flows along the crest which are interbedded with pink tuff bands. One or two ancient fall locations were observed in this area and many rock and cement pillars have been built to support severely overhanging rocks. These uppermost flows are potential rockfall sources from the mouth of the valley as far as High Knoll (though observations were only made along the ridge top as far as the area known as Cowpath).

While the areas noted above and shown on Figure 4, have been the source of the vast majority of past rockfalls and are the potential source of most future falls, isolated crags do outcrop on other parts of the slopes. These too may produce falls of rocks but make up only a small percentage of the total area of hillside and were generally too small to be exactly located and observed in detail in the time available for fieldwork.

Whatever course of action is decided upon to try to prevent rockfalls in James Valley it is unlikely that Jamestown will ever be completely free from the danger of falling rocks. The scale of the remedial measures undertaken and therefore their degree of effectiveness depends on how much money is available to carry out the work. If it is decided to embark on a major stabilisation programme it will be necessary to carry out a more detailed survey of those areas designated in Figure 4, and Section 5, to determine quantitatively the stability conditions of these rock faces.

This survey, which would include a full joint survey of the designated zones, would probably involve several man-months work and would be necessary to design the appropriate remedial measures to prevent further rockfalls. In some cases it is likely that rocks may be in such a dangerous condition that removal is the only solution. This in itself would be a tricky operation as great care would be needed to make sure no debris fell on the town below. However in the majority of cases rock bolting of large areas of the rock faces would probably be necessary. The purpose of rock bolts is to tie blocks of rock together into larger units which will be less likely to fail. To do this it is necessary to identify the "keystone" which, when removed produces progressive failure up the slope. On the valley sides of James Valley it seems that the tuff bands are effectively acting as "keystones". These are being rapidly eroded by percolating water and the rock above is consequently undercut so that eventually it fails by toppling. In those cases where the percolation of water is merely reducing the shear strength along joints rock bolting would probably be sufficient to secure a given face. However in the situation described above which is common to the slopes of James Valley rock bolting alone may not be sufficient as erosion of the basal tuff bands would still take place. In these cases it may be necessary to cover the exposure of tuff with gunite. This is a form of mortar consisting of fine-sand, cement and water which is sprayed on a face by air pressure. This will help prevent further erosion of the tuff. Drainage holes would have to be provided through the gunite to allow groundwater to escape. Gunite might also be used on those basalt faces that are breaking into smaller rock fragments too small for rock bolts to hold together.
