# The remediation and closure of the former Garryard and Gortmore sites within the historic Silvermines district, Ireland

**M. Dey** *SRK Consulting (UK) Ltd, UK*

**K. Cashen** *North Tipperary County Council, Ireland*

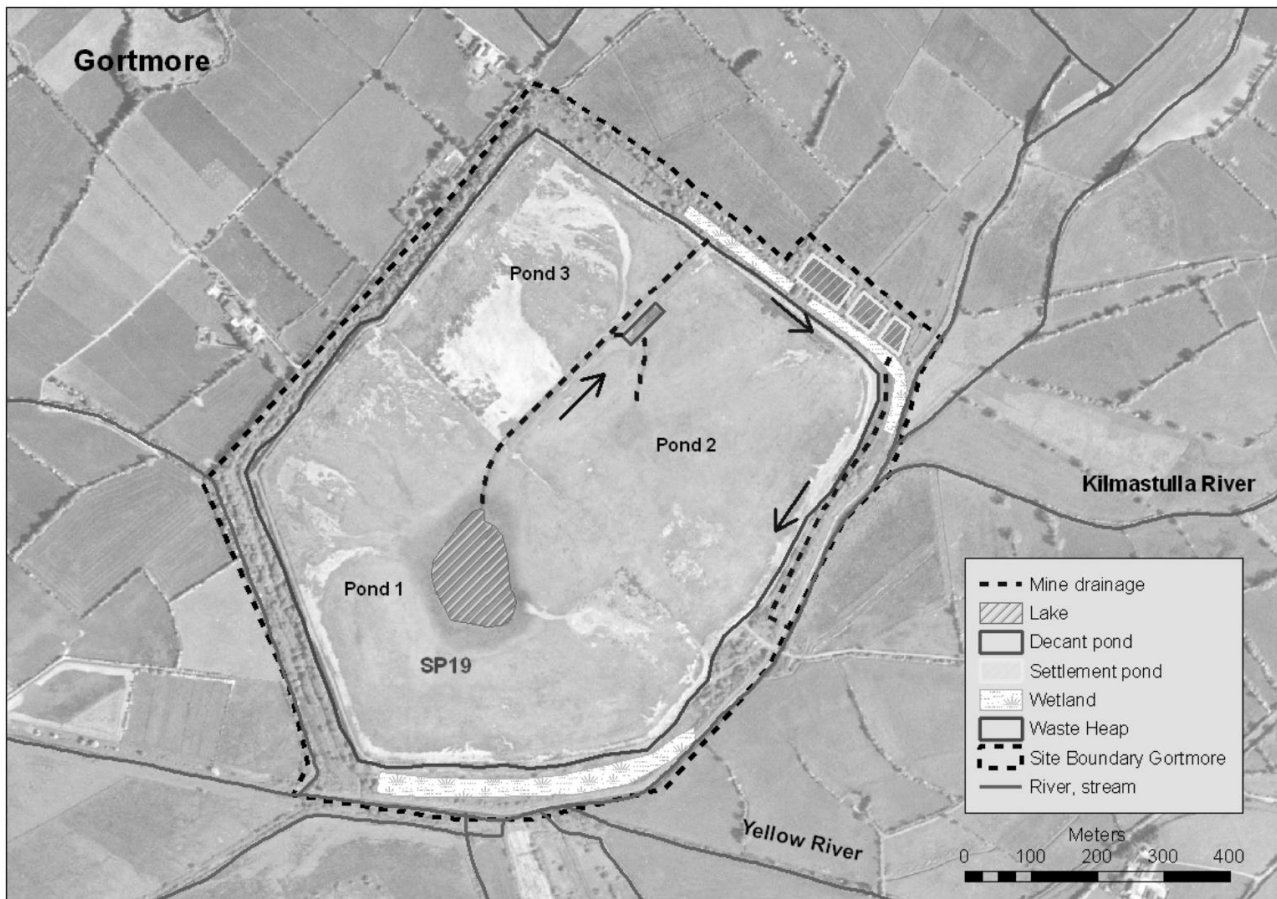
Following closure of the TMF, the surface layer of tailings slowly dried out and a major dust blow occurred in February 1985. Mogul undertook rehabilitation works to establish a grass cover across the surface of the TMF but this cover has deteriorated since then, although approximately 60% of the TMF area maintained its grass cover. The previous remediation work covered an area of circa 23 ha (visible as light coloured areas on Figure 3) (Stanley et al., 2010).

**Figure 3** Pre-rehabilitation overview of the Gortmore tailings management facility (Stanley et al., 2010)

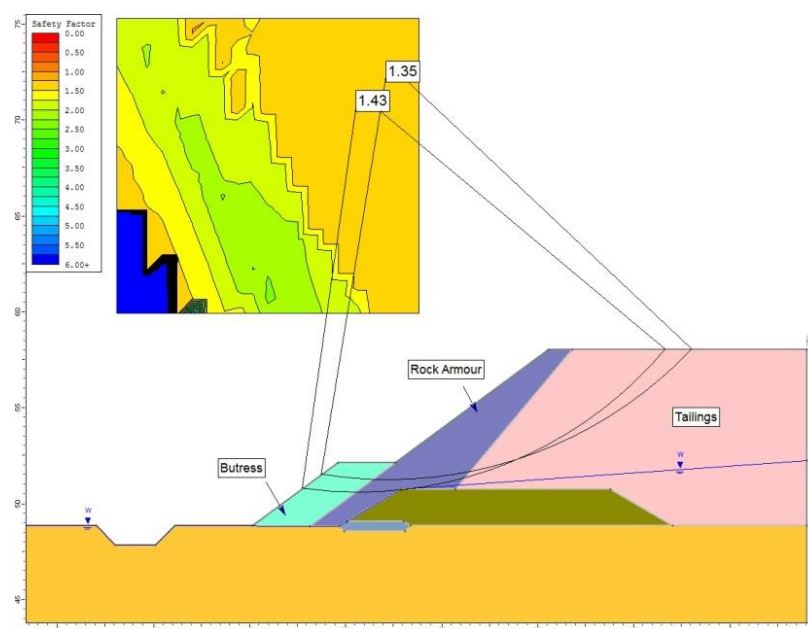
SRK's testing of the tailings with vane shear probe below the surficial crust (0.3 m thick) showed the strength of tailings varying from 5 to 10 kPa. If this strength of tailings is used in the slope stability model then the factor of safety drops below unity for the present conditions, without any buttressing. The present external slopes do not show any sign of instability with the exception of shallow erosion. The stable slopes indicate that the tailings contents have undergone a significant consolidation with depth and the overall stability of tailings is much higher than that which could be achieved in the numerical slope analysis utilising the strength of 5 to 10 kPa as measured in the field. It should be stressed that the low values were measured only from within 300 mm of the surface.

SRK performed the sensitivity analysis with a range of strength values for the tailings. This sensitivity analysis was used to determine the probable strength of the tailings waste. As a result of this sensitivity analysis, it was decided that  $c_u = 20$  kPa strength should be used for the tailings waste as the present dams do not show signs of instability.

Figure 4 below shows that adding the buttress in front of the existing slope at section 2 h will result in the factor of safety of slope of the dam above 1.3.

**Figure 4 Slope stability analysis at section 2 h with 3 m wide buttress**

The strength of  $c_u = 20$  kPa has been used in the further analysis to confirm the width of the buttress which has been required in some locations to bring the overall factor of safety to above 1.3.

The design of the buttress was performed utilising strength of tailings from the sensitivity analysis and strength of other materials from earlier studies.

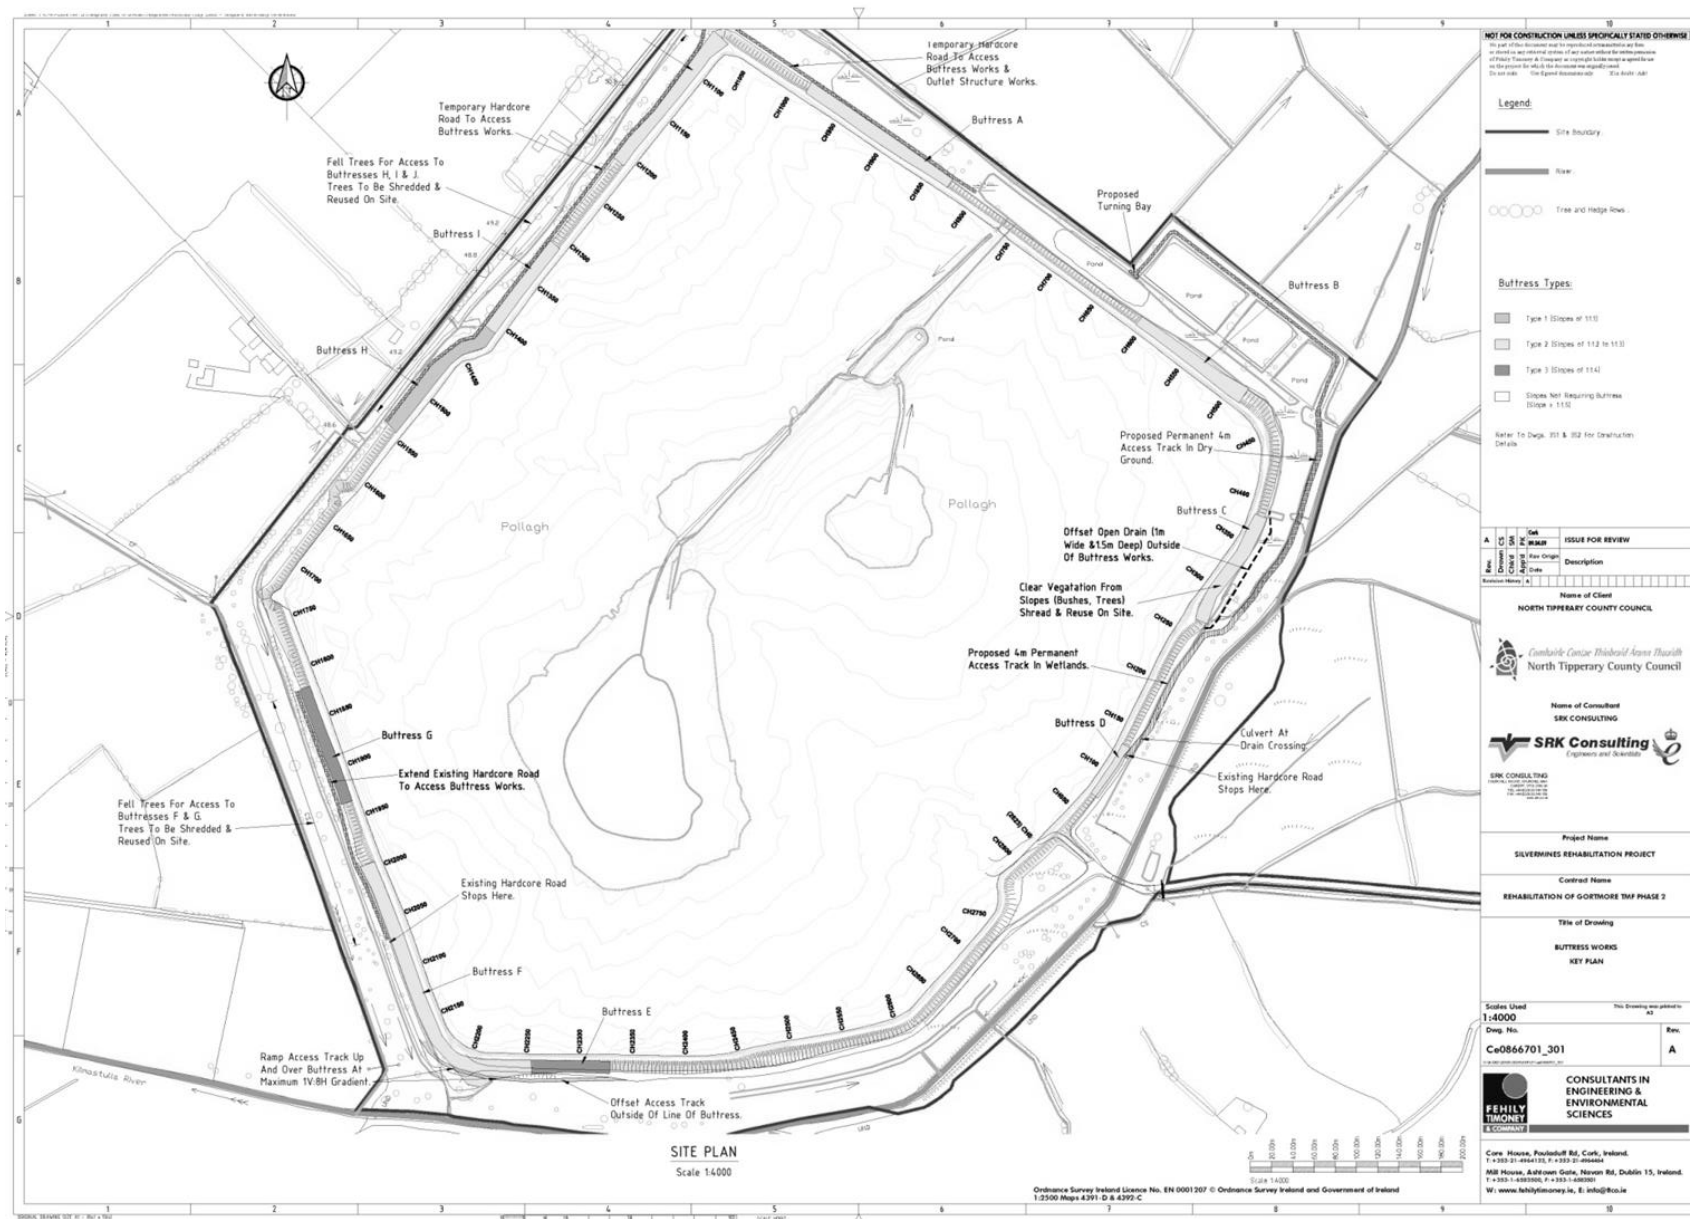
Table 2 shows the lateral extension of the buttresses as illustrated in Figure 4. For all subject areas, both the height and width of the buttresses should be 3 metres, respectively. These areas are illustrated in the large plan overleaf.

The buttress locations were determined based on the analysis as well as the visual inspection of the facility. This quasi-observational approach is appropriate given the lack of as-built precise drawings.

All buttresses have been constructed with good quality, stable materials. General specifications for borrow material and its placements are as follows:

- Largest particle size 150 mm with no sand and fine sizes.
- Non-acid generating.
- Only nominal (traffic) compaction of buttresses was required.
- Only placement of buttress on firm, approved surface of original soil was allowed.
- Final slopes were trimmed with no loose materials left on the slope.
- To improve the visual appearance of the final slopes some vegetation was planted.

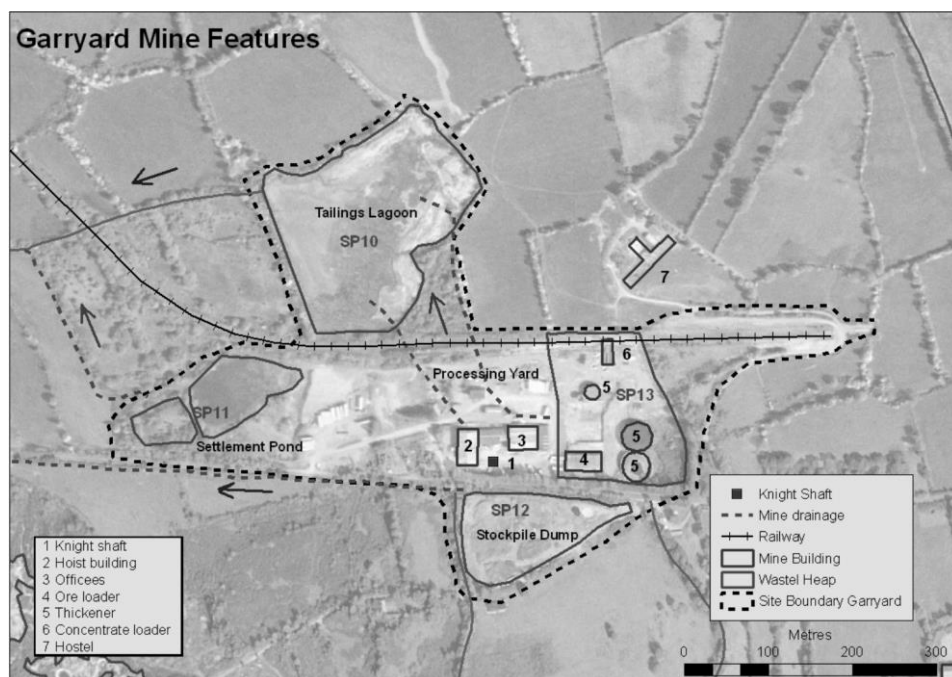
The Knight Shaft has a concrete cap but with an overflow pipe in the cap to discharge mine water, typically arising after heavy rainfall, which flows north under the railway siding to the tailings lagoon (SRK, 2001). The tailings lagoon also receives run-off from the concentrator area. Both the water and the tailings in this lagoon contain high concentrations of mine-related metals such as Pb, Zn, As and Cd. The two settlement ponds south of the rail siding historically receive surface runoff from the Garryard plant area. The larger settlement pond discharges water into the smaller pond which, in turn, discharges to a stream via a weir. This run-off can have high metal concentrations, however, the water discharged from the smaller settlement pond had very low metal concentrations, indicating that the ponds serve their purpose of trapping metals that enter them (SRK, 2001). Both the settlement ponds and the tailings lagoon ultimately drain into the Yellow River, 1 km downstream of the site'.

**Figure 6 Overview of the Garryard site (Stanley et al., 2010)**

The proposed remediation of the Garryard site is primarily aimed at stabilising the old tailings lagoon and wastes, and treating waters discharged from the Knight shaft and the tailings lagoon. As there is an upwelling of water from within the tailings lagoon through connection to the underground workings SRK proposed to stabilise the existing tailings by pushing all the tailings into the lagoon such that they would be maintained below the water level. It is then proposed that limestone waste materials from the Magcobar operations would then be brought in and placed as a layer over the tailings waste. The idea being that this waste would act as a safe material barrier, such that when subsequently the old ore stockpile from the southern side of the Garryard site was added to the waste facility it would be placed at an elevated position beyond the fluctuations of the water in the lagoon. Finally the facility would be capped to minimise water inflow. In this way the cyclic wetting of this old ore material could be minimised and the metal leaching of the wastes controlled.

However, it is acknowledged that a degree of metal leaching would continue and so a passive water treatment scheme was designed to treat both seepages from the waste management facility and the variable discharge from the Knight shaft.

The proposed water treatment scheme is to be located in the field immediately west of the existing tailings lagoon, alongside the rail line. It would comprise of an attenuation pond, a sedimentation pond, aerobic treatment followed by anaerobic polishing and finally discharged into a mixing pond over a cascade to ensure compliance. The attenuation pond is employed to smooth out the variable flows from the Knight shaft; it would be designed to hold and release a 20 year storm event, additional flows from higher rainfall fall events would by-pass the system untreated before being blended back at the final discharge point. With a constant flow the sedimentation pond would then retain the suspended sediments within the water, in order to minimise any detrimental effect from sediments to the subsequent operations. Next the aerobic treatment cells would aerate the waters and precipitate metals as hydroxides. The seepage from the proposed waste management facility would flow directly to this stage. Following the aeration of the water the next stage would be an aerobic polishing stage whereby the final metals would be removed through sulfide precipitate under anaerobic conditions. This cell would be sealed from the atmosphere but excess gases generated within the cell would be permitted to vent to atmosphere. Finally the cleaned anoxic effluent would be cascaded down steps to aerate the waters and permitted to equilibrate in a mixing pond prior to discharge to allow settlement of solids. At this stage any waters that were bypassed by the attenuation pond would be reblended thereby permitting a substantial proportion of the water to be treated. Unfortunately due to funding issues this remediation could not be completed.
