Bajtoš P, Pramuka S, Rapant S (2012) Impact of mineral extraction on the environment – Report for 2011, Report № ČMS Geological Factors 04–207–2012. Ministry of the Environment of the Slovak Republic | Section of Geology and Natural Resources | Dionýz Štúr State Geological Institute | Regional Centre Spišská Nová Ves, Spišská Nová Ves, 61 p

#### 4.8 Nižná Slaná R8 site

The occurrence of signs of subsidence – cave-ins, sinkholes and ground subsidence at the Kobeliarovo deposit – was limited in 2004 to a section of the deposit measuring approximately 200 x 200 m. According to information that has not yet been verified, surface subsidence in the Kobeliarovo deposit area, on the north-western edge of the village, has been occurring since the mid-1990s. According to data from Siderit, s.r.o. Nižná Slaná, the first collapse occurred in 1995. From August 2002, repeated field surveys and detailed photographic documentation were carried out in the collapse zone, initially of the nine collapses that existed at that time, and later, at the end of the monitoring period (August 2004), of up to 19 collapses that had gradually occurred in the collapse zone. Due to the high safety risk resulting

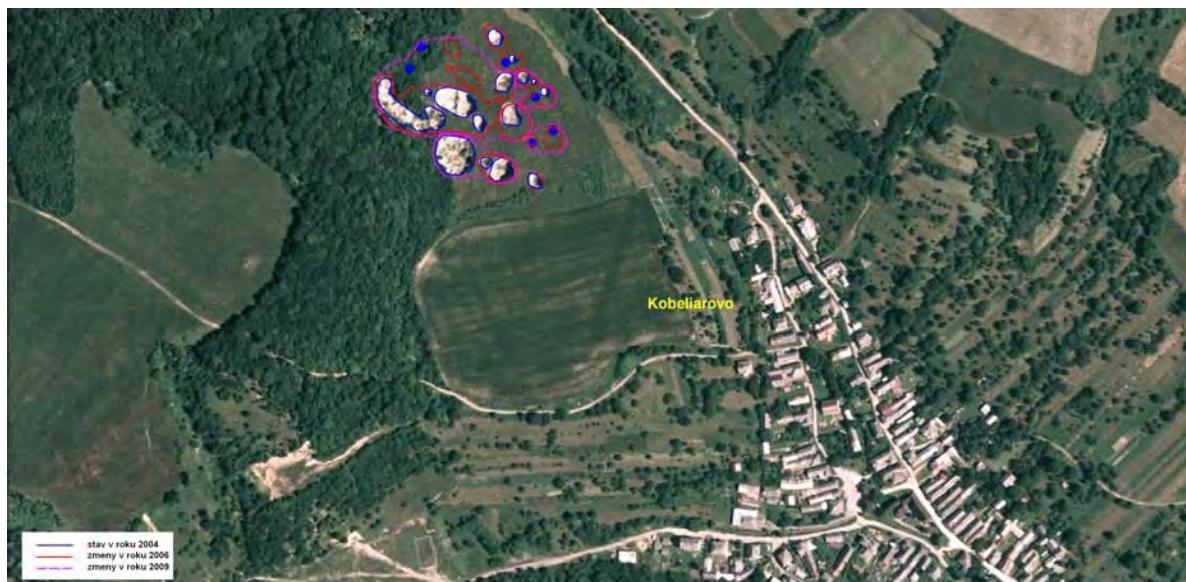
Fig. 15 Temporal development of the extent of the landslide zone in Kobeliarovo with the status as of 2004, 2006, and 2009 based on an orthophotomap from aerial photography

The temporal development of the landslide zone in Kobeliarovo is documented in Fig. 15. Based on an orthophoto map from 2004, the contours of the landslides from 2006 and 2009, obtained from Google Earth satellite images, are shown. The situation in 2004 corresponds to that documented in the report by Vranu et al. (2005). Compared to this situation, it is possible to see the expansion of individual landslides and the formation of new landslides in the area above the mined siderite deposit. The sizes of the areas affected by landslides in individual years at the Kobeliarovo site are as follows:

2004	5,047 m <sup>2</sup>
2006	10,451 m <sup>2</sup>
2009	16,255 m <sup>2</sup>

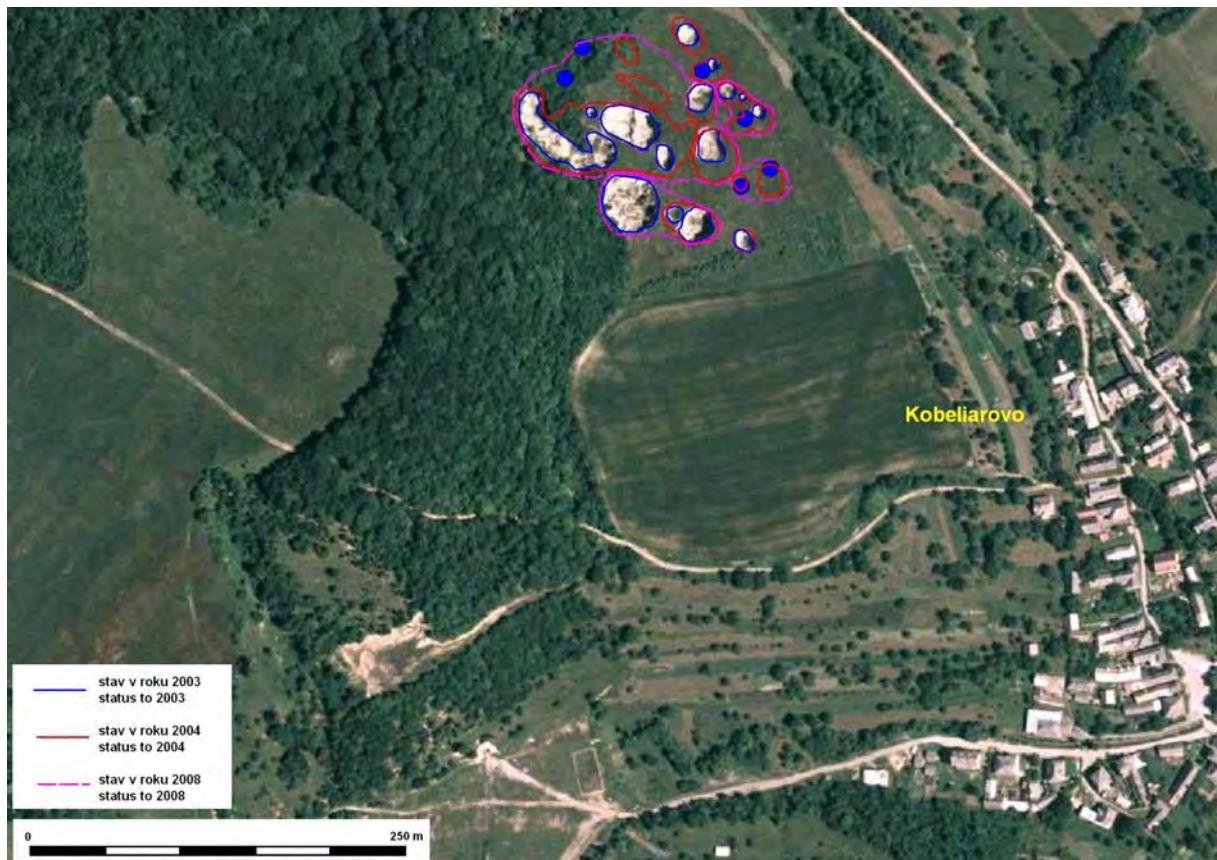
In the Nižná Slaná deposit area, the manifestations of terrain subsidence are linked to older excavations of the Manó siderite lens and to more recent collapses above excavations of a smaller siderite lens near Kobeliarovo. The collapses above the Manó deposit are stable and are located in a rarely visited and relatively inaccessible area around the Rimberg hill between Nižnoslanská Baňa and Kobeliarovo. According to a 1:10,000 scale topographic map from 1991, there are 31 mostly smaller sinkholes with a diameter of up to 20 m in an area of 1 km x 300 m. Since 1995, dynamic changes have been taking place in the collapse zone of the Kobeliarovo deposit on the north-western edge of the village (Fig. 10), with the continuous expansion and merging of the original 19 sinkholes. The temporal development of the extent of this collapse zone in 2004, 2006 and 2008 is documented in Fig. 8. Based on an excerpt from a digital colour orthophoto map processed from aerial survey images from 2002 and 2003 (Orthophoto map © Geodis Slovakia, s.r.o.), the contours of the landslides are visible, highlighted by a blue line (status in 2003). The contours of the landslides from 2004 shown by lines were obtained from Google Earth satellite images, and the extent of the landslides in 2008 was documented in the field using a GPS device. The total area of the landslides was 5,047 m<sup>2</sup> in 2004, 10,450 m<sup>2</sup> in 2006 and 16,255 m<sup>2</sup> in 2009.

Fig. 10: Temporal development of the extent of the landslide zone in Kobeliarovo in 2003–2004–2008 based on a digital colour orthophotomap of the Slovak Republic (Orthophotomap © Geodis Slovakia, s.r.o.).

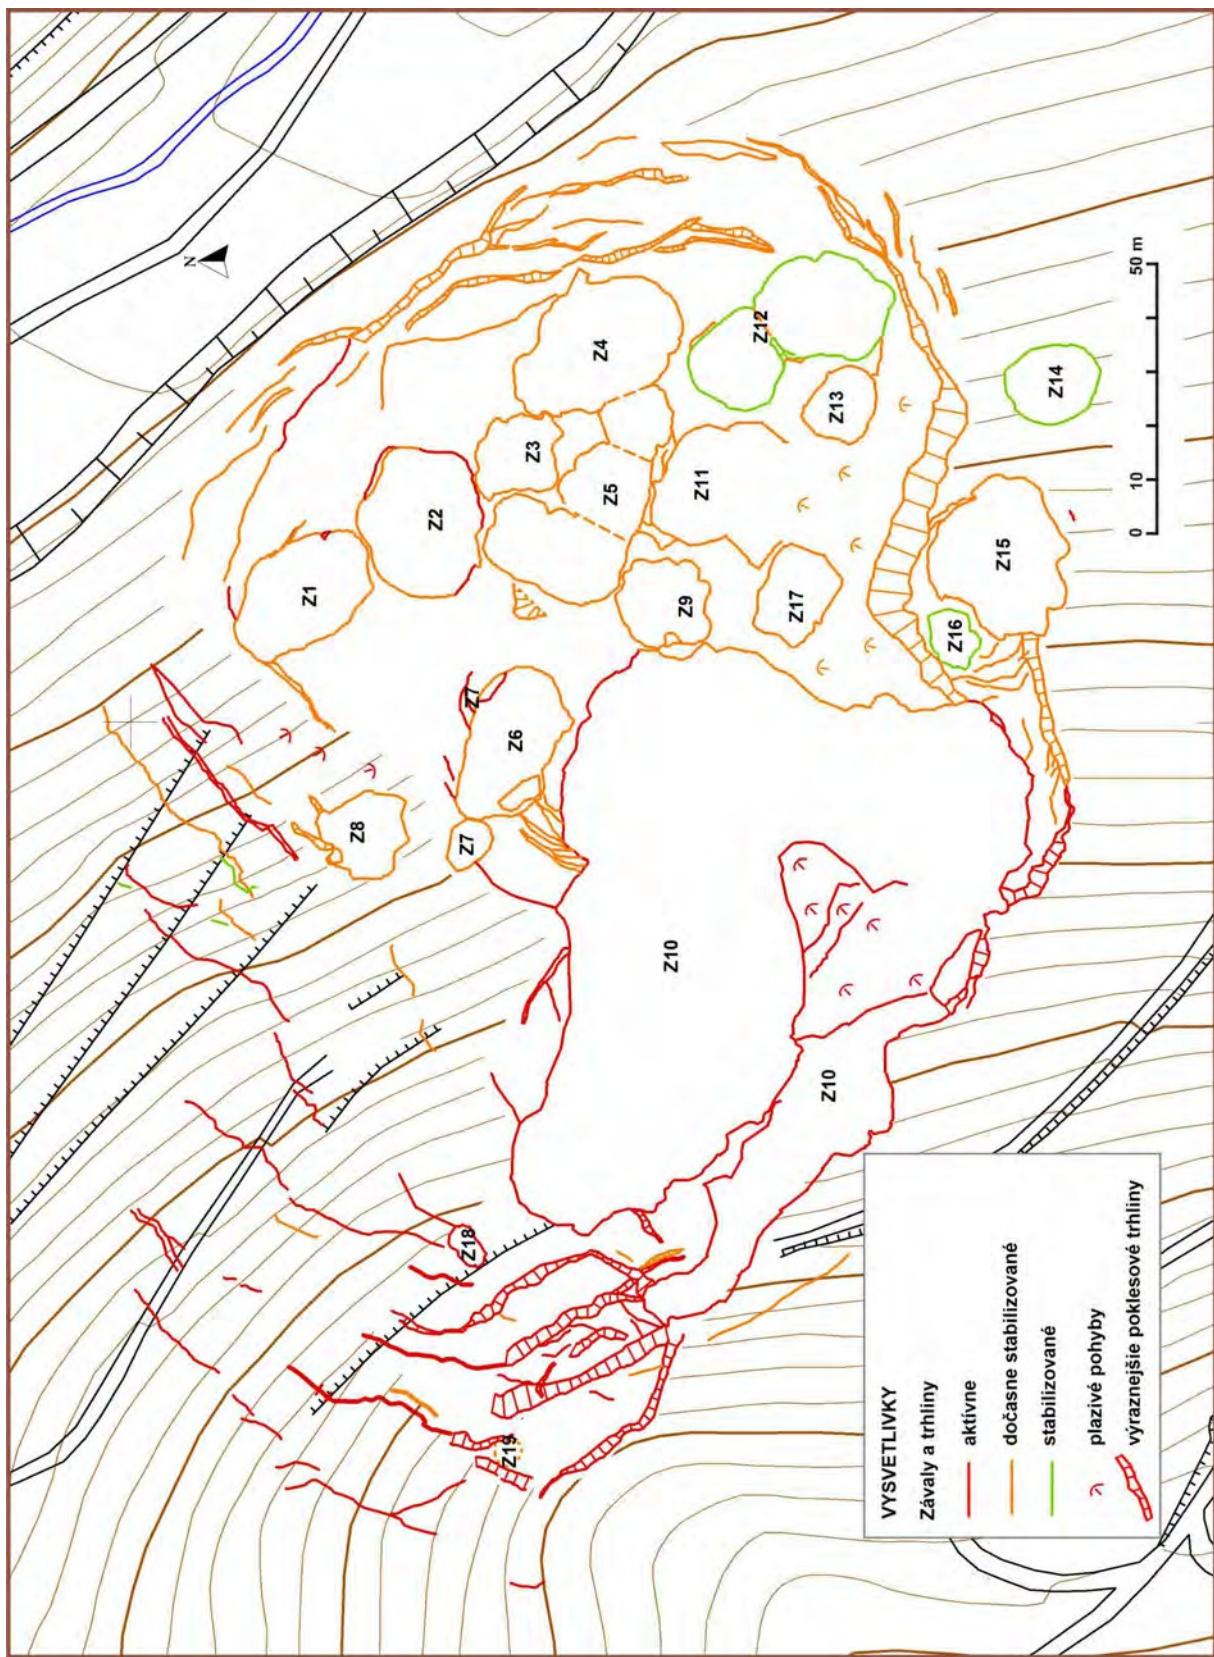
The result of the field surveys is an interpretation of the activity of landslides and other slope deformations caused by mining activities at the Kobeliarovo deposit in the form of a map. The map (Fig. 8) shows the location of landslides and cracks, where their activity or degree of stability is defined by colour, which may be stable, temporarily stabilised or stabilised phenomena. For cracks, the degree of subsidence or the degree of crack opening, as manifested on the surface of the terrain, was documented. For subsidence-type cracks, the directional orientation of the subsidence was documented.

The following facts emerge from the documentation of slope deformations. A total of 19 landslides were located. Some of them are also delimited groups of previously separate landslides (e.g. landslides Z5, Z12). The area covered by the landslides (excluding cracks) is approximately 200 m wide in the E-W direction (270 m including cracks) and approximately 170 m wide in the N-S direction (200 m including cracks).

The most active area in the monitored territory appears to be the south-western to north-western part. This is also where the largest and oldest collapse, Z10, is located, which began to form and expand into its present form from the first signs of the impact of mining activity, i.e. in April 1995. The collapse can still be considered active, as the walls of the collapse are exposed (Fig. 9). The course of the collapse is not uniform in shape, nor is the bottom of the collapse. Approximately in the middle part, there is a residual ridge that is actively subsiding. Transverse active open tensile cracks with a width of up to approx. 25 cm were found here.

Fig. 8: Map of landslides and other slope deformations caused by mining activities at the Kobeliarovo deposit (Topographic base Ščuka et al., 1982).

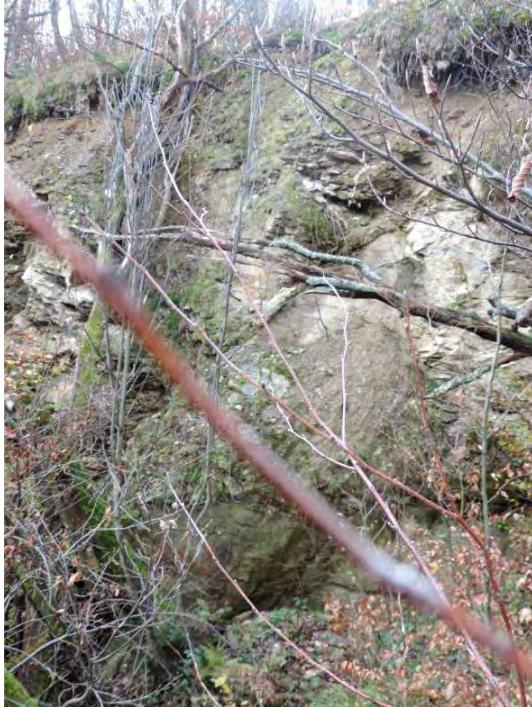
Fig. 9: Wall of the Z10 at its western edge.

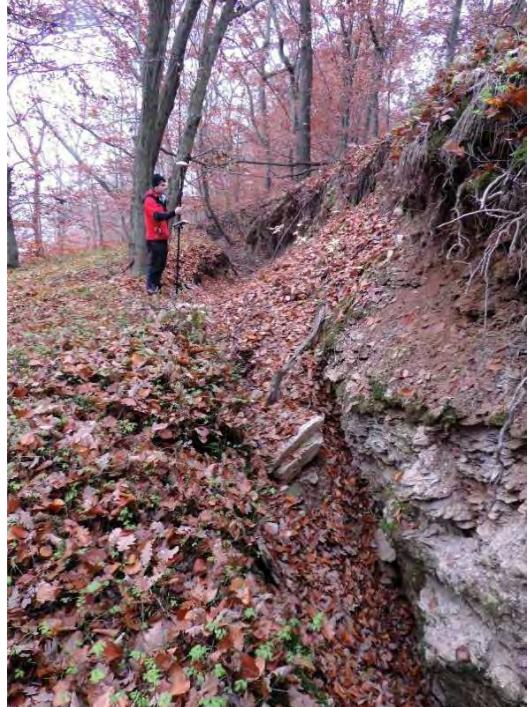
- up to approx. 2 m (Fig. 10). Their SE-NW direction is parallel to the direction of the edge of the collapse, with most of them practically starting from the edge of the Z10 collapse. Other (more distant) cracks in the north-western part more or less follow on from the cracks described, with their course turning in a SW-NE direction (Fig. 11). At the same time, their downward slope recedes or is even absent.

Fig. 10: Detachment surface of a significant tensile-subsidence fracture in the western part of the collapse area.

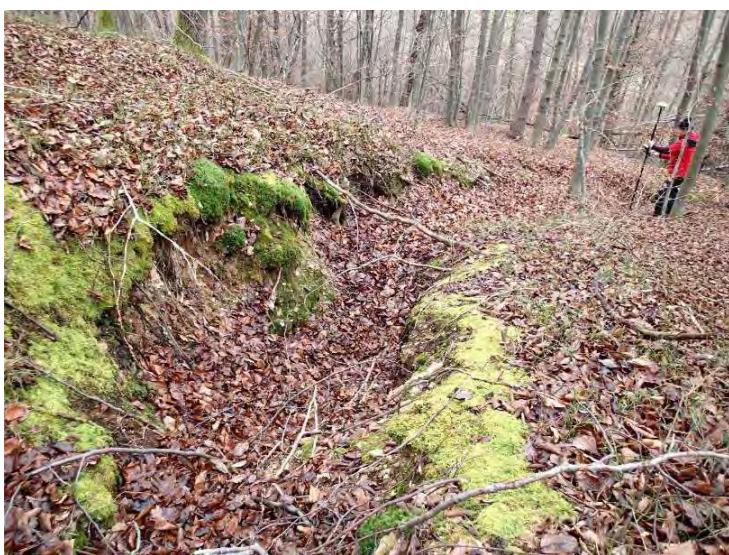
Fig. 11: Tensile-subsidence fracture with a predominantly tensile character in the north-western part of the collapse area.

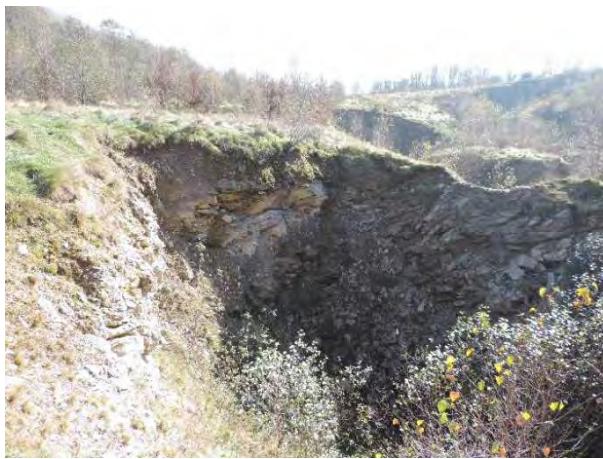
Fig. 12: SE wall of collapse Z2.

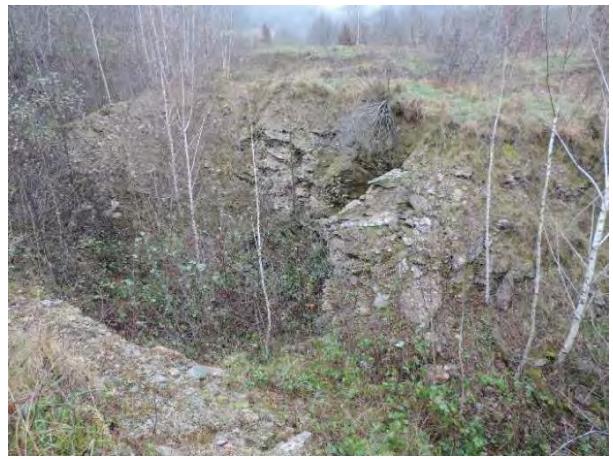
Fig. 13: Collapse Z5.

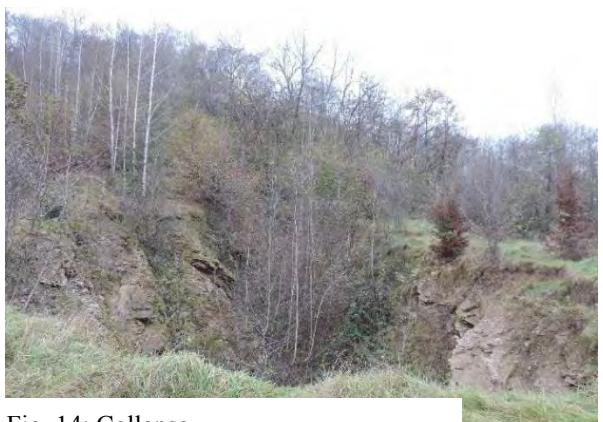
Fig. 14: Collapse Z6.

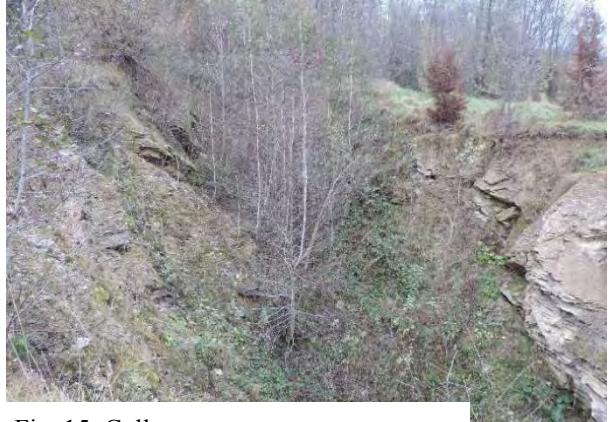
Fig. 15: Collapse Z7.

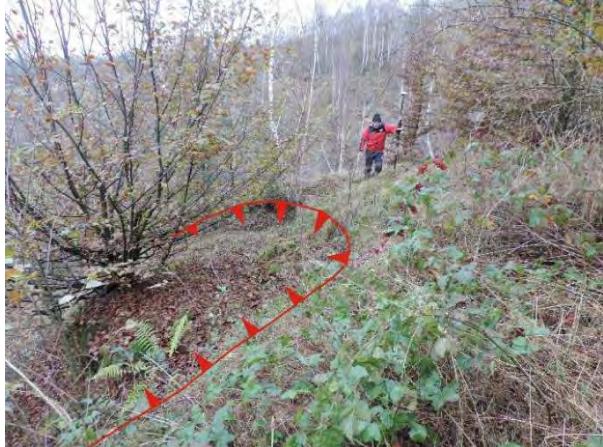
Fig. 16: Falling block on the Z8 landslide.

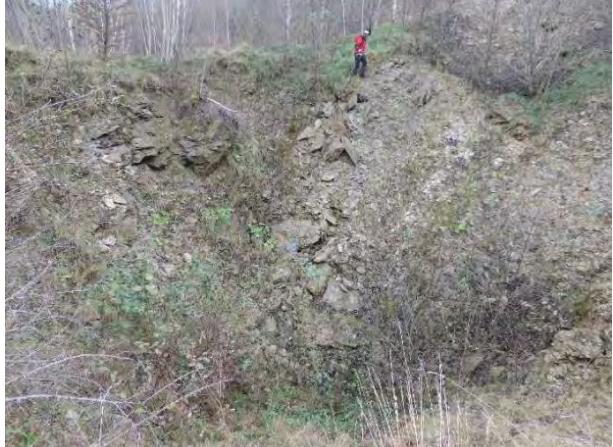
Fig. 17: Rockfall Z9.

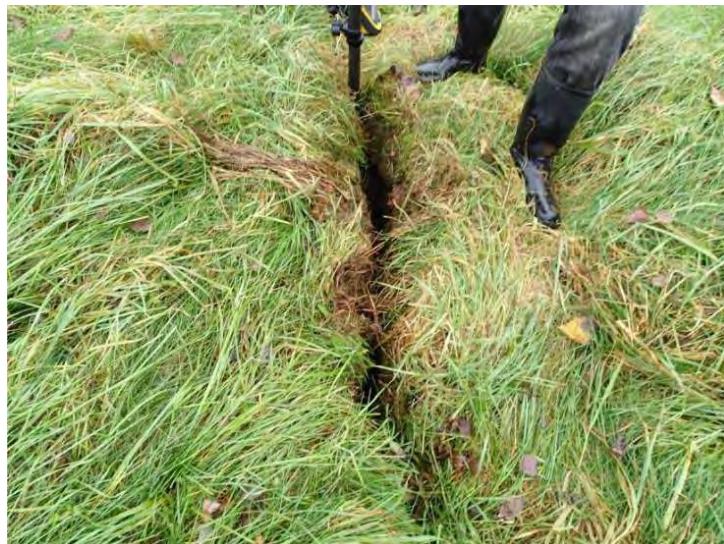
Fig. 18: Open tensile crack on the eastern edge of the collapse zone.

The cracks on the eastern edge of the collapse zone are more or less connected to cracks of a subsidence, tensile-subsidence and tensile nature, which gradually turn in a NE-SW to NE-SW direction.

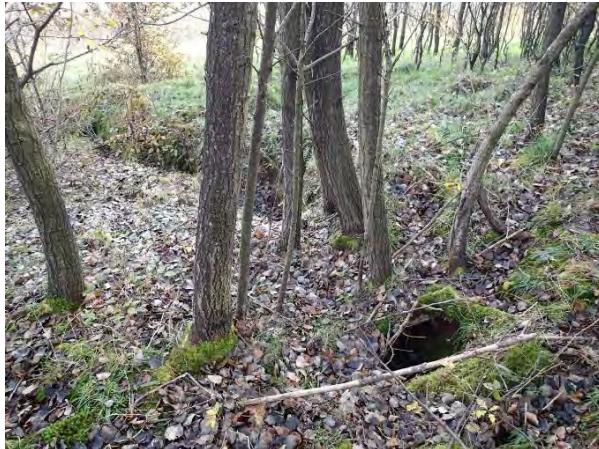
Fig. 19: Active tensile course of an open fracture at the southern edge of the Z10 collapse.

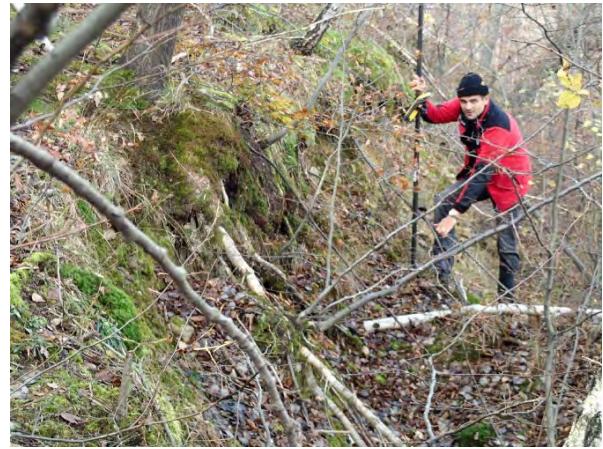
Fig. 20: Active tensile-compressive crack progression at the mouth of the Z10 collapse.

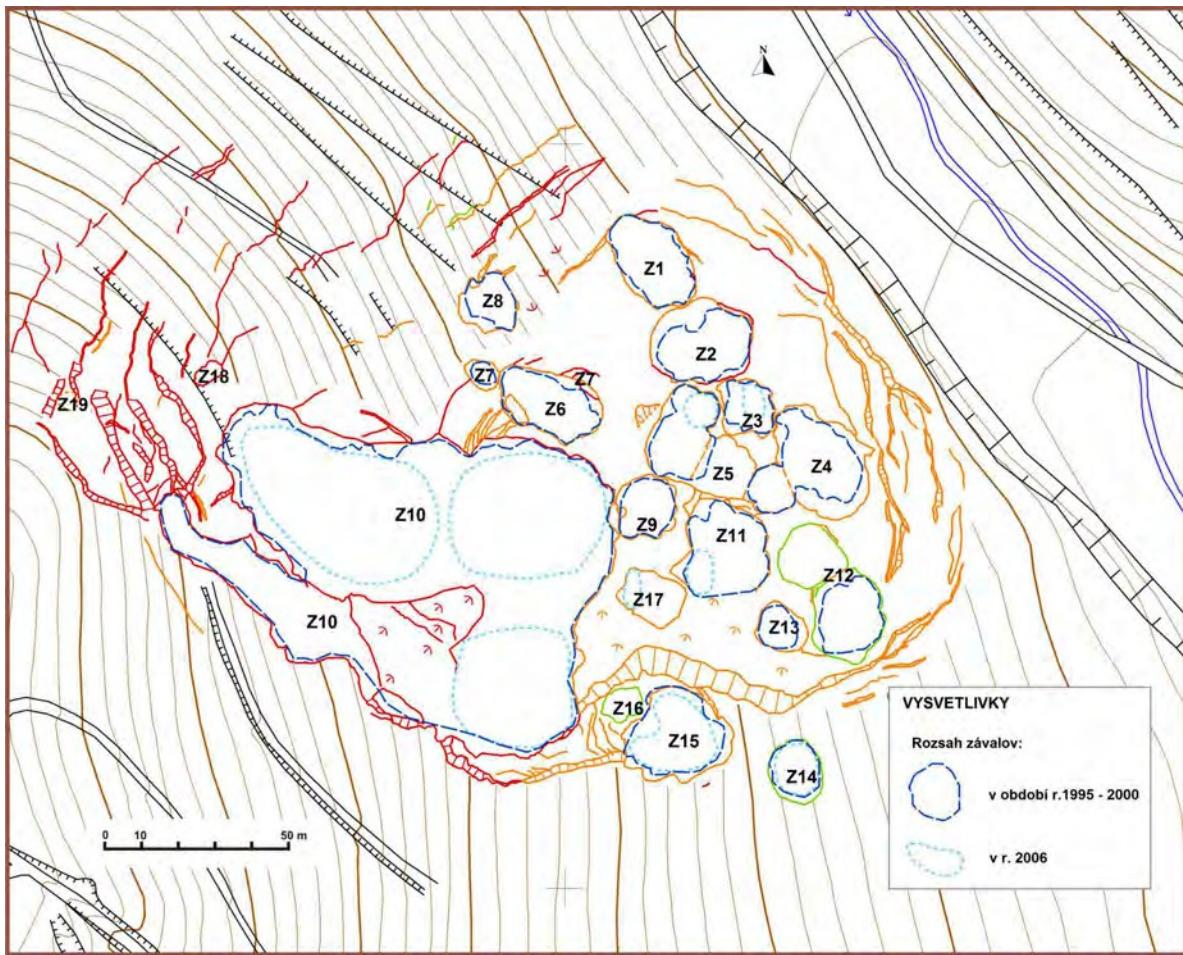
The extent of landslides for 2006 was approximately interpreted from an orthophoto map from 2006. The map in Fig. 21 shows a significant increase in the number of newly formed landslides. A comparison of this situation with the current situation shows a slight tendency for the landslides themselves to spread, but there is also a noticeable increase in the number of landslides, namely the landslide that connected the current landslide Z5 and the significant expansion of landslides Z12 and Z17. The temporal development of the Z16, Z18, Z19 and, in part, Z10 landslides cannot be assessed due to their location in wooded terrain. The photographic documentation in Figures 22 to 25 shows the development of the landslide zone from 1995 to 2014.

Fig. 21: Map of the development of landslides at the Kobeliarovo deposit between 1995 and 2014. (Topographic base Ščuka et al, 1982).

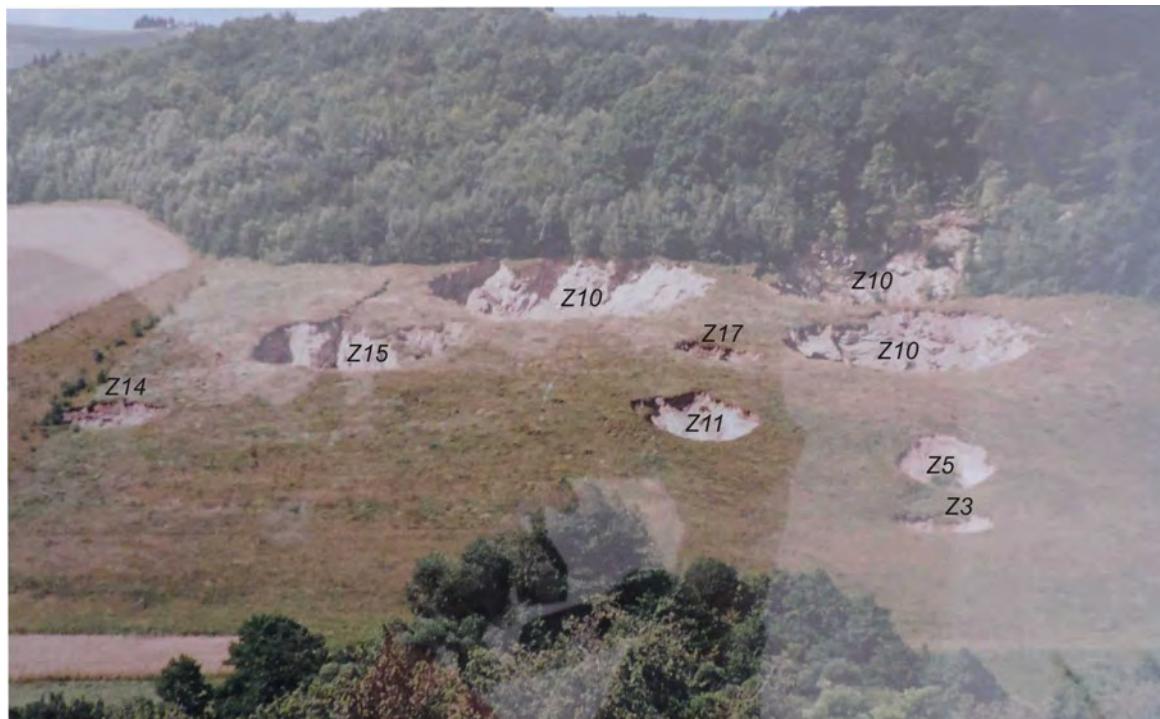
The oldest photographs obtained are not precisely dated, but are approximately from the period 1995–2000 (Fig. 22). The extent of the rockfalls was roughly marked on the map according to the photograph (Fig. 21). It is clear from this that separate landslides occurred during this period, which are now combined into a single landslide marked Z10. Landslides Z14 and Z15 also occurred (almost to their current extent). Landslide Z3 and a small part of landslide Z5 also began to form.

Fig. 22: View of the collapse area at the Kobeliarovo deposit sometime between 1995 and 2000. (photo: Dušan Vandrášik, Mining and Geological Exhibition in Nižná Slaná)

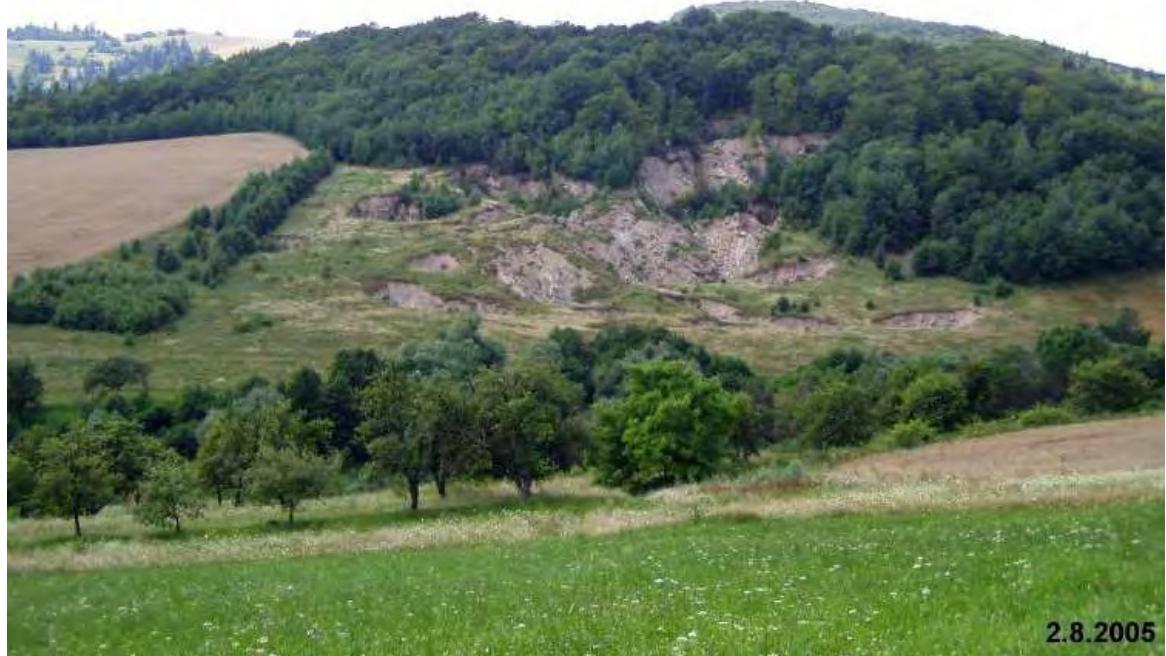
Fig. 23: View of the area of collapses at the Kobeliarovo deposit on 2 August 2005 (photo: Stanislav Lukáč).

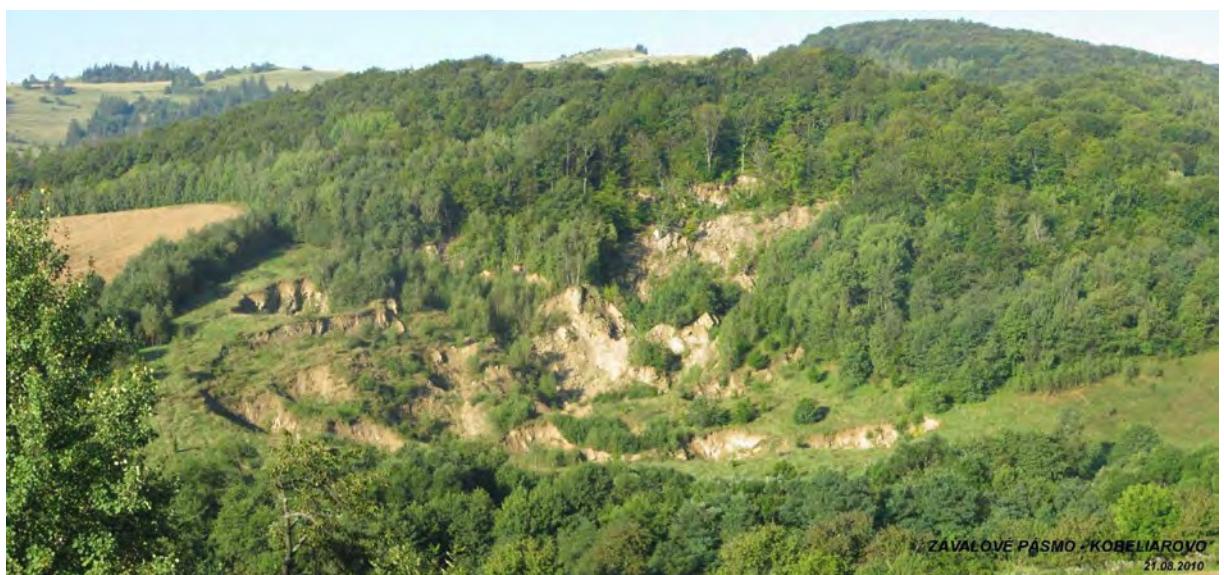
Fig. 24: View of the area of landslides at the Kobeliarovo deposit on 21 August 2010 (photo: Stanislav Lukáč).

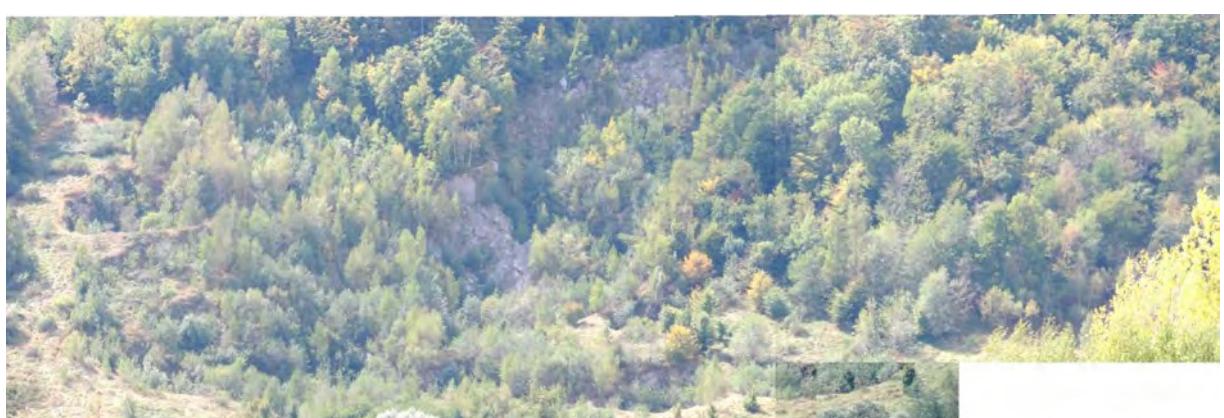
Fig. 25: View of the area of subsidence at the Kobeliarovo deposit on 8 September 2014.

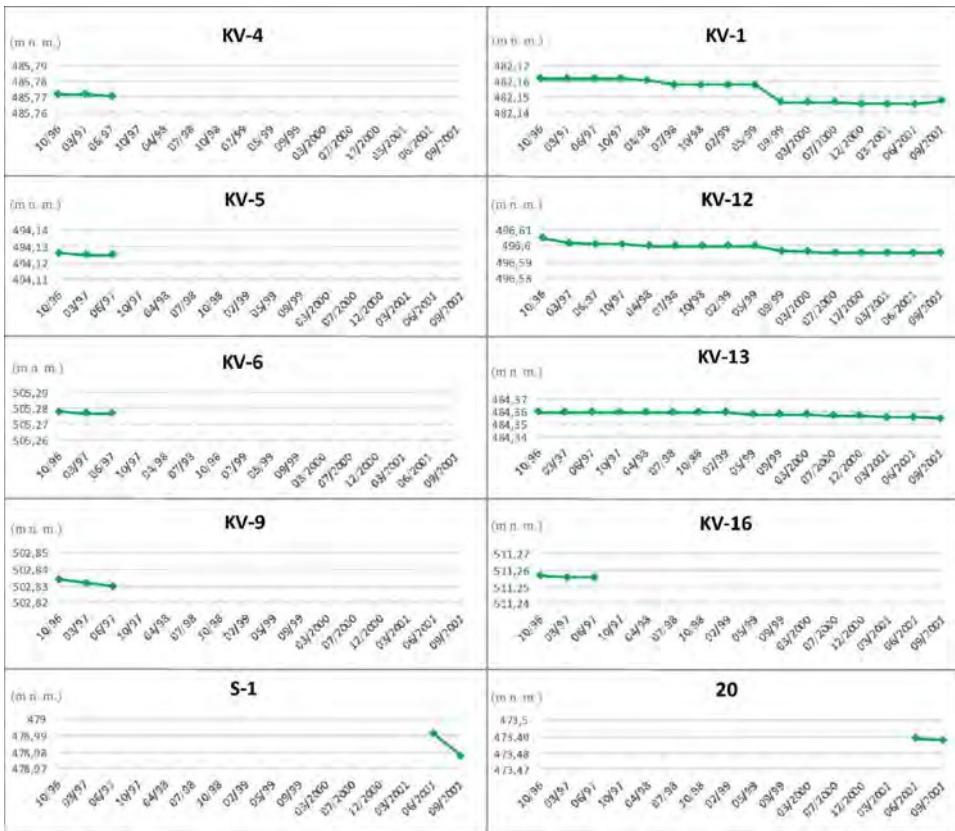
From the data mentioned above, provided by Vrana et al. (2005), we have compiled graphs showing the temporal development of the declines at these measuring points (Fig. 27). The graphs show that a minimal decline in ground level was observed at almost all measuring points, with the most significant decline occurring at points KV-1 and KV-12. Noteworthy is the decline observed at point S-1, which is located at a distance from the landslides where ground decline would not be expected. Due to the short monitoring period (June to September 2001), it is not possible to evaluate the time trend and rate of decline.

Fig. 27: Graphs showing the time course of subsidence at measuring points in the Kobeliarovo deposit.

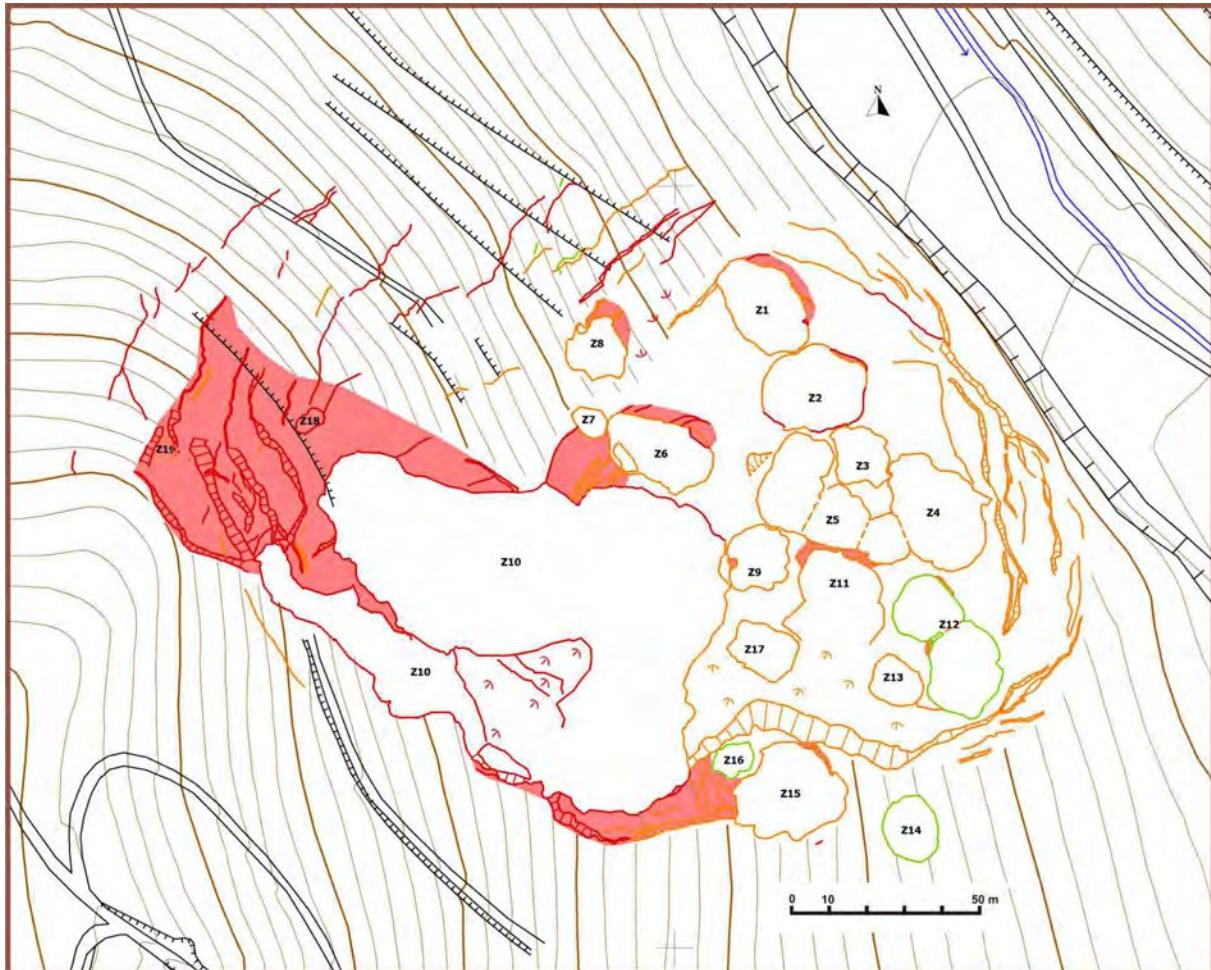
As can be seen from the map in Fig. 30, the most significant active form of cracks occurs around the western edge of the Z10 collapse, where significant cracks of a predominantly subsidence nature were located

a subsidence nature. In the area of expansion of these cracks, there is a reasonable assumption of further possible expansion of the main Z10 collapse in the future.

Further relatively minor expansion of the collapses can also be expected on the southern edge of collapse Z10 and on the northern edge of collapse Z10 in the direction of collapse Z6. Minor development (with the possibility of larger rock blocks being released into the collapses) is also expected in the near future in the vicinity of other collapses with shorter cracks parallel to the breakaway edge of the collapses (collapses Z1, Z2, Z5, Z6, Z8, Z9, Z11, Z12, Z15).

Fig. 30: Forecast expansion of landslides at the Kobeliarovo deposit marked with red areas (topographic base Ščuka et al., 1982).

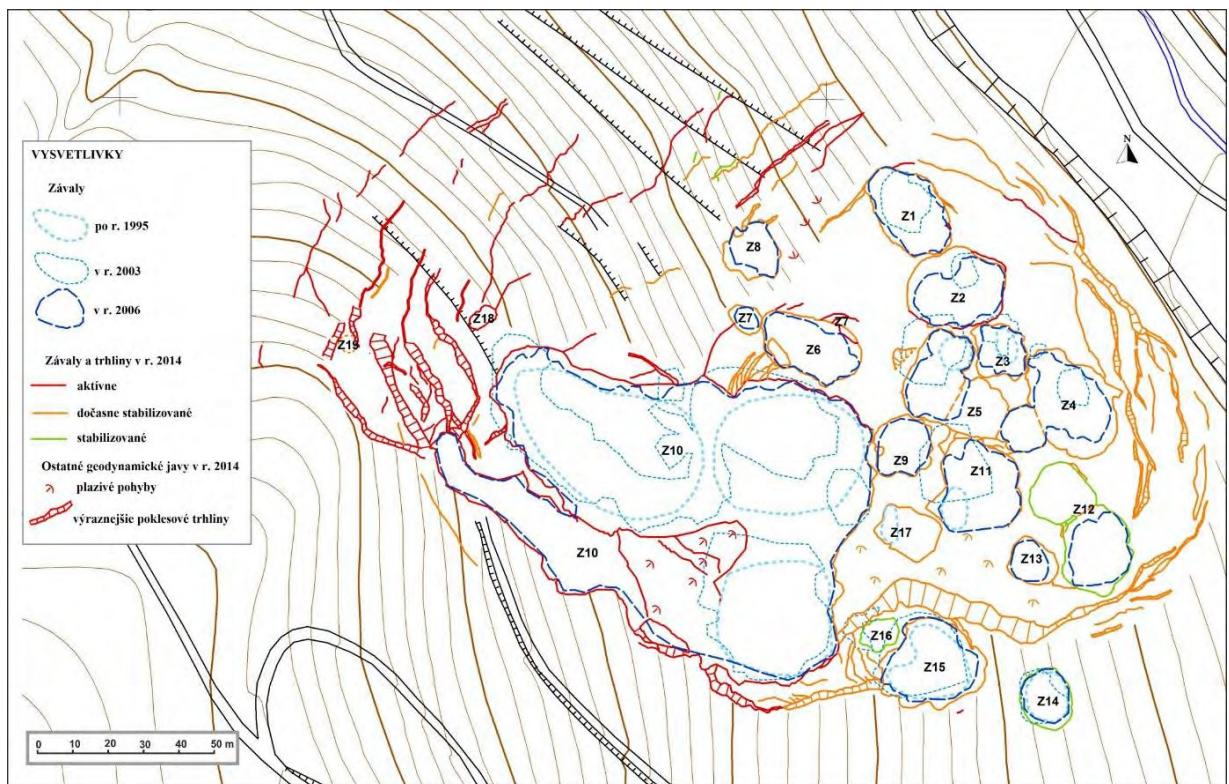
A total of 19 collapses were located, as shown in Fig. 40, which also shows the gradual spread of collapses in the deposit. Some of the collapses are also bordered by groups of previously separate collapses (e.g. collapses Z5, Z12). The area of the collapses (without cracks) reaches a width of approximately 200 m in the V-Z direction (270 m including cracks) and approximately 170 m in the S-J direction (200 m including cracks).

Fig. 40: Map of the development of landslides at the Kobeliarovo deposit in the period from 1995 to 2014.  
(Topographic base: Ščuka et al., 1982.)

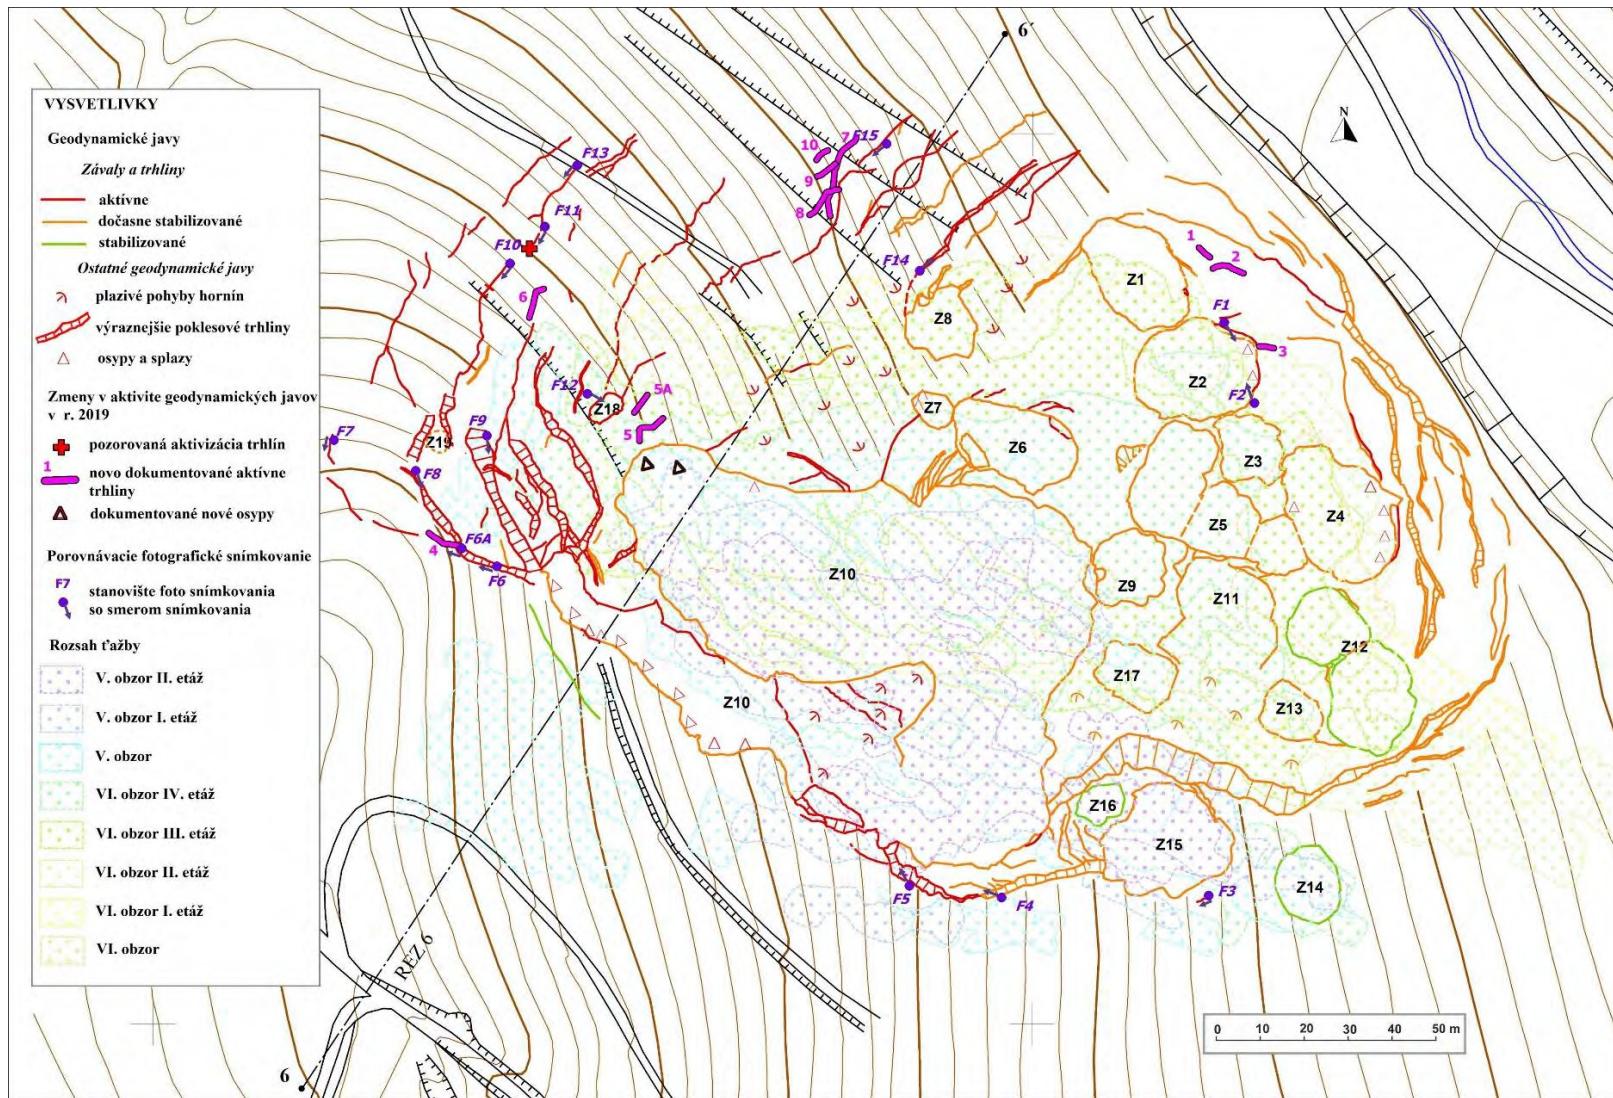
Field research conducted in 2019 revealed changes in the geodynamic activity of the monitored site in the form of new active cracks identified in the vicinity of the landslides marked 1 to 10 (Fig. 41). The area of landslides Z1 to Z17 is gradually becoming more and more overgrown with shrubs and trees and is increasingly difficult to observe. No expansion of the landslides due to undercutting was observed. Geodynamic activity on the landslides manifests itself only in the form of deluvial soil horizons or rocky to boulder fragments from the pre-Quaternary bedrock. These manifestations were recorded during reconnaissance, especially in the area of the northern wall of landslide Z10 (Fig. 42).

Fig. 41: Map of landslides at the Kobeliarovo deposit showing documented changes in 2019 and the extent of mining obtained by processing map data from the Slovak Mining Archive in Banská Štiavnica (topographic data: Ščuka et al., 1982).

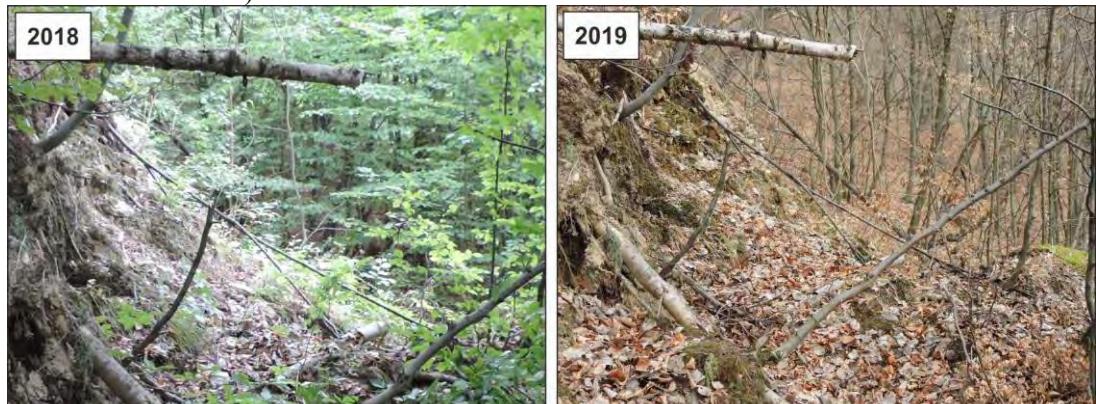
e)

The location where the significant downward crack ends in a collapse, photographed from observation point F5, showed no activity, as can be seen from a comparison of photographs from 2018 and 2019 (Fig. 44e) (including the preservation of the tree root connecting the upper and lower edges of the crack).

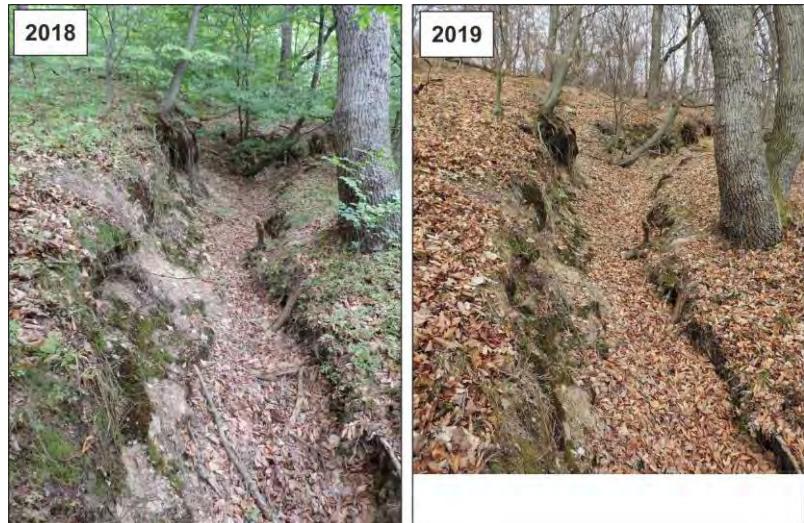
f)

An active subsidence-tension crack was photographed from location F6, and a comparison of the images from 2018 and 2019 (Fig. 44f) shows that there has been no observable change in the activity of the crack. During reconnaissance in 2019, a new tensile-subsidence *crack 4* was observed and documented (Fig. 41). The crack connects a significant subsidence crack and a less significant tensile-subsidence crack in the V-Z direction. The degree of subsidence is approximately 0.2–0.4 m (Fig. 44g). Its openness is also observable intermittently. Another imaging station marked F6A (Fig. 41) was set up to monitor this crack. Comparative imaging of the tensile-

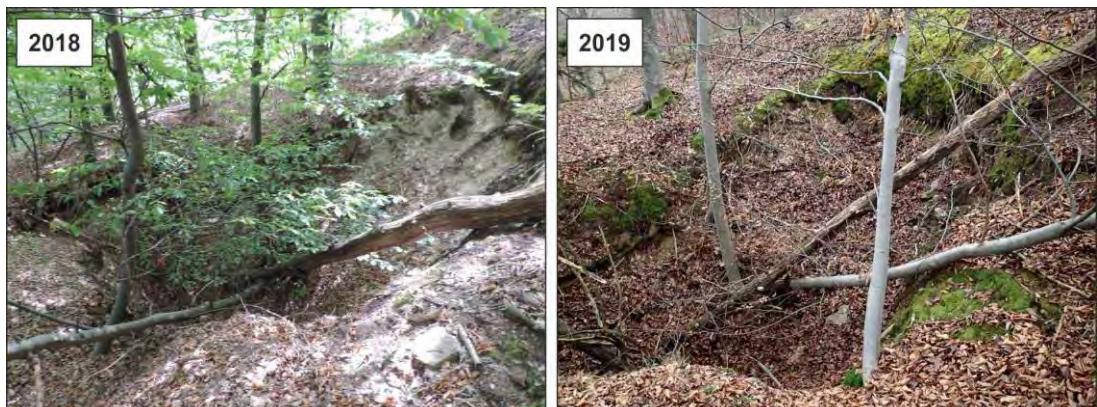
m)

Landslide Z18 was documented by comparative imaging from location F12 (Fig. 44m). No expansion of the landslide was observed. Geodynamic activity is manifested only in slight rockfall at the edge of the landslide.

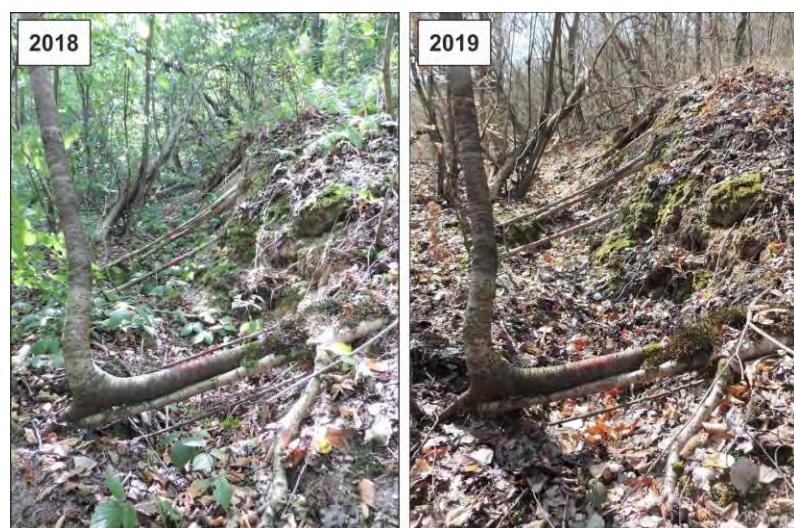
n)

No observable changes in activity were recorded on the prominent tensile crack photographed from location F13 (Fig. 44n). Similarly, no changes in activity were recorded on the tensile fracture photographed from location F14 (Fig. 44o) and the tensile-subsidence fracture photographed from location F15 (Fig. 44p).

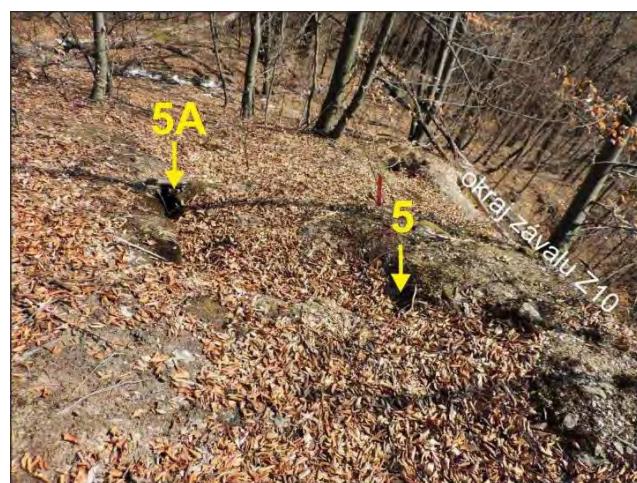
Fig. 45: Fracture 5 at the Z10 collapse with marked locations of visible fracture openings.

In the area between the Z18 and Z10 collapses, two continuously open cracks were recorded during a terrain reconnaissance in 2019 (Fig. 45), the course of which is parallel to the course of the edge of the Z10 collapse in these locations. *Fissure 5* (closer to the Z10 landslide) is tensile-subsidence in nature and approximately 10 m long. The subsidence of the terrain at the crack is approximately 0.2 m. Tensile *crack 5A*, further away from the collapse, probably runs mostly hidden under the surface of the terrain, with its observable section on the surface being approximately 2–3 m long.

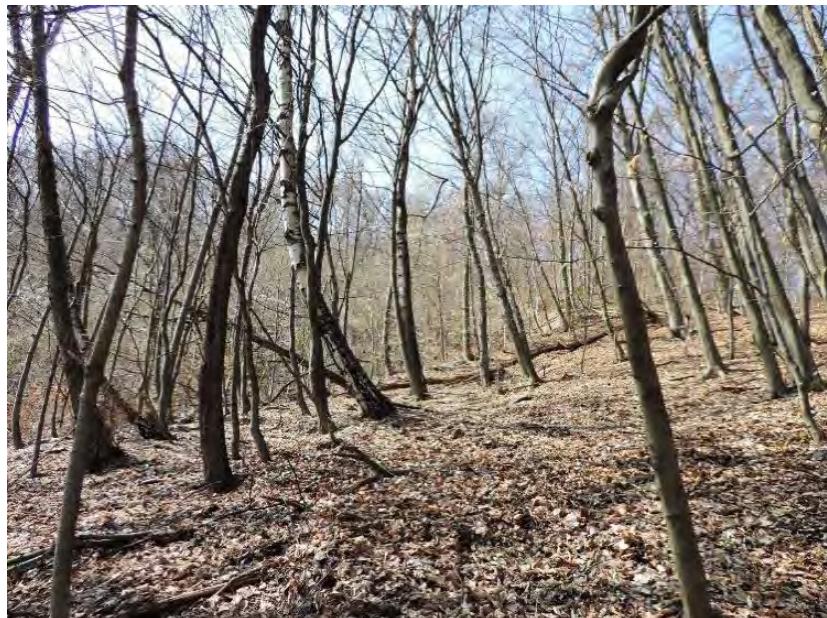
Fig. 46: Bent and tilted tree trunks in the fracture zone north of collapse Z10.

Monitoring of the Kobeliarovo deposit site in 2019 shows that the observable activity of geodynamic phenomena caused by mining continues to manifest itself primarily in the fracture zone, especially in the contiguous area in the western to northern region. The ongoing geodynamic activity in this area is also confirmed by creeping subsurface deformations of the rock environment. These are visible on the surface, as documented not only by directly observable changes in crack activity (documentation of new cracks) but also by bent and tilted tree trunks (Fig. 46).
