WATER POLLUTION FROM AND REHABILITATION OF AN EXPLORATION SITE IN THE BARBERTON AREA OF SOUTH AFRICA

S.E.T. BULLOCK¹, S. BARNARD² AND H.A. NICHOLLS³

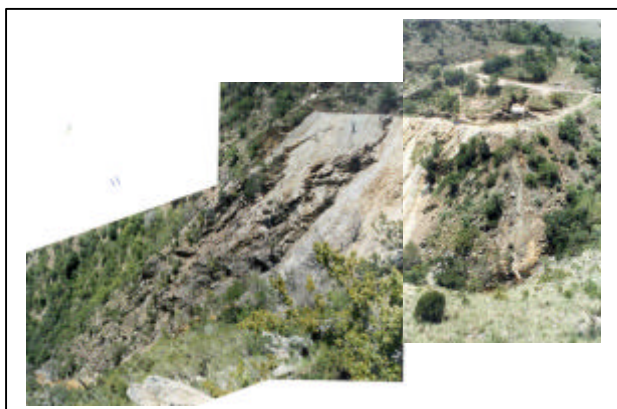
Figure 2:- Photograph showing the extent of the waste rock dumped down slope of the adit portal.

The rock dump was made up of two portions. The eastern portion of the dump extended down the N.E. slope of the hill at an inclination of about 33° for a vertical distance of 55m and with a surface length of at least 90m. This portion of the dump covered an area of approximately 1400m². The western portion of the dump extended down the N.E. slope at a 35° angle and covered a surface area of approximately 2100m. The toe of the western portion of the rock dump was at one point in time in the streambed. The total surface area of the rock dump was 3500m². Assuming an annual rainfall of 1000mm and 70% runoff, then the total estimated runoff from the rock dump would be 2000m³/annum.

As already mentioned, during the excavation of the adit, approximately 8000m³ of waste rock was generated. The waste rock was tipped down the hillside at a maximum inclination of 35°, with the toe of the dump encroaching on the local stream. With time it was noticed that the dump turned an overall yellow-ochre colour (See Figure 2). This yellow colouring is a typical indication that ARD is occurring and in this instance was due to the oxidation of the primary sulphide minerals pyrite (FeS₂) and chalcopyrite (CuFeS). It was also noticed that a dark reddish brown water with a pH of 2.5 was seeping from the dump. Both these phenomenon are attributed to ARD which had a significant impact on water quality in the local stream. ARD will be discussed in more detail.

The removal option considered the removal of all waste rock from the eastern and western sections of the rock dump and disposing of it in an encapsulated waste depository. This option offered a permanent "walk away" solution to Anglo-American and was acceptable to all interested and affected parties. Therefore it was the chosen method of rehabilitation.

Waste rock was removed from the hillside via a cable and rail transportation system. This system included the use of hand labour and mechanical grabs to lift waste rock into rail hoppers. The hoppers were then hauled up slope via the cable system to the terrace above the waste rock dump. From the terrace the waste rock was loaded into dumper trucks and transported to the disposal site, approximately 1.7 km from the adit. The final clearing of the hillside was done by hand and consisted of a "broom and spade" operation. Thereafter, the rock dump footprint area was washed down and a hydroseeded mulch and an indigenous seed cocktail applied to the area. Figure 5 shows a photograph of the hillside after all the waste rock was removed and rehabilitation of the area completed.

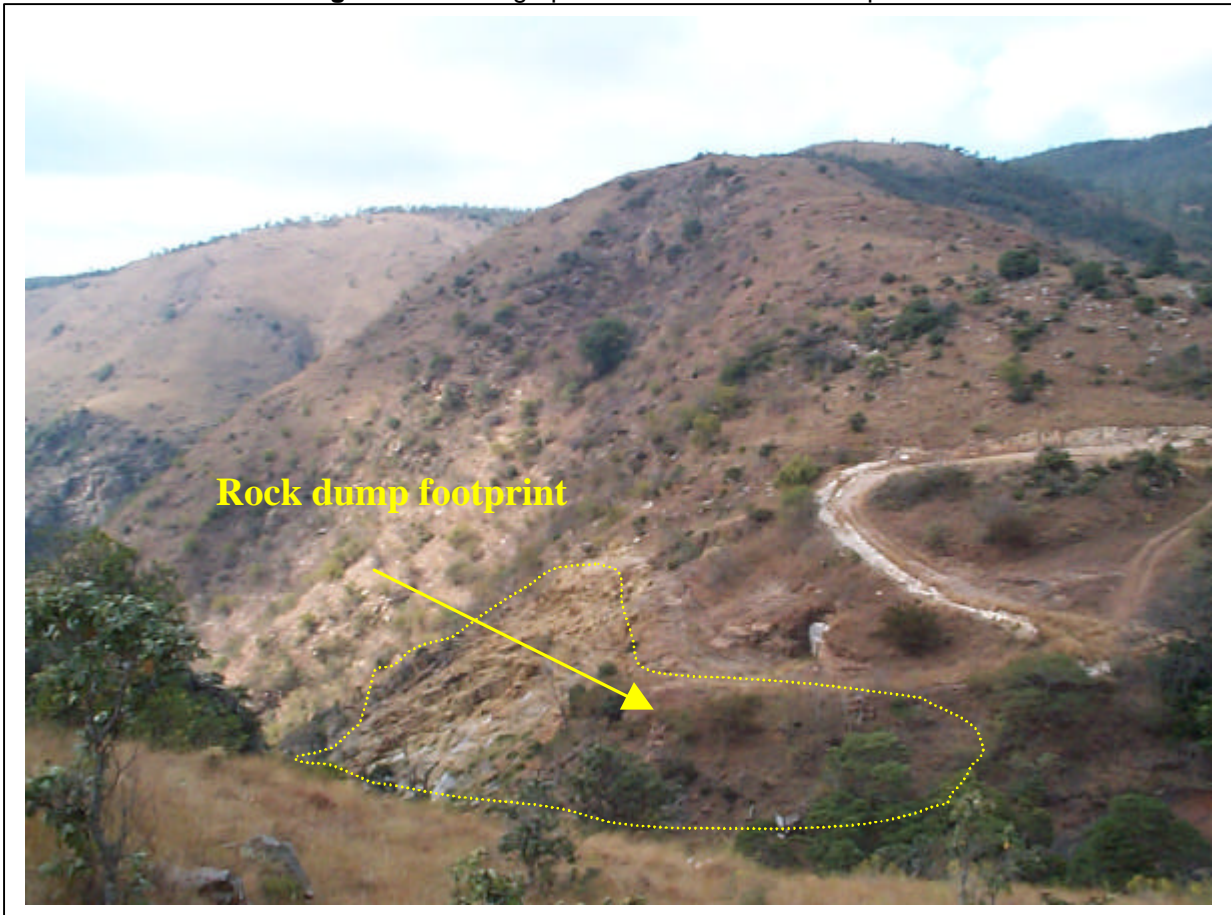
Figure 5:- Photograph of the rehabilitated foot print area.

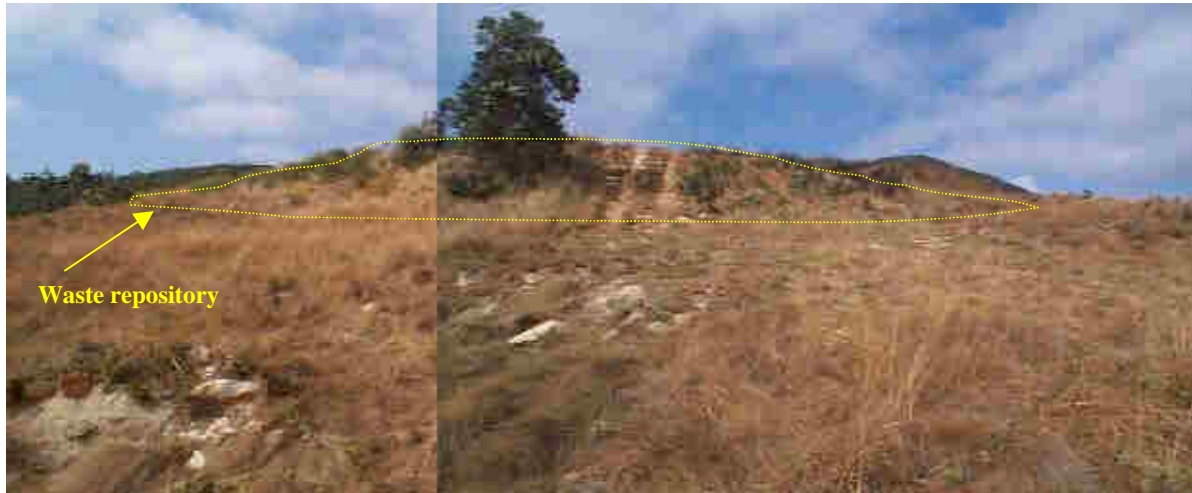
Figure 6:- Photograph of the waste repository taken 6 years after rehabilitation.

The waste repository area was designed in detail by professional civil engineers to ensure no further ARD generation would occur. The base of the depository was sealed with a compacted bentonite clay and soil mixture and lined with a HDPE liner. The waste rock was placed in layers on this seal and compacted. Special care was taken not to puncture the lining. The outer walls of the waste repository consist of a compacted earth bund. Stormwater diversion trenches have been constructed up slope of the repository to divert stormwater. Once all the waste rock had been dumped into the repository an impermeable HDPE liner was used as a seal. Topsoil was then placed over the liner and the repository vegetated with indigenous grasses. Figure 6 shows a photograph of the waste repository taken 6 years after completion of rehabilitation.

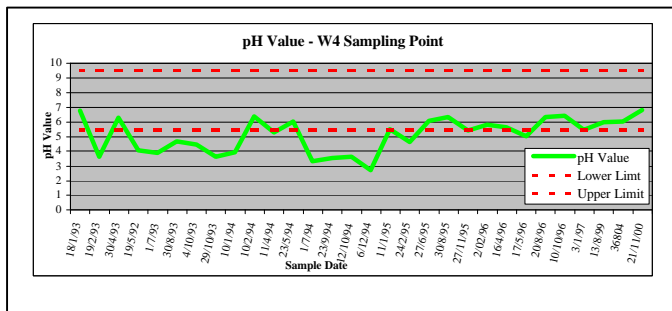
Water quality data from stream water samples show clearly that the rehabilitation at Bien Venue has been successful. Typical post rehabilitation in stream water quality averages are listed in Table 4. By removing the source of pollution from the stream banks Anglo-American have successfully ensured water quality in the stream has returned to its pre-exploration state. Furthermore, by encapsulating the waste rock in the waste repository the potential for further generation of ARD has been eliminated. This is due to the fact that both oxygen and water, two of the fundamental requirements for the generation of ARD, have been eliminated. Figures 7, 8 and 9 show a series of water quality graphs showing how the river quality in the stream has improved with time since rehabilitation was completed.

Figure 7:- pH readings subsequent to rehabilitation

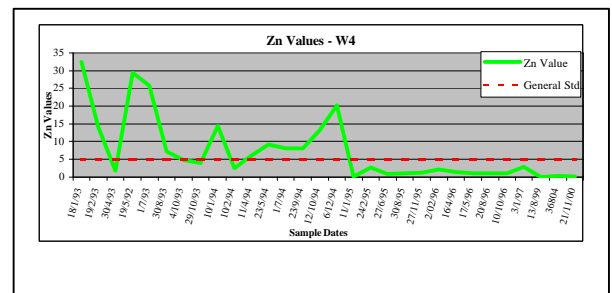
Figure 8:- In stream zinc concentrations.

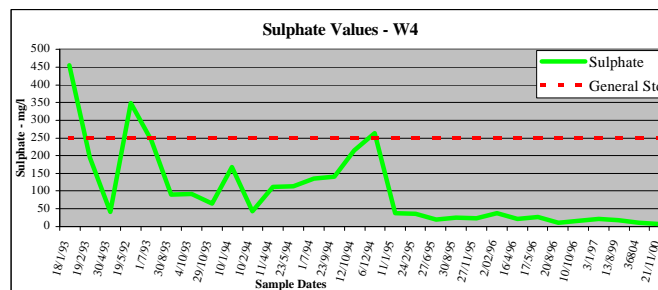
Figure 9:- In stream sulphate values post rehabilitation.
