# AN “AUTOPSY” OF THE FAILED TANGASKOOTACK #1 VERTICAL FLOW POND, CLINTON CO., PENNSYLVANIA<sup>1</sup>

Arthur W. Rose, David Bisko, Amidea Daniel, Mary Ann Bower and Scott Heckman<sup>2</sup>

**Abstract.** The Tangascootack #1 passive treatment system was constructed in 1998 to treat an acid discharge from an abandoned surface mine in Clinton Co., PA. The discharge averaged about 155 L/min with pH 4.0, acidity 235 mg/L CaCO<sub>3</sub>, Fe 3.7 mg/L, Al 24 mg/L and Mn 68 mg/L. The vertical flow pond had dimensions of 48 x 20 m and was preceded by a wetland and followed by an oxidation/settling pond. The system produced net alkaline effluent for a few months, but by 1 year after construction, the effluent acidity was 120 mg/L, and flows decreased to 20-60 L/min. Plugging by Al precipitate was suspected, despite occasional flushing.

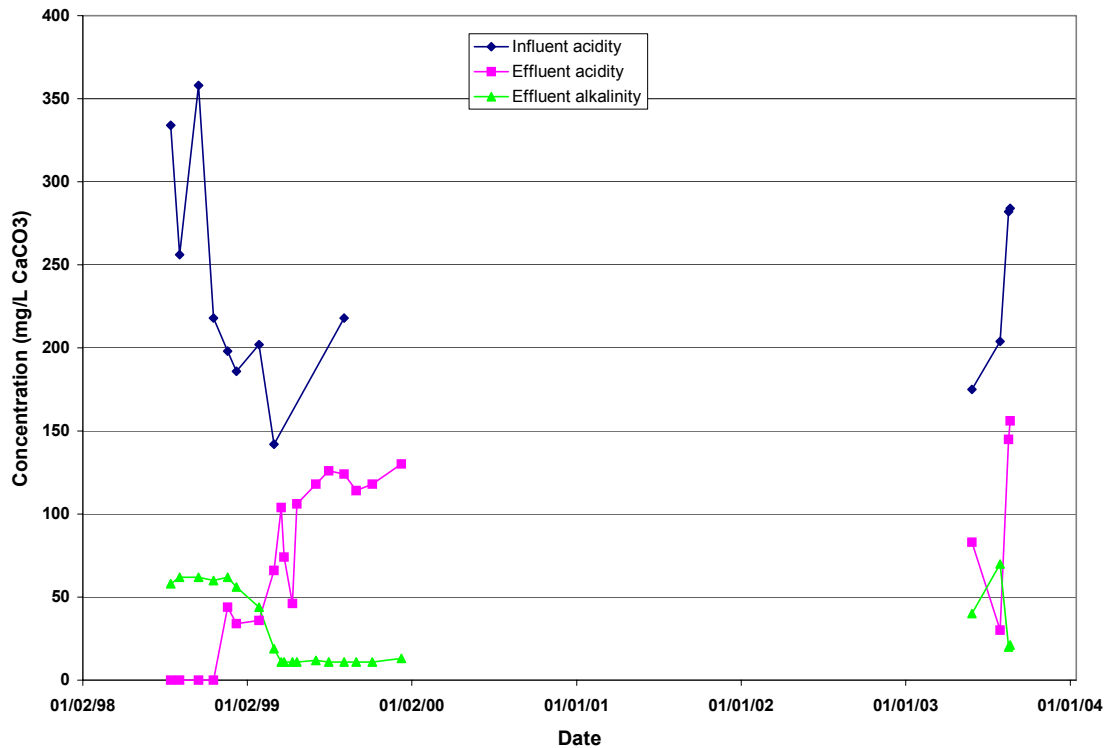
Figure 2. Acidity and alkalinity of influent and effluent vs. time. No samples from 1/00 to 5/03.

For the period 7/98 to 8/99, the discharge averaged pH 4.0, acidity 235 mg/L  $\text{CaCO}_3$ , Fe 3.7 mg/L, Mn 67 mg/L, Al 24 mg/L and  $\text{SO}_4$  1695 mg/L at a flow rate of 155 L/min (Fig. 2). No samples were collected between 12/99 and 5/03.

outflow are plotted on Figure 2 (Table 1). For about 3 months (7/98-10/98), the system generated alkaline effluent, removing all of the 300 mg/L acidity. Then acidity appeared in the effluent, and after 4/99, leveled off at about 120 mg/L acidity, compared with about 200 mg/L influent acidity. This behavior continued until at least 12/99, but flow dropped off markedly in summer and fall 1999. This decrease in flow may be partly due to the very dry spring in 1999. Also, the flow was measured at the outlet of the settling pond, and it is possible that the flow from the discharge was larger but was leaking out from the wetland area. The pattern of increased effluent acidity and decreased flow led to the conclusion that the system was becoming

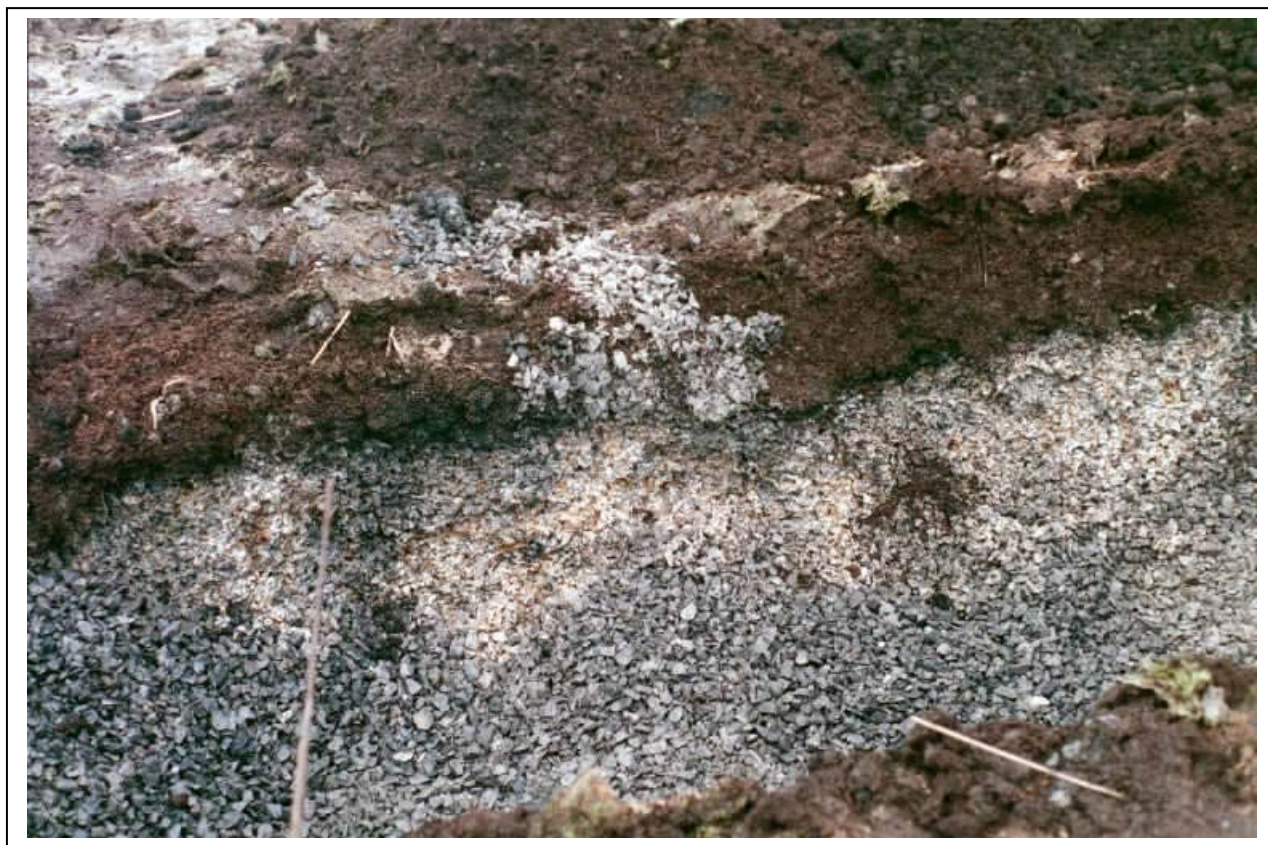
Figure 4. Well developed white coating on upper part of limestone bed, and black layer at base of compost. Area at left is obscured by loose limestone. Spilled compost covers limestone in a spot near right, and spilled limestone covers compost in center.

On 8/5/03, the pond was redrained, and three trenches were cut through the compost and limestone with a large backhoe supplemented with hand shoveling near underdrain pipes. The compost, limestone and underdrain pipes were examined, sampled and photographed. Limestone was coated with a gelatinous white material for 15 to 30 cm beneath the compost at most locations (Fig. 4 and 5). Limestone deeper than 30 cm was largely free of the white precipitate. In the zones of thicker compost (>15 cm), a firm black layer was observed at the base of the compost. Beneath this black material, the white precipitate appeared somewhat less abundant than elsewhere. Only traces of brown or red precipitate were observed.

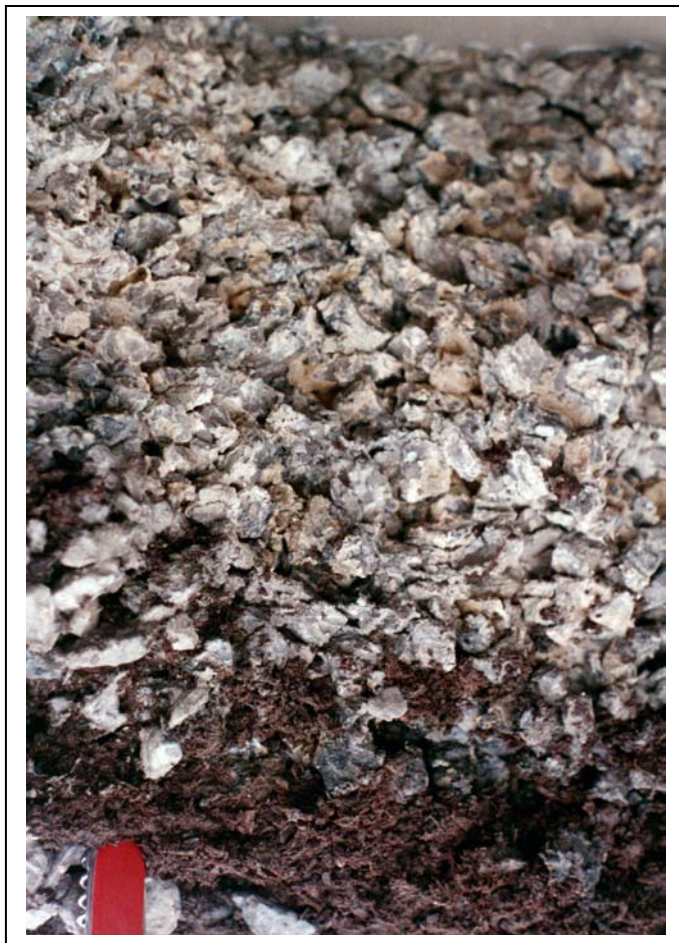
Figure 5. Close up view of white coated limestone. Note relatively open pores. Bright white is gypsum coating, and gray is Al coating. Red at bottom is a pocket knife.

The coating on limestone is composed of a mixture of an amorphous Al species, silt and clay, and gypsum. The Al material and the silt-clay are easily washed off the limestone fragments. At least some of the gypsum is cemented firmly to the limestone.

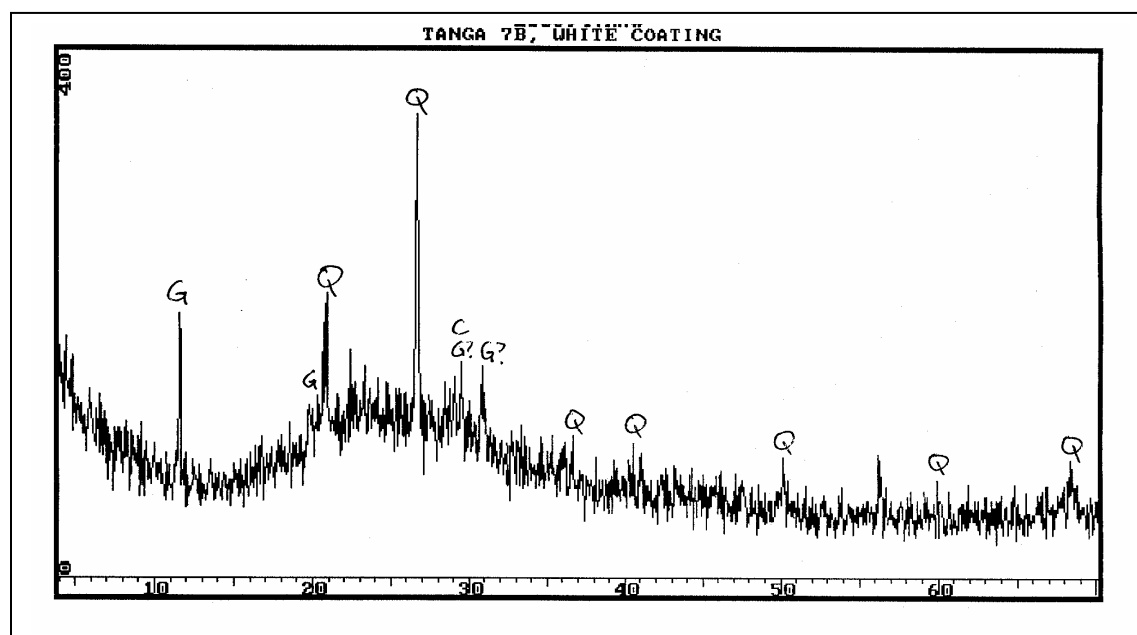
Figure 6. X-ray diffraction pattern of white precipitate coating limestone of sample 6a.

Q=quartz, G=gypsum, C=calcite

surfaces. X-ray diffraction analysis of this white coating scraped from the limestone surface showed that it is gypsum ( $\text{CaSO}_4 \cdot 2\text{H}_2\text{O}$ ).
