DEEP MINE ABANDONMENT SEALING AND UNDERGROUND TREATMENT TO PRECLUDE ACID MINE DRAINAGE

Danny R. Hause
Larry R. Willison

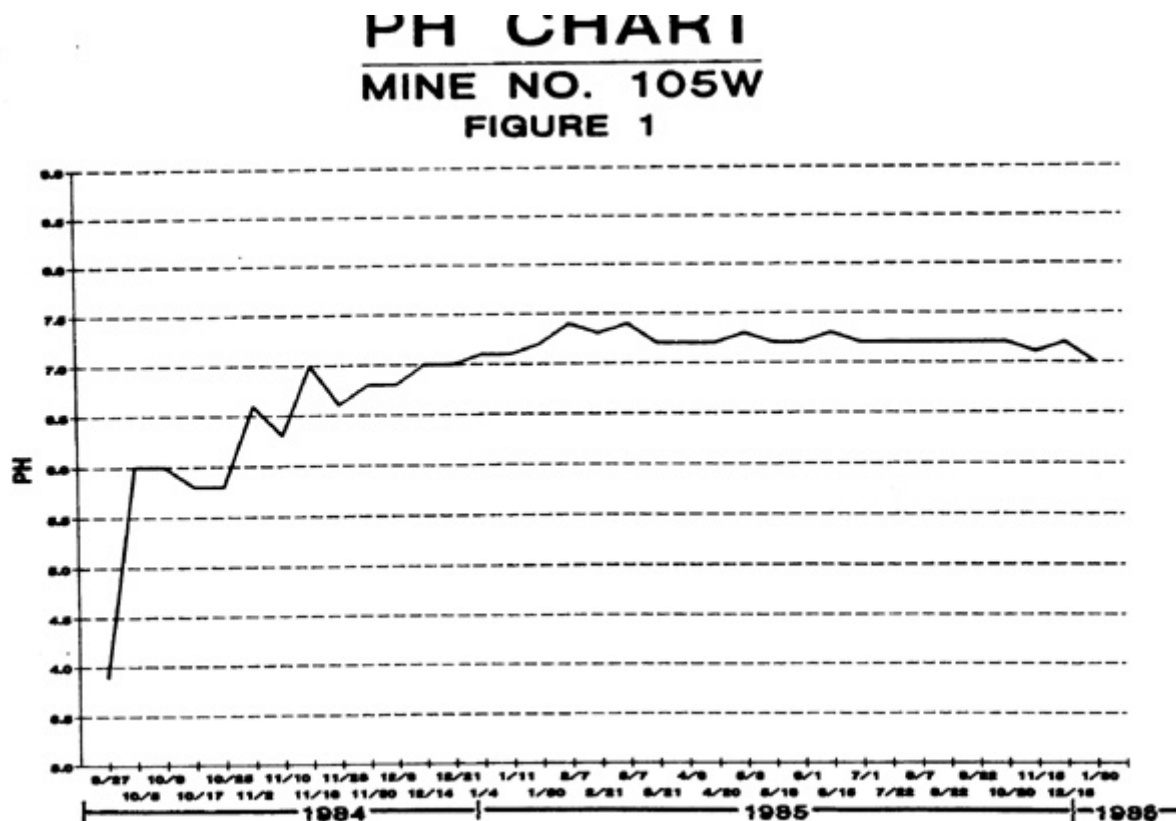
FIGURE 1

IRON CHART

MINE NO. 105W

To date the purpose of controlling water quality with little or no treatment has been achieved. Flooding of the mine began September 30, 1984, and by mid December, 1984, the 105W discharge pH had risen from 3.9 to 7.0 (Fig. 1) and has remained above 7.0. The iron decreased from 133 PPM to ± 1 PPM. Other indicators of acid generation have decreased, e.g., sulfates from 2,500 to 1,000 (Fig. 3), calcium from 385 to 120 (Fig. 4), alkalinity from nil to 350 (Fig. 5), and acidity from 470 to 20 (Fig. 6).

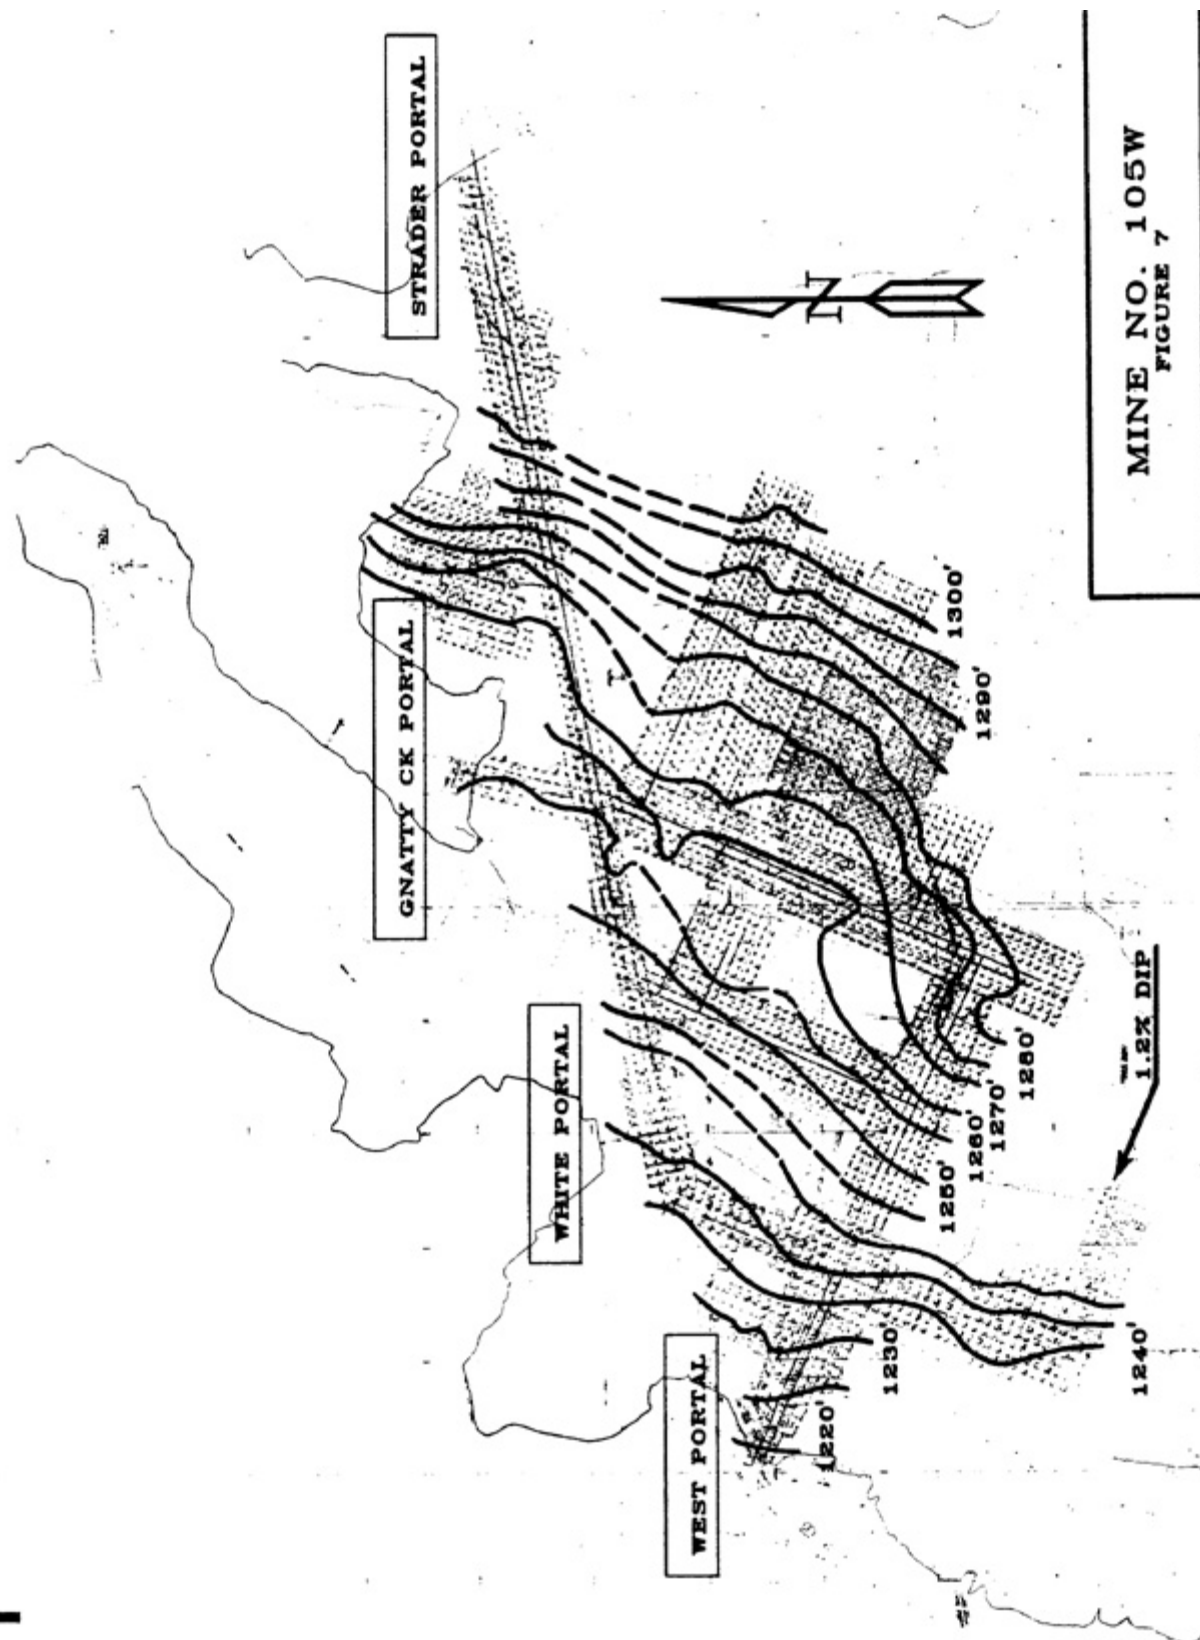
MINE NO. 105W
FIGURE 7

Mine 105W (shown in Fig. 7) dips approximately 1.2% to the west. In order to seal the mine, it was necessary to seal the West Portal, White Portal, and Gnatty Creek Portal. Because of different entry conditions and projected water heads, two different types of seals were utilized. On the relatively new entries with low head requirements, a type II Seal (Fig. 8) was used. This consisted of two cinderblock walls separated by 20 feet. These walls were hitched into the roof, floor, and ribs. The roof, floor, and ribs around the walls were injected with expanding polyurethane foam to a depth of ten feet. A 3/4-inch limestone aggregate was pneumatically stowed between the walls and the stowed area was injected with expanding polyurethane grout. The project required five of these seals (one at White Portal, four at Gnatty Creek Portal). The seals were installed by Micon Services, Inc., Pittsburgh, Pennsylvania. The seals have performed well with only minor leakage at White Portal, which was stopped with secondary grouting. This type of seal is preferred when the entry is accessible.

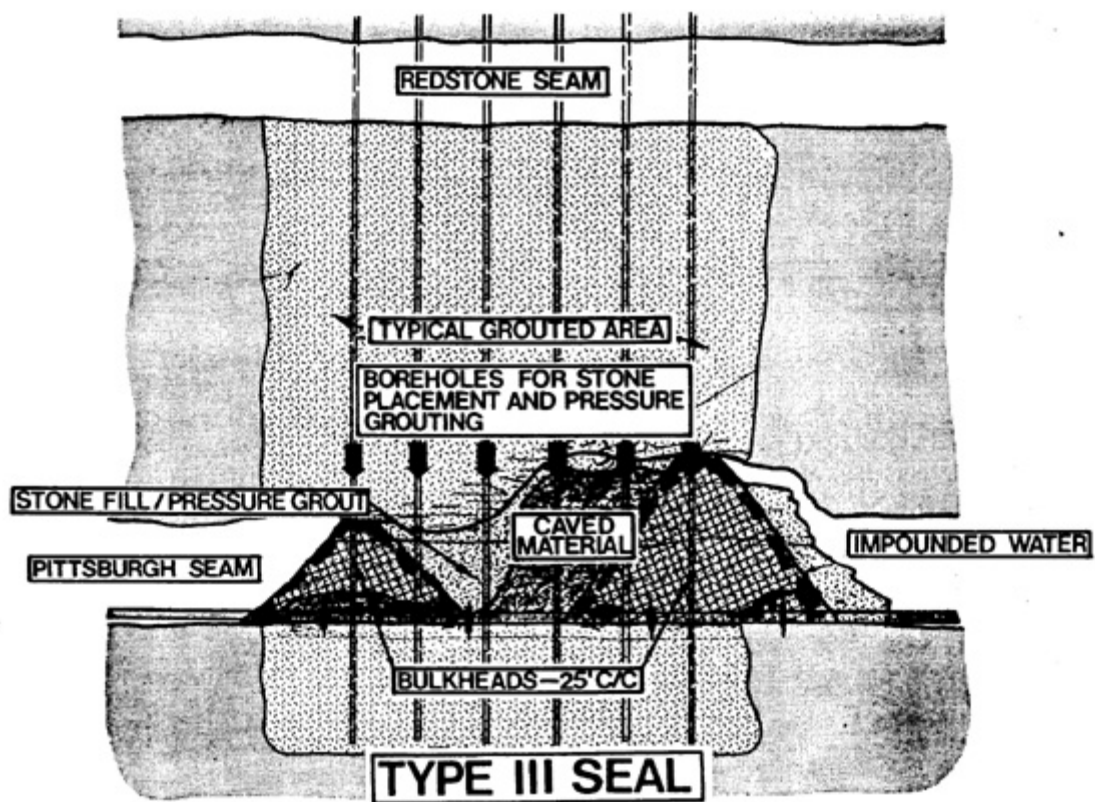
FIGURE 9

At the West Portal where the entries were older and roof falls had occurred, making the entries inaccessible for the most part, a different sealing technique was utilized. Available technology was reviewed leading to the decision to use a "double bulkhead" Type III Seal (Fig. 9). These seals were installed from the surface by drilling into the collapsed entries and stowing two gravel bulkheads approximately 25' apart in each entry. A cement/fly ash grout is used to stabilize the gravel and upon set up, a grout plug is installed between the two bulkheads. Then the entire area from 10' below the Pittsburgh Seam up to the floor of the Redstone Seam and 10' to either side of the set of four entries was pressure grouted to form a water tight curtain.

This method works best on entries that have a definite void area to seal, but on three of six seals at this portal, the entries had collapsed to the point that no large void existed. At this point, a compaction grouting technique was used in which holes were drilled on close center spacing (21'-5") and grout pumped in to refusal. This method of sealing can be costly as it is difficult to control placement of the grout. This work was performed by Hydro Group, Inc., Pittsburgh, Pennsylvania.

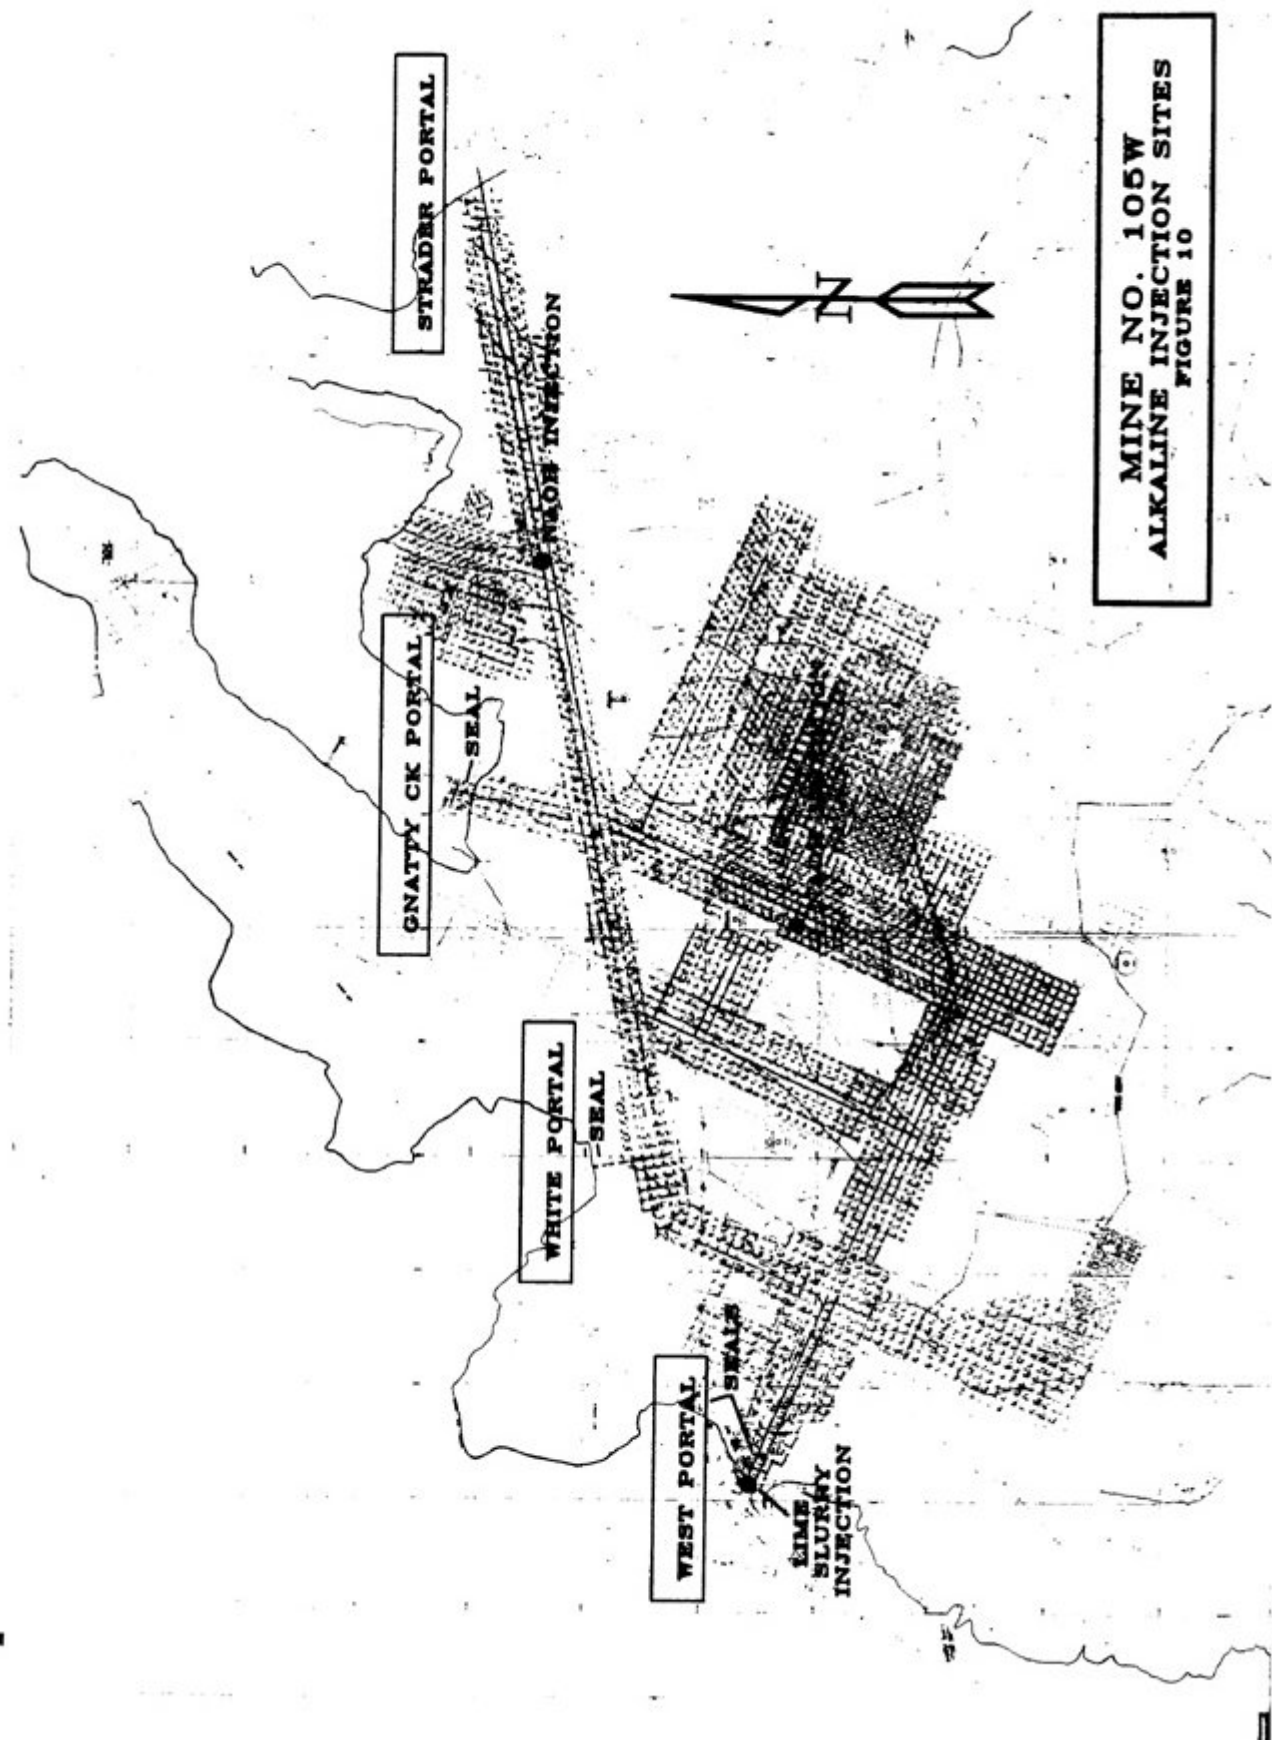
MINE NO. 105W
ALKALINE INJECTION SITES
FIGURE 10

The flooding of the mine commenced on September 30, 1984. This involved the pumping of lime/water slurry (285 GPM, 580 PPM lime) through a pipe in one of the West Portal seals. At the same time, flow was initiated from two surface injection stations to introduce NaOH through boreholes into the main drainage ways in Mine 105W (Fig. 10). The purpose of this controlled alkaline flooding was twofold: one to neutralize stagnant pools of acid water in the mine and two, to preclude acid formation until the oxygen was sealed out. The NaOH injection period was from September 30, 1984, to February 15, 1985, and lime slurry injection continued into June, 1985. During this time, 120 tons of lime were consumed and 150,000 gallons of NaOH. There has been no treatment since. The mine holds 170R gallons or 520 acre feet of water at the 421 level (Fig. 11). Historically, the mine makes 512M gallons/year, so that to date, there have been approximately four water changes in the mine.

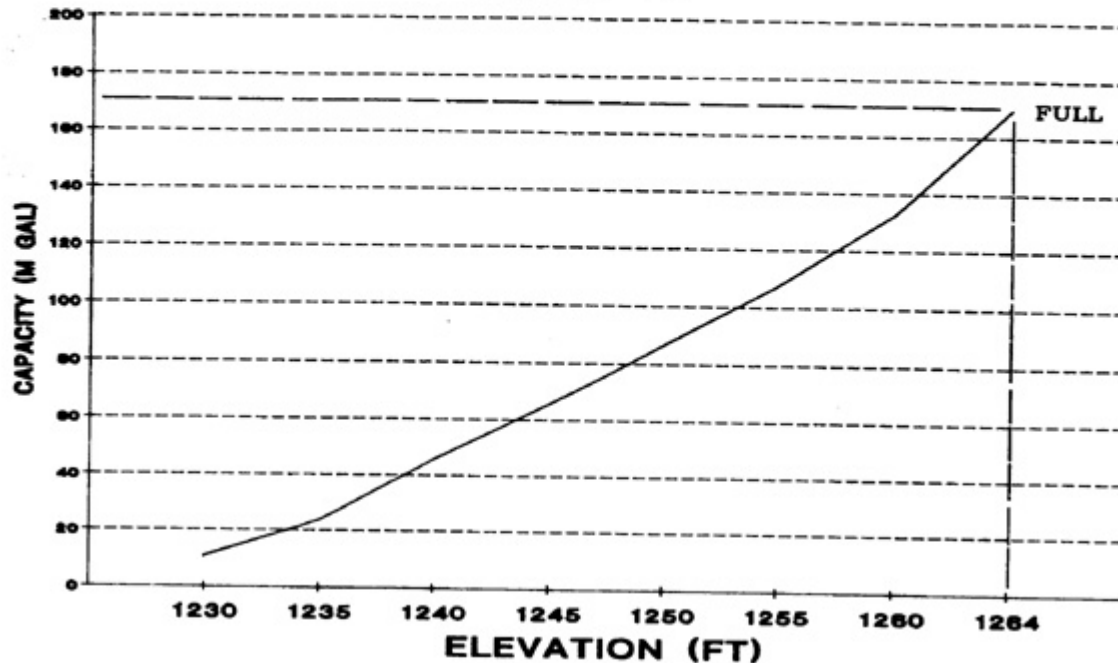
FIGURE 11

MINE CAPACITY CURVE

MINE NO. 105W

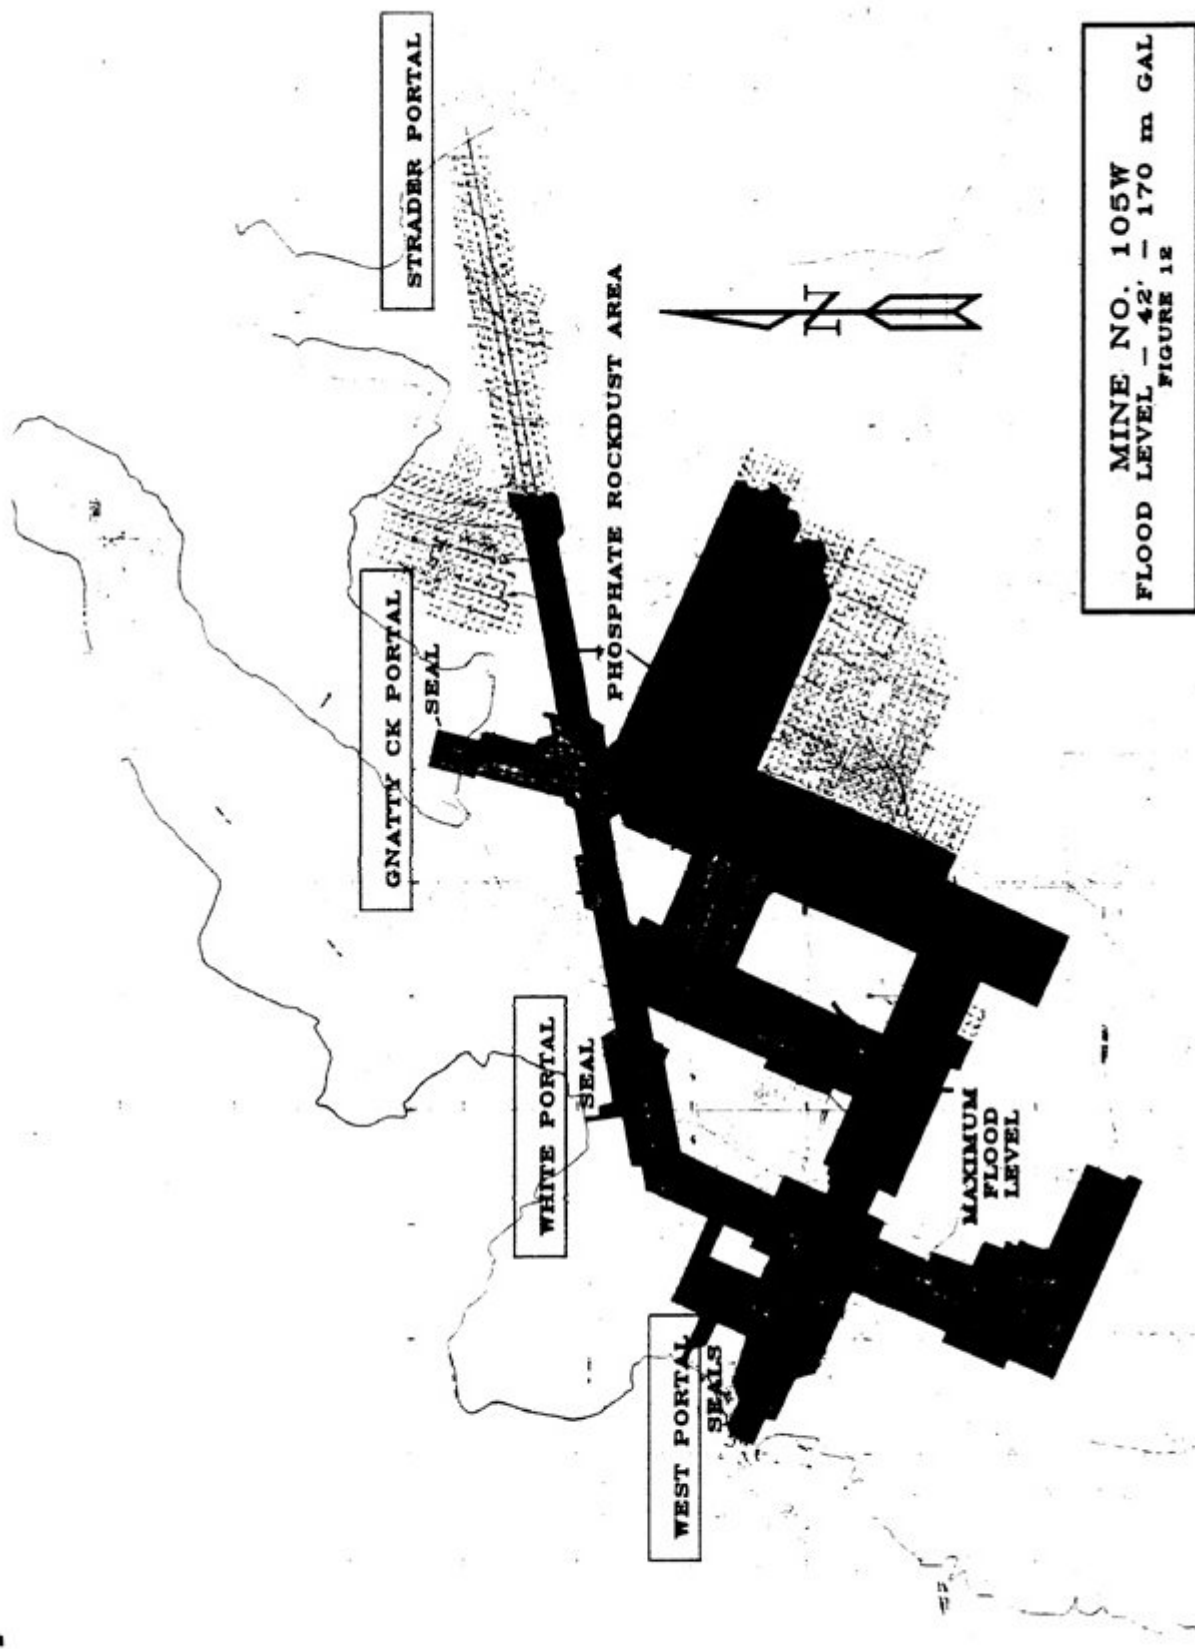
MINE NO. 105W AMD PROJECT

As shown in Figure 12, the mine is not completely flooded. This is due to the close proximity of the Redstone Seam (38' above at the West Portal) (Fig. 13). We realized that it was not practical to seal the old Redstone works (Mine 101) so a non-flooded area of Mine-105W was expected to exist after the head in the mine exceeded the interval between seams. The head against the West Portal seals was anticipated to range between 40 and 60 feet. An insurance factor was added to the project by rockdusting all exposed entries of the variable "beach" area with ground apatite rock. Apatite was chosen for its ability to lock up iron in an acidic environment and its relative inertness to leaching. The rock was supplied with the same size consistency of commercial rockdust, by Occidental Chemical Company, White Springs, Florida. The dust was shipped by special pneumatic rail cars to a nearby siding, was off loaded into standard rockdust trucks and dispensed underground with standard rockdusting equipment. In all, 700 tons of apatite were applied.
