# Implications of Pyrite Oxidation for Engineering Works

A. Brian Hawkins  
University of Bristol  
Bristol  
UK

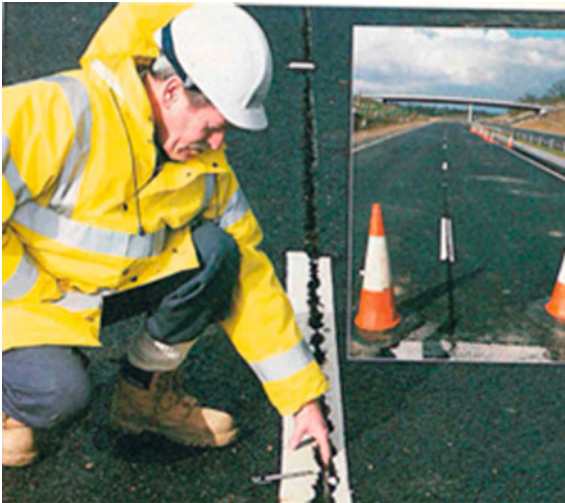
**Fig. 55** Distress in the A10 (north of London) following lime stabilisation of sulphate-rich soils (New Civil Engineer 25 March 2004)

Although the original site investigation indicated the presence of some sulphur and sulphates, a decision was made to lime stabilise the glacial boulder clay to form the capping layer. During the general earthworks, pyritiferous boulder clay was exposed and further sulphates developed in the warm, conditions of 2003, which was the fourth driest summer in England and Wales since records began in 1914 (see Hawkins 2013).

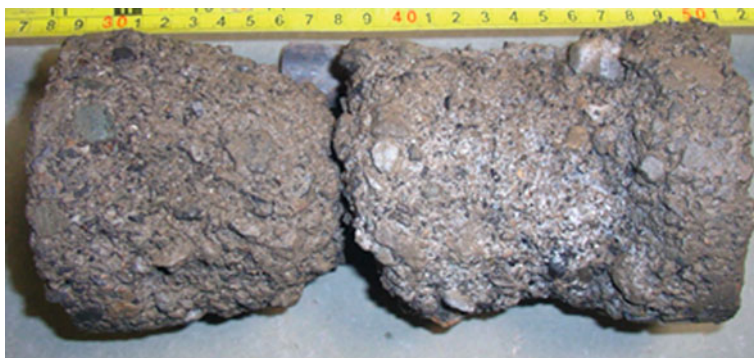
**Fig. 61** Degraded concrete with thaumasite developed in poor quality block in a rising wall

the inside face. Figure 60 shows thaumasite has developed at a depth of 9.4 mm into a concrete block where the sulphate content was up to 19.4 %  $\text{SO}_4$ . Figure 61 shows a core from a flat-lying concrete block which indicates significant deterioration of the concrete had taken place within five years of placement. It was not possible to obtain a good quality core either because of a lack of cement in the middle part of the block and/or the presence of thaumasite which weakened/disintegrated the material.

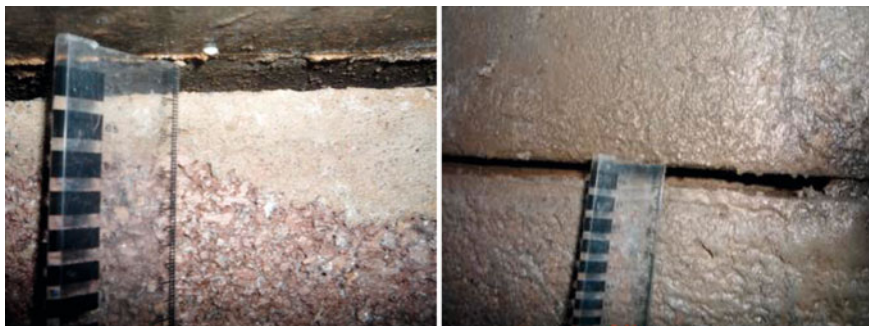
**Fig. 73** Rise of a manhole biscuit/cover slab of up to 13 mm due to the expansion of the surrounding pyritiferous fill (*left*). In the manhole wall itself gaps of up to 10 mm were noted (*right*) where the upper wall remained cemented to the biscuit

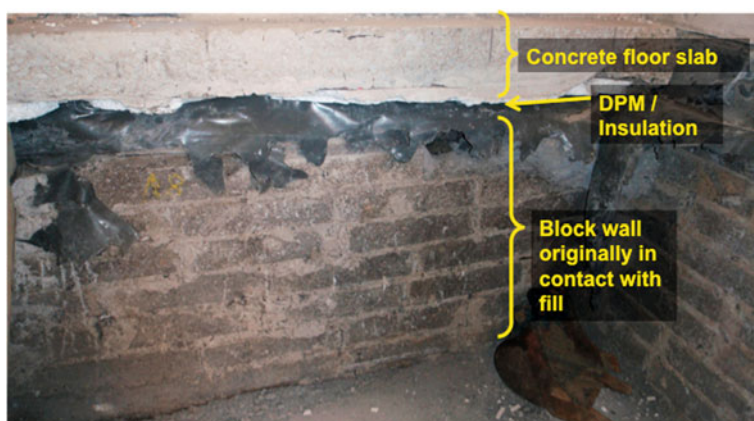
**Fig. 18** Exposed internal foundations constructed from concrete blocks on a concrete footing

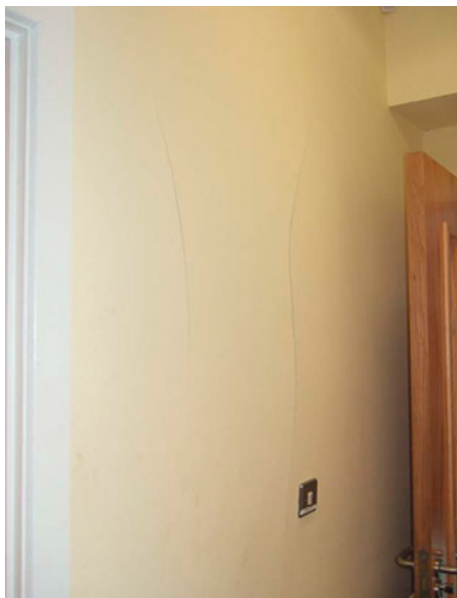
**Fig. 10** Bulging in part restricted by electric points; Youth Information Room (November 2007)

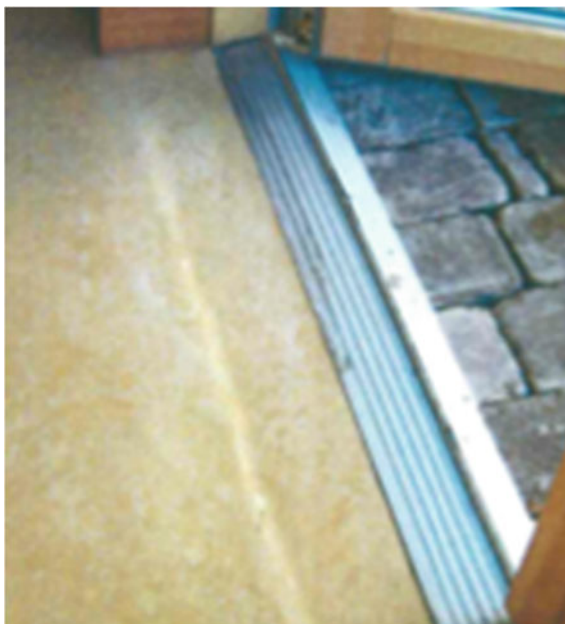
**Fig. 17** Rise of floor against the threshold into the stairwell (November 2007)

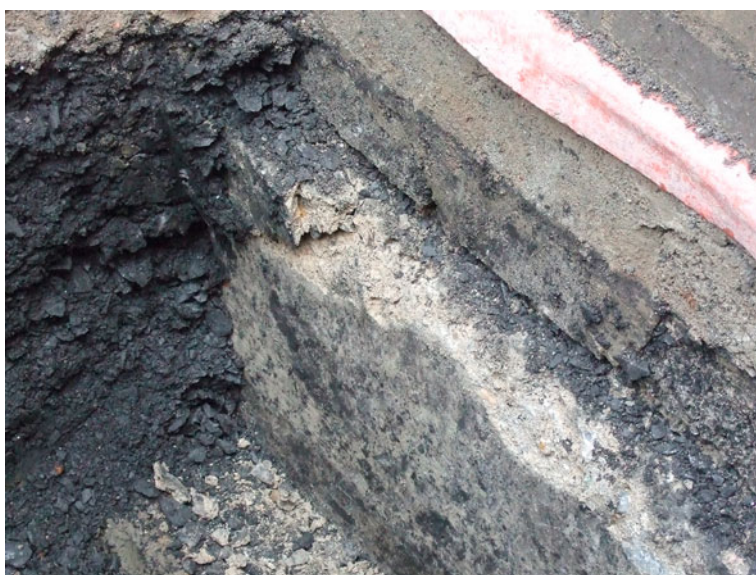
**Fig. 28** Deterioration of concrete at the top of the beam, TP 11, and the nature of the dark deleterious fill adjacent to it

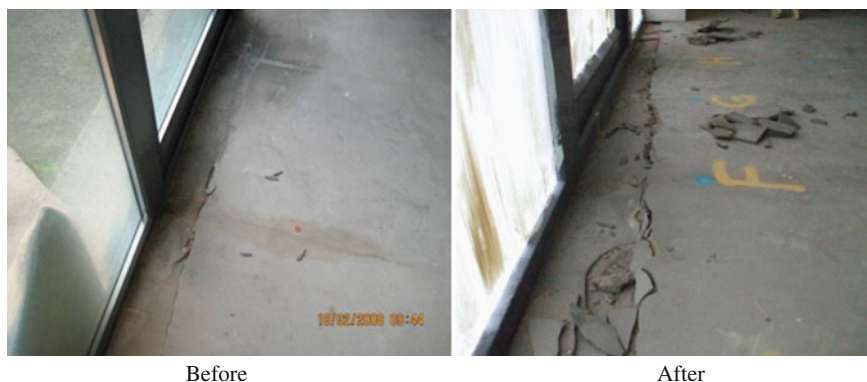
**Fig. 6** Effect on the ground-bearing floor slab after the removal of fill in an adjacent property

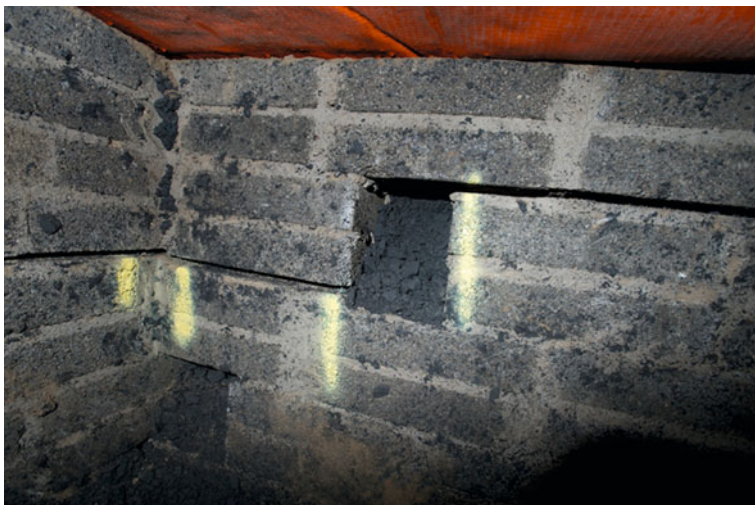
**Fig. 7** Horizontal gaps (up to 20 mm) observed in a rising wall immediately after the fill was removed in a localised trial pit (the balance of the fill beneath the floor slab was still in place at this time)

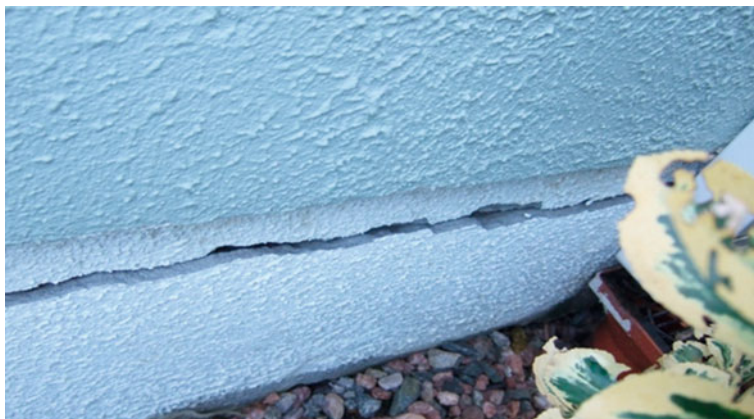
**Fig. 18** Cracking and displacement of external wall (plinth)

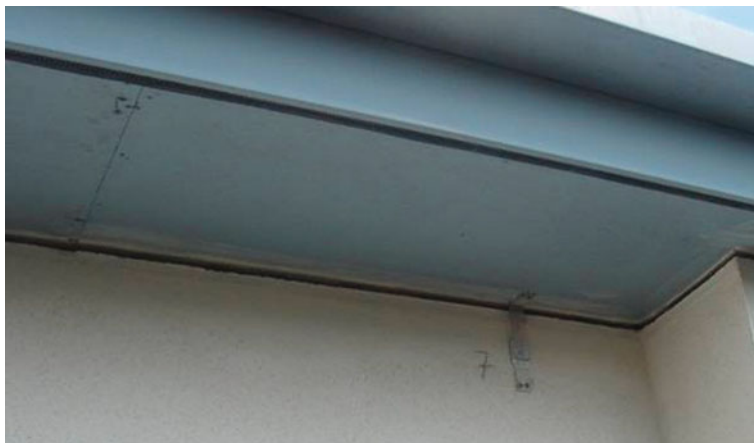
**Fig. 20** Gap of some 40 mm which developed at eaves level within 5 years of construction

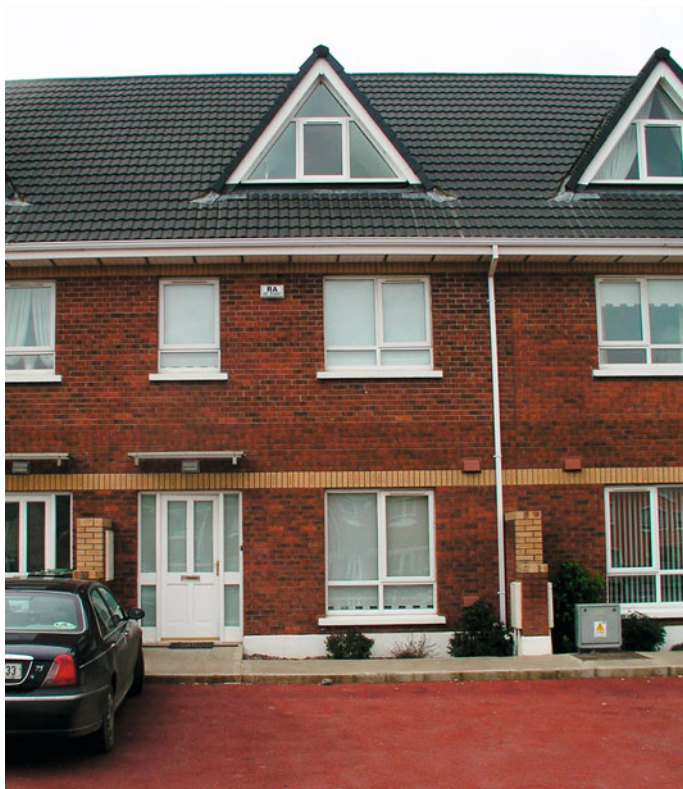
**Fig. 3** The second reported house in Ireland with pyrite-induced floor heave, Dublin

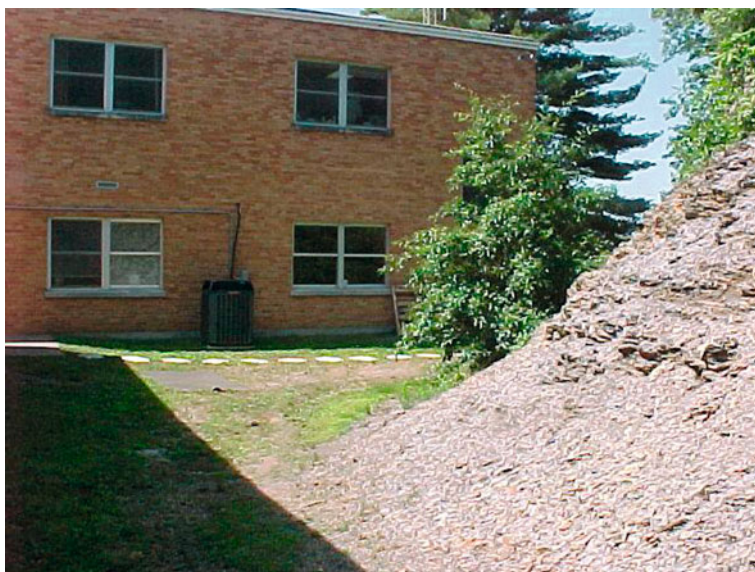
**Fig. 26** Exterior of the Marcum and Wallace Hospital office wing and an adjacent outcrop of the Cleveland Member of the Chattanooga (Ohio) Shale. Note the absence of cracks or offsets in the load bearing walls and exterior brickwork of rooms with heaved floor slabs
