**Innovative Mine Water Management Techniques for
Submarine Coal Mines of the Sydney Coalfield, Nova Scotia**

West Virginia Mine Drainage Task Force Symposium
Morgantown, West Virginia
April 22, 2008

Joe Shea
Cape Breton Development Corporation

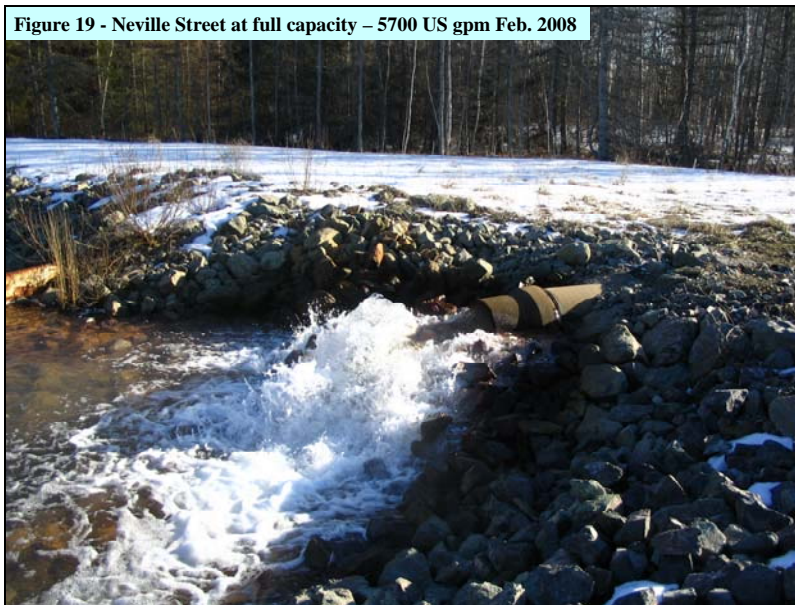
Figure 19 - Neville Street at full capacity – 5700 US gpm Feb. 2008

Since 2005, the Neville Street Wellfield has been further upgraded to a fully automated, 5700 US gpm capacity facility, consisting of twelve x 30 HP submersible pumps and related infrastructure (Figure 16). The extra capacity and full reliability was required to deal with major rain/snow melts that occur in the late Fall and early Spring. Inflows into the 1B System from large precipitation events are time dependent, normally showing up 24 hours after the event has started. Large event, peak inflows into the 1B System have been calculated at up to 8000 US gpm. The current operating plan is to maintain the mine water level in the 1B System within a stable maintenance zone, at the top of the mine pool between -17 and -19 ft below sea level (Figures 17,18,19,20).

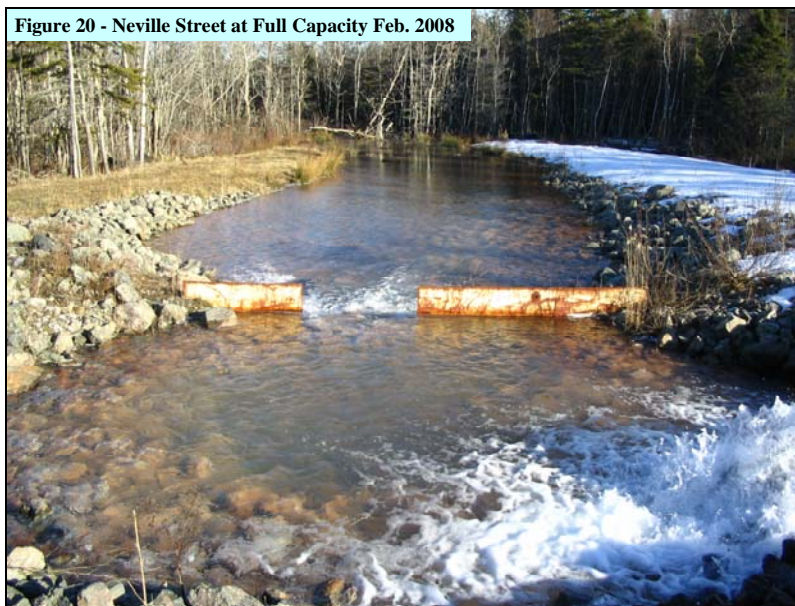
Figure 20 - Neville Street at Full Capacity Feb. 2008
