## Interaction of transport infrastructure with natural hazards (landslides, rock falls, floods)

VANÍČEK Ivan<sup>1</sup>, JIRÁSKO Daniel<sup>2</sup>, VANÍČEK Martin<sup>3</sup>

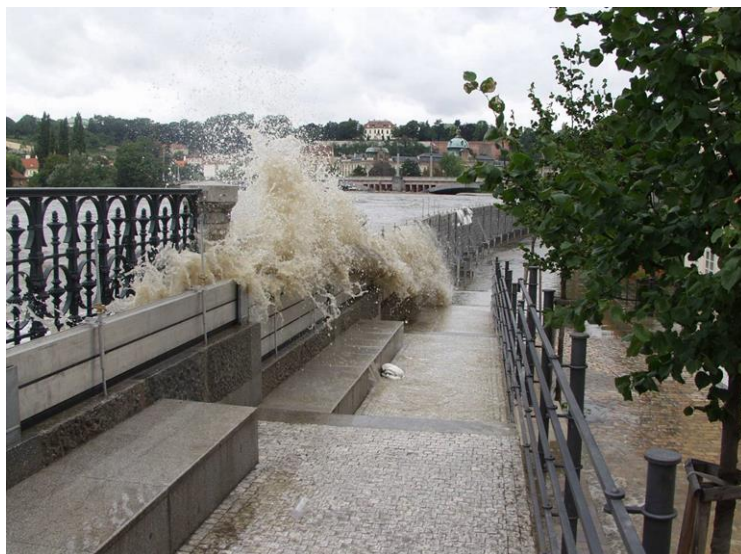
Figure 2. Mobile barrier used in Prague during floods in 2002.

Roughly at the same period, in middle Ages, construction of dikes along significant rivers started and practically still continues. And again the fill dams are the most often-used protection element during extreme hydrological situations. For Europe, namely Central Europe, the typical and big problems are connected with the Danube River. Significant floods occurred there in 1954, 1965, 1997, 2002 and 2006, e.g. (Peter 1975), (Brandl and Blovsky 2003), (Hulla and Kadubcová 2000), (Milerski et al. 2003). The construction of dikes in large cities is nearly impossible, therefore during few last decades construction of mobile barriers started. Mobile barriers applied in Prague on the river Vltava help to protect historical part of the city during floods in 2002, Fig. 2.

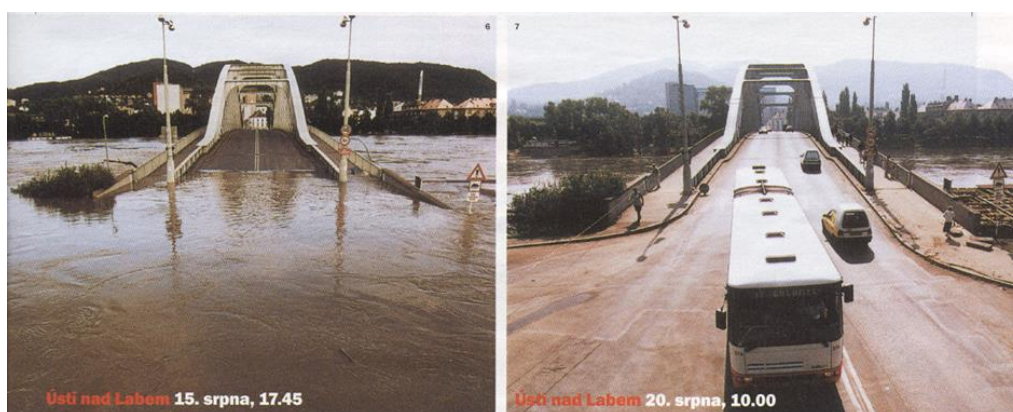
Figure 3. Flooded bridge in town Ústí nad Labem over river Labe (Elbe). Flood wave shorter than 5 days.

Flooding during higher level of water in rivers is the most typical case of interaction of floods with TI and is connected with all basic types of floods. Transport infrastructure cannot be used for limited time when is flooded by water. This time is usually relatively short, after water level decrease TI can be generally used again, usually without special effort. Fig. 3 is such example, after 5 days the bridge over river Labe in town Ústí nad Labem was fully functional again.

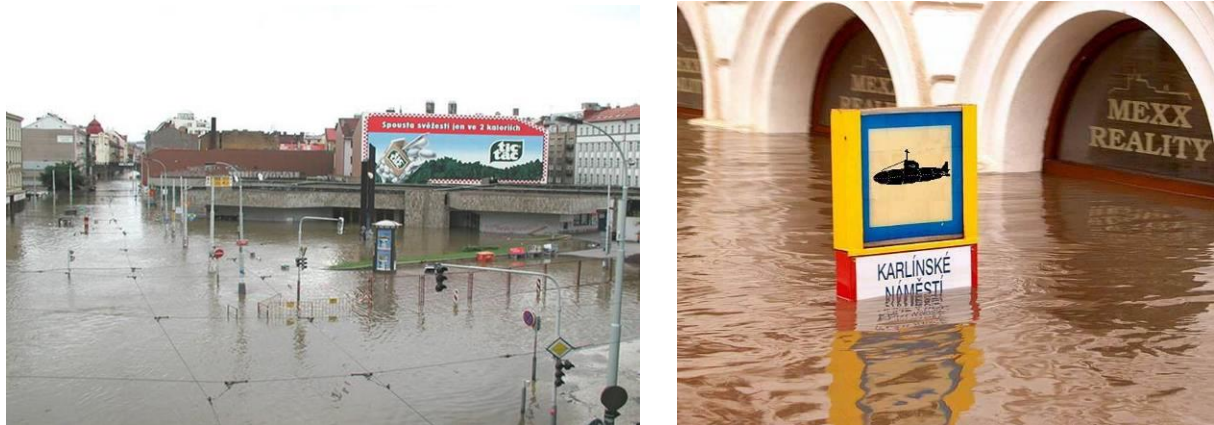
**Figure 4.** Flooded TI in Prague during floods in 2002.

Situation during floods was more complicated in Praha during floods in 2002. Town district Karlin was completely flooded, Fig. 4. In this case not only road transport but also tram transport was affected.

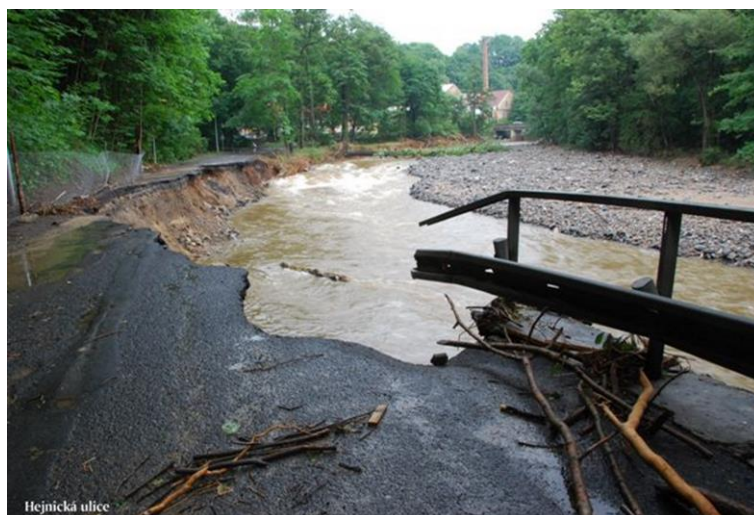
**Figure 6.** Typical case of damage of road following the water course.

The first form of this interaction is direct failure of road and railways following water course. During higher water level and speed of flowing water its erodibility is going up. Side walls of this infrastructure are eroded resulting up to final collapse. Fig. 6 shows such typical case. However there is a chance to appreciate weak places and to reinforce the resistance to erosion in advance. Similarly the same approach can be used during reconstruction of damaged segments. The problem is that very often the demand on quick reconstruction prevails and classical methods are used again. Therefore the new methods, accepting the principles of affordability and availability, should be prepared in advance to be able to reduce the probability of the failure at the same place in future, during next floods.

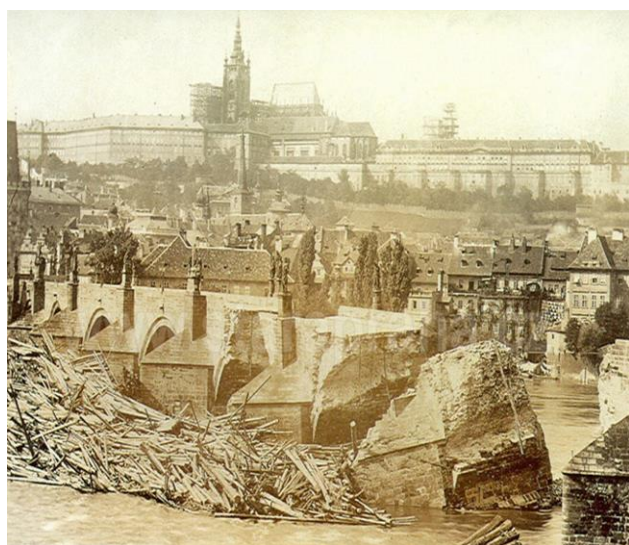
**Figure 7.** Prague - Charles bridge - failed piers in 1890 and the reconstruction of last two piers after 2002 floods.

Bridges crossing the river are second example of such interaction. With respect to scouring the bridge piers foundation create most sensitive place. This is especially valid for old, historical bridges, as there the foundation depth is relatively low. Charles Bridge in Praha from 14<sup>th</sup> century is such example. During centuries nearly all bridge piers failed as the result of shallow foundation of bridge piers and sequentially were reconstructed – Fig. 7. However it is possible to mention another historical bridge in town Písek, which survived in relatively good shape a complete flooding during floods in 2002, Fig. 8.

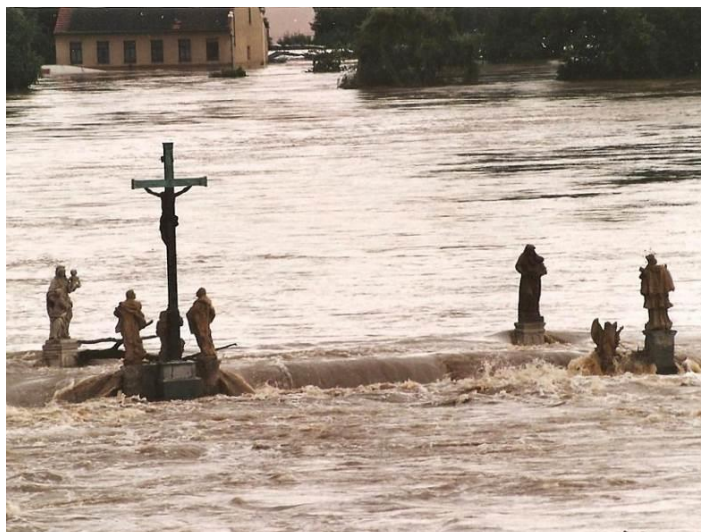
**Figure 8.** Historical bridge in Písek during floods in 2002.

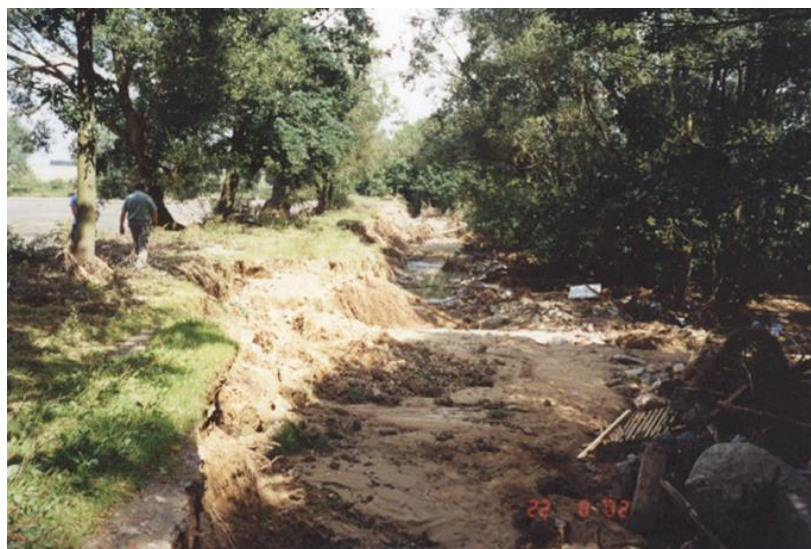
**Figure 9.** Typical case of the surface erosion during crest overflowing.

During heavy floods the number of damaged dams is in the order of units up to tens. Most often case of failure is connected with surface erosion during crest overflowing. For dams with long crest the downstream slope eroded along all length and the breakthrough starts in most weak place, sometimes simultaneously in two places – Fig. 9. Asphalt pavement has positive effect during crest overflowing, as speed of erosion is decreasing. Therefore the time of flood wave duration doesn't need to lead to the total collapse, which would create dangerous addition flood wave under this dam. – Fig. 10.

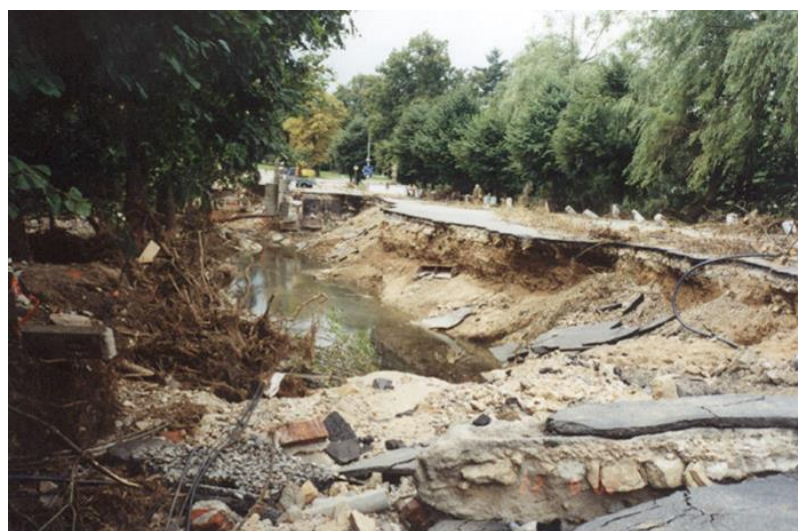
**Figure 10.** The result of surface erosion of the crest with asphalt pavement.

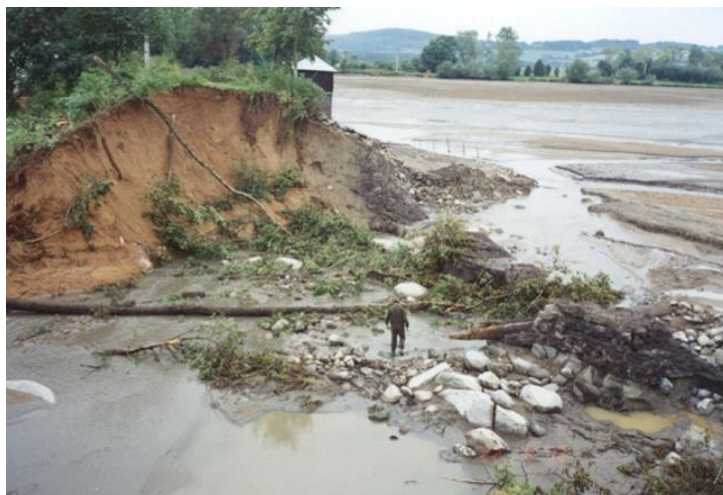
**Figure 11.** Old timber outlet – the reason of internal erosion.

Failures during floods event caused by internal erosion over a period of higher hydraulic gradient are less frequent. Failures by piping or by suffusion are not the cases for nearly homogeneous historical dams. The failures are mostly connected with some preferential path. The contact of the bottom timber outlet with surrounding soil is typical case of this preferential path. In some cases it is unsuitable technical solution performed in history. Fig. 11 shows old timber outlet, which was left in the dam body (when new outlet was set in another place). Ends of this outlet were sealed by soil, however this plug failed due to high hydraulic gradient and this preferential path was the initial point of internal erosion.

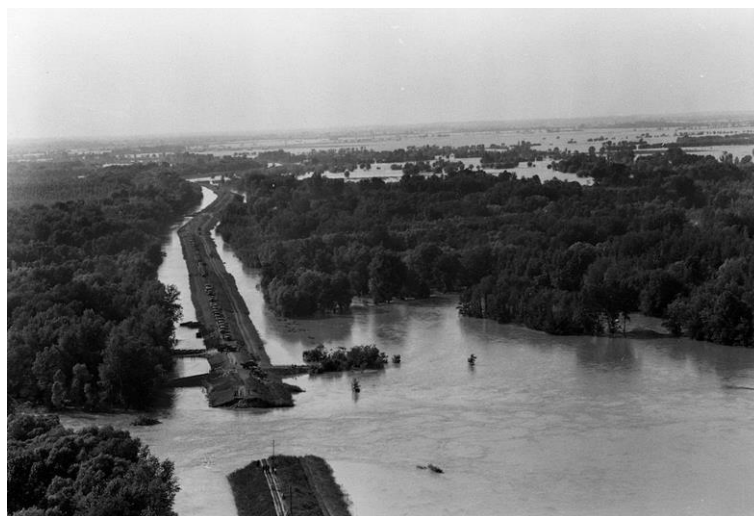
**Figure 13.** River Danube below Bratislava – example of dike failure, 1965.

The failures along Danube River had common character – were triggered off by the internal instability of fine sand induced by the high hydraulic gradient. Fine sand particles were washed out from the sandy gravel layer, causing a higher water velocity and also higher hydraulic gradient there. This higher hydraulic gradient washed out higher particles and so progressively created seepage canal, (Vaniček and Vaniček 2008).

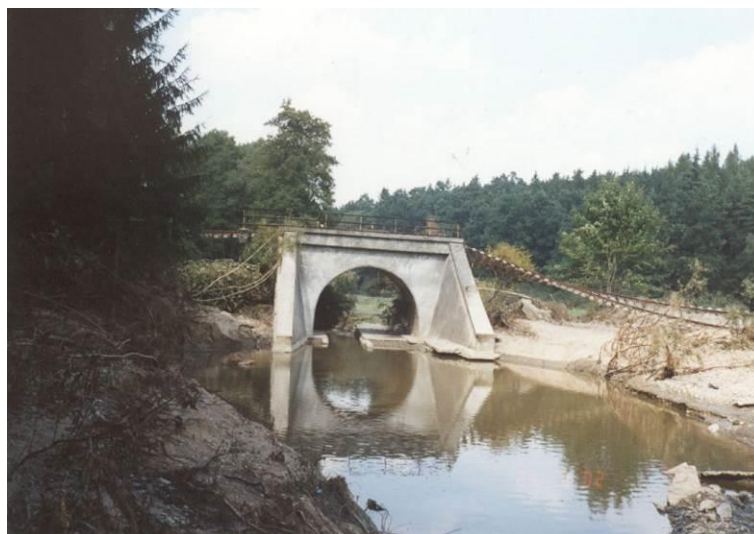
**Figure 17.** Failed railway embankment on small river Lomnice.

Usually when the transport embankment is crossing the river (brook) water is flowing through culvert. During higher flow rate and especially when outflow is obstructed by carried vegetation (bush, tree) the water front of embankment is uprising and subsequently can be the reason of embankment failure. Fig. 17 is showing such failures, the event happened on already mentioned small river Lomnice, the second one - Fig. 18 - is from Italy, (Burdo 2016).

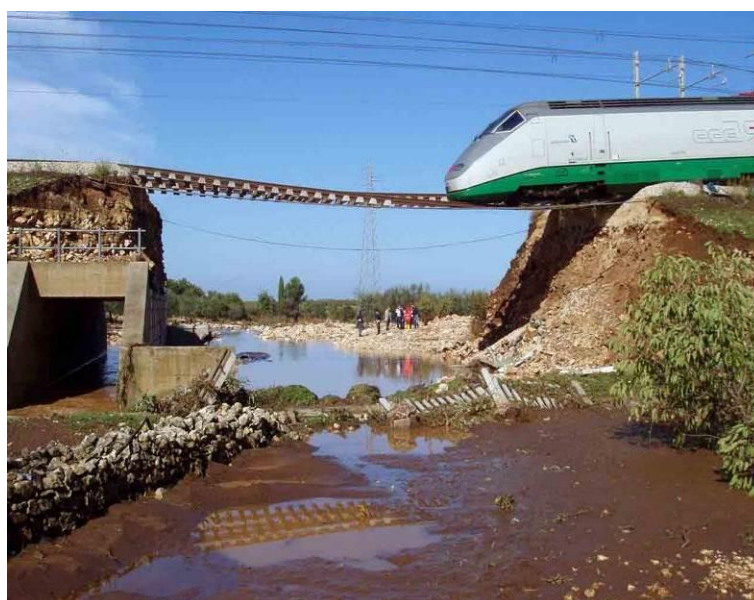
**Figure 18.** Embankment failure on the railway track Bari – Taranto.

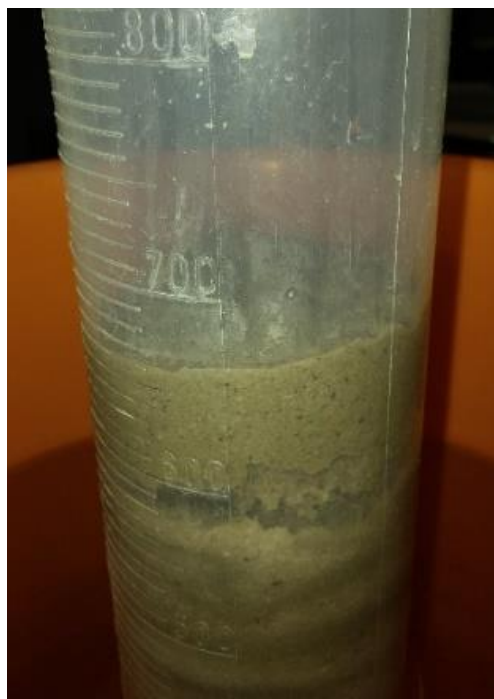
**Figure 19.** Upheaval of saturated sand layer by pore air pressure increase in partly saturated sand.

Therefore we simulated the behaviour of air trapped in soil pores in laboratory. Dry sand was placed into glass tube, only upper part was composed from fully saturated sand. Lower part of tube was put in tank with water, enabling to rise by capillarity forces. The crack, the separation of the two sand parts, was observed, as the result of air pressure increase between two saturated parts – Fig. 19. This experiment demonstrates the estimated character of failure described above. At the same time is pointing at partly saturated sand which can be most sensitive for described type of embankment failure.

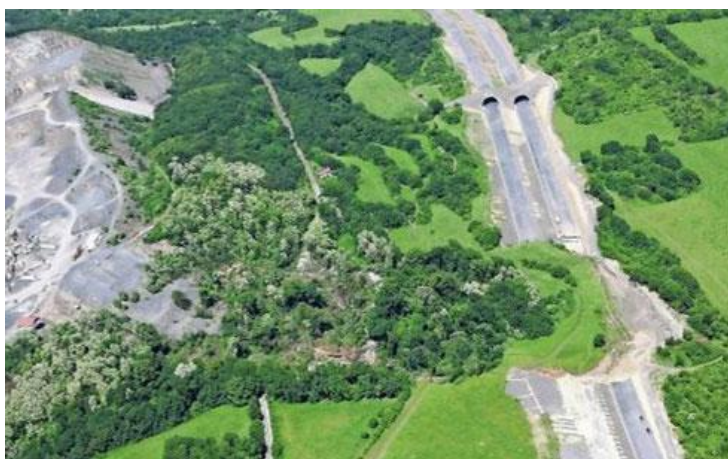
**Figure 21.** Character of landslide covering the constructed motorway D8.

The landslide occurred at the beginning of June 2013. The excavation for motorway roadways was finished about 3 years ago, only final pavement was missing. From the beginning the landslide was described as areal shallow one with length of about 500 m, width of 200 m and depth of 5-7 m. The railway track moved downhill by about 50 – 60 meters. Landslide mass overlaid the motorway roadways, Fig. 21. The depth of the landslide corresponded with the interface between weathered surface of calcareous clay and quaternary soil cover. Quaternary materials are characterized as colluvial deposits, fine soils with high up to very high plasticity.

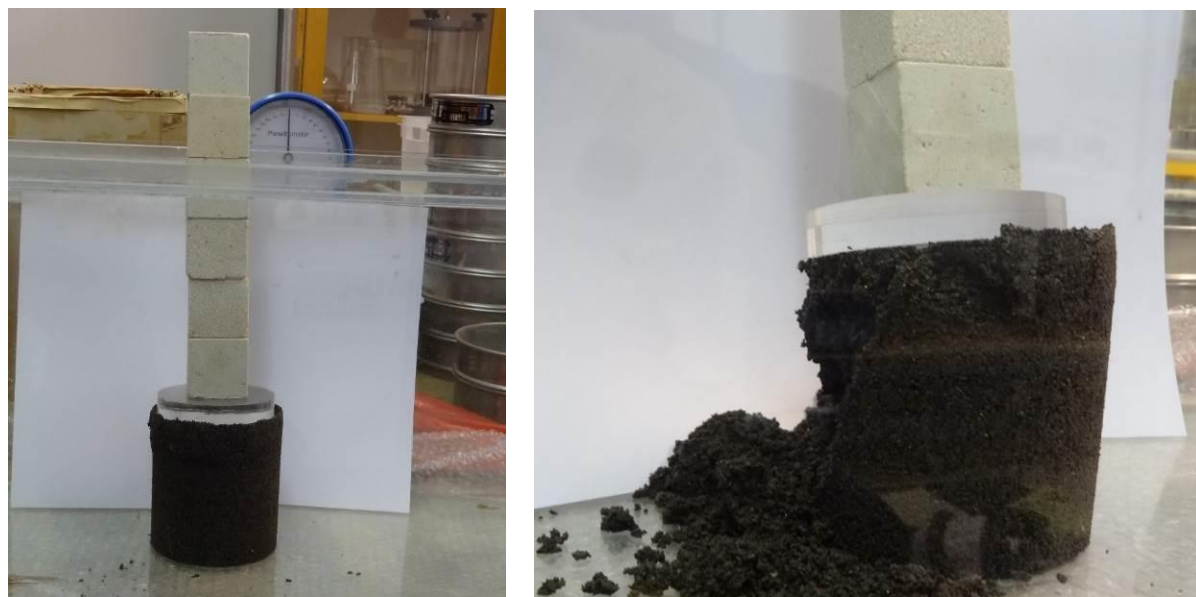
**Figure 22.** High bearing capacity of wet unsaturated sand.

This significant factor leading to slope stability decrease was simulated by authors in lab for given material. The angle of freely spilled material was between 32 and 35 degrees for dry material. For wet material the created sample can have even vertical walls and such sample was finally disturbed only by significant external load, Fig. 22. However for no-load condition the sample failed very quickly when flooded from the bottom, Fig. 23.

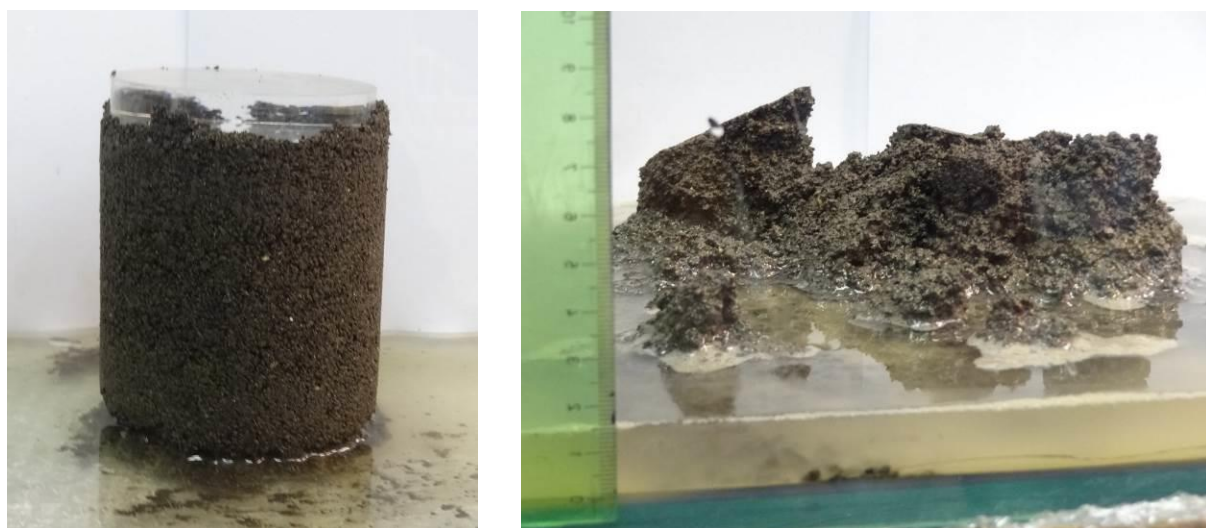
**Figure 23.** Initial phase of failure of sample loaded by water.

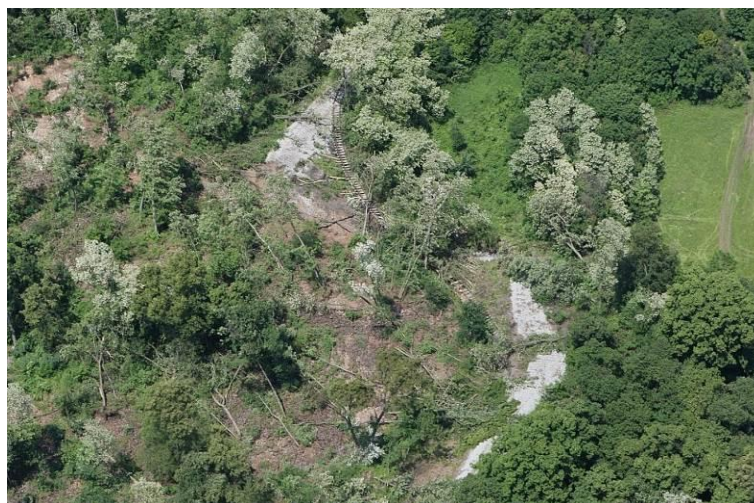
**Figure 24.** Compressed upper part of landslide.

After that there was and still is very sensitive discussion at which part of the slope the great landslide started. Authors are pointing out on the upper section. As the supporting arguments they are using the character of the landslide. The part of the landslide above railway track is strongly compressed, not only the surface but also vegetation on it, what is straightforward from the Fig. 24. Under the pressure from the upper part also movement of the railway embankment started even though this embankment had little bid higher stability than the surrounding terrain. When this embankment started to move also the remaining part did the same. From the photo – Fig. 25 - it is visible that the lower part under railway embankment is undisturbed, does not contain any cracks implying the retrogressive failure from the bottom upwards.

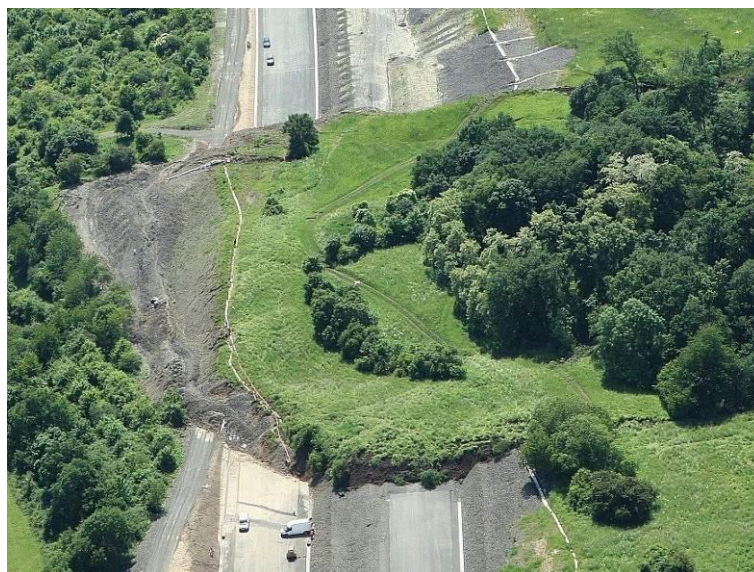
**Figure 25.** Undisturbed surface of the lower part of landslide.

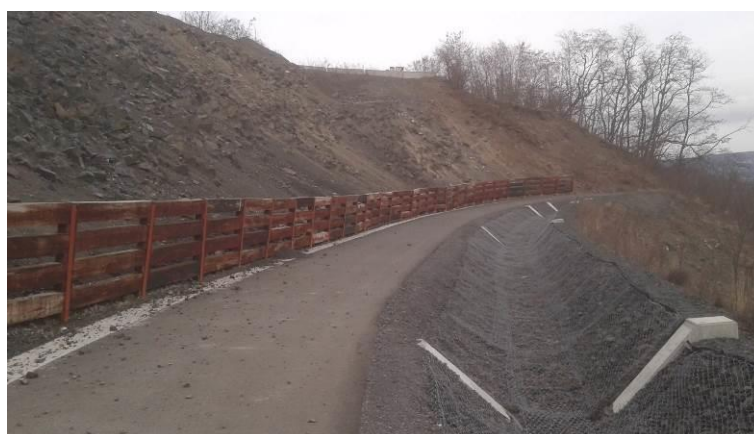
**Figure 26.** Drainage ditch in upper part of slope.

- Removal of the loose material in the upper part of the slope up to the basalt bedrock.
- Limitation of the surface water infiltration into slope from the quarry platform as well construction of drainage trench in the upper part to eliminate the infiltration into central part of the slope, Fig. 26.
- Construction of retaining elements – embedded retaining walls just above the motorway cut, guaranteeing the safe removal of the landslide mass covering motorway roadways but also long term stability of the motorway cutting slope.
- The performance of the drainage system in the central and lower parts to limit maximum ground water table there.

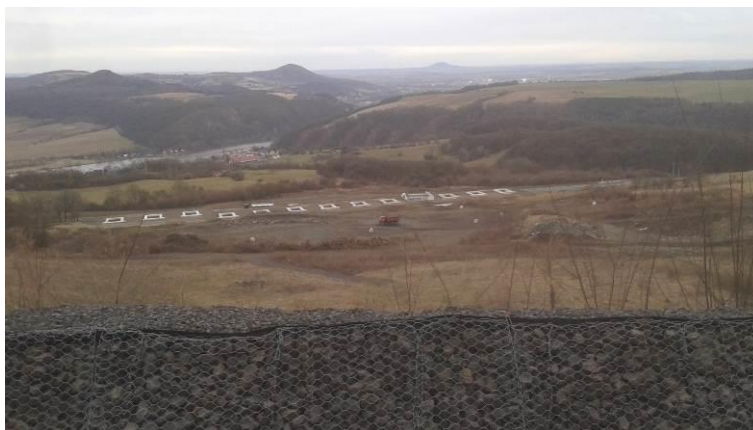
**Figure 27.** Retaining elements in the lower part of slope.

Numerical modelling was used by the authors for the design of retaining wall, taking into account different design situations, (Jirásko, Vaniček and Vaniček 2017). From the different alternatives for the retaining structure the one composed from the elements of diaphragm wall was finally constructed – Fig. 27 and 28.

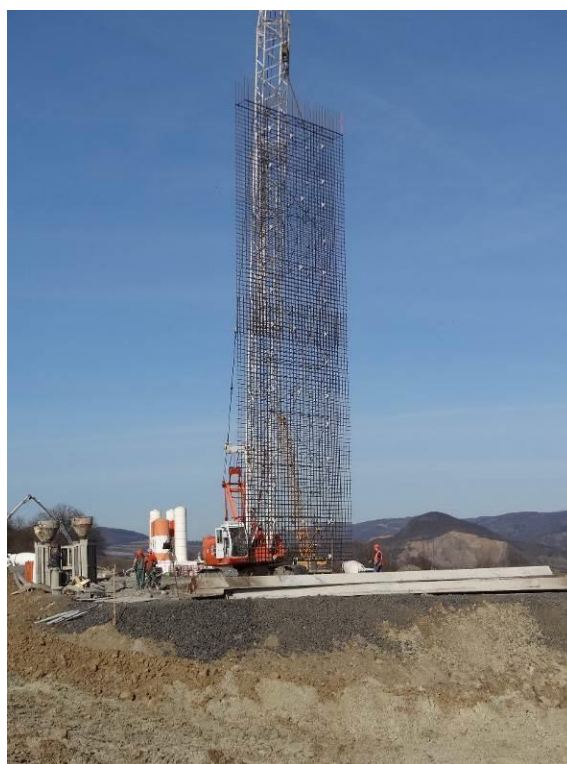
**Figure 28.** Armature for reinforcing element.

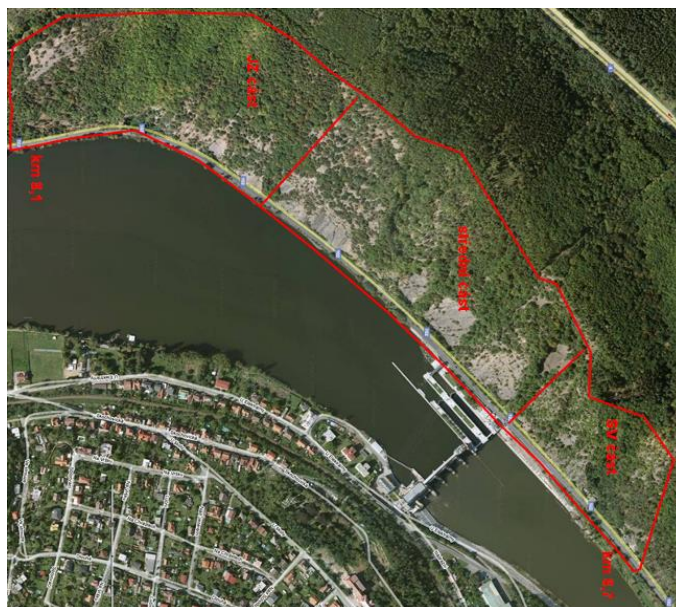
**Figure 30.** Rock slopes above the dam Vrané nad Vltavou.

Rock slopes above the dam Vrané nad Vltavou were evaluated as a riskiest part – Fig. 30 and 31. Dam was constructed in 30-ties of the last century and from these days there are many accidents. One of the main reasons of instability is dip of discontinuities, which are roughly parallel with slope surface – Fig. 32. First huge rockslide occurred in 1927 and was described by (Záruba and Mencl 1976), Fig. 33. After this rockslide protection local protection retaining wall were constructed, however with only limited effect – Fig. 34.

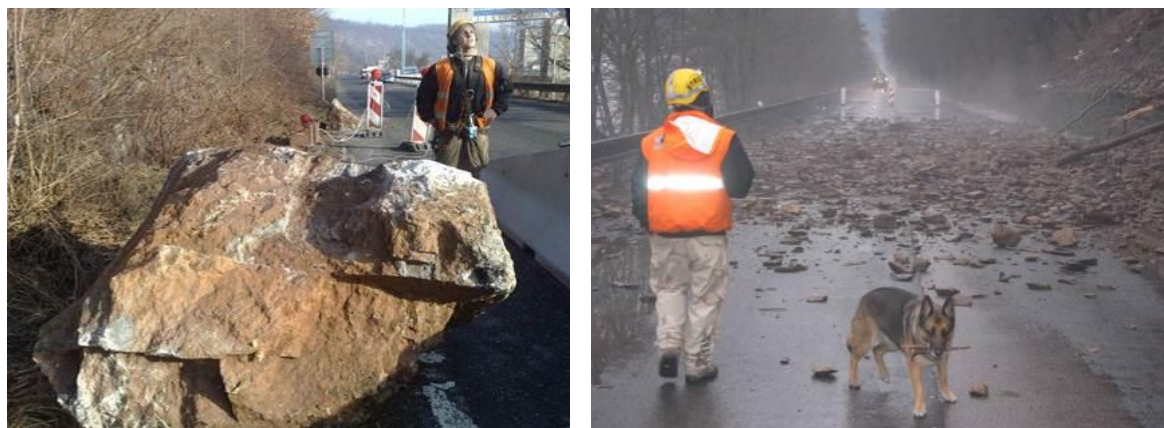
**Figure 31.** Direct impact with road.

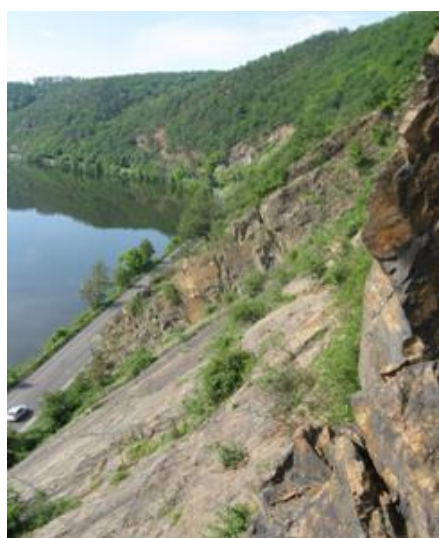
**Figure 32.** Unfavourable inclination of layers.

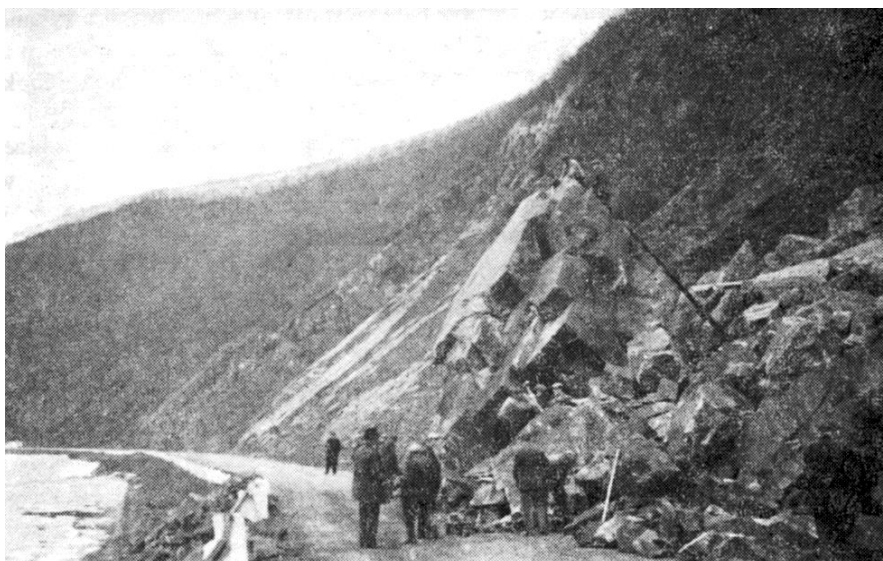
**Figure 33.** Rockslide after cuts for road.

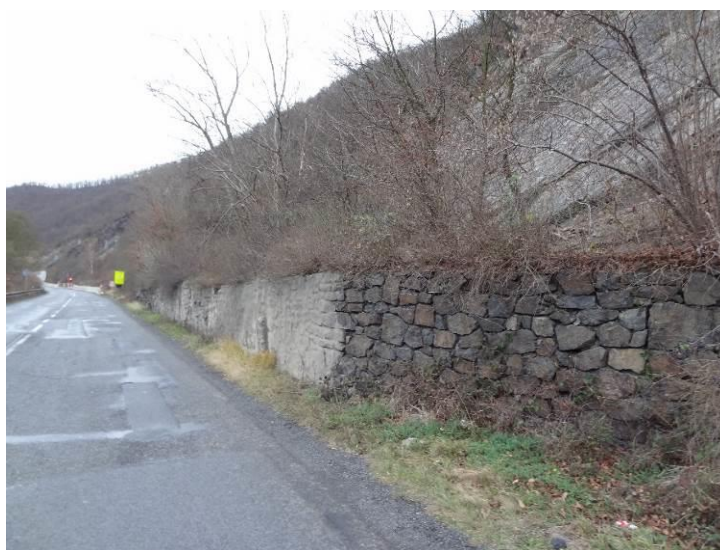
**Figure 34.** Old masonry retaining wall.
