# **LANDSLIDES**

# **AND THEIR CONTROL**

Second completely revised edition

QUIDO ZÁRUBA, VOJTECH MENCL

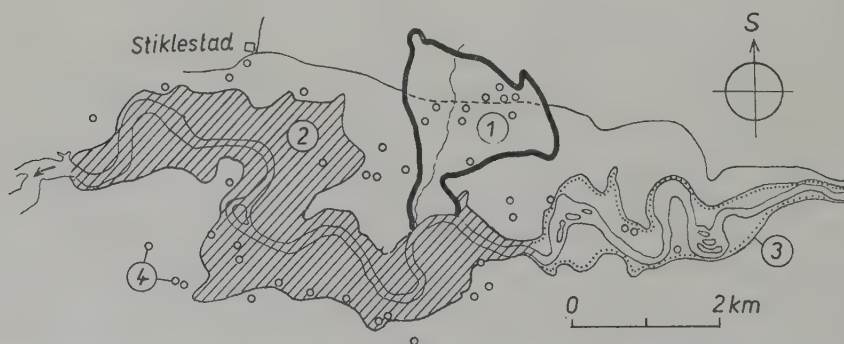
**Fig. 1-3.** Sketch map of the large landslip in Vaerdalen in 1893 (Holmsen 1953 ; 1 — head-scarp area, 2 — Vaerdalselven river-valley filled with liquid clay, 3 — temporary lake created by the damming of the valley, 4 — farms.

The slides that occur in the sensitive clay areas of Scandinavia and Canada often have tragic effects owing to the appalling suddenness of the motion. One of the largest landslides of this type occurred near Vaerdalen, north of Trondheim in Norway in 1893 (Holmsen 1953). A layer of sensitive clay of marine origin was laid bare by stream erosion and the liquefied clay, totalling 55 million  $\text{m}^3$  in volume, flowed down into the Vaerdalselven river-valley within 30 minutes. The dense liquid covered an area of 8.5  $\text{km}^2$ . The temporary lake created by the damming of the valley inundated 3.2  $\text{km}^2$ . The disastrous landslide destroyed 22 farms and 111 persons were killed (Figs. 1-3, 1-4).

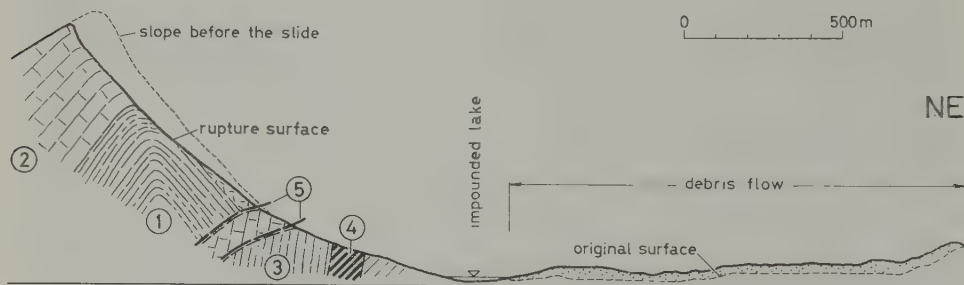
**Fig. 1-5.** Rockslide on Turtle Mountain in Canada, which destroyed part of the town of Frank; 1 — shaly limestone, 2 — solid limestone and dolomite (Carboniferous), 3 — sandstone and shale (Jurassic), 4 — Cretaceous sandstone and shale with coal seams, 5 — faults, disturbed zone (Cruden et al. 1978).

A classic example of catastrophic slope failures in North America is given by the rockslide which destroyed part of the town of Frank in Canada in 1903 (Fig. 1-5). Within two minutes about 30 million  $\text{m}^3$  of Carboniferous limestone broke away from the mountain face burying part of the town as well as an industrial plant and a long railway track; at least 70 lives were lost (McConnel and Brock 1904). The slide was originally grouped with rockfalls since the movements was thought to occur down a set of steep joints. Further investigation and detailed mapping, however, have shown that the site of failure was the steep limb of the Turtle Mountain anticline thrust on the Mesozoic sandstones and shales. The limestones slipped along bedding planes oriented parallel to the scarp; therefore, the term "rockslide" is more appropriate (Cruden and Krahn 1973). The movement was probably triggered by a deformation caused by operations in the coal mine at the foot of the slope and by the wedging effect of freezing water in fissures. However, according to stability analyses, the slope

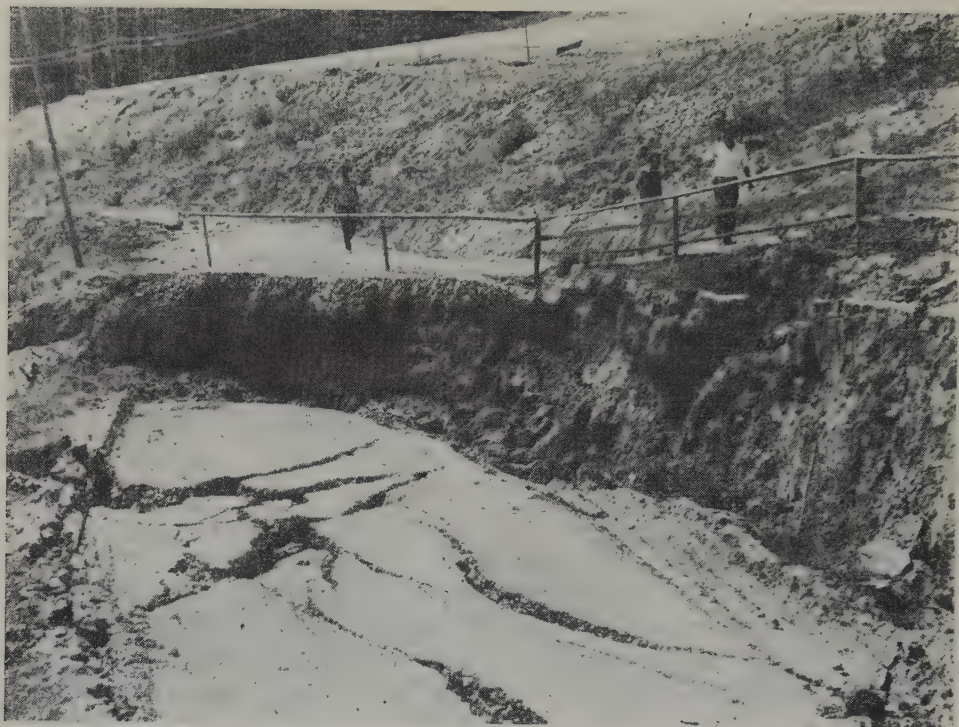
Fig. 1-10. Highway interrupted by landslide caused by excavation for dam abutment (photograph by Záruba).

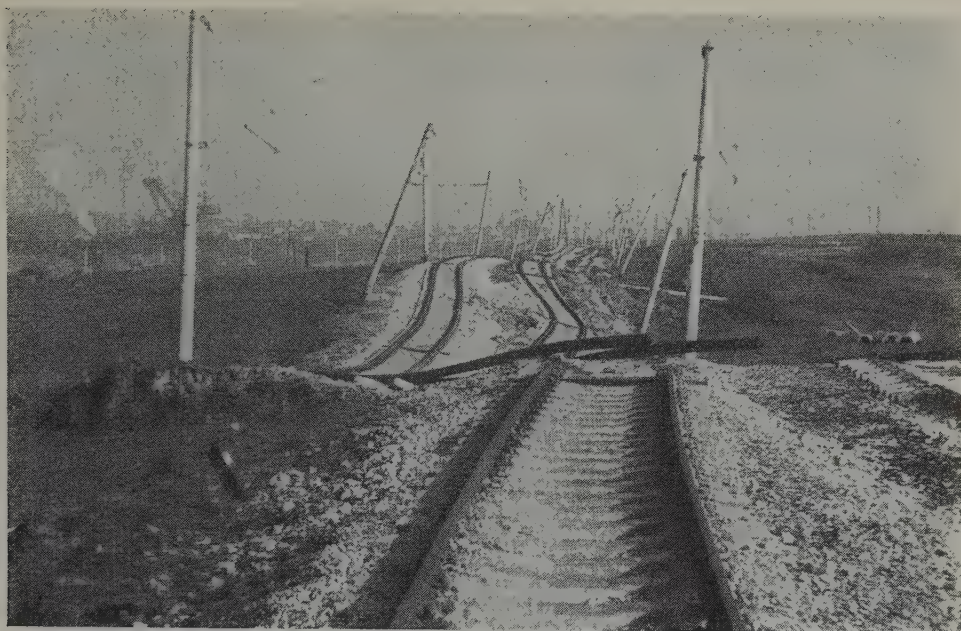
Fig. 1-11. A railway line interrupted by a landslide; Marica-Iztok brown-coal basin in Bulgaria (photograph by Rybář).

Considerable damage to railway lines may be caused by slope movements in opencast mines (Fig. 1-11).

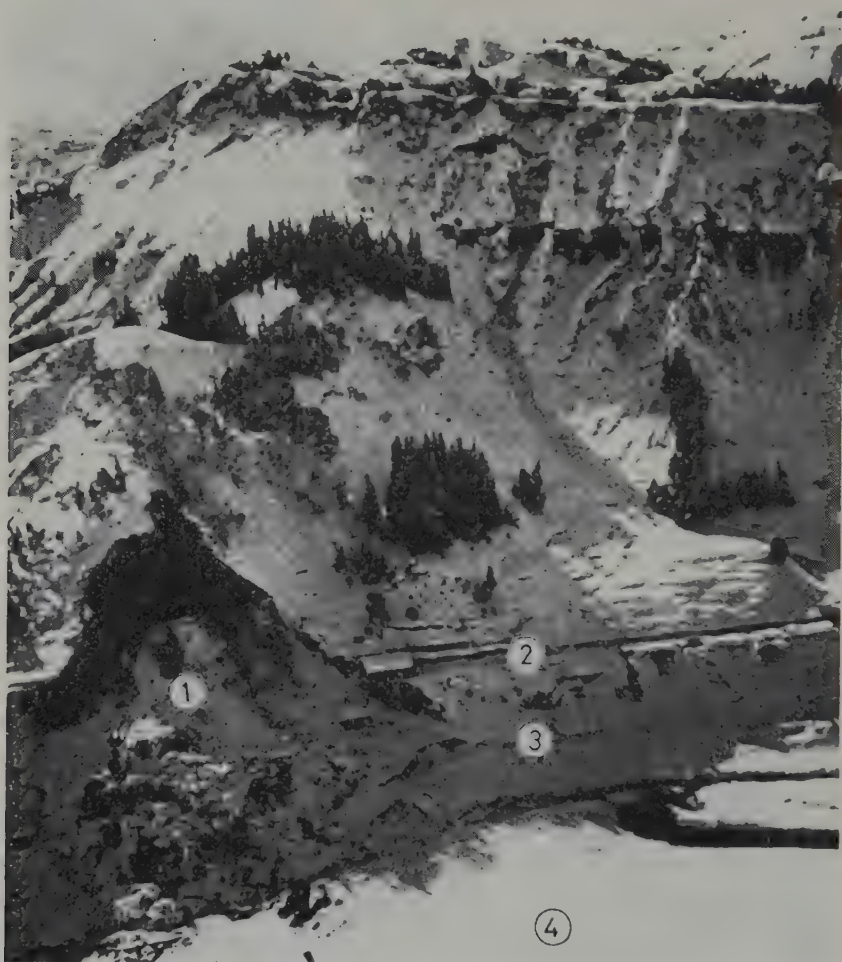
**Fig. 1-13.** The slope failure which destroyed the Takabayama tunnel in Japan, 1970; 1 — landslide in Neogene mudstone, 2 — railway line, 3 — highway, 4 — Shinano river (Japan Society of Landslides 1972).

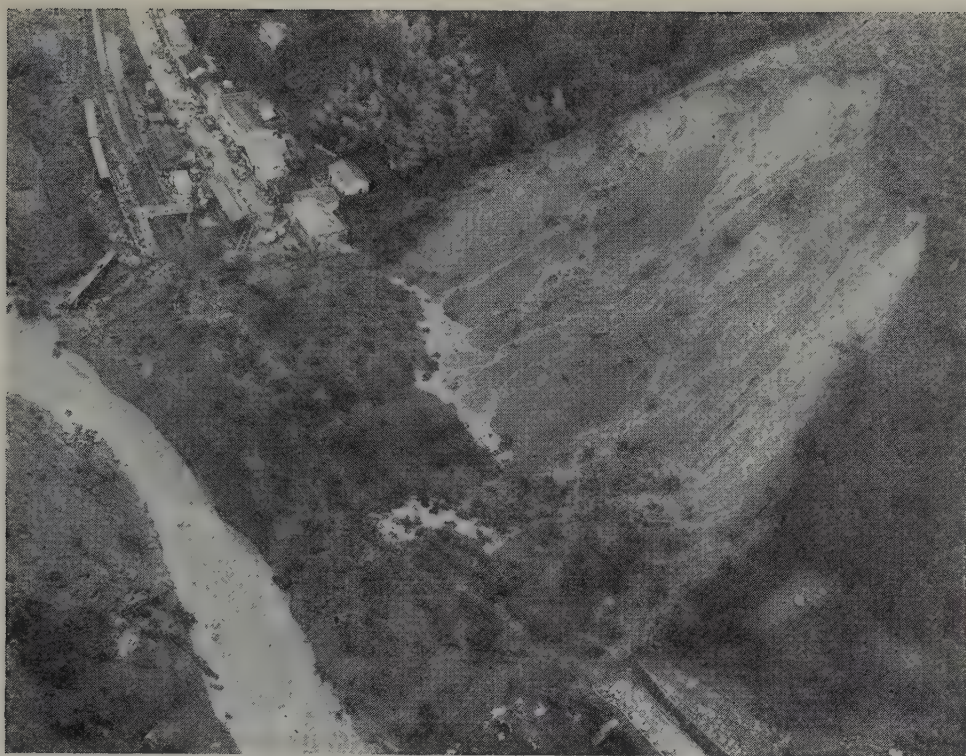
**Fig. 2-6.** The Shigeto railway station in Japan was partly buried by a landslide in 1972. The locomotive and two carriages were thrust into the river Ananai. The slope failure was triggered by torrential rain amounting to 742 mm per day (courtesy of Asahi Shinbun).

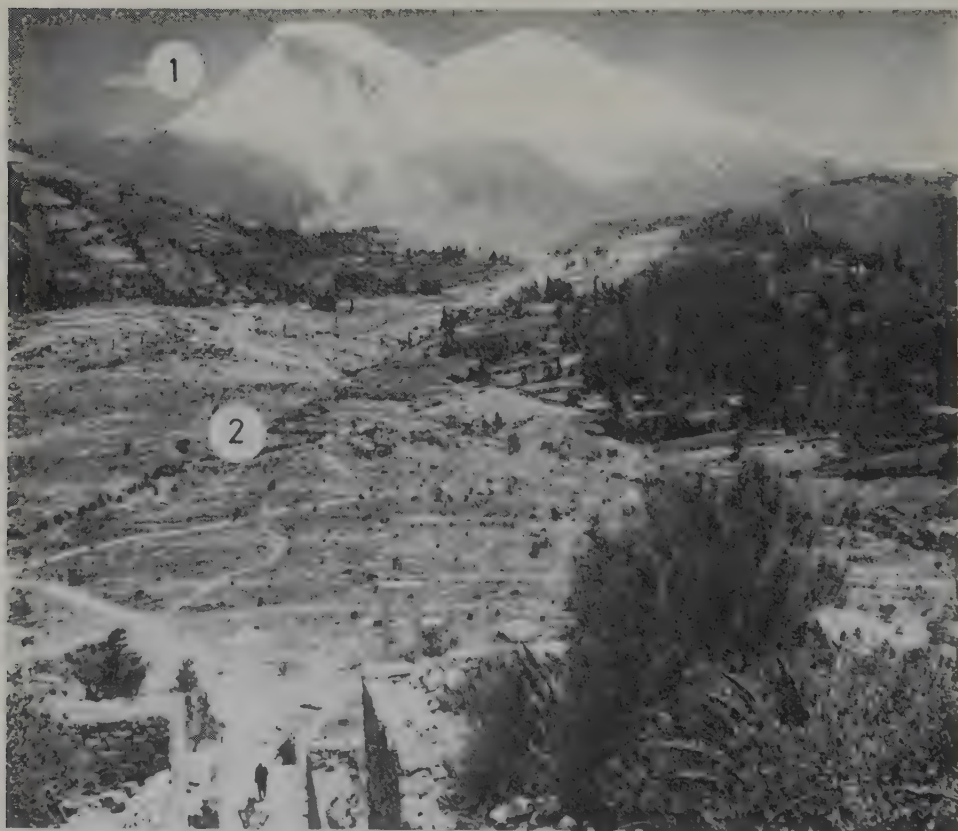
Fig. 2–10. Rockslide of Mount Nevados Huascarán, 1970. View of the NW part of the debris flow where it buried the town of Yungay (photograph by Novosad). 1 — Nevados Huascarán, 2 — site of the buried town of Yungay.

In Peru one of the largest rockslides was caused by an earthquake in 1970 (magnitude 7.7), when the western part of the summit of Mount Nevados Huascarán collapsed. The displaced masses of volume 50–100 million m<sup>3</sup> buried a major part of the city of Yungay and several villages, killing 18,000 people (Plafker, Ericson 1978). A similar avalanche was triggered by an earthquake in the same place in 1962. About 13 million m<sup>3</sup> of material were loosened and the city of Ranrahirca was buried. In 1970 a rock mass consisting of partly weathered biotite granodiorite fell from an altitude of 5400–6500 m onto the glacier. Snow and ice partly melted by the impact was incorporated together with morainic material into the debris, which formed a 16 km long debris flow moving at a rate estimated at 280 km, or in some

places up to 400 km per hour. At an abrupt break in the slope and at the morainic ridge the debris partly shot forth into the air to land approximately in the midst of the debris flow (Figs. 2–9, 2–10). The earthquake induced thousands of landslides within a radius of about 100 km around the city of Chimbote, near which was the position of the epicentre some 30 km off the coast of the Pacific Ocean.

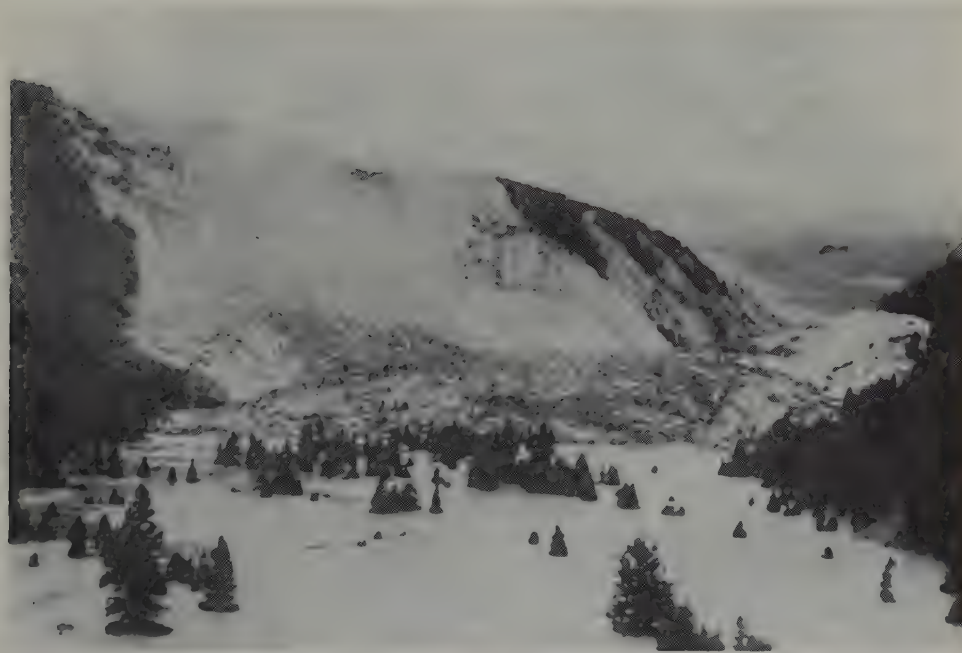
**Fig. 2-11.** Madison Canyon rockslide triggered by an earthquake in 1959. 20 million m<sup>3</sup> of Precambrian rocks dammed the Madison River valley (Courtesy U.S. Geological Survey).

The Madison Canyon Rockslide, one of the major seismically induced rockslides occurred in 1959 in the Madison Canyon, Montana (U.S.A.), near the Yellowstone Park (Fig. 2–11). The earthquake (known as the Hebgen Lake earthquake of Mon-

tana) caused additionally a number of minor landslides, slumps and earthflows, and longitudinal fissures opened along the mountain crests (Hadley 1959). The magnitude of the largest shock was 7.1 and the magnitudes of aftershocks which occurred during the following 24 hours ranged from 5.5 to 6.5. During the earthquake the crustal block containing the Hebgen reservoir subsided and several normal faults were reactivated. The subsidence in the area of the Madison Canyon rockslide

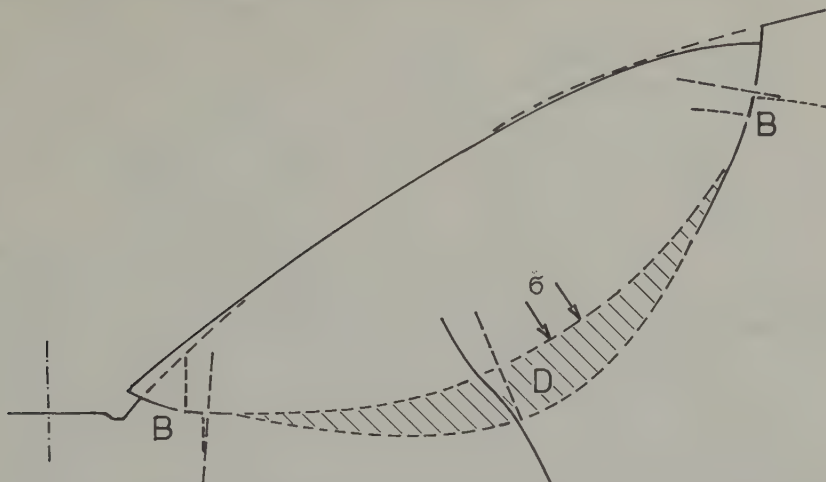
Fig. 4–8. Development of brittle shear failure B (a thin slip surface) and ductile shear failure D (a thick shear zone) in a slope (Menc 1968).

Fig. 4–8 illustrates diagrammatically the presence of both modes of failure in a slope, and Fig. 5–60 shows an actual case of this.

The development of the slope movement as influenced by the ductile yielding of the mass is again progressive, this time in an exaggerated mode. On account of its thickness, the deep ductile shear zone produces large displacements even when the overall factor of safety is of the order of 1.6. The boundary zones of the deformed mass (inclined to develop brittle shear failure) are carried along with the displacements of the shear zone. This leads to a slip failure in the boundary section of the potential slip surface although the overall factor of safety is distinctly greater than one.

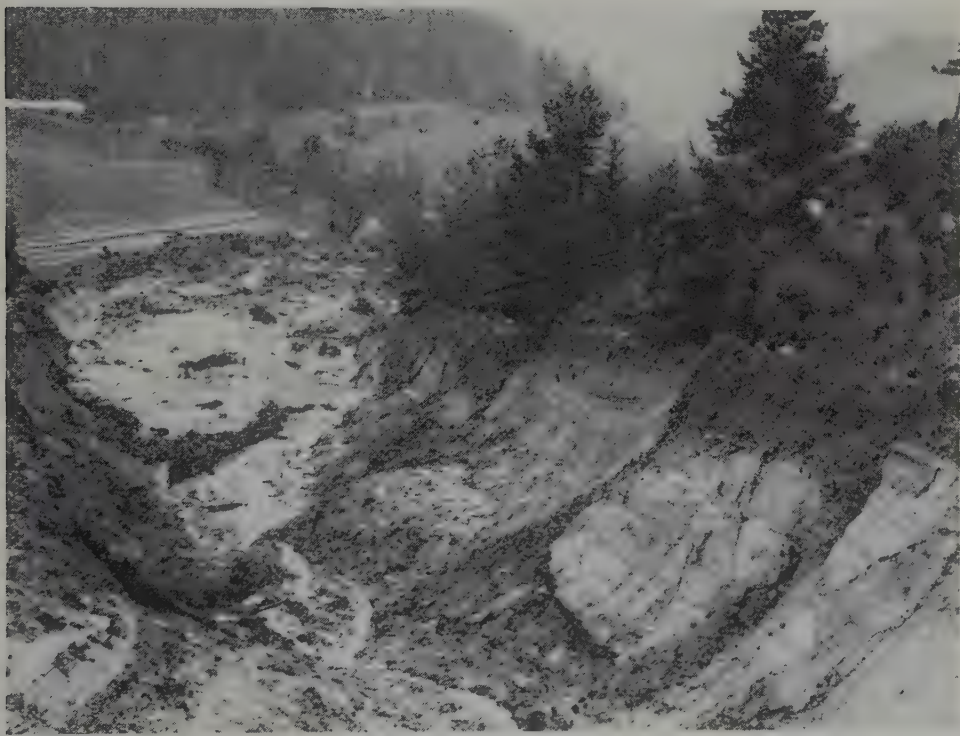
**Fig. 5-6.** View of the brook valley expanded by the earthflow near Dubková (photograph by Záruba).

material up to 18 m thick, and its hummocky surface indicated that it was an old sliding area. In March 1937 a warm spell caused sudden thawing and this was accompanied by heavy rain. In the upper part of the slope a deep slump occurred and the loosened waterlogged material flowed down the channel of the brook (Figs. 5–6, 5–7). Within 24 hours about 120,000 m<sup>3</sup> material moved towards the foot of the slope, where it destroyed several farm houses of the village of Hlboká. The surface forms of the earthflow were very prominent, especially in the first days after the event. There was a steep head scarp 18 m high and the brook descending this slope in the form of a waterfall flowed into forested slope deposits which were torn into irregular blocks. The original erosion channel of the stream was widened into a broad U-shaped valley as is more typical of glacial valleys. On the smoothed valley walls there were striae in the direction of movement, and on either side of the earthflow lateral ridges were formed of clayey material and uprooted trees (Fig. 5–8).

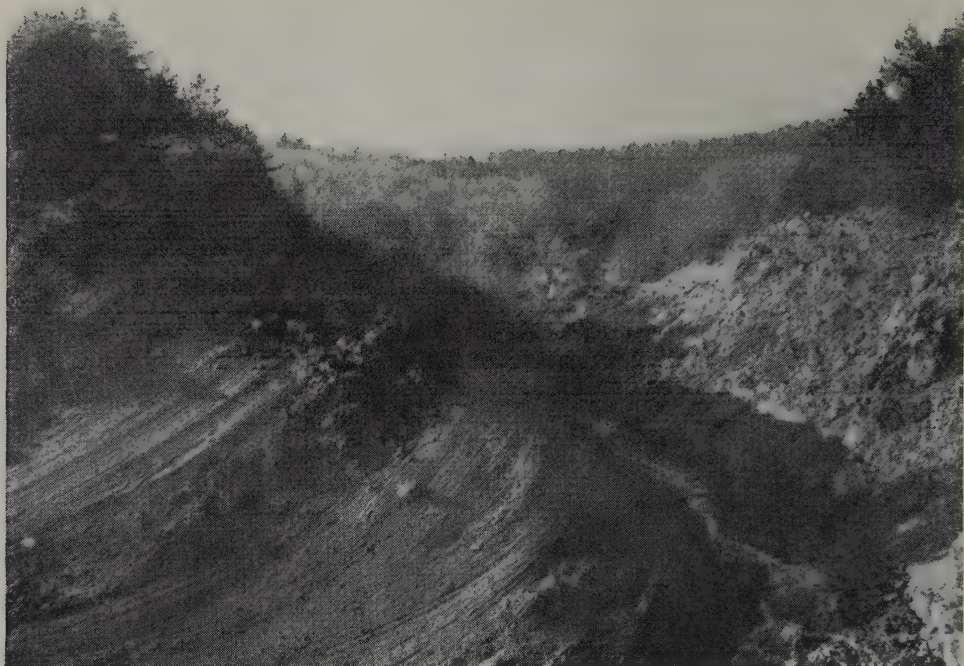
Fig. 5—7. Earthflow near Dubková — slickensided walls of the erosion valley (photograph by Záruba).

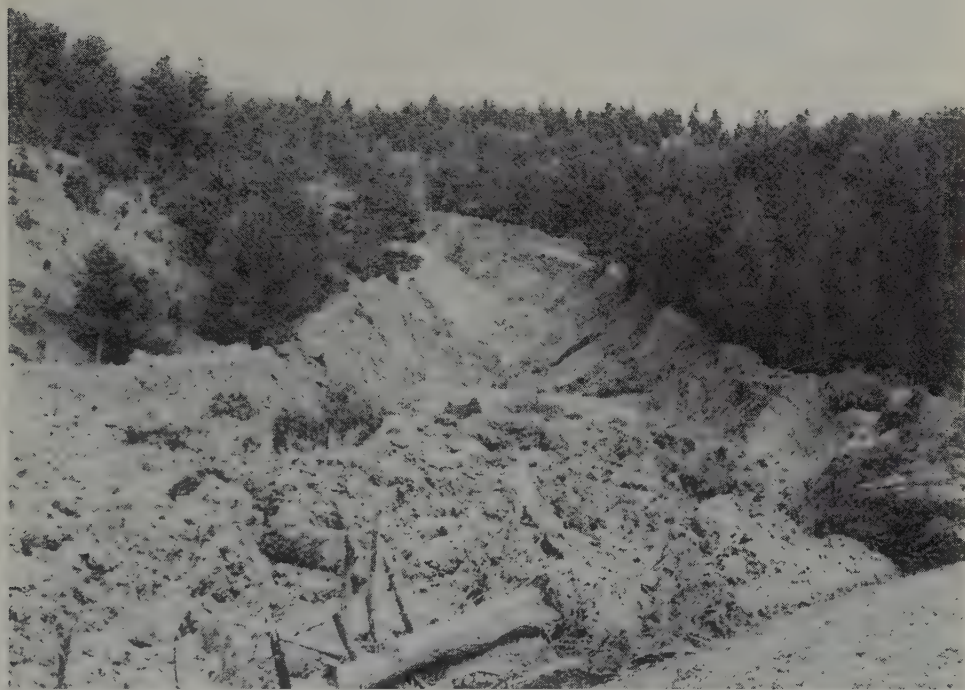
Fig. 5-8. Peripheral ridges rimming the gully of the earthflow near Dubková (photograph by Záruba).

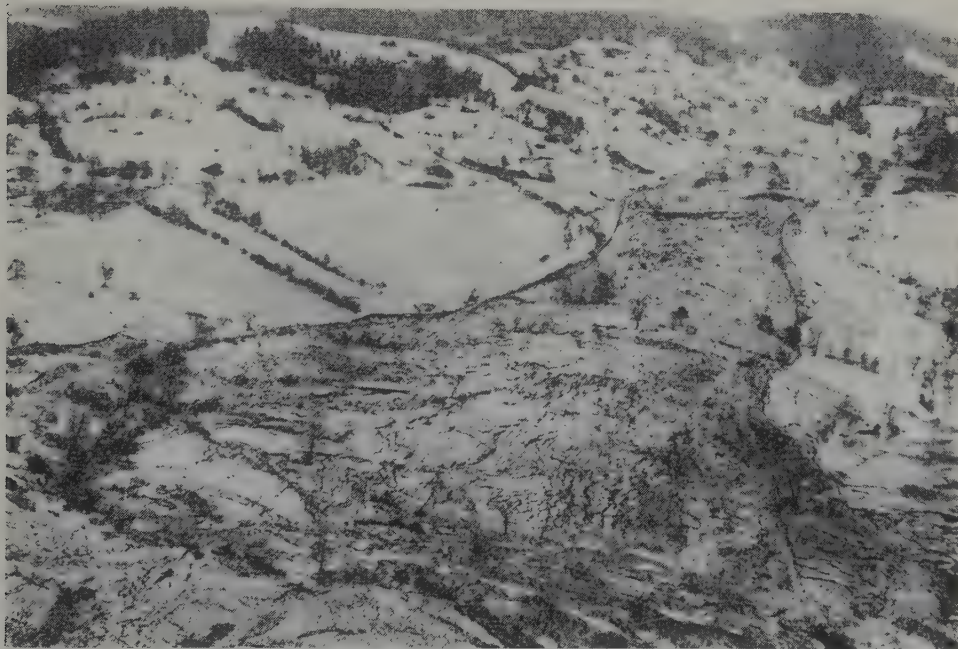
**Fig. 5-12.** Overall view of the Handlová earthflow from a helicopter (courtesy Geological Survey, Prague).

Earthflow I (Fig. 5–12) formed in December 1960 on the eastern side of the valley of the Handlovka river in a shallow gully filled with slope debris. From the topography of the slope above the present head area and from air photographs taken in 1955, it was apparent that it had been the site of sliding in the past. The movement involved debris of volcanic rocks and clayey and silty sediments of Sarmatian age which had already been drawn downwards by previous movements.

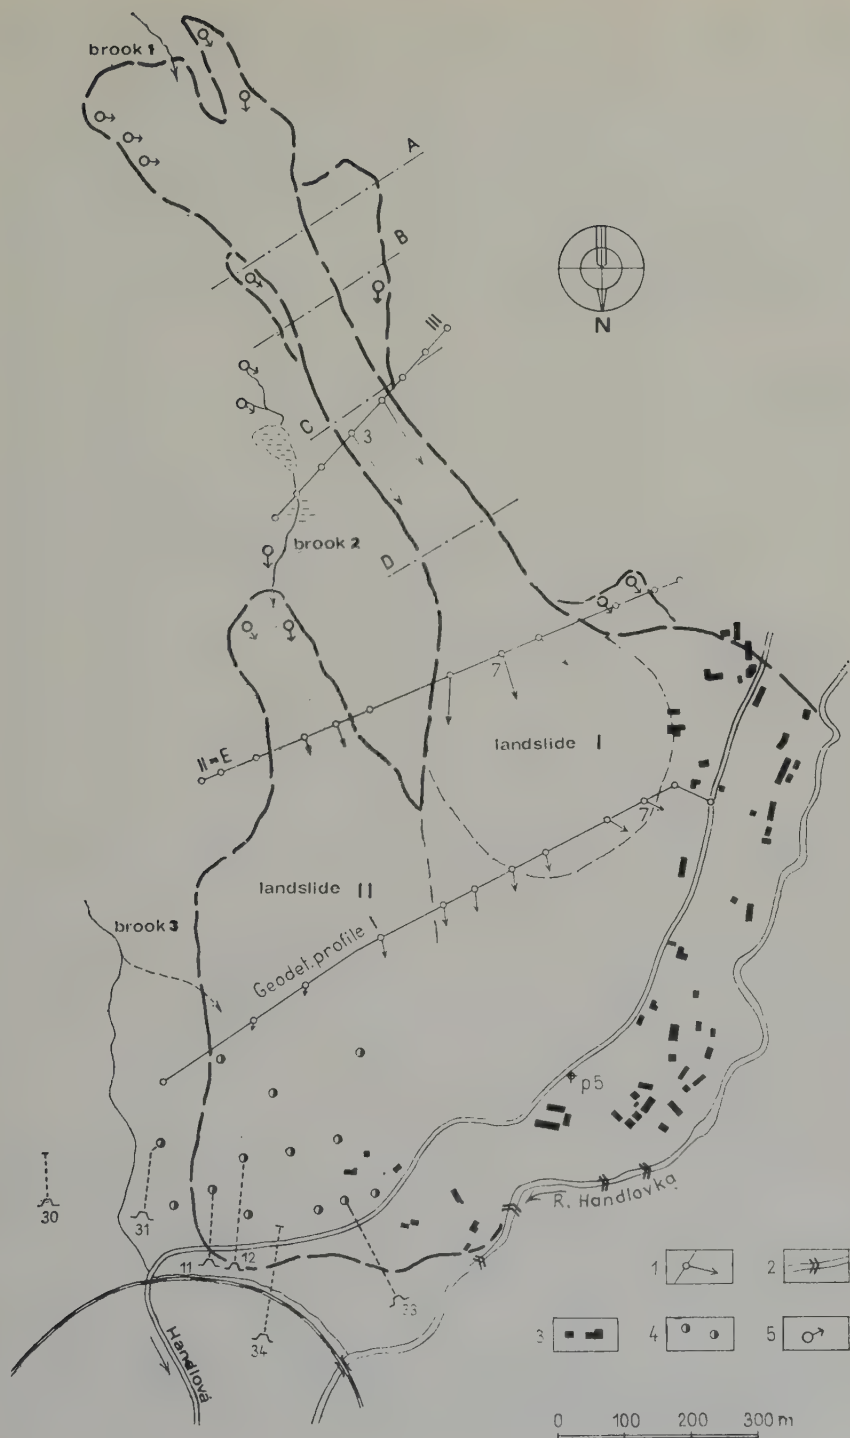
Fig. 5–13. Situation of earthflow I near Handlová in 1960–1961; 1 — vectors of points surveyed from January 1 to May 31, 1961, 2 — rubble work barriers in the Handlovka bed, 3 — destroyed buildings, 4 — hydrogeological borings from which water was pumped by means of submersible pumps; 5 — large springs in the head area.

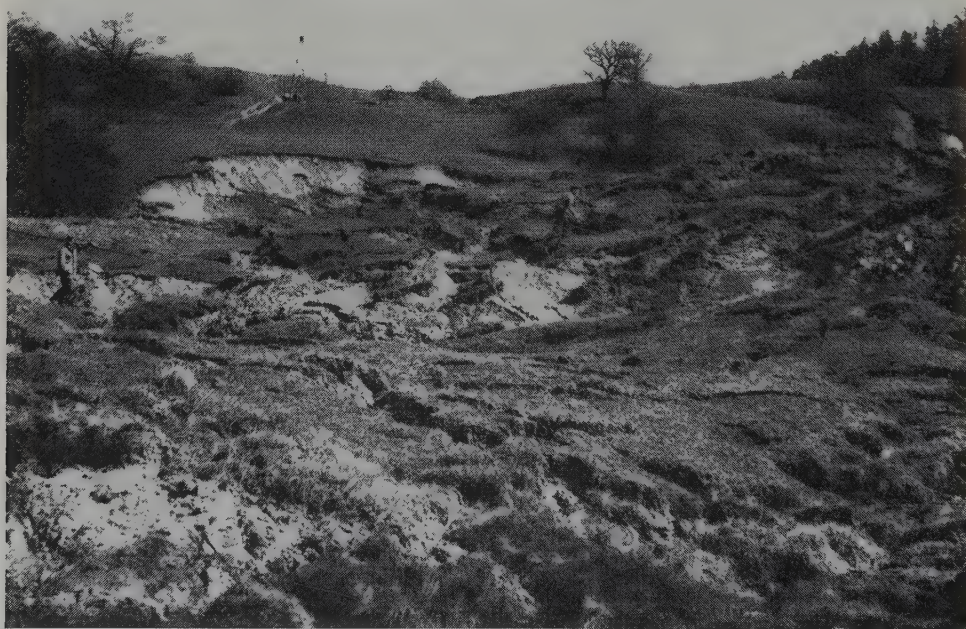
**Fig. 5-19.** The head area of earthflow I near Handlová (photograph by Záruba).

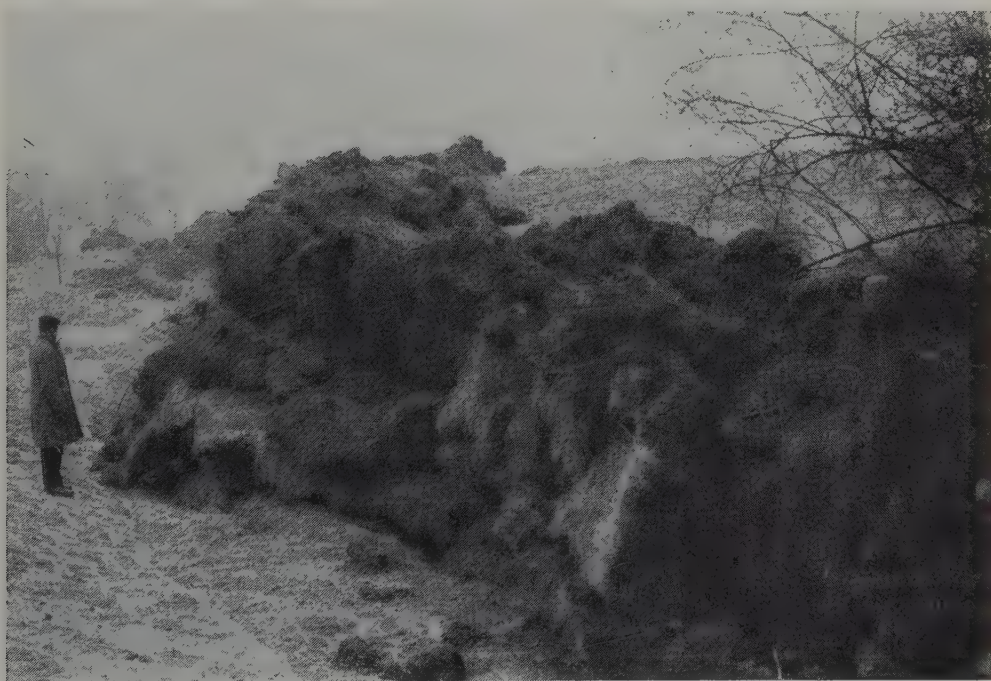
**Fig. 5–20.** Lateral ridges of the earthflow near Handlová (courtesy of the Geological Survey, Prague).

The driving of the galleries made it possible to conduct hydrogeological observations. The ground-water horizon at the Palaeogene-Quaternary boundary proved to have a very high yield, the water having accumulated mainly in the weathered and jointed surface layers of Palaeogene shales. In gallery 12 a strong inflow of water appeared in the fissured Palaeogene rocks (initial yield:  $100 \text{ l min}^{-1}$ ) at about 72 m from the entrance. In gallery 31 an inflow of water of up to  $40 \text{ l min}^{-1}$  was measured as soon as weathered Palaeogene shales were encountered. After galleries 11 and 12 had been completed, the ground-water table in the neighbouring boreholes dropped to the level of the gallery floors. The galleries and systematic pumping discharged a large amount of water from the permeable beds of the sliding masses as well as from the superficial Palaeogene beds forming the substratum of the earthflow (Figs. 5–19, 5–20).

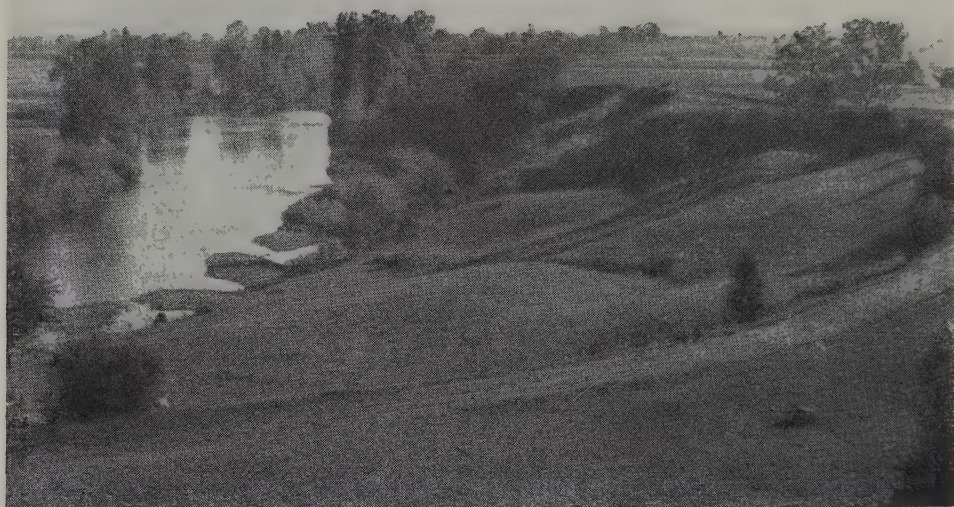
Fig. 5-28. Kettle-shaped scars of old landslide on the banks of the river Ohře (photograph by Záruba).

In this stretch of the Ohře river there is a series of similar but smaller slumps, their kettle-shaped scars being clearly visible on the banks. The bulges of the slipped material have not, however, been preserved, the material having been carried away by floods (Fig. 5–28).

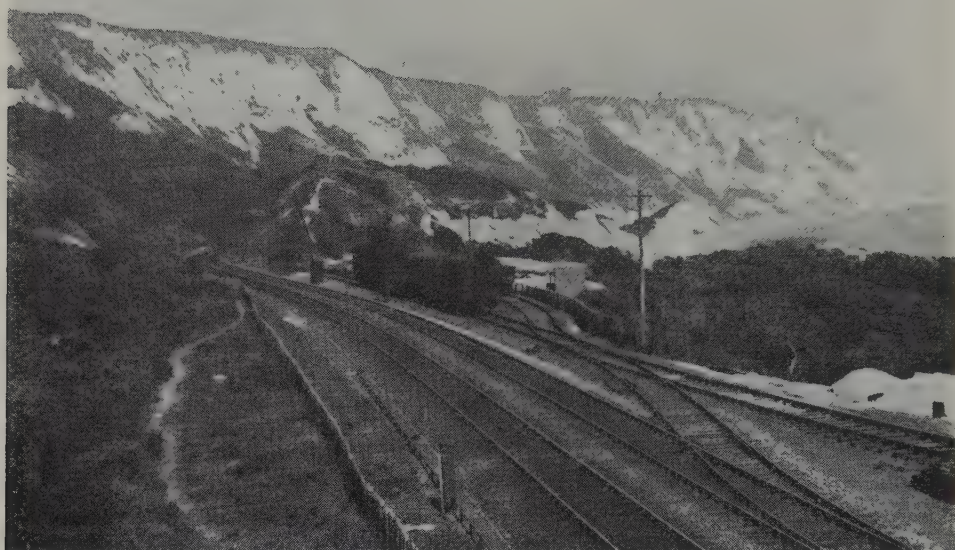
Fig. 5-31. Railway line near Folkestone threatened by sliding (photograph by Záruba).

slides interrupted the Dover-Folkestone railway on several occasions (Fig. 5–31). The cause of these landslides was marine abrasion of clays at sea level, which resulted in the release of load on the foot of the steep shore and, consequently, in its slumping along a curved slide surface. The stability of the shoreline was decreased by the hydrostatic pressure of water in the fissures and joints traversing the Cretaceous rocks. Tests on samples taken from borings have revealed that the Gault clays near the slide surface possess only a fraction of the strength of the undisturbed clays. As

mentioned above, this reduction in strength can be attributed to the unloading of clay and the seepage of water into it, in this case from the glauconitic rocks.

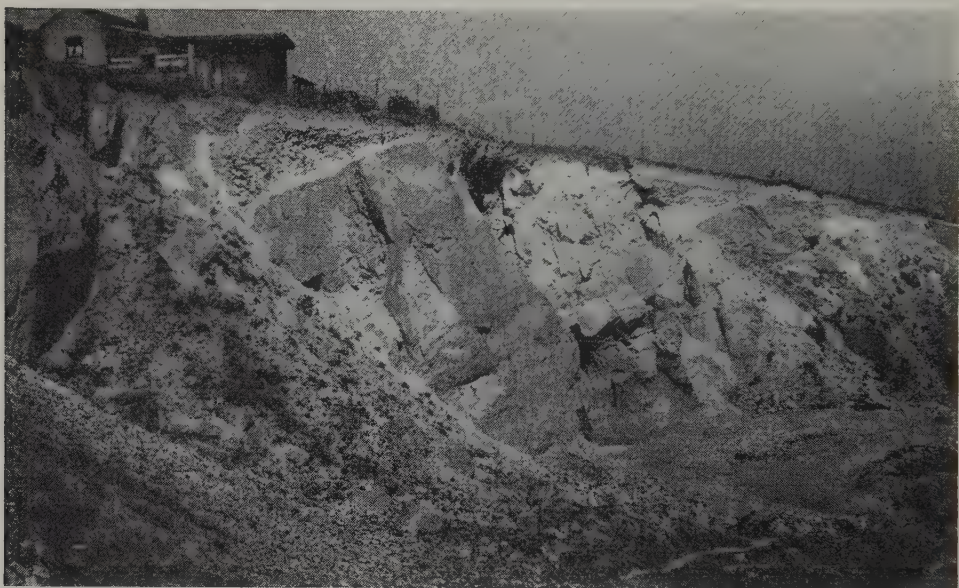
**Fig. 5–40.** Block slide at the margin of the Cretaceous Plateau on the outskirts of Prague. Large blocks of sandstones have sunk into soft underlying clays and have moved downslope (photograph by Záruba).

Fig. 5-39. Pleistocene block slide of Cretaceous beds in the Motol valley in Prague; 1 — weathered Ordovician shales, 2 — Cenomanian clays, 3 — Cenomanian sandstone, 4 — glauconitic sandstone, 5 — Turonian sandy marls, 6 — older loess blanket, 7 — young loess blanket. A — area shown in photograph, Fig. 5-40.

exposed in an abandoned quarry on the northern slope of the Motol valley in Prague. Several large sandstone blocks have sunk into soft Cenomanian clays and shifted downslope. The bedding of the sandstone blocks dips  $14-16^\circ$  into the slope and in the steps above there are relics of the Turonian sandy marlstones which were dragged out during the sinking of the sandstone blocks (Fig. 5–40). On the floor of the quarry,

bulges of stiff dark-grey Cenomanian clays squeezed out by the heavy blocks can be seen. Cretaceous clay and sandstone boulders have also been found in the test pits lower down the slope, having been redeposited by periglacial solifluction. The movement even affected the weathered Ordovician shales underlying the Cretaceous clays. In this case, the slide is a fossil phenomenon because the slope is covered by two loess-loam layers separated by the relics of a fossil soil. The older loess-loam with its abundant flat fragments of sandy marlstone is preserved at the foot of the slope and levels out the steps above the inclined sandstone blocks. The younger loess loam forms an almost continuous cover and is evidently younger than the slope movements described above. When the blocks sank into the clays, these must have been softer than they are today, and their softening may reasonably be attributed to thawing of the perennially frozen ground in the Pleistocene (Záruba 1943).

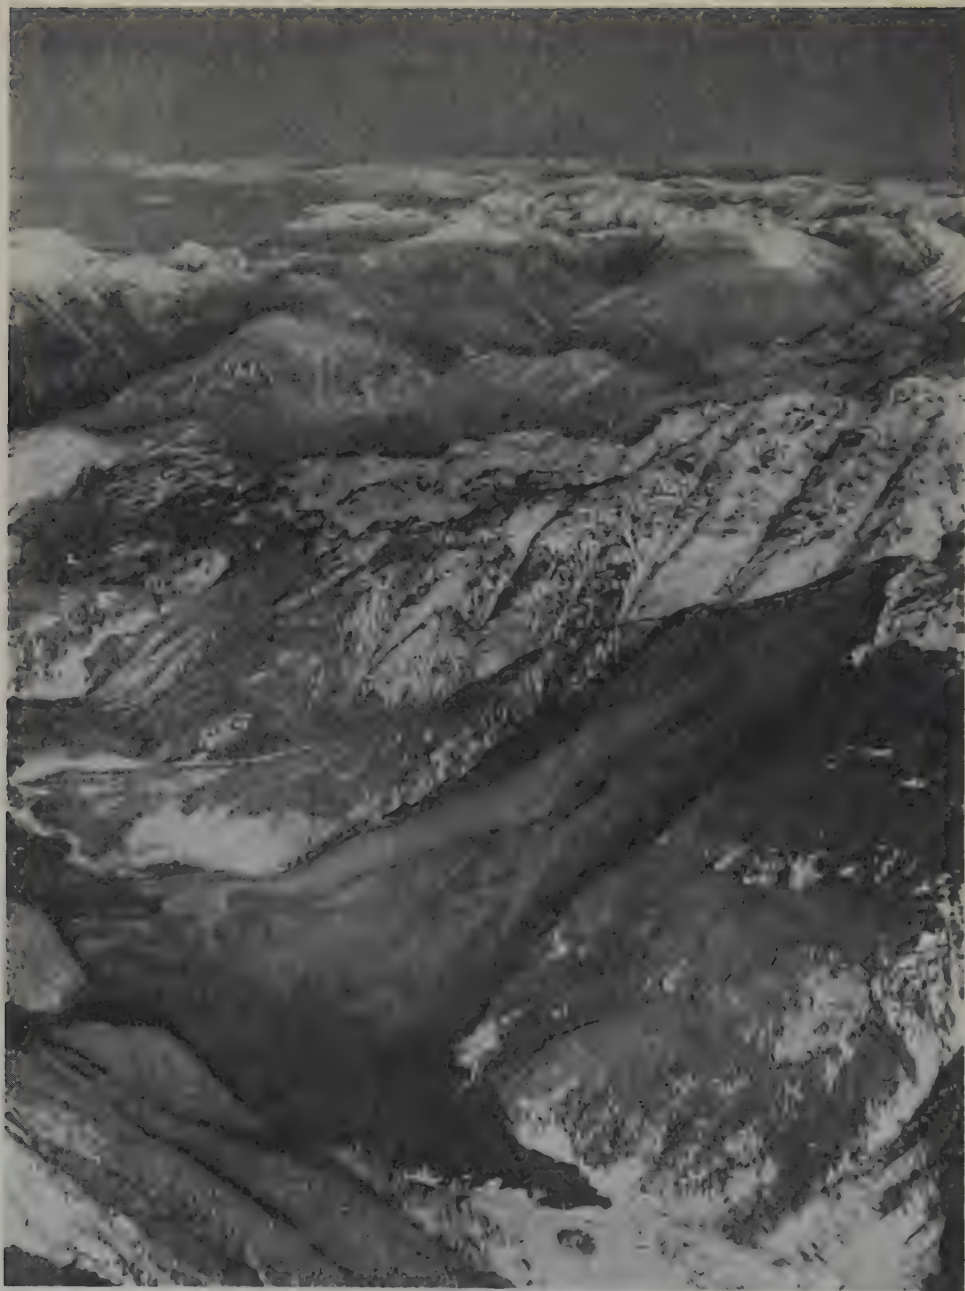
**Fig. 5-55.** Hope rockslide, Cascade Mts., Canada (courtesy of the National Research Council, Canada).

A number of extensive rockslides has been described by Cruden (1976) in the Canadian Rocky Mountains. The most serious of these was the Hope rockslide in the Cascade Mountains in 1965 (Mathews and Taggart 1978). The slipped rock mass of 47 million m<sup>3</sup> volume buried the British Columbia Highway over a distance of some 3 km (Fig. 5–55). The movement was so abrupt that the rock debris buried three vehicles moving along the road. The slide occurred on a mountain slope formed of green metavolcanics containing layers of intrusive felsite. Geological conditions of the site were conducive to slope movement, viz. the reduced shear strength along the intrusion layers, the schistosity and jointing of greenstone parallel to the slope surface, local serpentization and the relatively rapid weathering of zeolite and carbonate fissure fillings. The rockslide is thought to have been triggered by earthquake events which also caused snow avalanches but it should be noted that the stability of the slope had not been disturbed by the earthquake of 1872 which was of much greater intensity. The 1965 earthquake set the rock mass into motion probably because of its small focal depth and suitable orientation of the horizontal component of the shock.

The coarse rock debris slid from a height of up to 1200 m above the valley floor and settled in the form of concentric ridges, pushing the muddy valley alluvium up the opposite side. The aerial photographs taken before 1965 show the definite scar

of an ancient slide that occurred after the retreat of the last continental ice-sheet. The recent slide involved part of the headwall of this prehistoric rockslide. Fissures on the mountain ridge above the head scarp suggest the possibility of further mass movement.

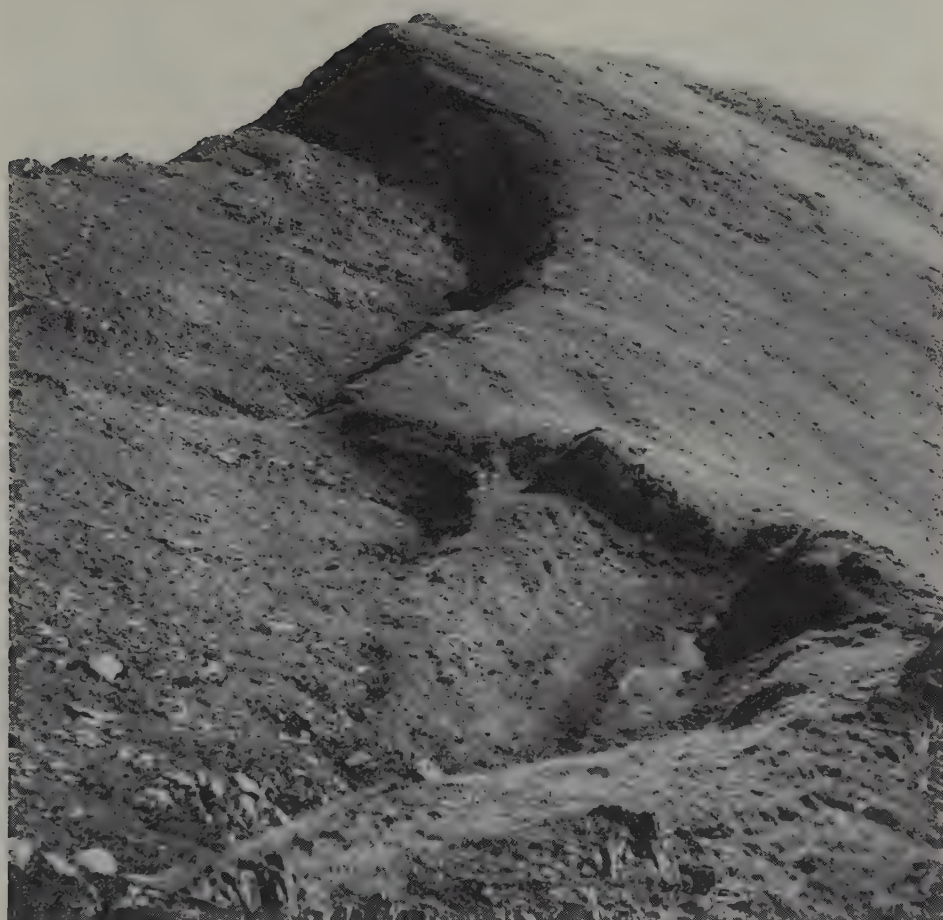
**Fig. 5-61.** View of the summit of Mt. Smrk (West Tatra Mts.). The scar demonstrates the movement of the ridge downwards to the left (photograph by Rybář).

More than one hundred analogous deformations of mountain slopes have been recognized in the West Carpathians, particularly in the Tatra Mountains (Nemčok and Pašek 1969, Nemčok 1972). They have been found in slopes of both crystalline schists and granitoids and are topographically prominent particularly in the summit parts where the outcrops of slide surfaces form striking rock steps. Figure 5–61 shows a typical double-crest form of a ridge arising from slow gravitational movements.

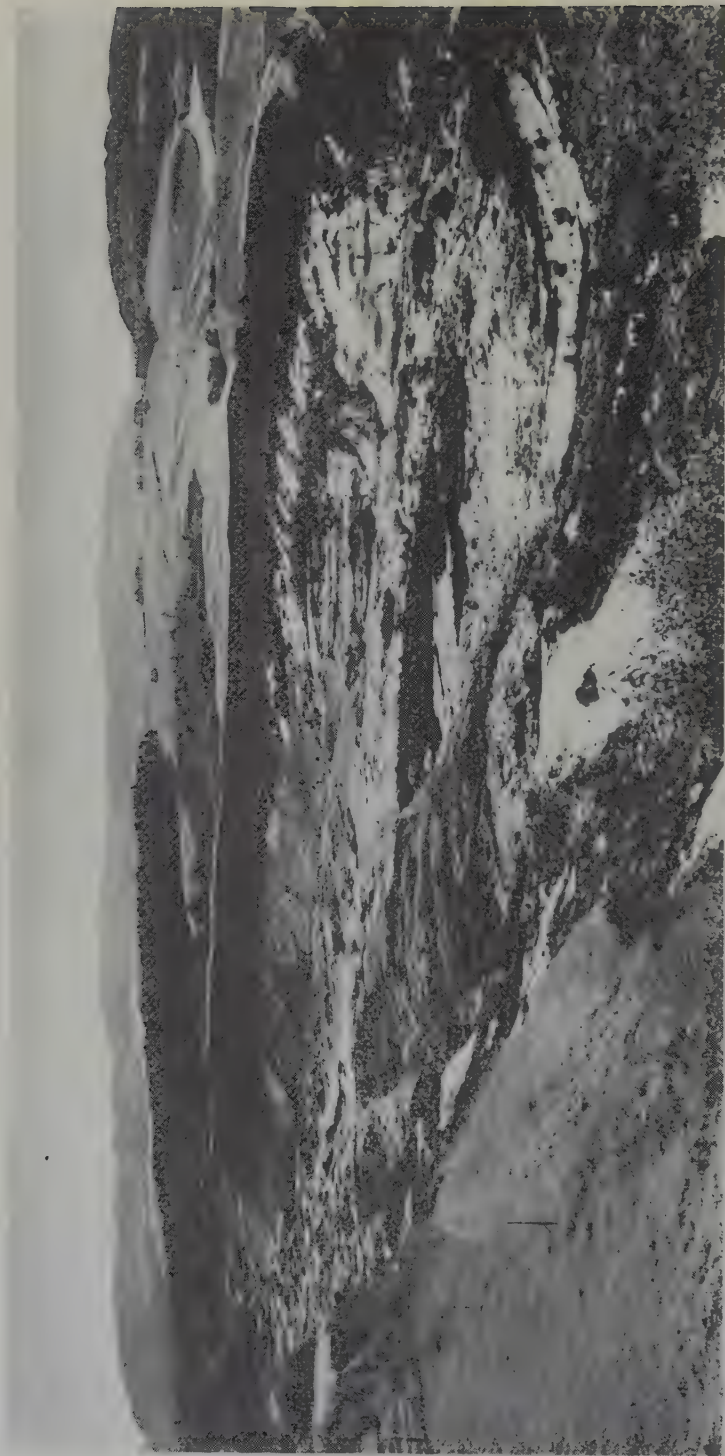
Fig. 5-67. Air photograph of a landslide in quickclays near Skjelstadmark, Norway, in 1962 (courtesy of the Norwegian Geotechnical Institute).

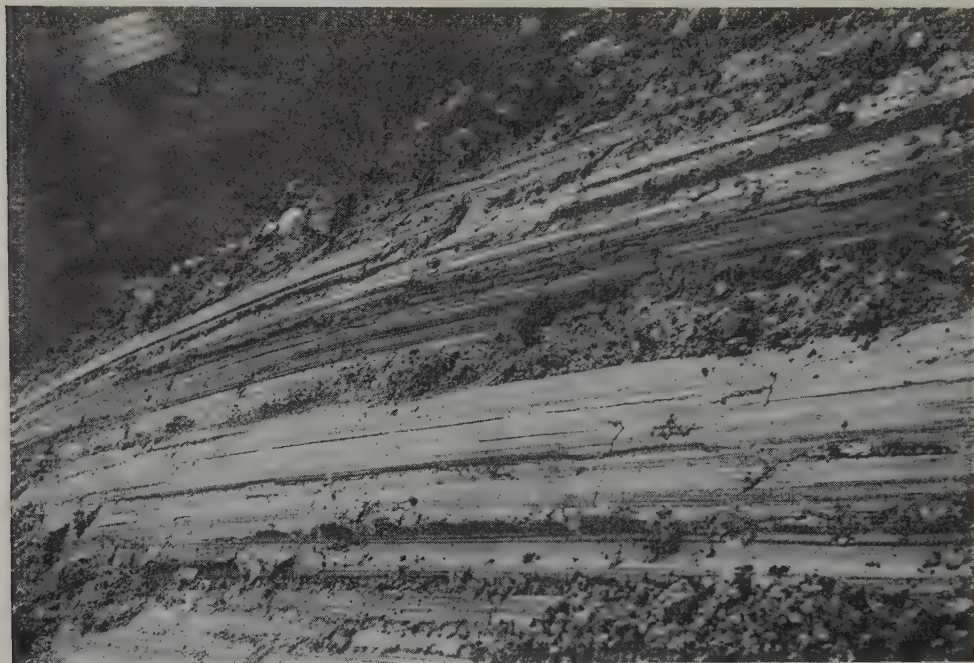
Fig. 6-3. Slickensided lateral ridges of the Riečnice earthflow in the Orava area of Slovakia (photograph by Rybář).

On the landslide body itself, a series of transverse cracks is observable which in the upper part are generally open and of the tension type. In the lower parts the cracks are closed and sometimes even deformed by pressure. The accumulation zone of a slide is occasionally cut by cracks arranged radially in relation to the arcuate outline of the mass. On both flanks of a landslide longitudinal shear cracks develop along which lateral ridges may be squeezed out. After movement has subsided, striation parallel to the direction of movement is observable on the ridges (Fig. 6-3).

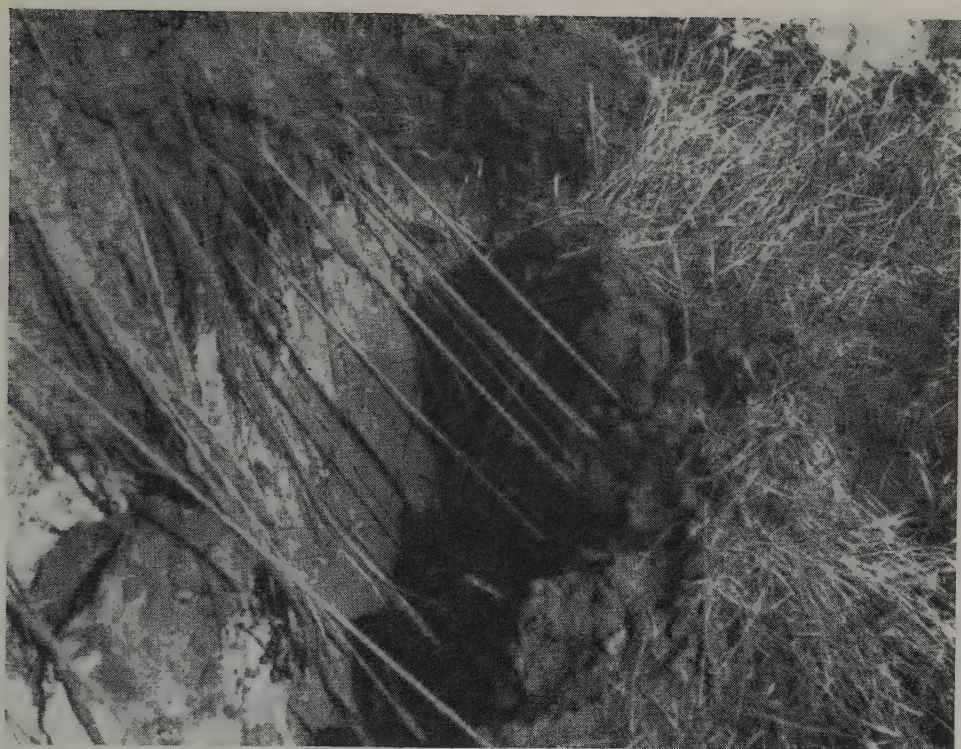
**Fig. 6-4.** The stretched roots of trees in fissures are indicative of an active landslide (photograph by Záruba).

Active landslides are characterized by a fresh appearance; the head scarp is steep and free of any vegetation cover, cracks are open, tree roots are strung (Fig. 6-4),

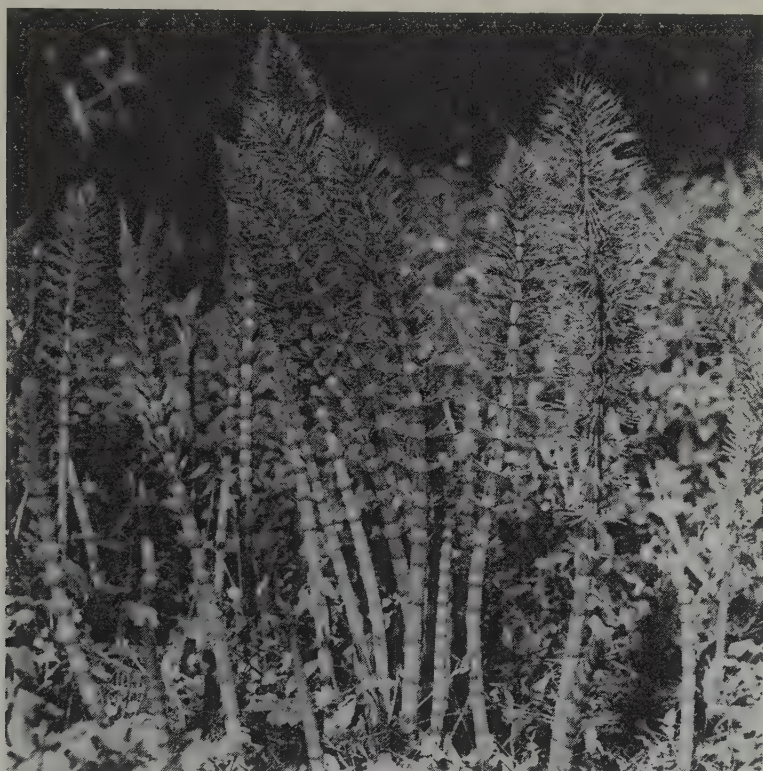
Fig. 6–10. Horsetail growth (*Equisetum maximum*) in the head area of a landslide near Dčín, northern Bohemia (photograph by Rybář).

(1929) likewise reports a value of 40–96%  $\text{SiO}_2$  in the ash of horsetails. Thus, horsetail growth is indicative of the presence of potassium and hydrated silicates from which  $\text{SiO}_2$  is liberated by alkaline water. For this reason, *Equisetum* (in particular *E. maximum*) is a good indicator plant of slide areas in potassium-rich, e. g. glauconite-bearing rocks.

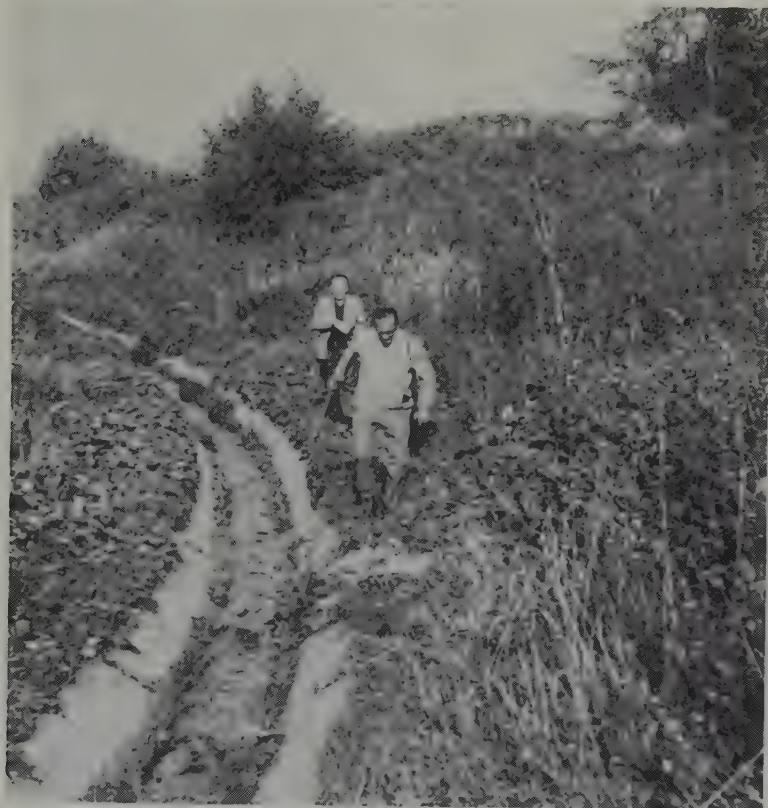
**Fig. 8-7.** Handlová landslide; drainage ditches paved with concrete tiles (photograph by Záruba).
