# **LANDSLIDES**

# **AND THEIR CONTROL**

Second completely revised edition

QUIDO ZÁRUBA, VOJTECH MENCL

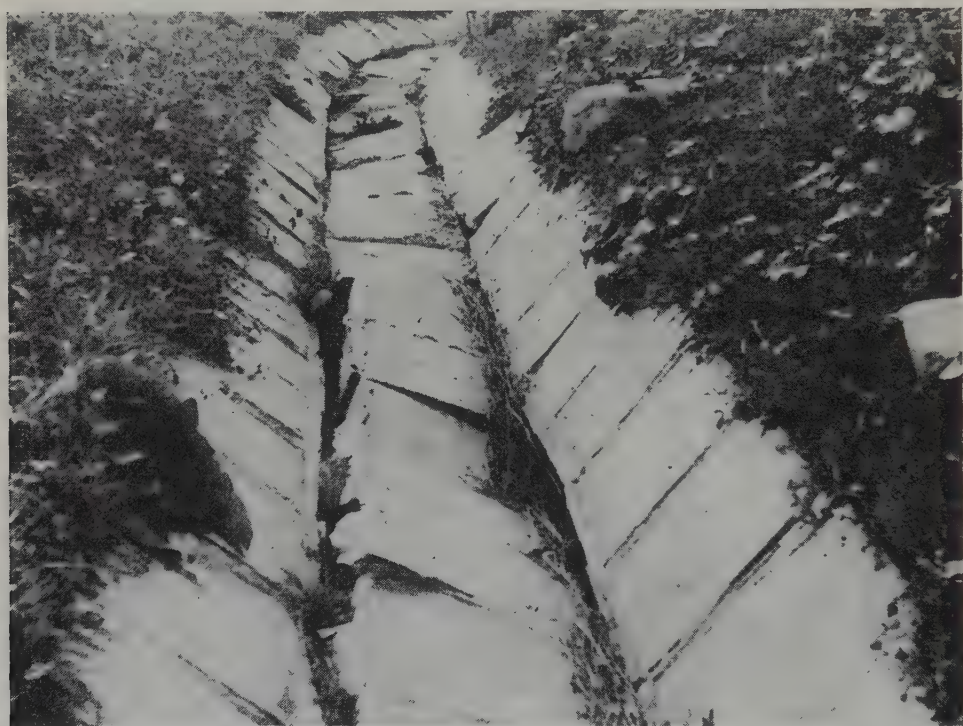
Fig. 8-8. Handlová landslide; continuous maintenance of the paving is necessary, as even small movements disturb the ditch and impair its function (photograph by Záruba).

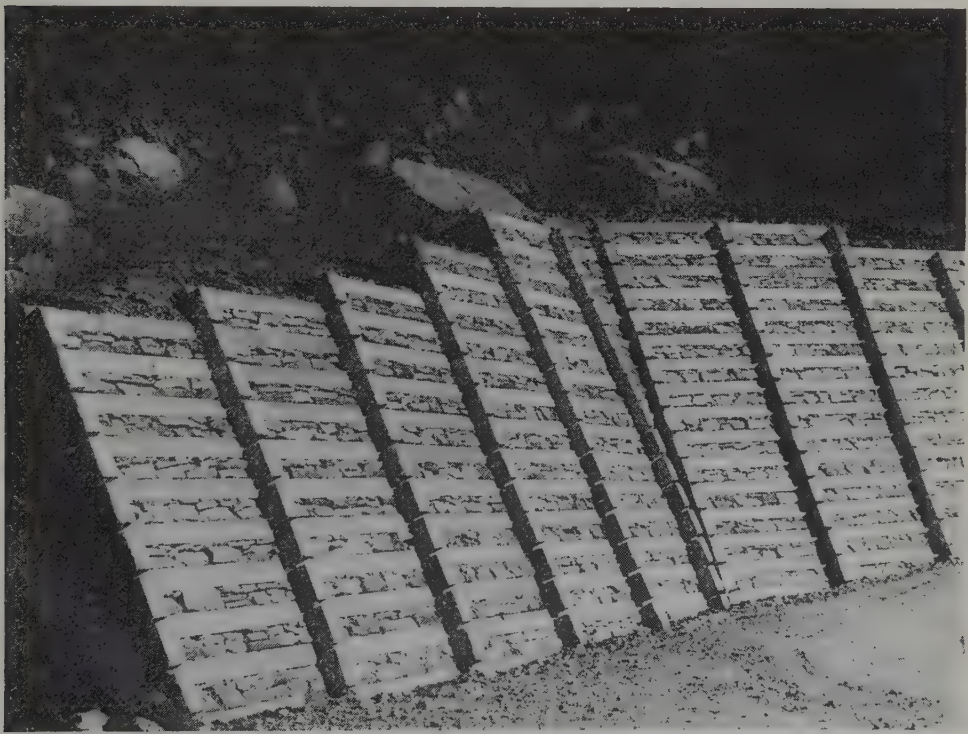
Fig. 8—16. Concrete crib walls, the Tauern Mts., Austria (photograph by Rybář).

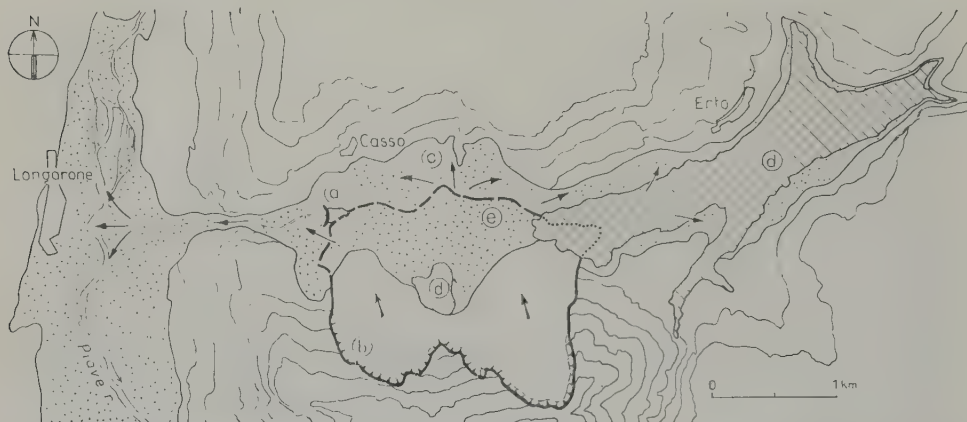
**Fig. 10-14.** Map of the Vaiont rockslide in the Italian Alps; a — dam, b — outline of the head area, c — area devastated by the high wave of water and by air pressure, d — lakes, e — outline of the slide body (after Selli and Trevisan, 1964).

The purport of the studies performed was that the geological investigations of the foundation conditions of the dam site were adequate to the importance of the structure, as can also be deduced from the fact that the dam sustained the enormous surcharge at a sudden overflow by a water wave one hundred metres high. Although the susceptibility of the left slope to sliding was recognized during the investigation works, it did not indicate that it might develop into an abrupt collapse of the slope.

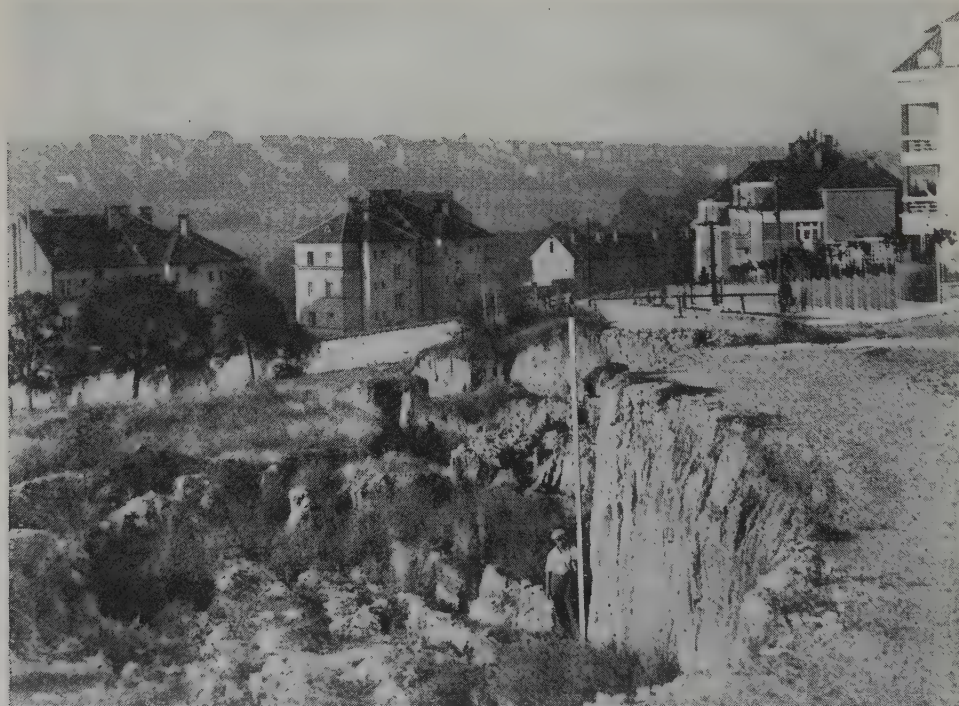
**Fig. 12–11.** Collapse of a steep slope of an abandoned loam pit in a suburb of Prague. Streets and buildings in the neighbourhood were damaged (photograph by Záruba).

A collapse of the wall of an ancient loam pit in the northwestern part of Prague is shown in Fig. 12–11, and Fig. 12–12 portrays a rockslide that badly damaged buildings built too near a steep quarry wall.

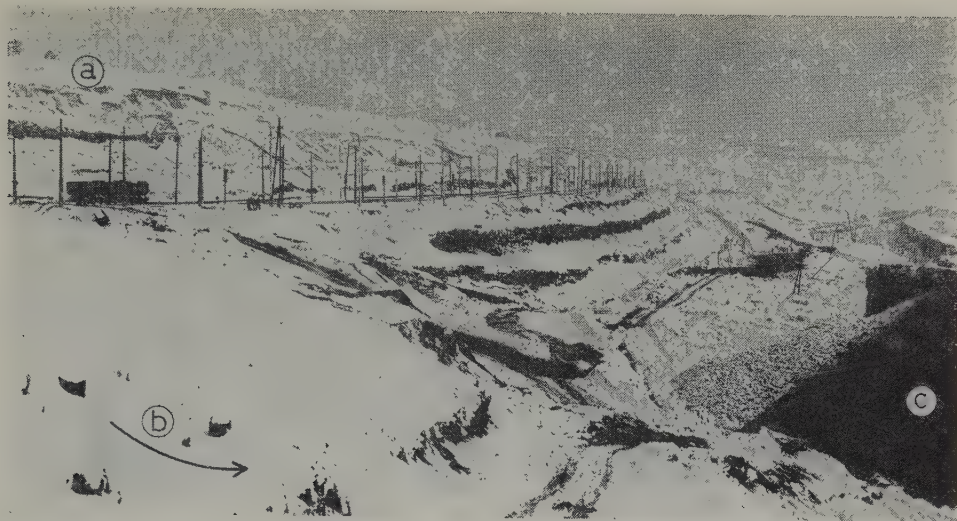
Fig. 13-8. View of slope failure along the slip surface indicated by 8 in Fig. 13-7; a — head scarp, b — direction of movement, c — loading fill.

The example shown in Fig. 13-7 illustrates a typical coal basin margin. The coal bank (3) remaining on the slope gave way twice after it had been reduced by two successive trial cuts (5 and 6) which were made in order to exploit this part of the coal. The high ground-water table could not be substantially lowered either by two rows

of pumping wells or by the horizontal boreholes that were driven from the worked-out area to the east of the profile. The sand inclusions in the interbedded strata (2) prevented proper functioning of the drainage installations. The large uplift force acting at the base of the coal seam contributed to the buckling of the weakened coal bank, although this was still almost 10 m thick. The platform for the mine railway track was seriously damaged. To stabilize the movement, a loading fill was dumped in both of the excavations which had given rise to slope movement (5) and (6). The third cut (7) into the coal seam was successful. A new row of pumping wells was installed and the mining was successfully continued southwards, again leaving a coal bank 7 to 10 m thick at the bottom. Fig. 13-8 shows the filling of the first of the cuttings.
