# Mine water capture

Catriona Schmolke and Stewart Drennan

*The Kames No. 1 shaft discharge had been identified by the Scottish Environment Protection Agency as a priority polluting discharge. The colliery had been constructed on the flood plain of the River Ayr and Garpel Water and all that remain are two abandoned mineshafts. The discharge was emanating from the No. 1 shaft and causing pollution of the Garpel Water by direct contact, and of the River Ayr by diffuse pollution. Detailed hydrogeological studies were undertaken into the nature of the discharge. The main problems to be overcome were harnessing the discharge, managing the flow and constructing the subsequent downstream wetland treatment system, all within a flood plain scenario, without further pollution of the watercourses. This paper focuses on the engineering design and physical site works involved with the capture of the mine water from within the 330 m deep mineshaft. Successful capture of the mine water was found to be critical to engineering the downstream treatment option.*

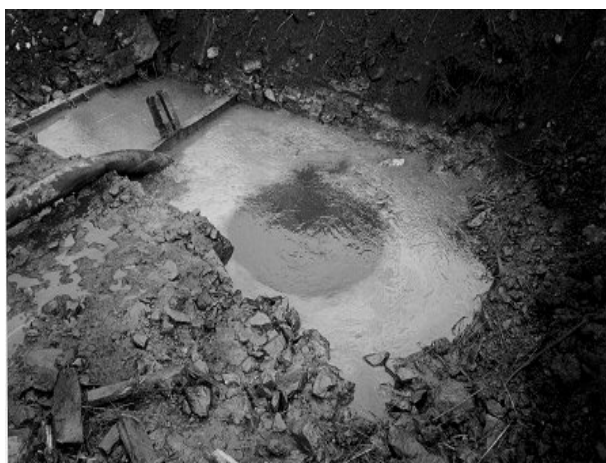
Figure 2. Discrete upwelling within the Kames No. 1 shaft

The investigation of the shaft showed that the first theory was likely to be correct. A discrete upwelling from a point within the shaft was observed (Figure 2). The shaft area was secured and the shaft was left in this disturbed state to allow the flow to be monitored and further checks on quality to be made.

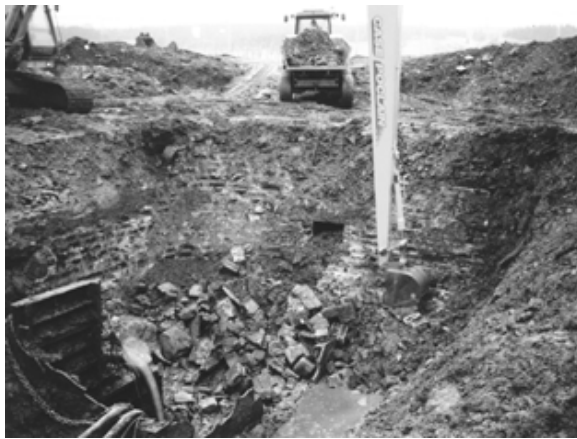
Figure 3. View of the excavation to intercept the Kames No. 1 shaft (located bottom left)

large excavation. Figure 3 shows the depth and extent of the excavation and the presence of many of the substructures and underground services associated with the former colliery buildings.

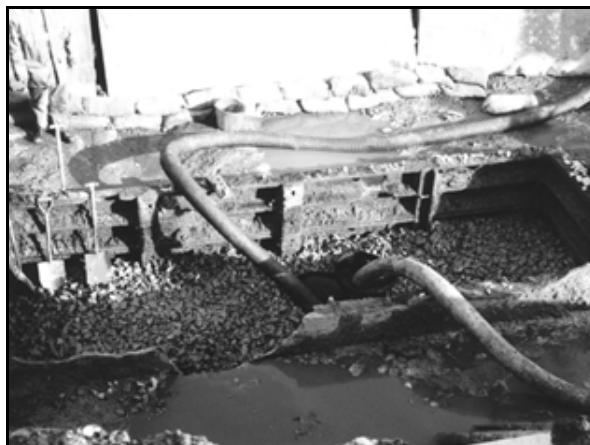
Figure 5. The shaft lining is exposed, dressed off and prepared for concrete

The bolted steel segments that formed the shaft lining can be seen in Figure 5, these were removed to bed-rock level. Cohesive clay was placed outwith the main upwelling area to form an impermeable barrier prior to capping the shaft with a reinforced concrete slab. The concrete slab extends beyond the steel segments in accordance with best practice guidance for stabilisation of mineshafts.

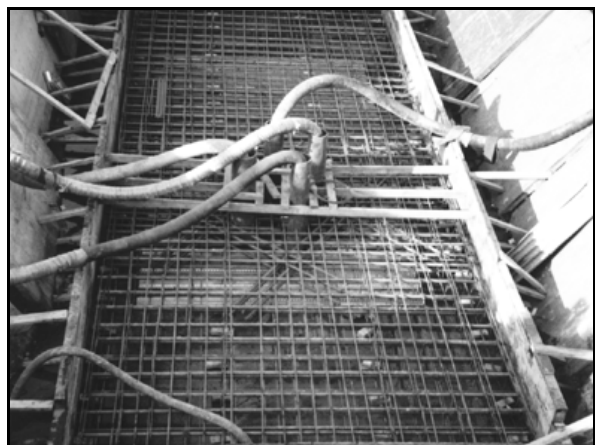
Figure 6. The shaft cap is prepared for the concrete pour; dewatering pipes in centre

Pipes were cast into the slab to convey the mine water to the surface in a controlled manner for future treatment, Figure 6. The pipes were raised simultaneously, Figure 7, within protective concrete sleeves, as the excavation was backfilled to the existing ground surface.

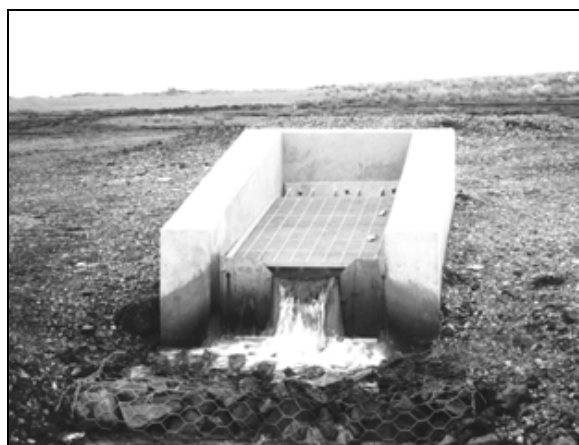
Figure 8. Finished mine water discharge point (the harness)

There had been no loss of head during the capture process and the flow remained constant, which can be observed in Figure 8. There was an extended period of monitoring over twelve months to ensure that the mine water discharge had stabilised while the detailed design of the wetland treatment system continued.
