JOHN S. MASON - PREVENTION OF ENVIRONMENTAL DISASTER AT CWMRHEIDOL MINE, CENTRAL WALES, EARLY 1990s

PART 1 - The problem:

PART 2 - The solution - No 9 Adit:

PART 3 - The Surge!

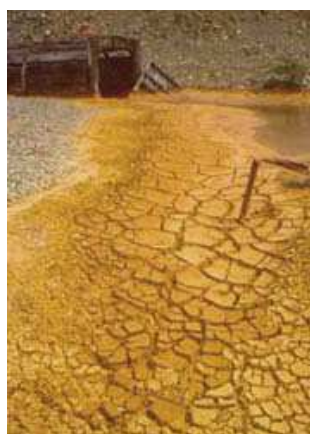
Here is an image of the entrance to the No 9 Adit which was taken in the summer of 1992. Dried-up, cracked ochre (hydrated iron hydroxide) covers the foreground. The timber lagging of the adit where it passes through shaly scree can clearly be seen. The discharge flows into Afon Rheidol via a settling tank put in by the C.E.G.B. in the 1970s. Filled with limestone chips, this worked initially but is now less effective because the reaction in time coats the limestone with insoluble gypsum.

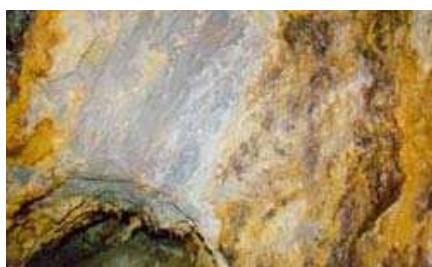
The mines in this immediate area all worked mineralised fractures associated with the Castell Lode, a major ENE-striking tensional fault system. Immediately to the west of Cwmrheidol the lode could in the early 1990s be seen at the neighbouring small Tynyfron mine, where over 1m of shattered marcasite is exposed in pillars along the small stopes (above). This gives an indication of the mineralisation cut by Cwmrheidol, and why there is such a pollution problem there.

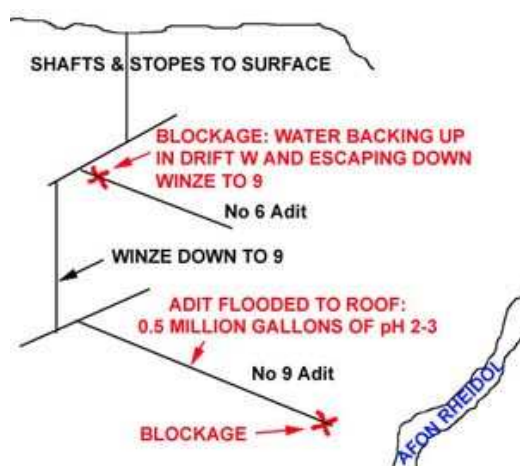
This is a simplified diagram of the mine. The oldest part is up on the hilltop at Ystumtuen. Here, workings go back into the 1700s. Lewis Morris described the marcasite at Ystumtuen thus, in the mid 18th Century:

The No 6 and No 9 levels at Cwmrheidol were driven more recently to make dewatering the mine easier. No 6 was started in 1824 while No 9 was a later 19th Century venture. The main mine drainage exits from No 6 as a moderate stream. This tunnel drains a lot of the Ystumtuen area

and in heavy rain the water roars out. However, in the early 1990s water was backed up due to a fall of ground, which allowed it to escape down a winze into No 9 Adit.

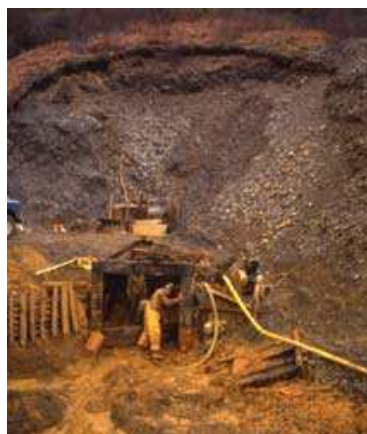
Opening up the adit mouth and setting up pumps. A considerable amount of scree had to be cleared off the back of the adit. The excavator dug well back to allow for further landslides, this permitting access to a "porthole" into the water at the back of the dam. A submersible pump was lowered just under the surface of the water, to avoid stirring up the ochre below. A digital pH meter was installed in the mine discharge, a large stash of agricultural lime was placed just upstream and we were ready to go.

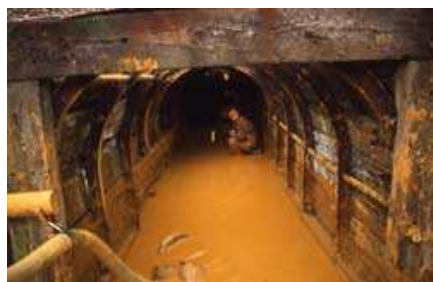
A view up the adit during pumping. The dam lies ahead in the darkness. While pumping was ongoing the adit floor up to the dam was cleared of debris.

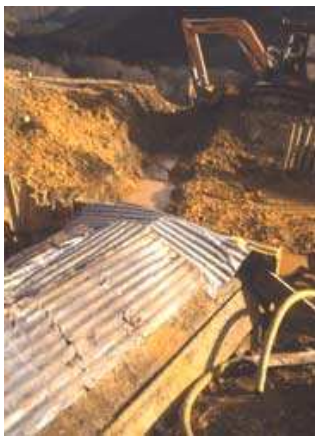
The lagging on the level portal was replaced. Note that this was a temporary job designed to tackle an environmental emergency: we made it clear at the time that a longer-term solution must be found and implemented. However, the adit should not let in any more scree for a few tens of years.

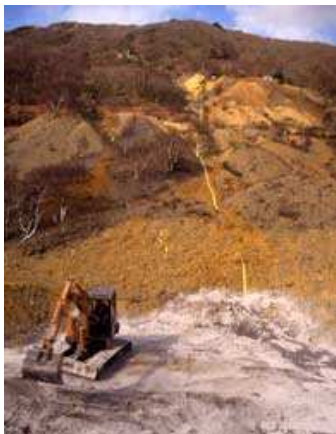
Here, one of the NRA excavators is spreading lorryloads of powdered limestone over the ochre pumped from the mine into the big lagoon. The ochre in turn was pumped onto a powdered limestone bed. This image also shows the rusty mine-tips.

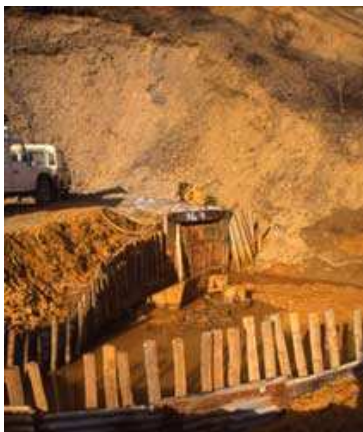
Here the No 9 job is nearing completion. The words "Keep Out - bad air" were added to the mine door after this photo was taken. In front of the door are the remains of a mine-wagon which was found buried in shale and winched out of the way. The water was set to discharge via a pipe from this small settling lagoon.

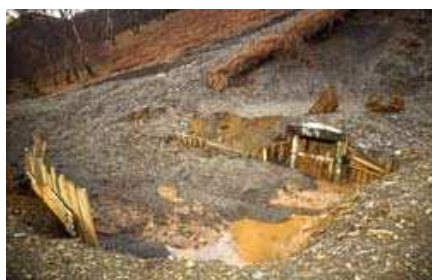
November 1993!

What had happened? Clearly an overwhelming flood: after all there had been heavy rain on and off through the autumn. But this surge had come from above. It had come down the drainage gully that takes the discharge from the No 6 adit. Higher up it had scoured to bedrock and washed away several trees. The next step was to try to find out why so much water had suddenly entered the workings to exit from No 6. It didn't take long...

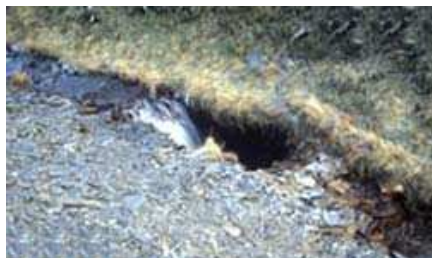
Here it is - the stream known as Nant Bwlchgwyn to the east of Ystumtuen. The course of the stream follows in part the outcrop of the lode. Subsidence has occurred and the entire stream has entered old workings. Since all of these workings - Ystumtuen, Penrhiw and Bwlchgwyn - are drained by No 6 adit at Cwmrheidol, here we have the culprit.

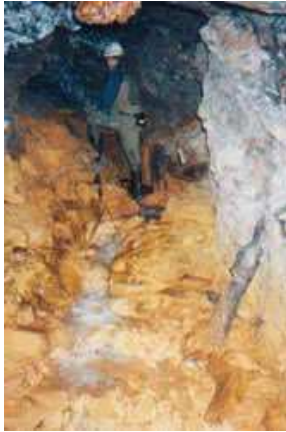
Attention then turned to the No 6 Adit at Cwmrheidol, where a shaly dam had developed in an area where the roof was steadily crumbling close to the adit's intersection with the lode. This image depicts the general scene at this point, way in underground.

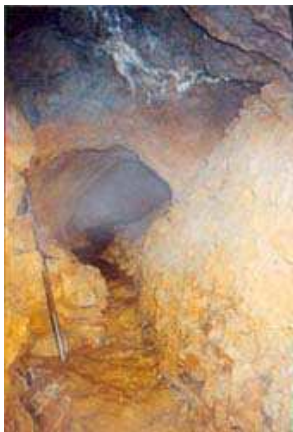
The dam was gradually lowered bit by bit to avoid any sudden water surges. Beyond lay tunnels left and right driven along the lode. The left-hand one was walled-up but archival work by Simon Hughes had already determined that it connected down to No 9 by a winze. Such tunnels are driven with a slight gradient "outbye" - that is, towards the adit, to allow water to flow outwards. But, because the water level was so high, it had overcome the gradient, so that it was able to escape down the winze into No 9. The removal of the dam allowed the correct direction of flow to be re-established.
