# Quality of roof-harvested rainwater – Comparison of different roofing materials

The main objective of the study reported herein was to examine the effect of roofing materials on the chemical and microbiological quality of rainwater harvested for domestic use. This paper also provides guidelines for the selection of roofing materials that will aid in the harvesting of clean rainwater.

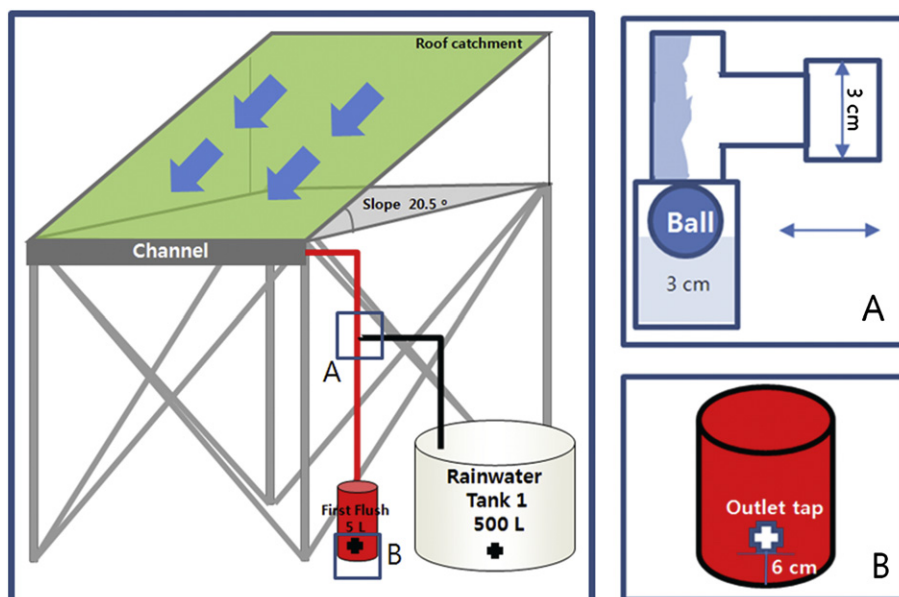
**Fig. 1.** Schematic diagram of the pilot-scale design.

Conventional pilot-scale roofs were constructed with wooden shingles (Seoul, South Korea), concrete tiles (Seoul), clay tiles (or Gi-Wa; E-cheon, Gyeonggi-do,

South Korea), and galvanized steel (zinc alloy coated steel, Seoul). The roofing materials were left in their natural condition for one year before the pilot-scale roofs were constructed. The roofs were angled 20.5° from the horizontal with a catchment area of 2.55 m<sup>2</sup> (length = 1.5 m, width = 1.7 m). The channel, gutter and downpipe systems were manufactured from PVC (SAMIK Co. Ltd). The gutter shape was half round formation. Fig. 1 shows a schematic diagram of the pilot-scale design. To divert the first flush, the inside of the downpipe was a floating ball and its position is located at the top of the first flush downpipe when it is full in the first flush tank. The runoff rainwater from rooftop flows into the rainwater tank. Harvested rainwater samples were collected from the four pilot-scale roofs made of different materials on 10 occasions in 2009 and 30 in 2010. Each sample was collected in a 500 mL sterilized bottle and subjected to chemical and microbiological analyses. The time of sample taking were July (2 events), August (3 events) and September (5 events) in 2009 and May (3 events), June (5 events), July (5 events), August (6 events), September (8 events) and October (3 events) in 2010.

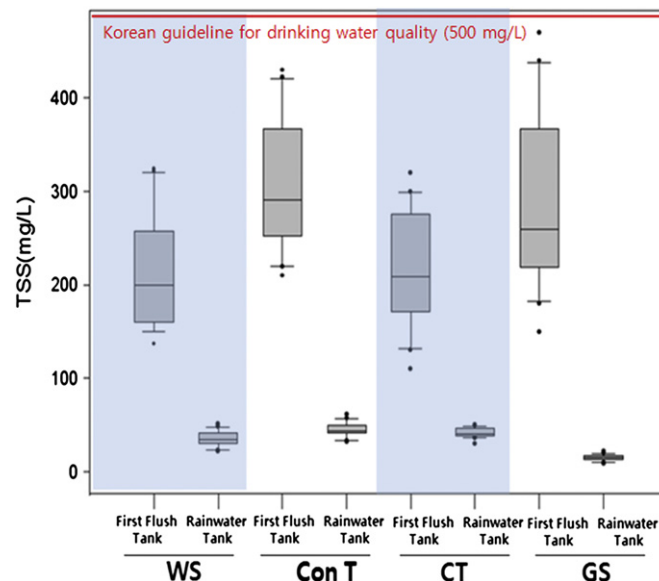
Fig. 3. Box plot diagram of the TSS concentrations in the rainwater harvested from the four roofing materials (total events [ $n = 40$ ]).

**3.1.1.2. Total Suspended Solids.** The average TSS concentrations of the concrete tile (309 mg/L) and galvanized steel (285.8 mg/L) samples were significantly higher than those of the two other roofing material samples in the first flush tanks: 213.9 mg/L for the wooden shingle and 219.3 mg/L for the clay tile. The average TSS concentrations of 35.65 mg/L for the wooden shingle roof ( $p$ -value < 0.05), 45 mg/L for the concrete tile roof ( $p$ -value < 0.05) and 41.6 mg/L for the clay tile roof ( $p$ -value < 0.05) were higher than the average TSS concentration of 15.1 mg/L for the galvanized steel roof after the first flush. Interestingly, the lower TSS concentration measured for the galvanized steel after the first flush displayed an almost total wash-off in the first flush stage. The other roofing materials, in contrast, exhibited no significant differences. The TSS found in the water from the concrete and clay tile roofs were mainly inorganic materials (i.e., air dust and roofing debris), whereas those found in that from the wooden shingle tile roof also included organic materials (i.e., lichens, mosses and plants). It was further observed that lichens, mosses and plants frequently colonized the wooden shingle tile roof. The U.S. Environmental Protection Agency's (USEPA, 2004) suggested guideline for non-potable urban water reuse is that sedimentation should not exceed 5 mg/L. The levels found in the harvested rainwater from the rainwater tanks of all four pilot-scale roofs in this study failed to exceed 5 mg/L within 2–3 h of rain cessation. The TSS values are shown in Fig. 3.

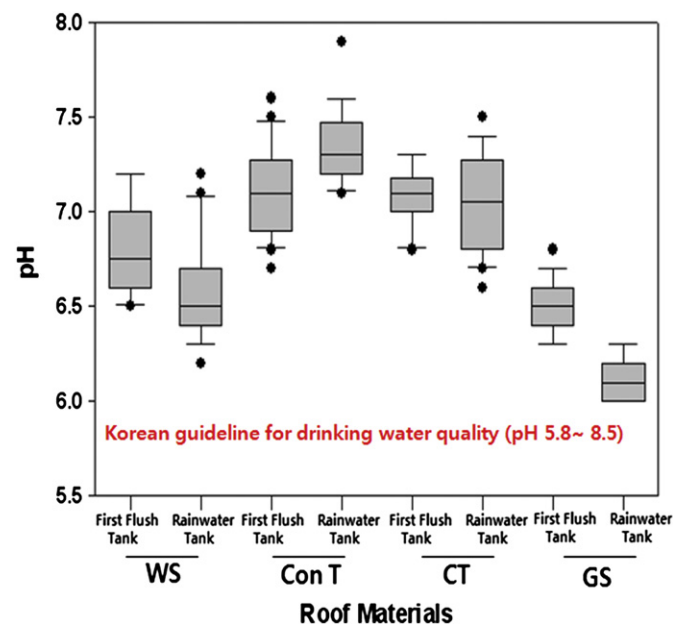
Fig. 2. Box plot diagram of the pH values of rainwater harvested from the four roofing materials (total events [ $n = 40$ ]). Note: WS = Wooden Shingle; Con T = Concrete Tile; CT = Clay Tile (Gi-Wa); GS = Galvanized Steel.

**3.1.1.1. pH.** The average pH of the harvested rainwater from all of the pilot-scale roofs was in the near-neutral range (pH 6.0–7.9). The pH of the samples taken from the wooden shingle, concrete tile and clay tile roofs was higher than that from the galvanized steel roof. The rainwater harvested from the concrete tile roof had the highest level, with an average pH of 7.2 found in both the first flush and

rainwater tanks, due to the reaction of pure rainwater (pH 4.8–5.9) to the alkaline components of the tiles. The pH values are shown in Fig. 2.

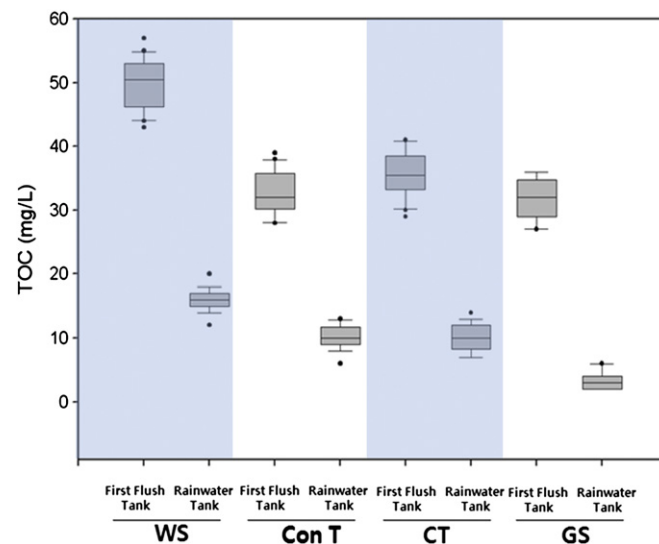
Fig. 4. Box plot diagram of TOC concentrations in rainwater harvested from the different roofing materials (total events [ $n = 40$ ]).

**3.1.2.1. Total Organic Carbon.** The TOC concentrations of the water from the different roofing materials are given in Fig. 4. The highest concentration (average = 49.7 mg/L) was found in the first flush and rainwater tanks of the wooden shingle roof, no doubt due to the weathering of the roofing material, which is itself composed of organic material. Additionally, the presence and growth of lichen was also observed mainly in the wooden shingle roof. The other roofing materials displayed no significant differences in TOC concentrations: 32.9 mg/L for the concrete tiles, 35.6 mg/L for the clay tiles and 31.8 mg/L for the galvanized steel, as measured in the first flush tanks ( $p$ -value < 0.05). It should be noted that the drinking water guidelines promulgated by South Korea, the USEPA and the European Commission have no stated limits for TOC concentrations.

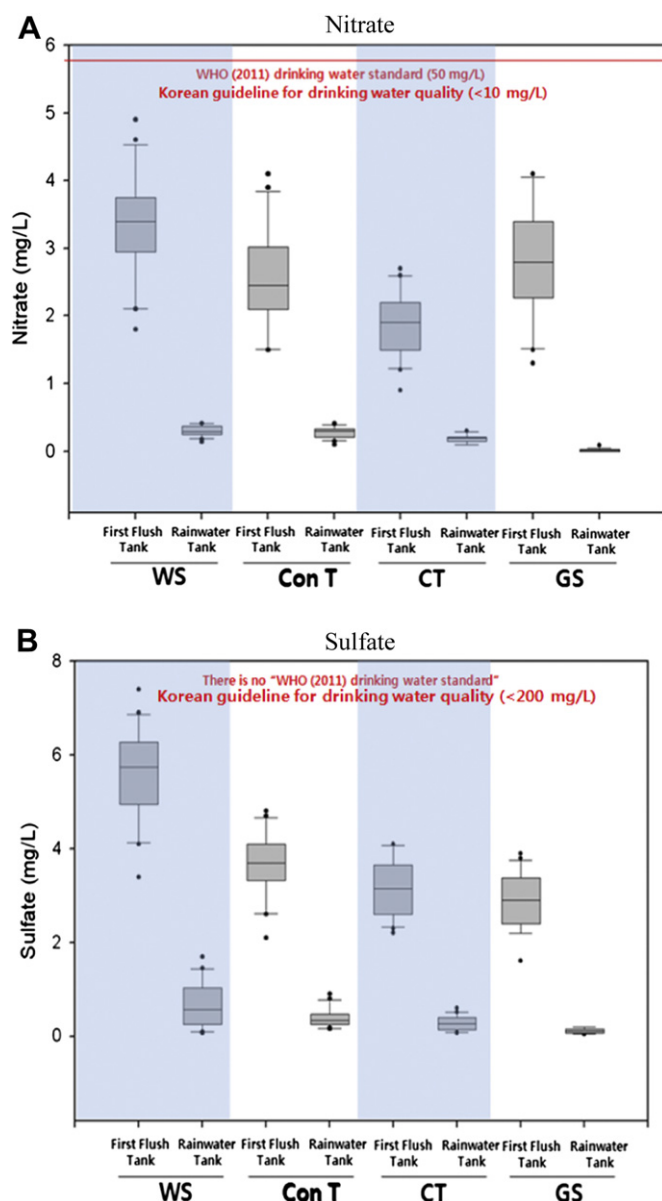
Fig. 5. Box plot diagram for the nitrate ( $\text{NO}_3^-$ ) and sulfate ( $\text{SO}_4^{2-}$ ) concentrations in the water collected from the different roofing materials (total events [ $n = 40$ ]).

**3.1.2.2. Nitrate and sulfate.** The nitrate (NO<sub>3</sub><sup>-</sup>) and sulfate (SO<sub>4</sub><sup>2-</sup>) concentrations of the rainwater samples from the different roofing materials are displayed in Fig. 5. These concentrations were expected due to the presence/growth of lichens, animal waste and wet/dry deposition on the rooftops. The average concentrations found in the wooden shingle sample (3.3 NO<sub>3</sub><sup>-</sup> mg/L and 5.57 SO<sub>4</sub><sup>2-</sup> mg/L) were higher than those for the three other roofing

materials in the first flush tank ( $p$ -value < 0.05): 2.55 NO<sub>3</sub><sup>-</sup> mg/L and 3.64 SO<sub>4</sub><sup>2-</sup> mg/L, 1.89 NO<sub>3</sub><sup>-</sup> mg/L and 3.1 SO<sub>4</sub><sup>2-</sup> mg/L, and 2.8 NO<sub>3</sub><sup>-</sup> mg/L and 2.87 SO<sub>4</sub><sup>2-</sup> mg/L for the concrete tile, clay tile and galvanized steel samples, respectively. This result is unsurprising, given the different characteristics of the four roofing materials. Wooden shingle roofs, in particular, have a relatively high degree of porosity compared to the other three, and colonies of lichens and mosses are frequently found on this type of roof. The associated microbiological processes produced higher levels of nitrate and sulfate. The results from the rainwater tank measurements showed average concentrations of 0.02 NO<sub>3</sub><sup>-</sup> mg/L and 0.11 SO<sub>4</sub><sup>2-</sup> mg/L in water from the galvanized steel roof, significantly lower concentrations than those found for the three other roofing materials: 0.30 NO<sub>3</sub><sup>-</sup> mg/L and 0.65 SO<sub>4</sub><sup>2-</sup> mg/L for the wooden shingle tiles, 0.28 NO<sub>3</sub><sup>-</sup> mg/L and 0.38 SO<sub>4</sub><sup>2-</sup> mg/L for the concrete tiles, and 2.81 NO<sub>3</sub><sup>-</sup> mg/L and 2.87 SO<sub>4</sub><sup>2-</sup> mg/L for the clay tiles. The water in neither the first flush

nor rainwater tanks exceeded the maximum contaminant level (MCL) recommended in the USEPA (10  $\text{NO}_3^-$  mg/L) and European Commission guidelines (50  $\text{NO}_3^-$  mg/L and 250  $\text{SO}_4^{2-}$  mg/L) (Mendez et al., 2011; Nicholson et al., 2009; European Commission, 1998).

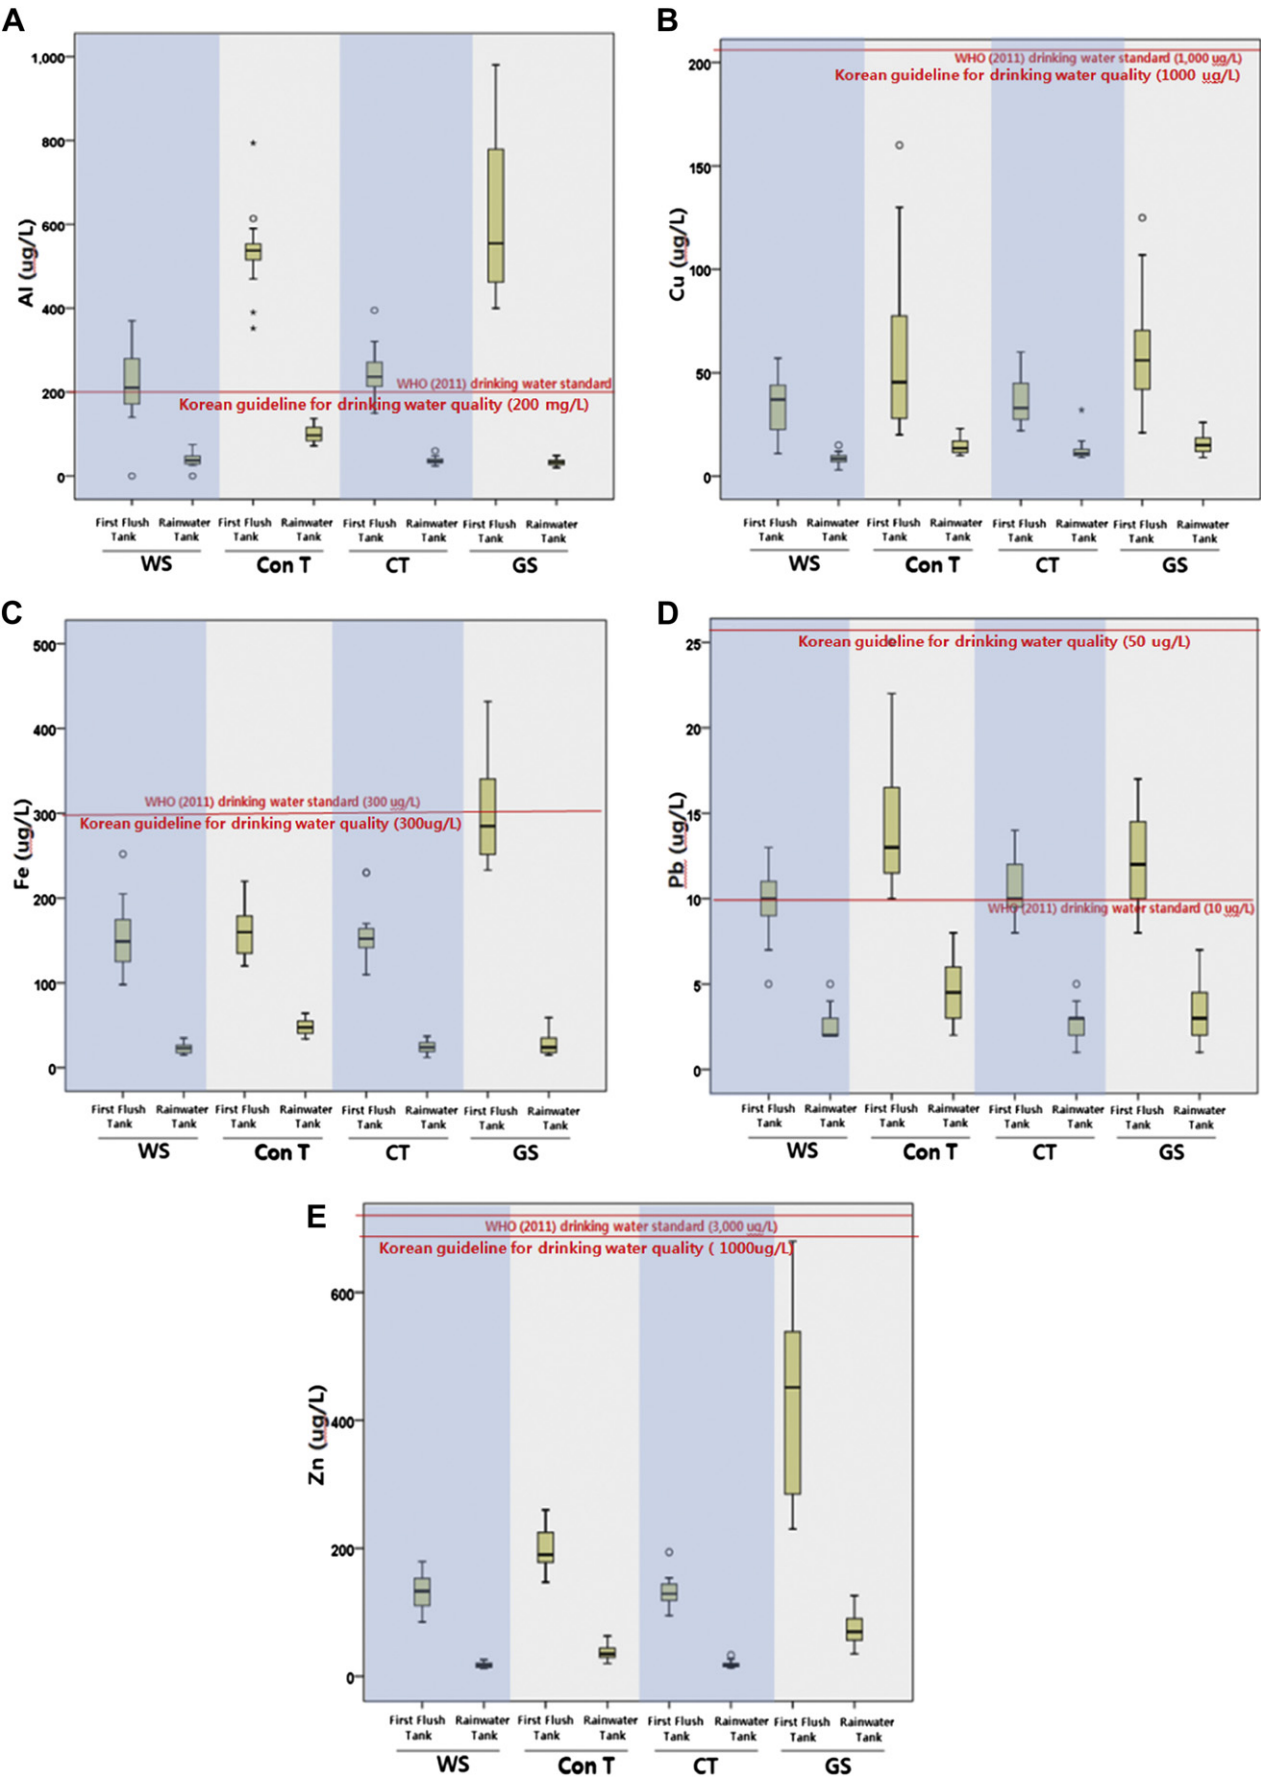
Fig. 6. Box plot diagram for the total metal (Al, Cu, Fe, Pb and Zn) concentrations in the water from different roofing materials (total events [n = 40]).

**3.1.2.3. Metals.** The total metal concentrations (i.e., Al, Cu, Fe, Pb and Zn) are shown in Fig. 6. The average concentration of total aluminum was found to be 227  $\mu\text{g/L}$  for the wooden shingles, 535  $\mu\text{g/L}$  for the concrete tiles, 243  $\mu\text{g/L}$  for the clay tiles and 622  $\mu\text{g/L}$  for the galvanized steel in the first flush tank (Fig. 6-A). Following the first flush, the average concentration of total aluminum in the rainwater tank was measured at 43  $\mu\text{g/L}$  for the wooden shingles, 99  $\mu\text{g/L}$  for the concrete tiles, 36  $\mu\text{g/L}$  for the clay tiles and 33  $\mu\text{g/L}$

for the galvanized steel (Fig. 6-A). The samples from the galvanized steel roof had strikingly higher total aluminum levels than those from the other roofs in the first flush tank ( $p$ -value < 0.05). Given that a galvanized steel roof is composed of zinc and iron, it may be that the aluminum levels found in this study originated in atmospheric dust and dry deposition. It should also be noted that the water in the rainwater tank after the first flush did not exceed the USEPA's recommended MCL for aluminum in drinking water (200  $\mu\text{g/L}$ ).

The average concentration of total copper in the first flush tank was measured at 34  $\mu\text{g/L}$  for the wooden shingles, 58  $\mu\text{g/L}$  for the concrete tiles, 37  $\mu\text{g/L}$  for the clay tiles and 59  $\mu\text{g/L}$  for the galvanized steel (Fig. 6-B). The average concentration of total copper in the rainwater tank after the first flush fell to 9  $\mu\text{g/L}$  for the wooden shingles, 15  $\mu\text{g/L}$  for the concrete tiles, 12  $\mu\text{g/L}$  for the clay tiles and 16  $\mu\text{g/L}$  for the galvanized steel (Fig. 6-B). In sum, the average total concentration of copper in the water samples from the concrete tile and galvanized steel roofs was notably higher than that in those from the wooden shingle and clay tile roofs. Atmospheric deposition may be the source of the copper we found. Wooden shingles and clay tiles are densely porous materials, and the lower copper concentrations measured for them here is likely the result of pollutants becoming trapped within their porous sites. None of the rainwater samples exceeded the USEPA's MCL for copper in drinking water (1300  $\mu\text{g/L}$ ).

The average concentration of total iron was measured at 154  $\mu\text{g/L}$  for the wooden shingle, 160  $\mu\text{g/L}$  for the concrete tiles, 155  $\mu\text{g/L}$  for the clay tiles and 302  $\mu\text{g/L}$  for the galvanized steel in the first flush tank (Fig. 6-C). The average concentration of total iron in the rainwater tank after the first flush was measured at 23  $\mu\text{g/L}$  for the wooden shingles, 48  $\mu\text{g/L}$  for the concrete tiles, 24  $\mu\text{g/L}$  for the clay tiles and 27  $\mu\text{g/L}$  for the galvanized steel (Fig. 6-C). The galvanized steel samples had higher average total iron concentrations than the other three in the first flush tank ( $p$ -value < 0.05). The source of this iron may be the galvanized steel itself and atmospheric deposition. With the exception of the water from the first flush tank of the galvanized steel roof, none of the samples exceeded the USEPA's MCL guideline for iron in drinking water (300  $\mu\text{g/L}$ ).

The average concentration of total lead was measured at 10  $\mu\text{g/L}$  for the wooden shingles, 14  $\mu\text{g/L}$  for the concrete tiles, 11  $\mu\text{g/L}$  for the clay tiles and 12  $\mu\text{g/L}$  for the galvanized steel in the first flush tank (Fig. 6-D). After the first flush, the average concentration of total lead in the rainwater tank was measured at 3  $\mu\text{g/L}$  for the wooden shingles, 5  $\mu\text{g/L}$  for the concrete tiles, 3  $\mu\text{g/L}$  for the clay tiles and 3  $\mu\text{g/L}$  for the galvanized steel (Fig. 6-D). The average total lead concentrations found in the concrete tile and galvanized steel samples in the first flush tank were higher than those in the samples from the other two roofing materials. The source of the lead may be atmospheric deposition and the galvanized steel itself. With the exception of the water from the first flush tank of the concrete tile roof, the harvested rainwater in all of the tanks met the USEPA's MCL guideline for lead in drinking water (15  $\mu\text{g/L}$ ).

Finally, the average concentration of total zinc was measured at 135  $\mu\text{g/L}$  for the wooden shingle, 196  $\mu\text{g/L}$  for the concrete tile, 131  $\mu\text{g/L}$  for the clay tile and 428  $\mu\text{g/L}$  for the galvanized steel samples in the first flush tank (Fig. 6-E). The average concentration of total zinc in the rainwater tank after the first flush was measured at 18  $\mu\text{g/L}$  for the wooden shingle, 38  $\mu\text{g/L}$  for the concrete tile, 19  $\mu\text{g/L}$  for the clay tile and 74  $\mu\text{g/L}$  for the galvanized steel roofs (Fig. 6-E). The average total zinc concentration of the water samples from the galvanized steel roof was higher than those from the other three roofing materials in the first flush tank ( $p$ -value < 0.05). The source of the zinc could be the galvanized steel itself and atmospheric deposition. The rainwater harvested from all of the tanks met the USEPA's MCL for zinc in drinking water (5000  $\mu\text{g/L}$ ).

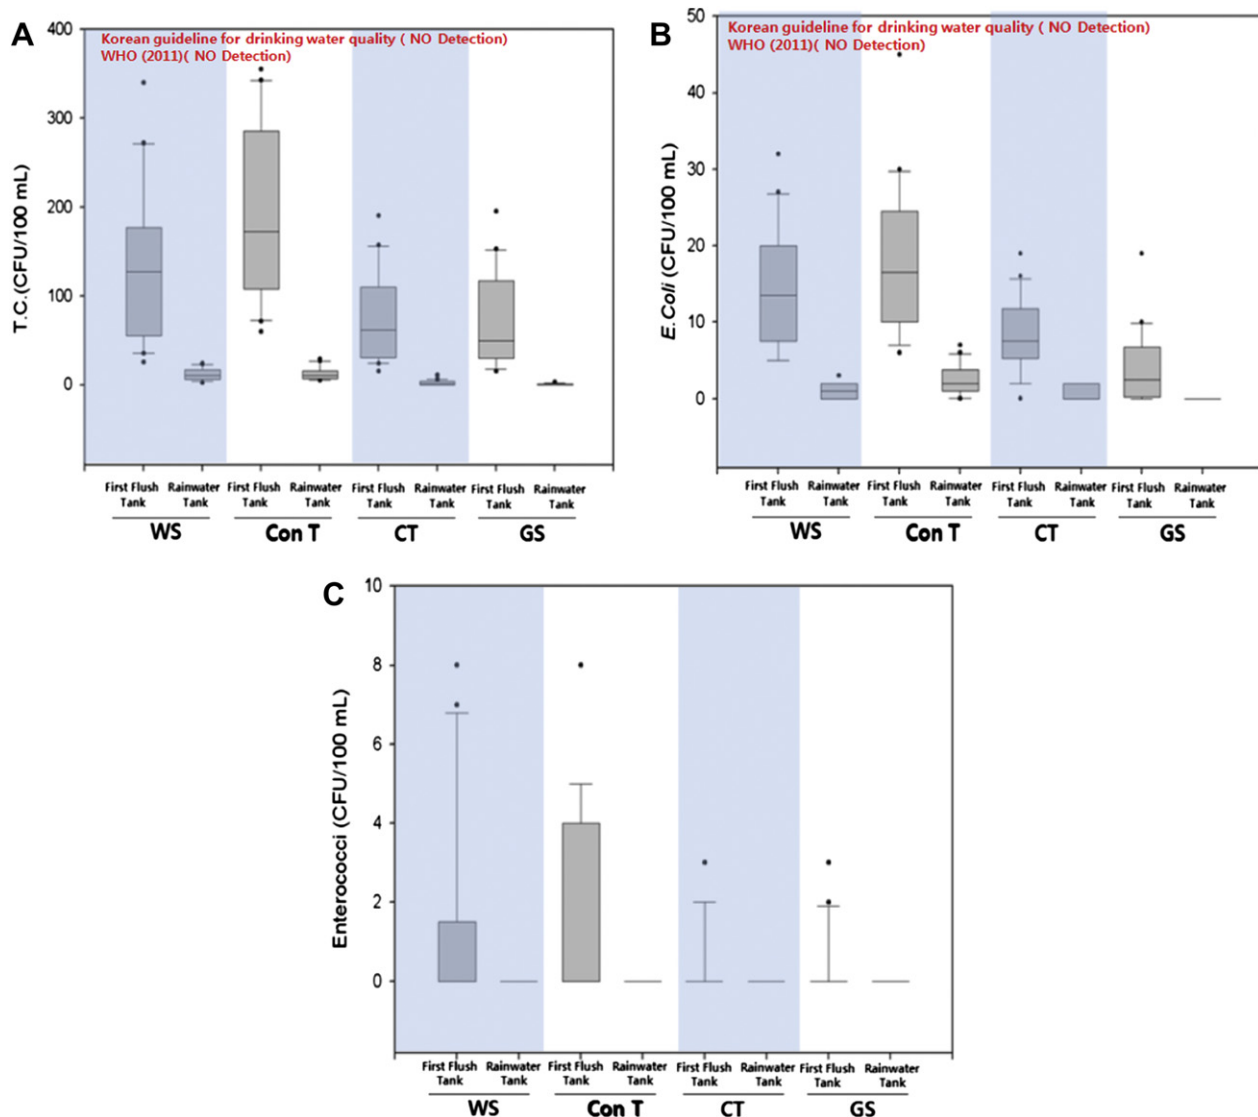
Fig. 7. Box plot diagram for the fecal indicators (total coliform, *E. coli*, enterococci) identified in the different roofing material samples (total events [ $n = 40$ ]).

**3.1.3.1. Fecal indicators.** To determine the suitability of harvested rainwater as a source of drinking water, the samples were tested for total coliform count, *E. coli* and enterococci. These fecal indicators may be fecal in origin, but can also originate from dust and plants. In the samples from the first flush tanks, we detected average total coliform counts of 131 CFU/100 mL for the wooden shingle, 197 CFU/100 mL for the concrete tile, 76 CFU/100 mL for the clay tile and 70 CFU/100 mL for the galvanized steel roofs (Fig. 7-A). In those from the rainwater tanks after the first flush, we found average total coliform counts of 12 CFU/100 mL for the wooden shingle, 12 CFU/100 mL for the concrete tile, 2 CFU/100 mL for the clay tile and <1 CFU/100 mL for the galvanized steel roofs (Fig. 7-A). The result for the galvanized steel roof samples from the rainwater tank is particularly notable: 82.5% of these samples had no measurable total coliform count because the total coliforms were completely washed away by the first flush. The WHO (2004) recommends a total coliform count <10 CFU/100 mL in 95% of samples collected from a particular drinking water source (see also Ahmed et al., 2011).

The average *E. coli* counts in the first flush tank were 14 CFU/100 mL for the wooden shingle roof, 18 CFU/100 mL for the

concrete tile roof, 8 CFU/100 mL for the clay tile roof and 4 CFU/100 mL for the galvanized steel roof (Fig. 7-B). In the samples from the rainwater tanks after the first flush, in contrast, we found average *E. coli* counts of 1 CFU/100 mL for the wooden shingle roof, 2 CFU/100 mL for the concrete tile roof, <1 CFU/100 mL for the clay tile roof and zero CFU/100 mL for the galvanized steel roof (Fig. 7-B). All of the samples (not shown) taken from the rainwater tank of the galvanized steel roof were negative for *E. coli* because any that had been present was completely washed away by the first flush. The Australian Drinking Water Guidelines (ADWG, 2004) state that the *E. coli* count should be zero CFU/100 mL (see also Ahmed et al., 2011).

The average enterococci counts in the first flush tank were measured at 1 CFU/100 mL for the wooden shingle roof, 2 CFU/100 mL for the concrete tile roof, <1 CFU/100 mL for the clay tile roof and <1 CFU/100 mL for the galvanized steel roof (Fig. 7-C). Of these first flush tank samples, 88% of those from the wooden shingle roof, 77% of those from the concrete tile roof, 92% of those from the clay tile roof and 92% of those from the galvanized steel roof (none shown) had no measurable levels of enterococci. In the rainwater tank, 100% of the samples from all four roofing materials

tested negative for enterococci (Fig. 7-C). Thus, all of the harvested rainwater in this study met the recommended enterococci level (zero CFU/100 mL) in the ADWG (2004; see also Ahmed et al., 2011).
