Chapter 15

The Flims Rockslide Dam

Andreas von Poschinger

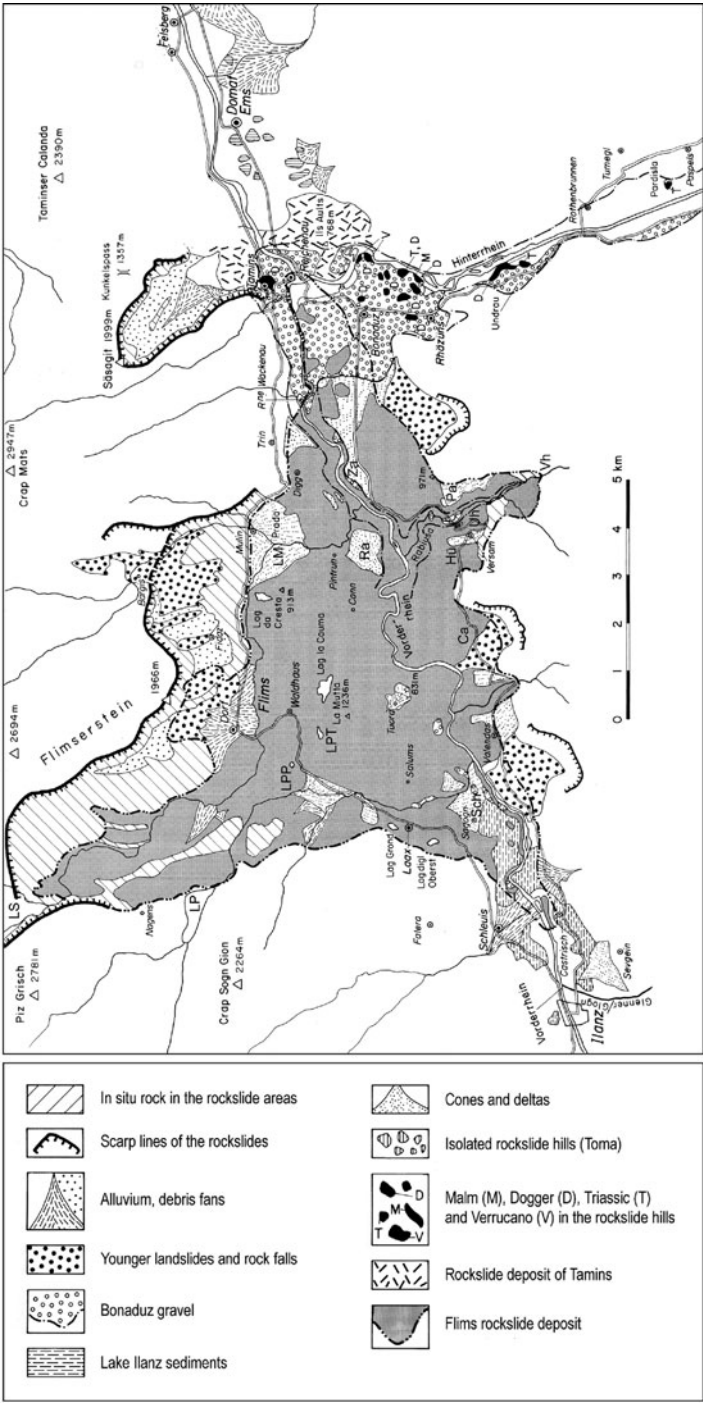
Fig. 15.1 Site map (previous page) and legend. In the map the following sites are indicated by letters: Ca, Camifels; Hü, Hüschera; Pa, Parstogn; Ra, Ransun; Sch, Schiedberg; Uh, Unterhof; Vh, Vorderhof; Za, Zault. The lakes are: LM, Lag Mulin; LP, Lag Plaun; LPP, Lag Prau Pulta; LPT, Lag Prau Tuleritg; LS, Lag Segnes Sut

and can only be assumed. It is evident that it was significantly higher than 820 m a.s.l., because the large flood plain must have been created by a large amount of water. It also obvious that the lake level did not exceed 936 m a.s.l. At that elevation, a morphological depression on the right bank near Carnifels – Erlacresta (Figs. 15.1 and 15.5) shows clearly that no important overflow has ever taken place. So, the

Several small lakes were created due to lateral damming by the rockslide mass (Fig. 15.1). Lac Grond and Lac digl Oberst still exist, Lac Plaun, Lac Segnes Sut and Lac Mulin have since been filled up with sediments. The basin of Hüschera near Versam was drained through the permeable rockslide mass and was not filled by

Also on top of the rockslide mass some lakes were created (Fig. 15.1). Lac Prau Pulta, Lag Prau Tuleritg, Lag la Cauma and Lag la Cresta are lakes or ponds with a very sophisticated hydrology. Analysis of the lake sediments in those lakes by Deplazes et al. [5] showed a younger age that did not contradict the radiocarbon dating of the rockslide mentioned above.

- (b) The Bonaduz gravels are almost only found upstream of the Tamins rockslide barrier and far up the Hinterrhein valley (Fig. 15.1). If they were generated by the Tamins slide they should be found downstream as well. In the case of generation by the Flims slide, an already existing barrier at Tamins would have been the perfect barrier responsible for diversion of the debris up the Hinterrhein valley (Figs. 15.1 and 15.10/3).
- (c) The flood sediments of the outbreak of Lake Ilanz are incised into the Bonaduz gravel. Accordingly, the flood event is younger than the Bonaduz gravel (Fig. 15.10/5).

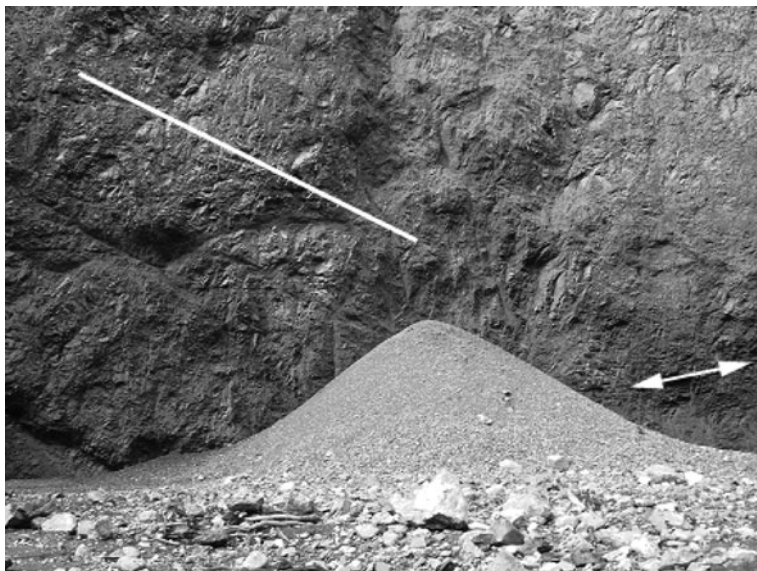
Fig. 15.2 Rockslide material in “three-dimensional jigsaw-facies” in the Rabiusa gorge. The direction of movement was from *right to left*. At the *right* margin sub-horizontal former bedding is visible (parallel to the *white arrow*). Important deformation plains cross-cut it and follows upward ramps (*white line*)

In many places a small-scale three-dimensional jigsaw has been produced, still preserving the original structure (Fig. 15.2). This general structure is cross-cut, more or less densely, by deformation planes and zones. Along these zones the limestone has been crushed to fine gouge. In some places these planes are sub-parallel to the former sedimentary layering as indicated by Pollet [13]. It seems that even more important are ramp-like deformation planes, cross-cutting the bedding and mostly dipping northward.

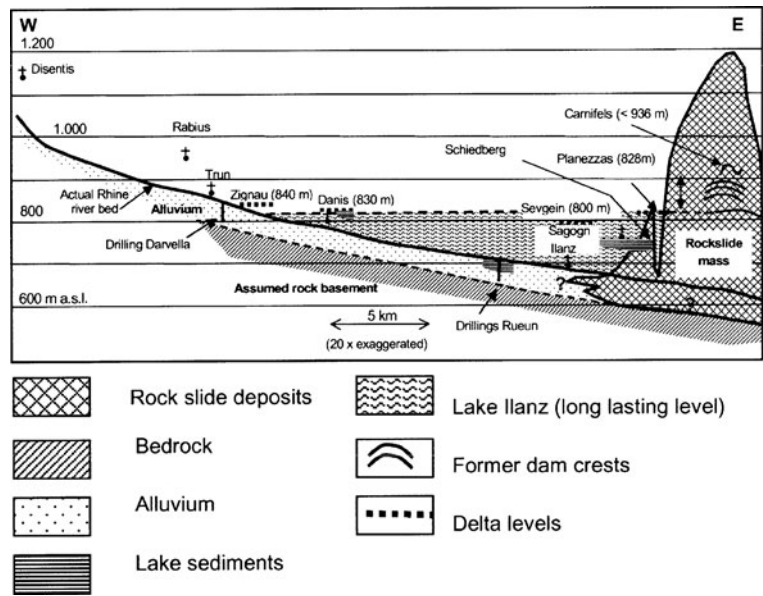
Fig. 15.3 Section along Lake Ilanz. The distribution of rockslide material under the Rhine river bed is assumed only. The maximum lake level did not exceed the Carnifels pass at 936 m a.s.l. and probably reached 870 to 900 m only. The attribution of the Zignau delta to Lake Ilanz is in doubt

The Flims rockslide dammed two large lakes and several small lateral ponds [9]. The biggest lake was that of Ilanz. The maximum level of that lake is a crucial point of discussion. A level of about 820 m a.s.l. is demonstrated by lake sediments (Fig. 15.3), morphological traces and by delta sediments (Fig. 15.4). This evidence marks the level at which the lake existed for some time. As the floodplain sediments also reach to that level, a first breach must have affected a higher level and the lake must have been dammed at that higher level for only a short time without leaving any clear traces. The exact position of that maximum lake level has not been established

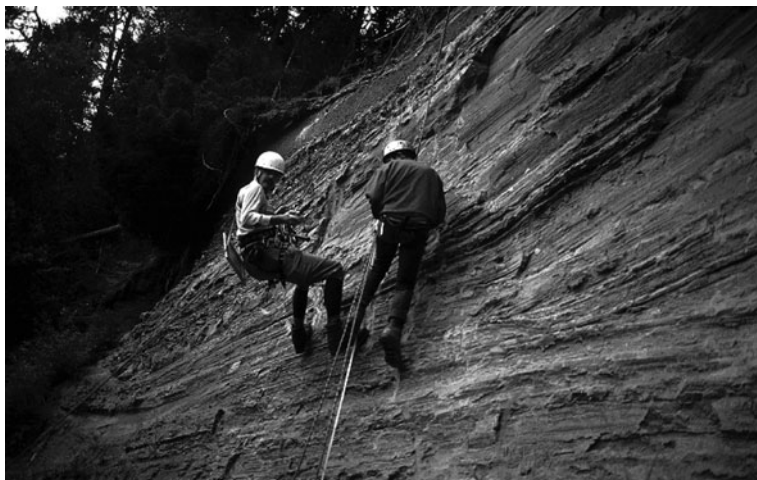
Fig. 15.4 Sediments of Lake Ilanz near Schiedberg. The clearly and regularly layered silts and sands show a horizontal bedding surface. The origin of the bedding might have been seasonal changes, but, also, repeated single heavy rain events

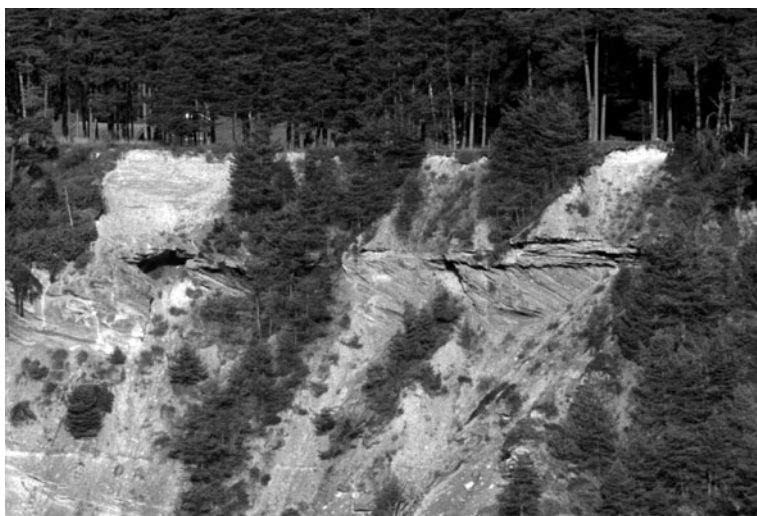
Fig. 15.5 Delta sediments of the Laaxerbach at Planezzas south of Laax with topset and foreset beds. The top of the foreset beds has an elevation of about 820 m

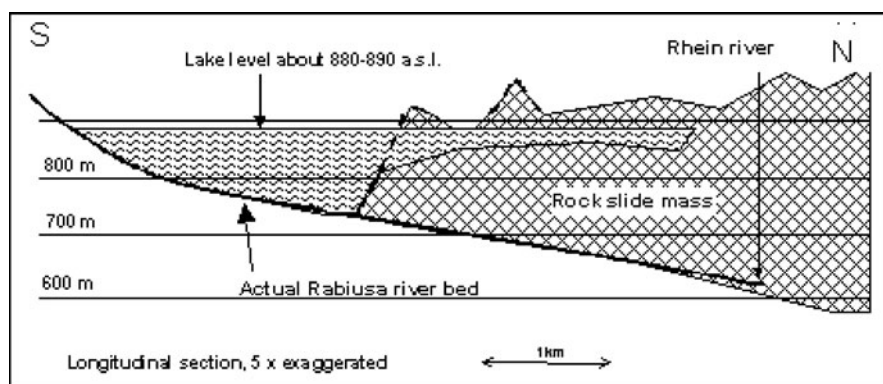
Fig. 15.6 Section along Lake Versam. The steep gradient of the Rabiusa river and the narrow valley are responsible for a relatively small basin

Lake Versam and Lake Ilanz were dammed by the same event but filled and drained independently. The smaller Lake Versam was dammed to a level of about 870–880 m a.s.l. and had a length of about 5 km (Fig. 15.6). The steep gradient of the Rabiusa river and the steepness of its slopes are responsible for the comparatively small volume of the basin. As the Rabiusa valley has been strongly eroded, no assumption about the previous volume of the basin is possible. Lake sediments are found near Versam-Unterhof (Fig. 15.1) at an elevation of 860 m and at Parstogn at 870 m a.s.l. On the right bank a slightly inclined shoulder is visible, climbing southward up to about 900 m near Vorderhof. This shoulder is interpreted to be the former delta level. Furthermore, well-bedded laminated silty lake sediments that can be attributed to Lake Versam are found at the footpath from Parstogn down to the Rabiusa bridge at 850 m a.s.l. The lake level did not exceed the elevation of 908 m, because the morphological pass leading to the depression of Hüschera (Fig. 15.1) did not experience any major discharge. According to the gravel and sand layers found at Parstogn, Lake Versam was filled up completely with sediments before the incision of the gorge started.

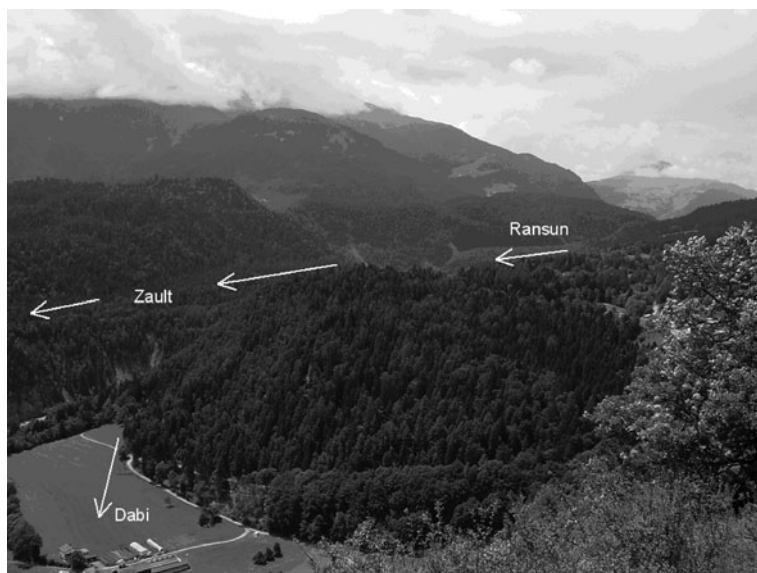
Fig. 15.7 View from Trin towards SW over the rockslide deposits (forested hills in the centre) to the Ilanz floodway (arrows) of Ransun (Ra), Zault and Dabi (see Fig. 15.1)

Several earlier authors [e.g. 16] assumed a complete and instantaneous break of the Ilanz dam with catastrophic circumstances. All refer to the huge inclined eroded floodway, stretching over more than 6 km from Ransun to Zault (Fig. 15.7), further on to Reichenau, and finally disappearing under younger sediments at Domat-Ems. The surface of the floodway has a strikingly constant inclination of about $2\text{--}2.5^\circ$ (4%). Only the uppermost part at Ransun is flatter, indicating that in that part erosion of the barrier was prevalent. The floodway spread out laterally up to more than 1 km. The volume of the debris eroded is hard to estimate, because its thickness is only known in few outcrops and borings. Very roughly it is assumed to be about $30\text{--}50 \times 10^6 \text{ m}^3$.

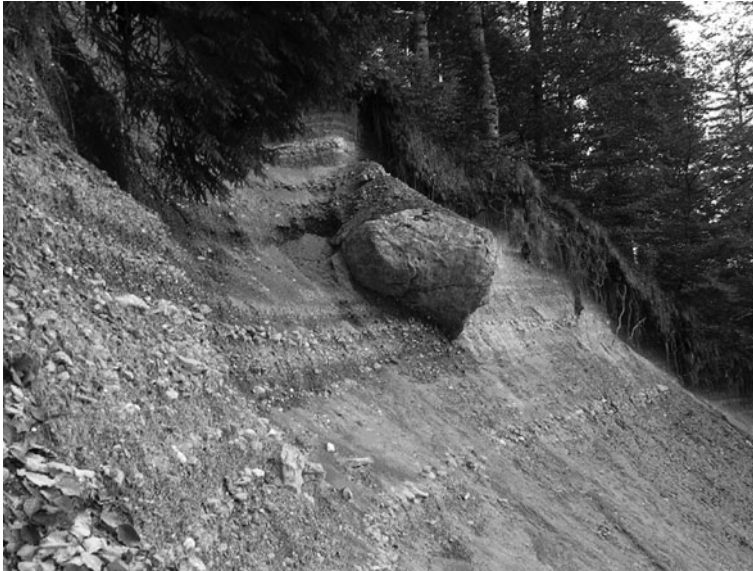
Fig. 15.8 Sediments of the Ilanz outbreak flood at Zault showing clear layering. The fragments consist of angular rockslide material (limestone). In some layers the particles have the size of coarse gravel, in some they consist of sand or even silt only. Around the single large block no disturbance of the bedding is apparent

In several erosion gullies the vertical structure of the flood deposits is well exposed (Fig. 15.8). The rockslide deposits are covered by gravel sediments that have been bulldozed by the rockslide from their former situation in the valley floor to an elevated position [14, 15, 16]. Accordingly, they are part of the rockslide event, forming together with the rockslide debris an undulating surface. This relief was filled up by outbreak sediments. NW of Zault the sedimentation of the flood starts with a typical debris flow deposit, dominated by coarse, slightly rounded blocks. These blocks are concentrated in several layers, separated by finer material. This blocky sediment is about 15 m in thickness. Above it, gradually finer sediments (medium gravel size) occur, showing a layering (Fig. 15.8). The sequence of the layered gravel attains about 10 m in thickness, each single layer about 5–15 cm. All constituents are angular fragments of the rockslide. Some layers contain only sand or even silt. At first sight, the layered gravel indicates a low energy environment. However, single large blocks within these layers (Fig. 15.8) led to questions of origin. Manville (personal communication, 2004) has suggested that, a “hyperconcentrated flow”, as described in Pierson and Costa [12], might be the origin for this sediment. A giant flood as assumed to have happened could have induced such a process of transport. Its deposition was the last phase of the flood event. The layered gravel beds with few boulders are parallel to the surface of the inclined floodway. After this sedimentation, the floodway was incised by fluvial erosion.

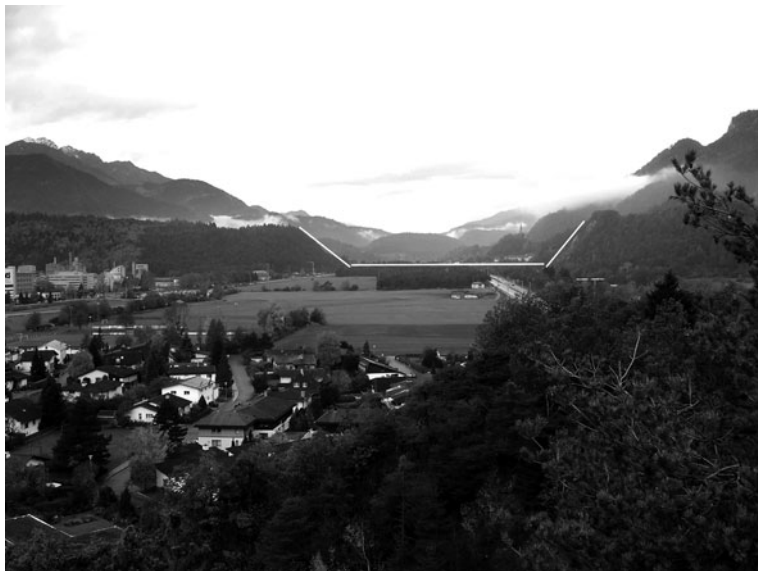
Fig. 15.9 The Tamins rockslide deposits, seen from the Toma hills of Domat-Ems (looking towards West). The slide mass forms a straight barrier across the Rhine valley. A distinct breach (*white line*), caused by the outbreak of Lake Bonaduz, was partly filled later by the outbreak sediments of Lake Ilanz. The inclined flood plain in the centre of the photo has a direct extension to that of Zault. Within the breach in the background the Flims deposits are visible

The Flims rockslide is closely related to its neighbour, the Tamins rockslide (Fig. 15.9). With a volume indicated by Abele [1] of “only” about $1\text{--}1.6\text{ km}^3$ it always stood in the shadow of its big brother, the Flims slide. The interpretation of the succession of the events is important for the understanding of the mechanisms. Unfortunately, there is until now no radiocarbon dating for the Tamins slide. Preliminary results of recent surface exposure dating on ^{36}Cl done by Ivy-Ochs (personal communication) indicate an age close to that of Flims. The range would be less than $\pm 1,000$ years.

- (d) The astonishingly straight and evenly inclined floodway of the Flims dam crosses the Tamins barrier without any disturbance. This indicates that not only the Tamins barrier existed during the flood event, but also the breach in it (Fig. 15.9). Lake Bonaduz, dammed by the Tamins barrier, had already drained through this breach. Remnants of a second flood sediment are to be found in an erosional terrace at the village of Felsberg-Altdorf (Figs. 15.1 and 15.10/3). They have a clearly higher elevated position with respect to the Flims flood sediments and have no extension upstream of the Tamins barrier. So, they are attributed by the author to the Tamins breach event.

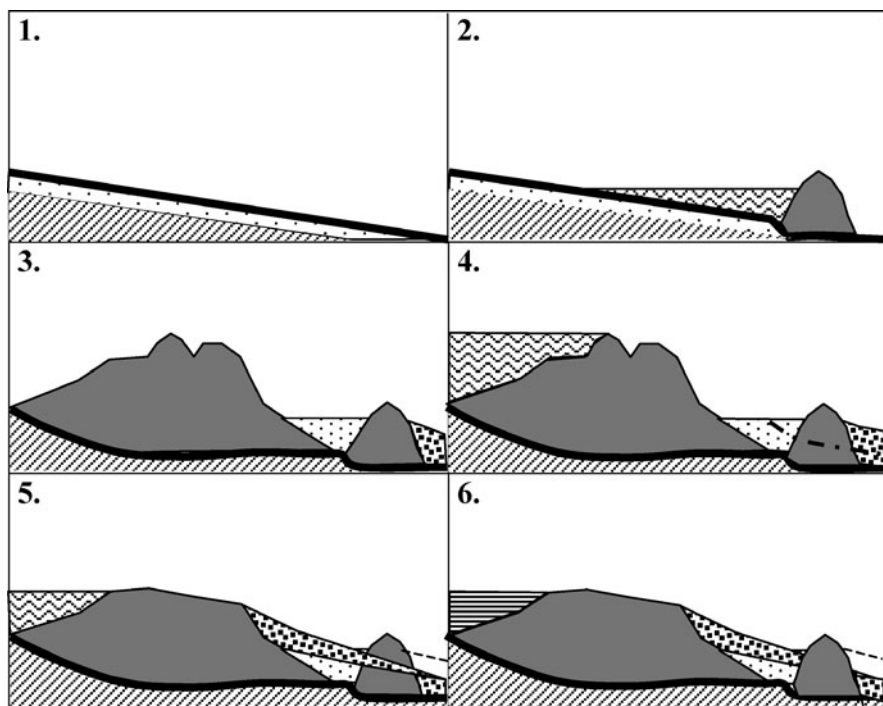
Fig. 15.10 Sketch of the development of the Flims site: 1. Original state of the Vorderrhein river with alluvial sediments; 2. Deposition of the Tamins rockslide and damming of lake Bonaduz; 3. Deposition of Flims rockslide and mobilisation of alluvial sediments (= Bonaduz gravel), drainage of Lake Bonaduz with flood sediments downstream of the Tamins deposits; 4. Partial or even complete filling of Lake Ilanz, erosion in Tamins deposits; 5. Break of Flims barrier down to 820 m, flood sediments crossing the breach in Tamins deposits; 6. Filling of Lake Ilanz with sediments before further erosion to the present river bed

Several observations favour the assumption that the Tamins slide is older than the Flims event (Fig. 15.10):
