TECHNICAL ARTICLE

Degassing Pit Lakes: Technical Issues and Lessons Learnt from the HERCO$_2$ Project in the Guadiana Open Pit (Herrerías Mine, SW Spain)

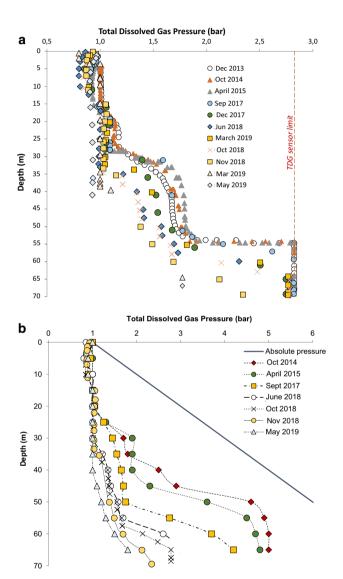
Figure 5 illustrates the effects of the degassing on dissolved gas pressure in the pit lake during the last 5 years. TDG profiles taken in different periods from December 2013 to May 2019 with the Hach membrane sensor (hence limited by the 2.7 bar sensor limit) are displayed in Fig. 5a, while those obtained by the gas-sampling method or by the custom-made probe are given in Fig. 5b. In the latter, the horizontal scale has been enlarged to display the absolute pressure as a reference.

In both plots, the temporal evolution of TDG clearly shows a continuous decrease of dissolved gas pressure due to degassing. Although the decrease in TDG has occurred in the whole water column below 20 m, the drop in gas pressure has been especially important at depths below 50 m (Figs. 5 and 6a). This point is particularly important, as it has decreased gas pressures in the deep water from close to 5 bars in 2013, which was not too far from the absolute pressure (hydrostatic plus atmospheric) limiting gas solubility, to values of 1.0–1.8 bars at present, which can be considered safe (Fig. 5b).

Fig. 5 Vertical evolution of total dissolved gas (TDG) pressure in Guadiana pit lake: **a** TDG profiles obtained directly with a TDG Hach sensor; **b** TDG profiles calculated from gas volume measurements (October 2014 and April 2015), Pro Oceanus mini-TDG probe (September 2017) and TDG Hach sensor (all other dates)

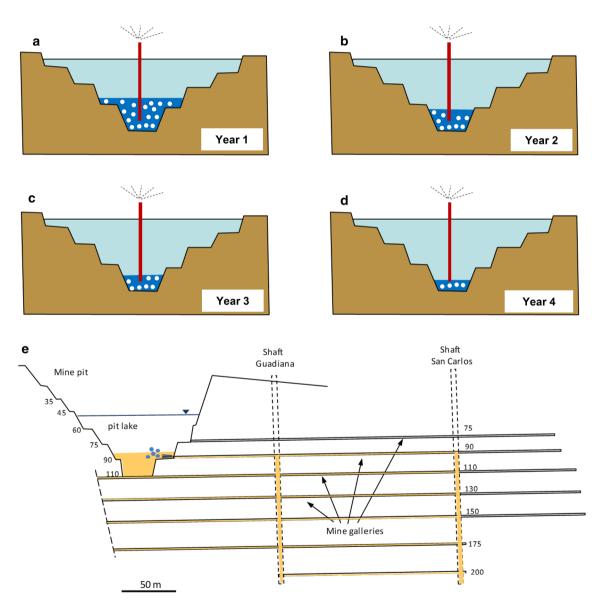
moving shallower waters of lower density progressively to greater depths. As a final result, the thickness of the CO_2-rich bottom layer shrank from 25 m in 2014 to 4–5 m above the pit lake bottom at present (Fig. 8a–d).

Fig. 8 **a–d** Schematic diagram showing the evolution of Guadiana pit lake during the last 4 years as a result of controlled degassing; **e** Idealized cross-section of the whole Guadiana mine complex, including the open pit as well as the set of sub-horizontal mine galleries and vertical shafts which are hydraulically connected with the pit; numbers next to the mine pit and galleries refer to depths (in meters) below the topographic surface (modified from Pinedo Vara 1963)

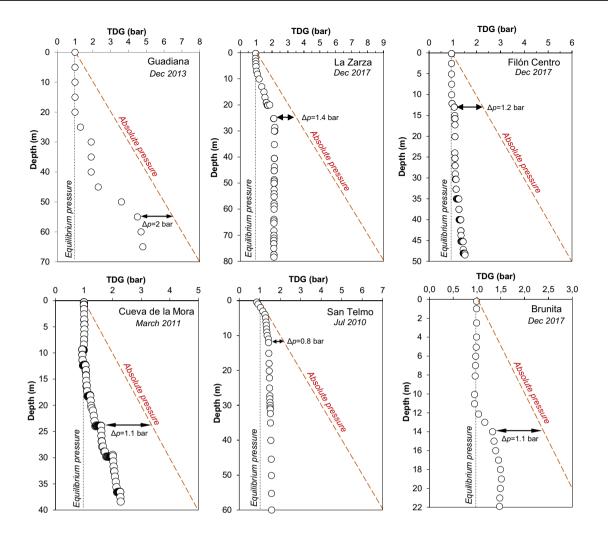
As can be deduced from the TDG profiles of Fig. 12, the Guadiana pit lake case seems to be quite unique. None of the other pit lakes has developed even a remotely similar situation with regard to elevated dissolved CO_2 pressures. Only Cueva de la Mora, which displayed peak TDG values of 2.3 bar near the pit lake bottom at depths of 35–40 m (Fig. 12). The acidic pit lake of Brunita, in the La Unión mining district, has developed TDG pressures of ≈ 1.5 bar above the sediments at 22 m depth, resulting mostly from carbonate (siderite, dolomite) dissolution and the consequent release of CO_2. Most other pit lakes (La Zarza, Filón Centro, San Telmo) showed low TDG values at depth, which were all very far from the absolute value, and apparently do not represent a safety risk at this moment. It would be advisable, however, to follow the temporal evolution of TDG values and CO_2 concentration in pit lakes like Cueva de la Mora or Brunita, since such data would allow rates of CO_2 accumulation to be calculated in these mine sites and predict possibly dangerous scenarios in the future.

Fig. 12 Depth profiles of total dissolved gas [TDG] pressure in some Spanish pit lakes in the Iberian Pyrite Belt (Guadiana, La Zarza, Filón Centro, Cueva de la Mora, San Telmo) and La Unión mines (Brunita). In all cases, we indicate the date the profiles were taken, the atmospheric equilibrium pressure (= 1 bar), the absolute pressure (for reference), and the minimum difference (Δp) between the TDG pressure and the absolute pressure at that depth
