GEOSS Report No: 2017/04-23

Cedarberg Aqua is a bottled water company which obtains its water supply from a single borehole (KSV1). Following on from an assessment in 2008, 2010, 2012, 2014, 2015 and 2016, GEOSS was requested to complete another assessment in April 2017. The borehole is drilled into the Nardouw Sub-group quartzitic sandstones on the eastern limb of the Citrusdal syncline. The water bearing fractures are about 100 m below the ground level and the borehole is 180 m deep. The geological formations dip to the west and there are no contamination sources up-gradient of the borehole. The groundwater recharge is into the pristine geological formations in the mountains to the east of the borehole and the Nardouw Sub-group aquifer is confined.

GEOSS (2017). Cedarberg Aqua – Geohydrological Review 2017. GEOSS Report Number: 2017/04-23. GEOSS - Geohydrological & Spatial Solutions International (Pty) Ltd. Stellenbosch, South Africa

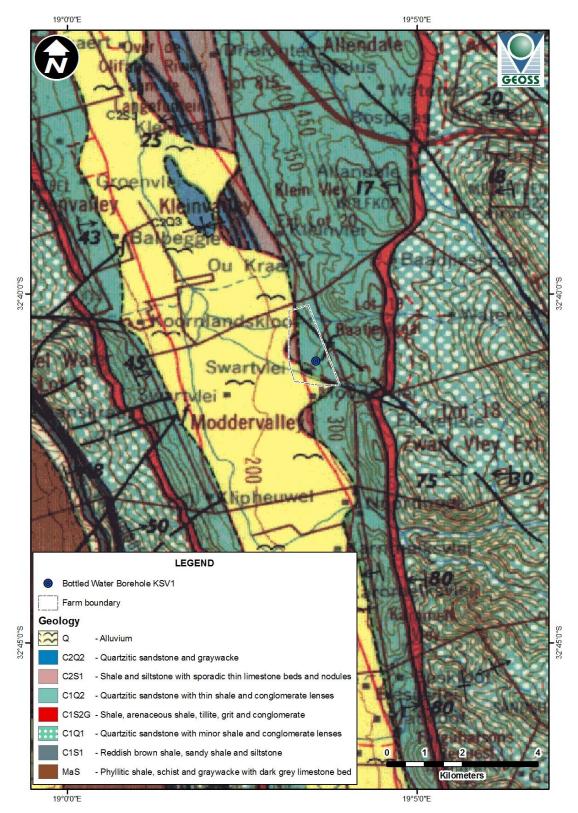
Map 3 Geological setting of the Cedarberg Aqua borehole (KSV1)

The geological setting of the borehole means that there is essentially no risk of surface based contamination to the groundwater in the vicinity of the borehole. The borehole setting is presented in **Map 3** (**Appendix A**). The borehole is drilled into the quartzitic sandstones of the Nardouw Sub-group (C1Q2) on the eastern limb of the Citrusdal syncline. The geological formations dip to the west and the water-bearing fractures were intersected at a depth of 100 mbgl. The Nardouw Sub-group is the upper portion of the Table Mountain Group, and the fractured nature of this aquifer reduces the possible risk of contamination to the borehole.
