How to Prevent Flow Failures in Tailings Dams

Roberto Rodríguez¹ · Alejandro Muñoz-Moreno^{1,2} · Ana Vanessa Caparrós³ · Cristóbal García-García⁴ · Ángel Brime-Barrios⁵ · Julio César Arranz-González¹ · Virginia Rodríguez-Gómez¹ · Francisco Javier Fernández-Naranjo¹ · Alberto Alcolea³

Abstract

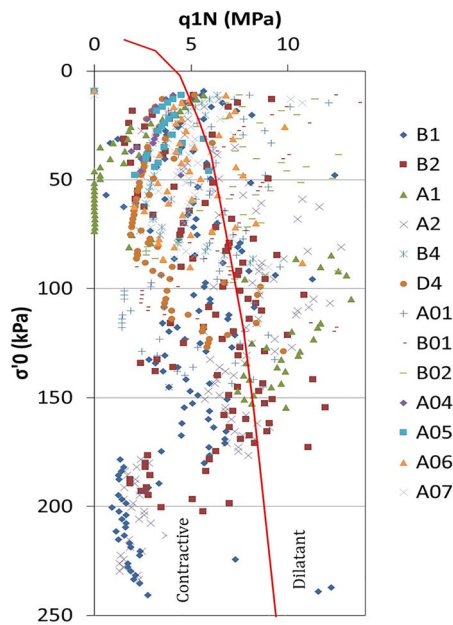
Fig. 23 Results of a CPT according to the criteria of Olson and Stark (2003) in fourteen boreholes in the tailings dam La Luciana. The legend indicates the boreholes location on the surface of TD Fig. 28d

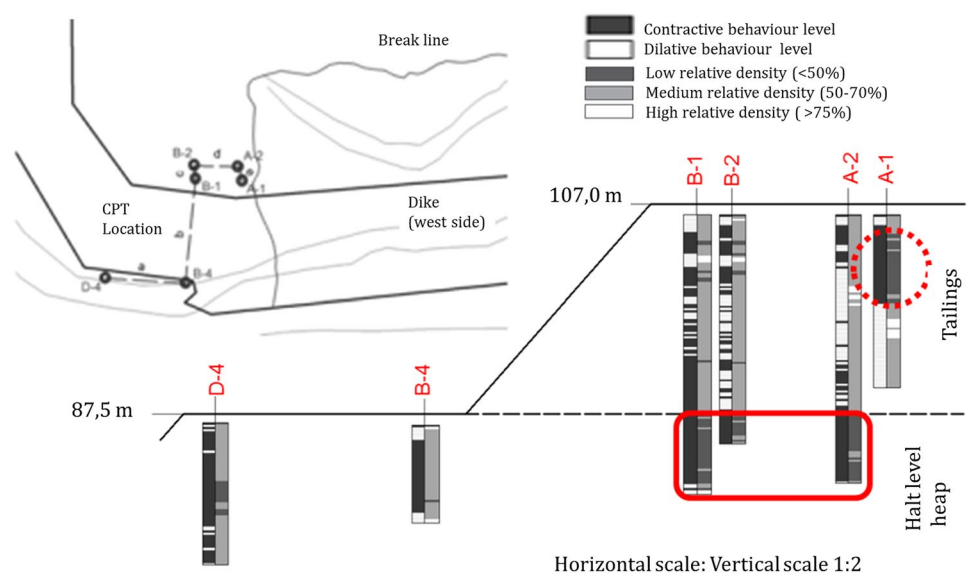
Fig. 24 Assessment of the susceptibility of liquefaction through the CPT analysis on the left and relative density on the right. Note that the profile does not respond to a linear trace of the soundings

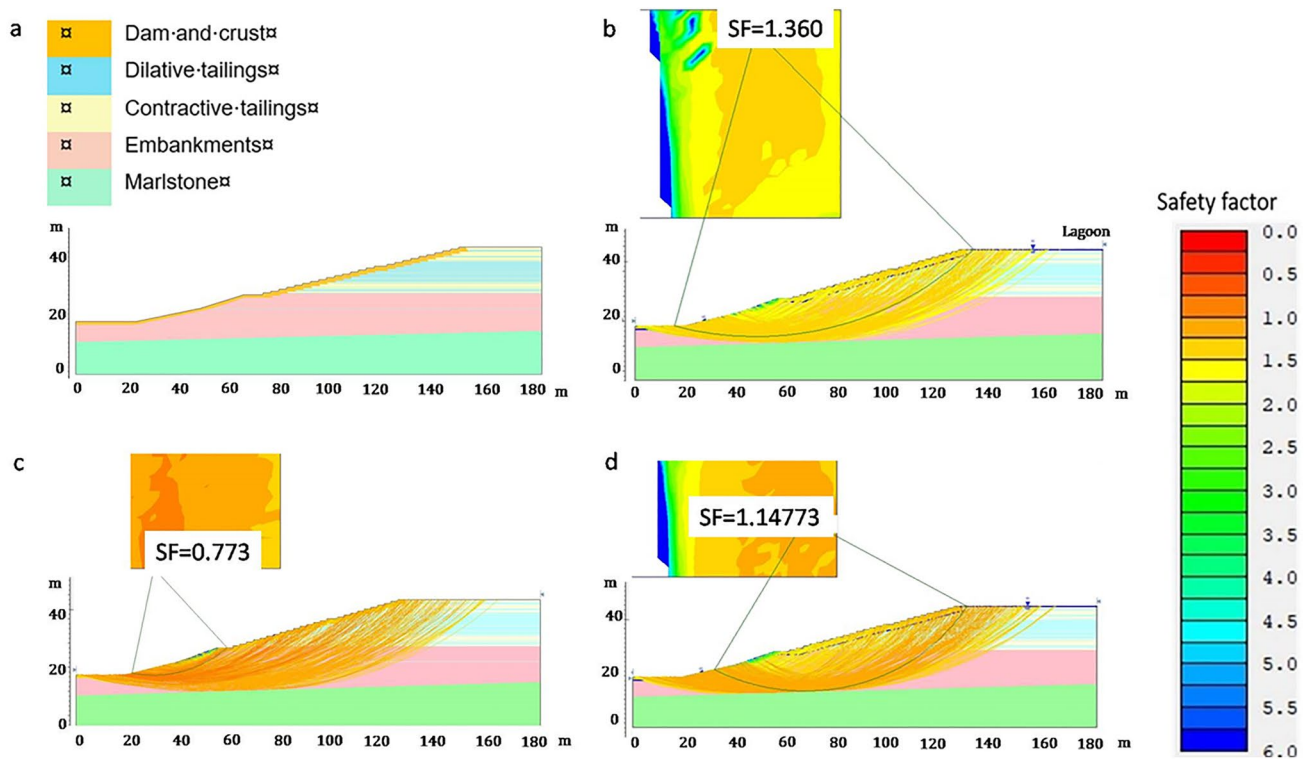
The effect of the distance of the decant lagoon on the SF were investigated within our model, using distances of 30, 20, 10, and 0 m (Table S-15, Fig. 26b). The trend seen in Fig. 31 shows that the closer the decant lagoon is to the dam (freeboard), the lower the SF. At 0 m from the slope, the SF obtained by the Fellenius method is 0.947, an “unsafe” value, while the other methods show values just above the equilibrium value (SF > 1).

Fig. 25 **a** Geotechnical stratigraphy considered for the modelling, **b** the circular failure surface envelope for the Fellenius method with the decant lagoon at 0 m from the slope edge, **c** the circular failure sur-

face envelope for the Bishop simplified method, at r_u value of 0.6, **d** the circular failure surface envelope for the Bishop method, with the water table height at surface

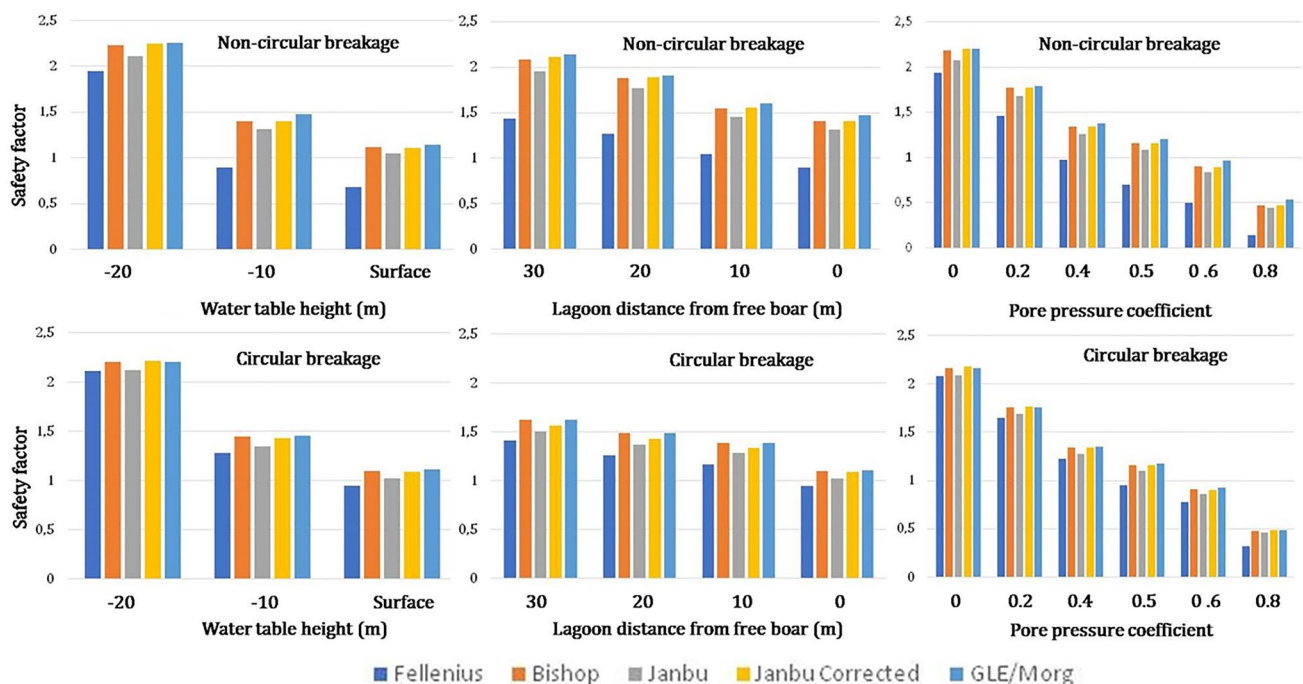
Fig. 26 Stability results of the TDs “La Luciana”. **a** Fellenius method (1927), **b** simplified Bishop method (1955), **c** Janbu corrected method (1968), **d** GLE/Morgenstern-Price Method (1965)

The water head had a negative effect on the dam's SF. When the water table was at a depth of 20 m, the SF values were all > 2 , meaning the dam was safe. The Fellenius method exhibited unsatisfactory SF values when the water table was at the surface for circular (SF = 0.947) and non-circular (SF = 0.679) failures. The four other methods had values > 1 , but were deemed unsatisfactory, especially when the water table was at the surface (Table S-15, Fig. 26c).
