HYDROLOGIC INVESTIGATION AND REMEDIATION OF A POST-REMINING ACIDIC SEEP¹

William W. Aljoe²

Nile A. Linberg³

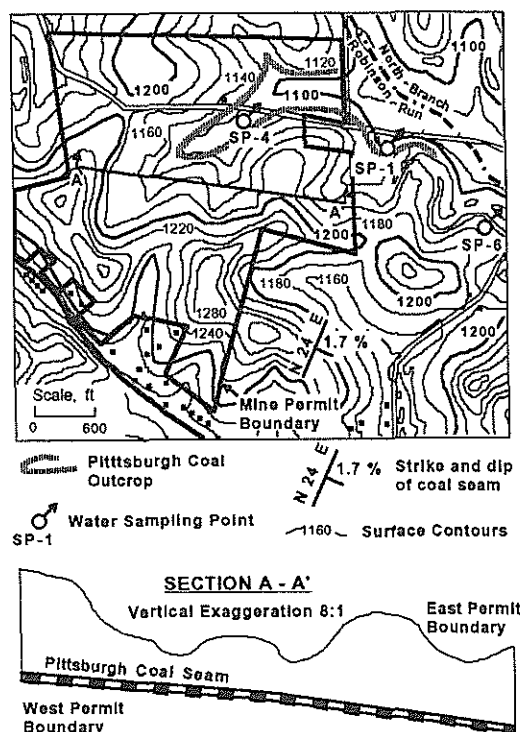
Figure 2. Pre-remining Topography and Sampling Points

Figure 2 shows the topographic contours and a cross section of the mine permit area prior to the most recent period of surface mining. This mining took place between 1985 and 1990, beginning at the coal outcrop area shown in Figure 2 and progressing to the southwest, southeast, and northwest until the permit boundary or an uneconomic overburden depth was reached. The overburden consisted mostly of shale, with some sandstone. A persistent limestone bed of 5-10 ft thickness was located approximately 40 ft above the Pittsburgh coal. This limestone was believed to be responsible for the alkaline discharges that were produced from remining operations in the vicinity of the study site, despite the fact that the deep mines had discharged acidic water prior to remining. Because of this, the mine operator sought a permit under SMCRA regulations rather than under the Pennsylvania remining program. Therefore, while the subject mine was a remining site in a physical sense, it

Although no ground water elevation data were available for the 1985-90 period, it can be assumed that the local ground water flow direction was from northwest to southeast due to geologic structure, and was dominated by the presence of the active surface mine and the mined-out Pittsburgh coal seam (see cross-section in Figure 2). Figure 2 also shows the locations of the three surface water sampling points which were closest to the downgradient edge of the mine permit boundary. Sample point SP-4 was intermittent and consisted mostly of surface runoff; it did not show evidence of mining-related contamination before or after the period of mining. Sample point SP-6, located about 1000 ft southeast of the permit boundary, was moderately acidic before, during and after mining. This discharge occurred at the side of a collapsed mine portal structure, and it was obviously connected to a deep mine pool; however, its relationship to the surface mining operation could not be determined. The sampling point of greatest interest was SP-1; prior to mining, this discharge originated as seepage from a swampy area in a natural hollow near the east permit boundary. However, for compliance purposes, sampling was performed at the outlet of a concrete culvert that carried the discharge under the road. Samples were collected on approximately a quarterly basis from 1984 through 1994. Table 1 summarizes the changes in pH, flow rate, and the concentrations of acidity, iron, manganese, and sulfate that occurred at sample point SP-1
