Identification of Flow Zones Inside and at the Base of a Uranium Mine Tailings Dam Using Geophysics

Erika Juliana Aldana Arcila¹ · César Augusto Moreira¹ · Pedro Lemos Camarero² ·
Matheus Felipe Stanfoca Casagrande¹

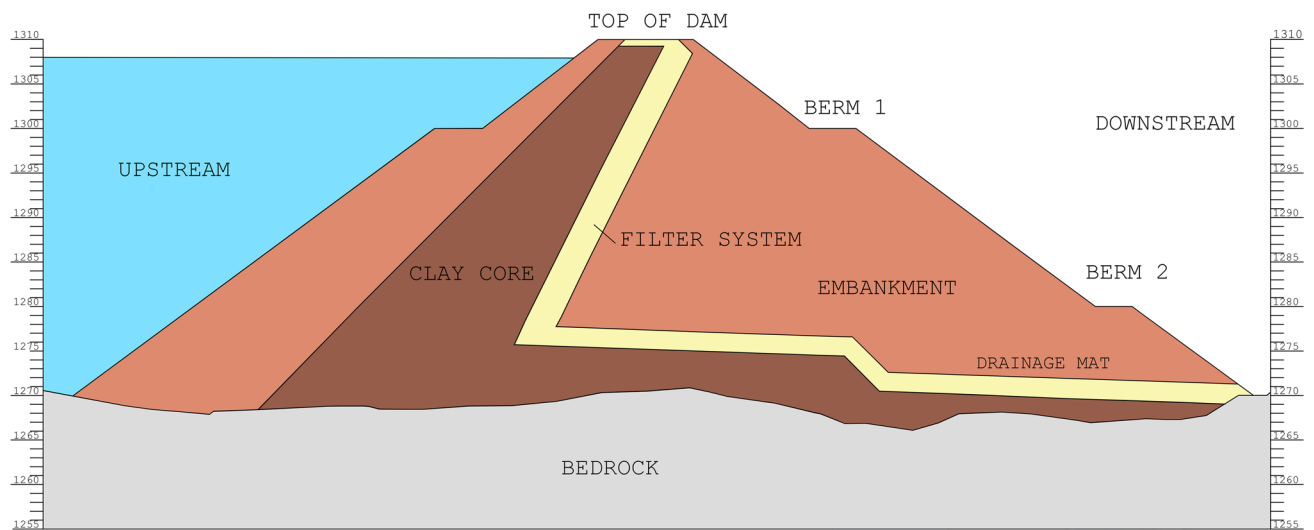
Fig. 3 Dam design profile

with two levels of construction visible downstream, and is monitored by a series of piezometers (Fig. 3). The dam has chimney sub-vertical sand filters between the clay core and the upstream and downstream rocks. The transition filter system is connected to a horizontal drainage mat to capture the filtered water in the dam body and in the bedrock-supported foundations. The bedrock follows the topography of the local relief, so it tends to be closer to the surface near the abutments.
