# Interpretation of the Failure of the Aznalcóllar (Spain) Tailings Dam

Joaquín Martí<sup>1,2</sup> · Francisco Riera<sup>2</sup> · Francisco Martínez<sup>2</sup>

## Abstract

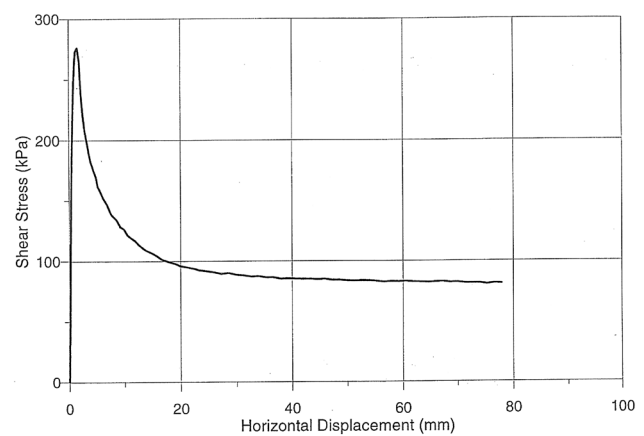
Figure 4 shows a typical curve depicting shear stress vs relative displacement, produced in ring shear tests conducted on undisturbed samples by the Norwegian Geotechnical Institute at Eptisa's request; similar behaviour was observed

Fig. 4 Brittle behaviour evinced in ring shear tests

by Alonso and Gens (2000). In direct shear tests, cohesion vanished over displacements on the order of 1 mm, while friction evolved to its residual value over relative displacements an order of magnitude greater. There was wide consensus that the residual strength was characterised by  $12^\circ$  friction and null cohesion. Figure 5 presents the idealised stress–strain curve, with cohesion and friction decreasing to their residual values over different strains. This type of behaviour has also been subsequently observed in the context of the neighbouring Las Cruces mining operations (Cooper et al 2019; Galera et al. 2009).

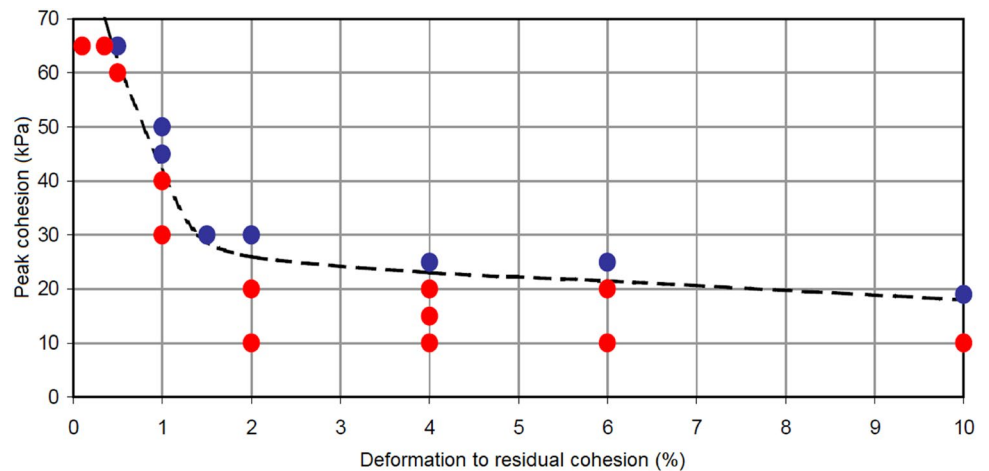
The investigation was carried out by repeating the calculations for selected combinations of  $c'_p$  and  $\epsilon_c$  and observing whether failure was predicted before or after April 1998 (a height of 27 m). The results are summarised in Fig. 15, where the conditions leading to an early failure are represented with red circles, while those allowing survival past April 1998 are indicated by blue circles. The dashed line approximately separates the two regions. The effects of brittleness are quite important, at least while  $\epsilon_c$  is below about 0.02. In that range, moderate changes in  $\epsilon_c$  require drastic variations in the peak cohesion  $c'_p$  needed to match the timing of the failure; after 0.02, further increases in ductility have a much smaller impact on the peak cohesion required. In principle, any combination of  $c'_p$  and  $\epsilon_c$  located along the dashed line will result in failure in April 1998.

**Fig. 15** Consistency between peak cohesion and degree of brittleness: red dots indicate failure before April 1998 and blue dots survival

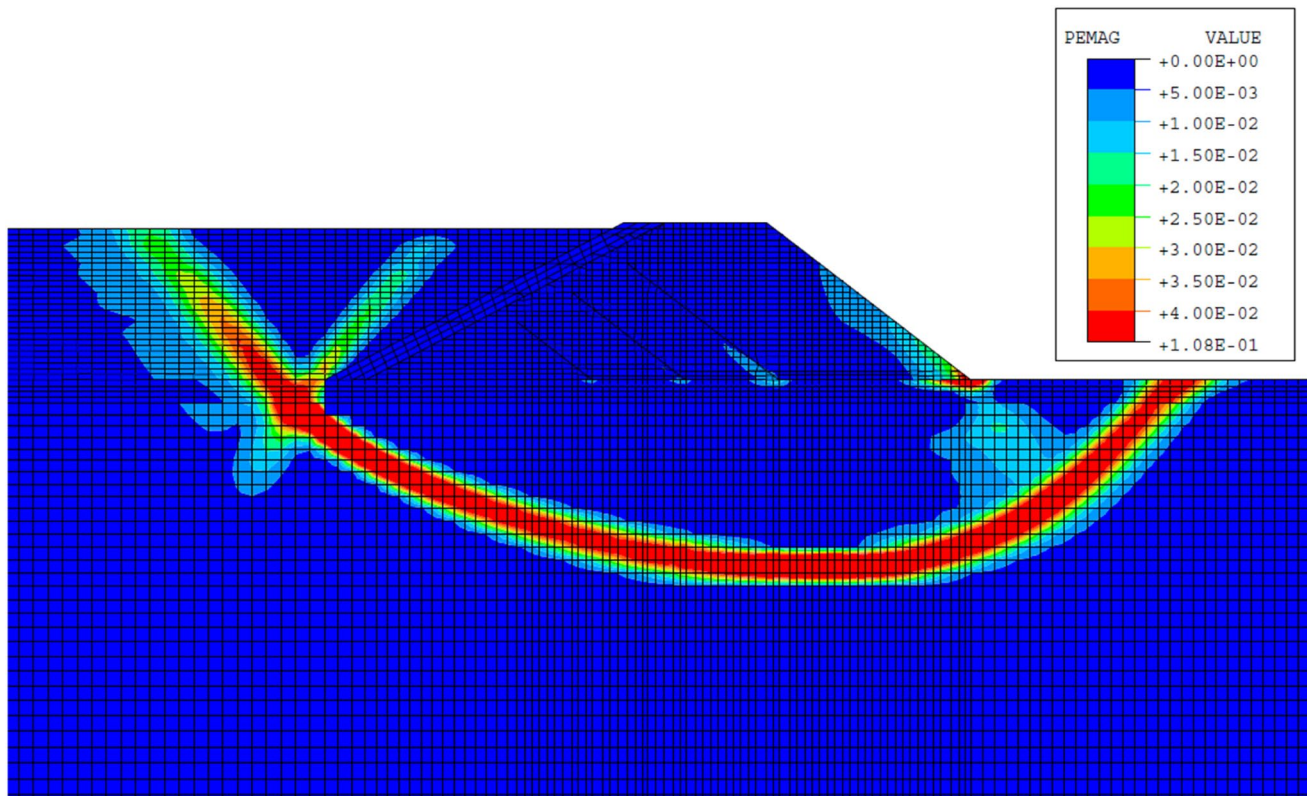
Apart from the timing, other things are also known about the failure: in particular, the failure surface that developed was planar and shallow, located some 10–12 m within the clays. As seen earlier, a marked brittleness naturally results in failure surfaces that are roughly consistent with the observed characteristics. However, this is not the case when failure occurs with greater ductility and less peak cohesion. There is no need to provide here the failure configurations resulting in each of the cases shown in Fig. 13, but Fig. 16

**Fig. 16** Plastic strains just before 27 m ( $C_v = 0.001 \text{ cm}^2/\text{s}$ ;  $c'_p = 20 \text{ kPa}$   $\varepsilon_c = 0.06$ ;  $\varepsilon_\varphi = 0.10$ )

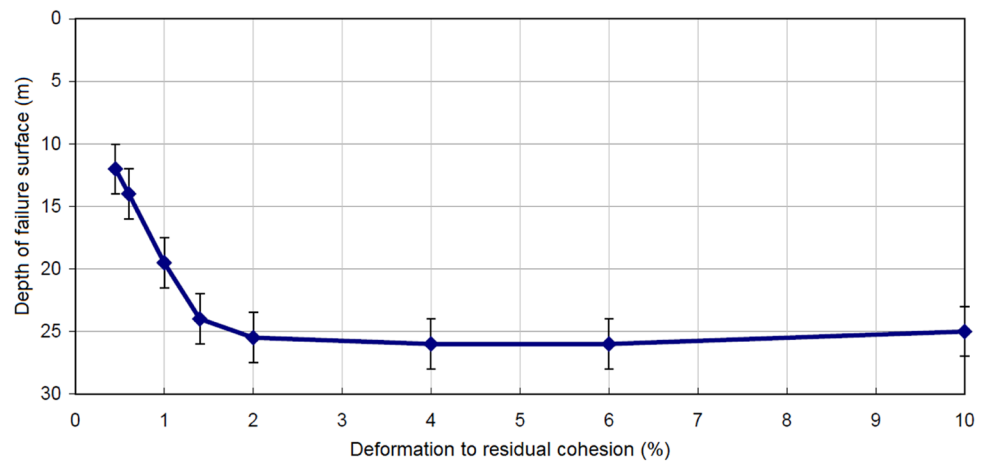
This observation is shared by all failure surfaces resulting from assuming less brittleness. To quantify this, each degree of brittleness, characterised by  $\epsilon_c$ , has been plotted against the depth of the failure surface (Fig. 17) that results when the peak cohesion is chosen to produce failure in April 1998. The error bands shown in the figure span one element dimension in each direction.

As seen in the figure, all the more ductile hypotheses ( $\epsilon_c$  greater than about 0.015 or 0.02) led to deeper failure surfaces, descending some 25 m inside the clays. However, as the clays become more brittle, progressively shallower and more planar failure surfaces are predicted. Figure 15 would allow expressing this effect in terms of peak cohesion. Clearly, failure surface depths on the order of 10–12 m require a very brittle behaviour ( $\epsilon_c$  below 0.004) and a peak cohesion at or near the value of 65 kPa reported by Alonso and Gens.

**Fig. 17** Depth of the failure surface as a function of the degree of brittleness for failures occurring in April 1998

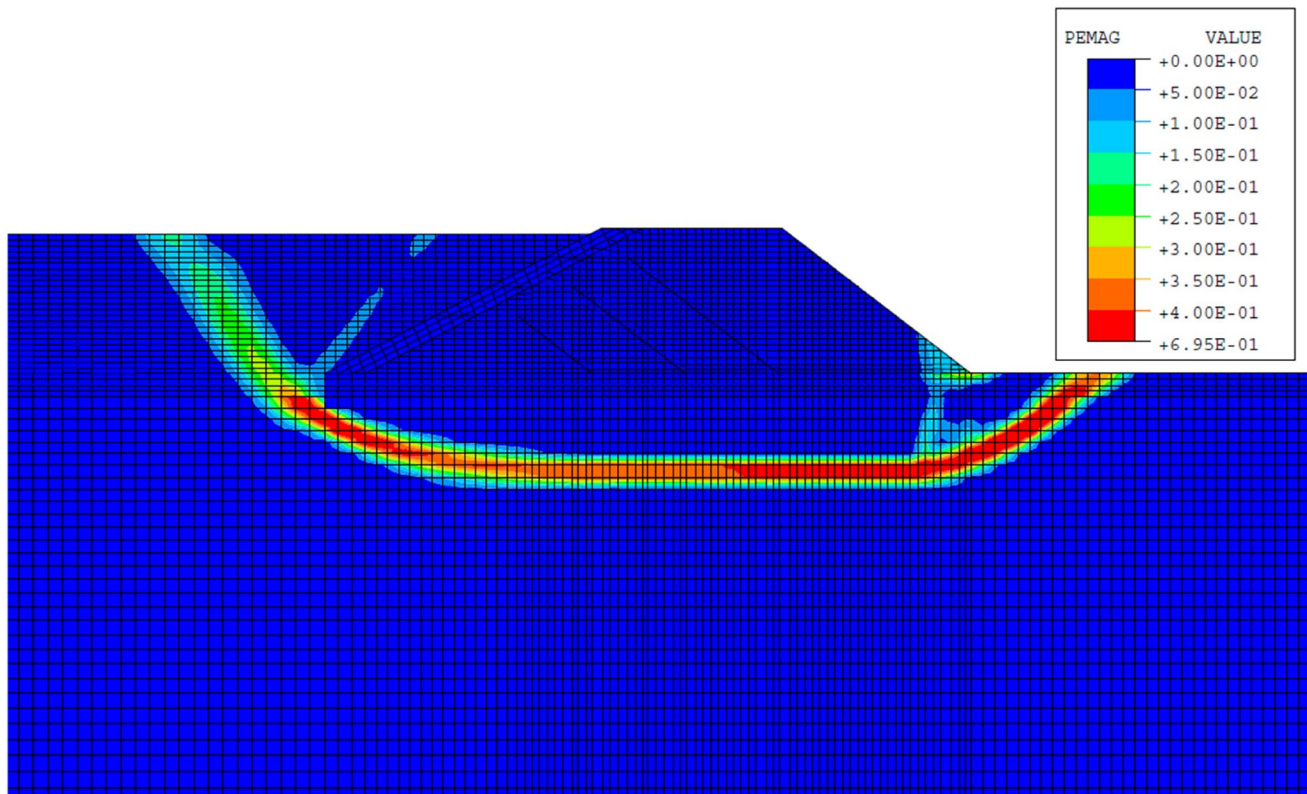
Finally, the effect of the pre-existing level of horizontal stresses in the clays was also investigated. Figure 19 shows the plastic strains at failure with horizontal stresses equal to 0.9 times the vertical stresses ( $K_0 = 0.9$ ). The clays are

**Fig. 19** Plastic strains at 25 m  $K_0=0.9$
