## Technical Evaluation of the Gold King Mine Incident

San Juan County, Colorado

U.S. Department of the Interior  
Bureau of Reclamation  
Technical Service Center  
Denver, Colorado

October 2015

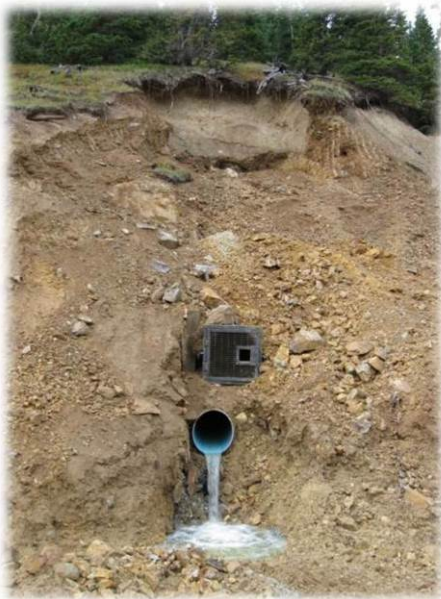
*Gold King Level 7 Old Portal Closure*

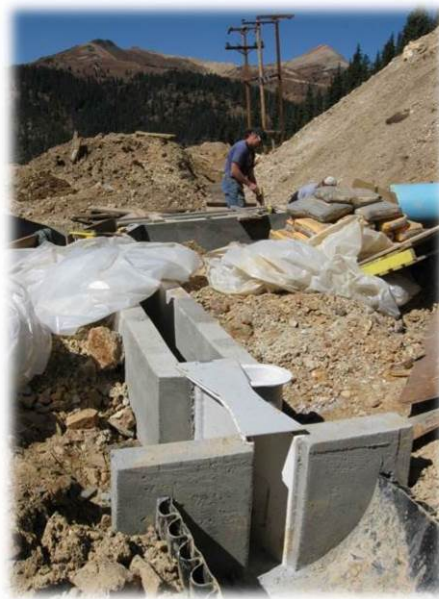
*Gold King Level 7 Old Portal with 2" Parshall Flume Installed in Concrete Lined Ditch*

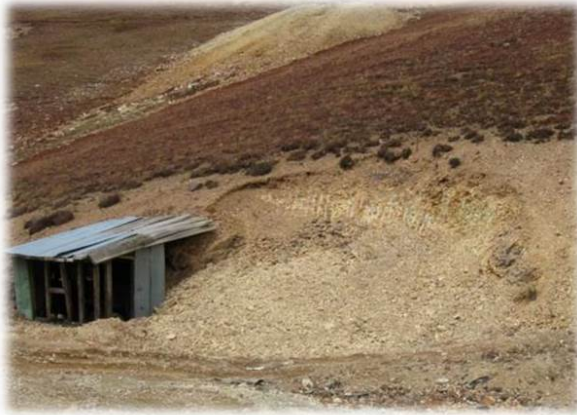
*Number 1 Portal backfilled*

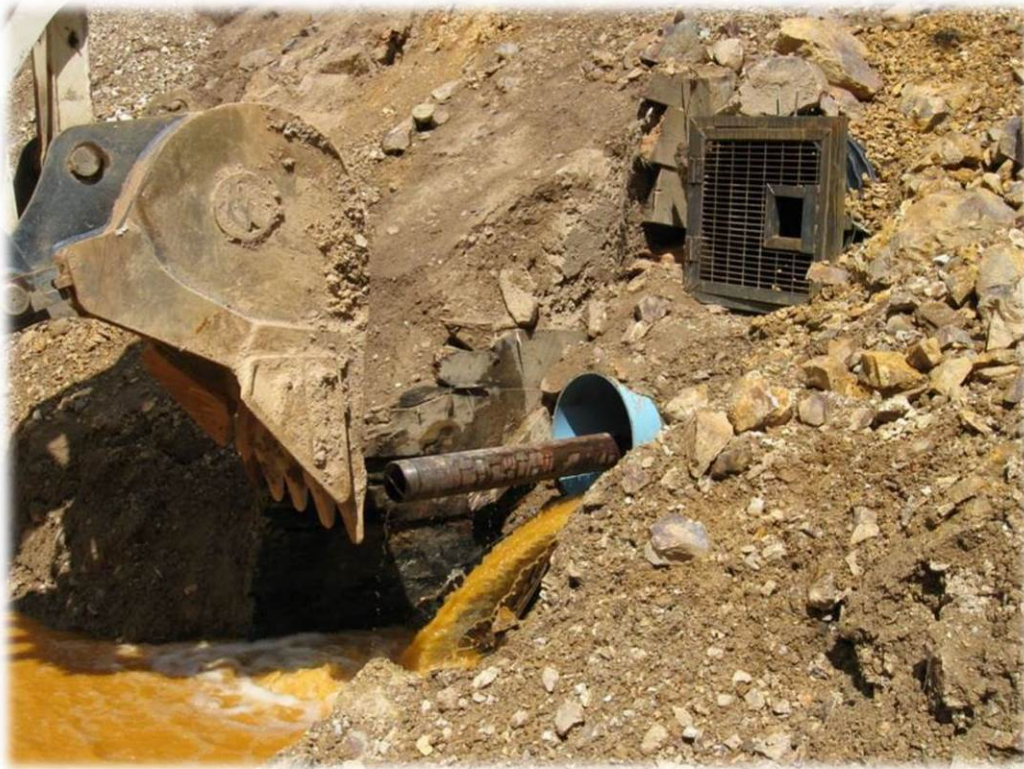
The mine drainage at the Gold King Level 7 Mine contains extremely high levels of metals and continues to flow between 150 and 300 gallons per minute. The mine drainage began after bulkheads were installed in the American Tunnel in 1995, which previously deep-drained the mining district. The mine drainage and the collapse at the Level 7 Old Portal continues to be of concern to the landowner, DRMS, and ARSG. A future project at the site may attempt to cooperatively open the Level 7 Old Portal in an effort to alleviate the potential for an unstable increase in mine pool head within the Gold King workings.

*Gold King Level 7 Old Portal with well-point installed through the drain pipe. This portal may be re-opened in a future project to help stabilize the mine drainage and prevent future increases in mine pool head.*

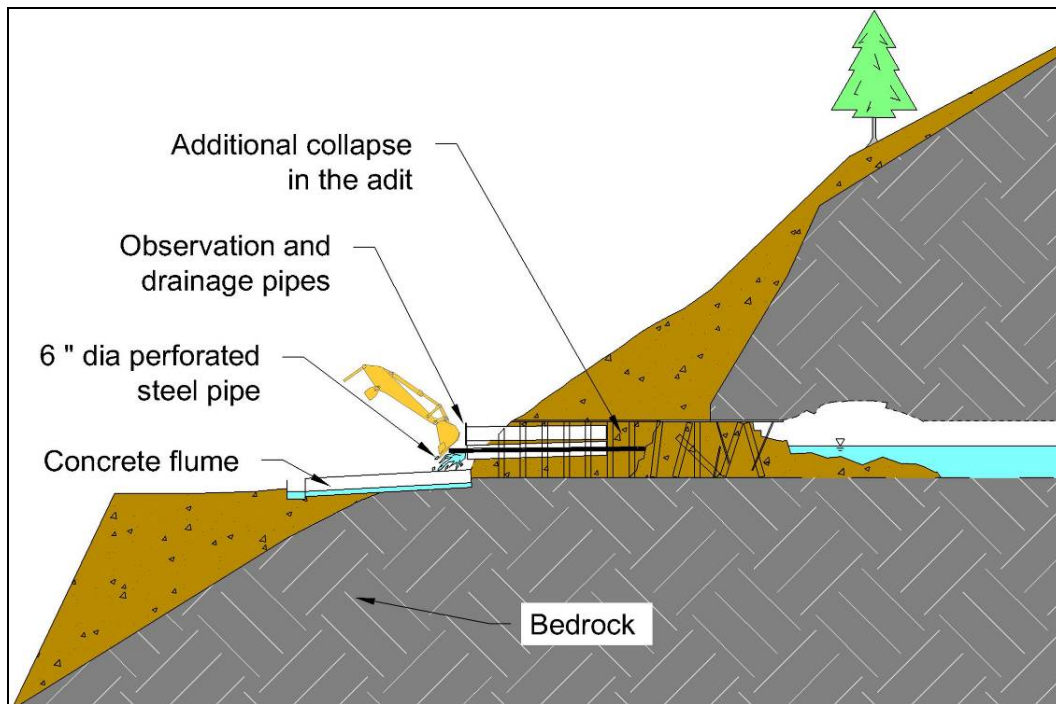
The DRMS stated in the project summary, “A future project at the site may attempt to cooperatively open the Level 7 Old Portal in an effort to alleviate the potential for an unstable increase in mine pool head within the Gold King workings.” Essentially, the closure did not provide adequate drainage and had the potential to blowout.

Figure 21.—Cross-section showing the installation of pipes by DRMS at the Gold King Mine Level 7 New Adit in 2009 (water level as assumed by DRMS) (not to scale).

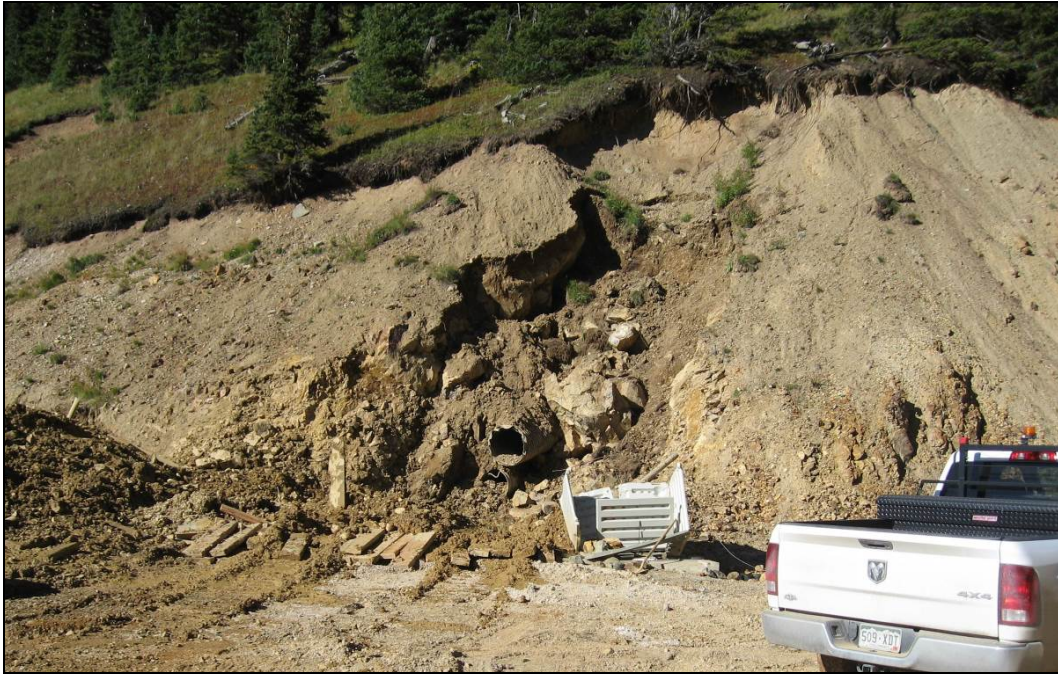
On September 11, 2014, excavations were performed to remove the metal grating and portions of the two pipes installed in 2009. As the excavation progressed down through the fill, seepage appeared (figures 25 through 27). The work stopped when EPA, DRMS, and others observed that in addition to the seepage from the base of the fill, additional seepage was now flowing from higher up on the face of the backfill. Because the excavation had a lip, the seepage ponded at a level equivalent in elevation to about 4 feet below the top of the adit. It was reportedly concluded by those onsite that there was 6 feet of water impounded in the mine (Way, 2014b). A small settling pond was installed at the base of the waste-rock dump to remove sediment from the mine water. The pond was not large enough to treat and settle what was believed to be 6 feet of impounded water. Therefore, the project was put on hold until the following year.

Figure 25.—Photograph showing excavation of the Gold King Mine New Adit portal on September 11, 2014. The metal grating and portions of the upper corrugated HDPE pipe and the lower solid-wall drain pipe have been removed (photograph from EPA project files).

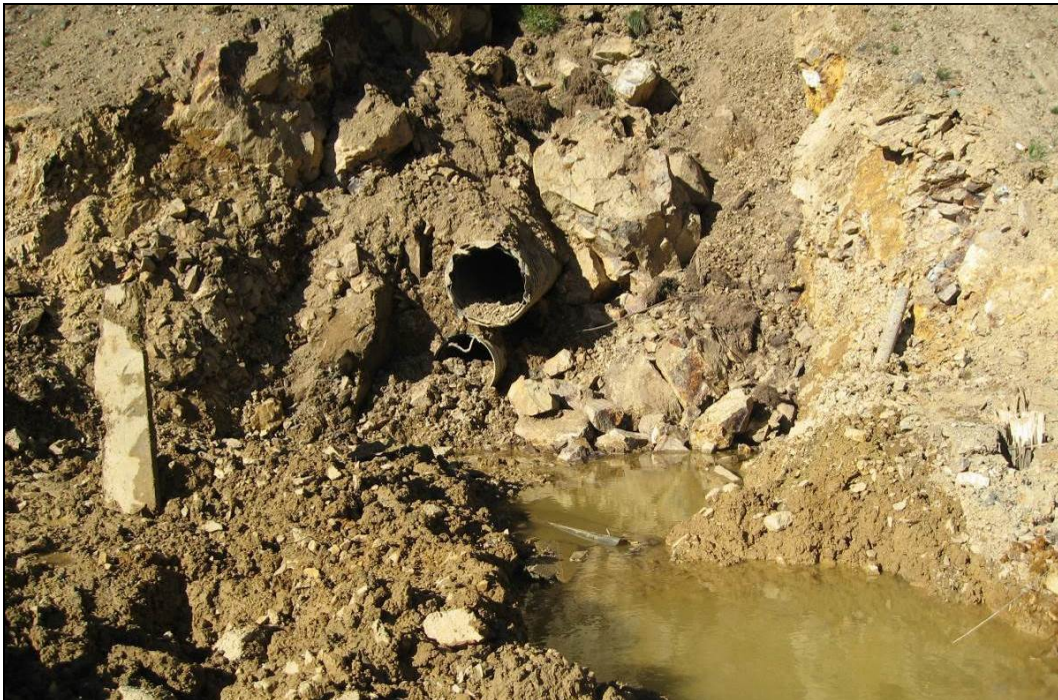
Figure 26.—Photograph showing the excavation of the Gold King Mine New Adit portal on September 11, 2014, taken shortly after the photograph in figure 23 (photograph from EPA project files).

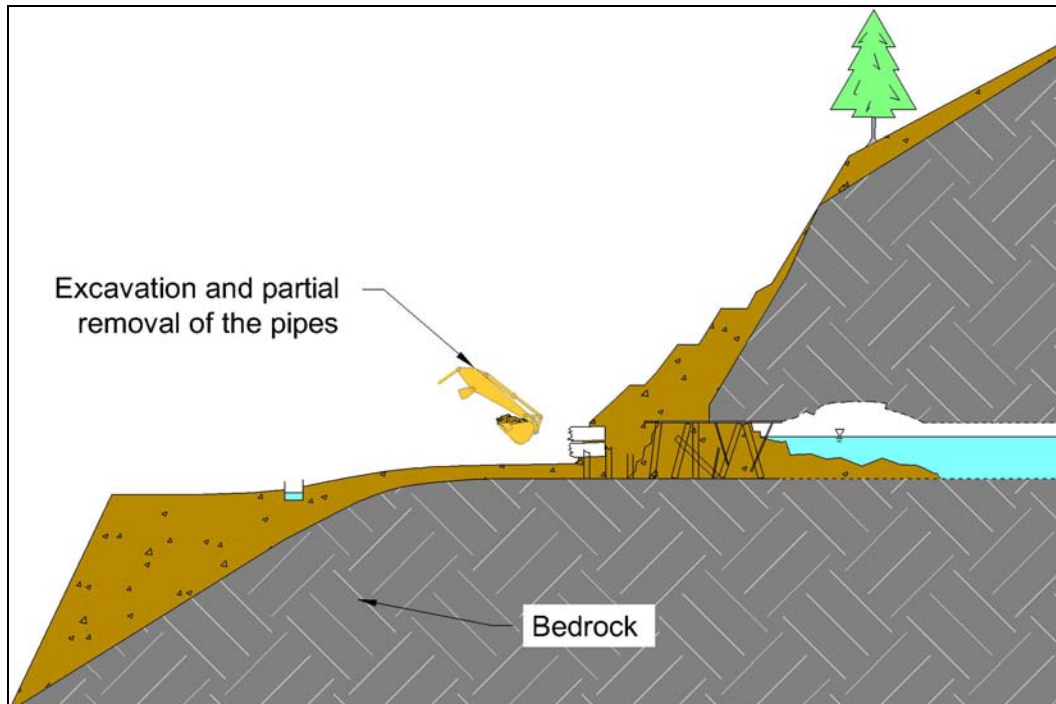
Figure 27.—Cross-section showing the condition of the Gold King Mine New Adit in 2014 (water level as assumed by EPA and DRMS) after the excavation shown in figure 23 was complete (not to scale).

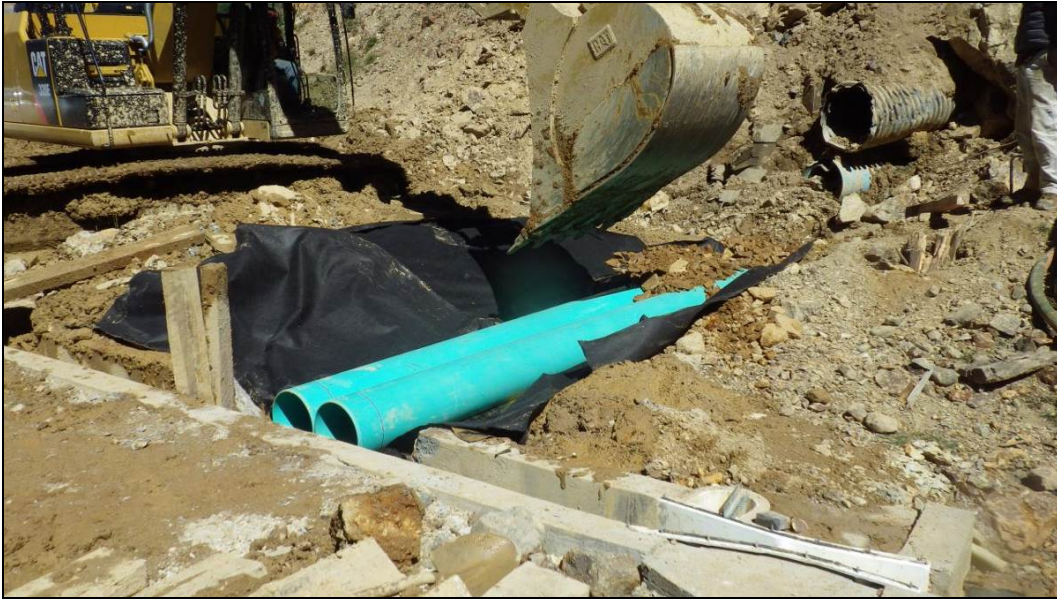
Because they had torn out most of the drain and observation pipes installed by DRMS in 2009, EPA decided to install two new drain pipes surrounded by gravel and a geotextile as a temporary measure. The new pipes were laid at a different angle than the 2009 installation. The side of the concrete trough had to be cut open to accommodate the new drain pipes (figure 28).

Figure 28.—Photograph taken on September 11, 2014, showing the installation of two new 2-foot-diameter drainage pipes. An entrance slot has been cut into the concrete trough for the pipes to discharge into (photograph from EPA project files).

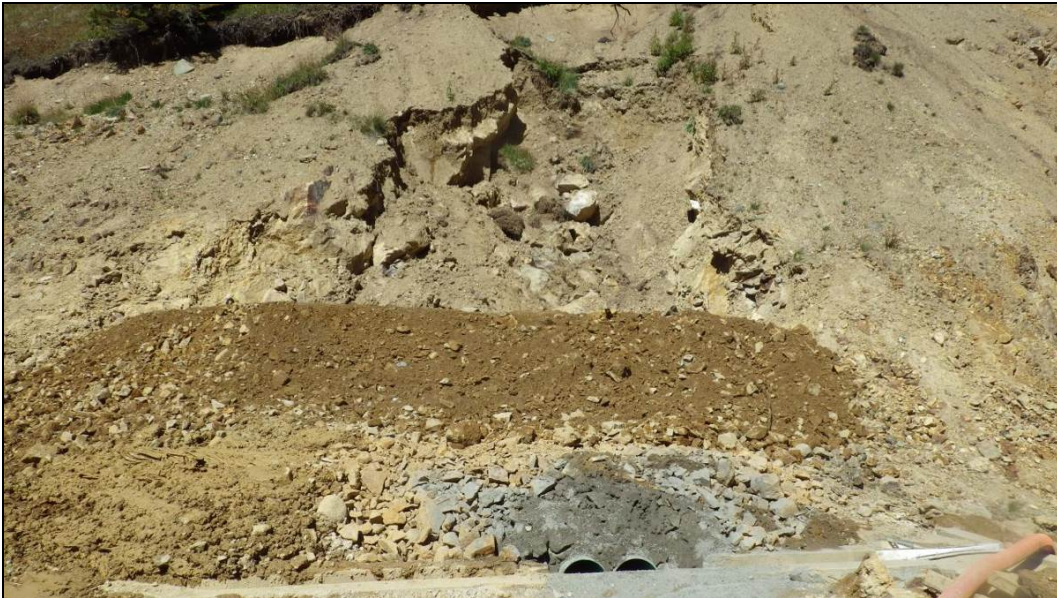
The pipes were covered with gravel. The geotextile was wrapped around the gravel to prevent infiltration of backfill to maintain a pervious zone around the pipes. The geotextile was then covered with backfill. In order to prevent erosion of the backfill soil into the concrete trough, a layer of fast setting concrete was placed over the backfill slope adjacent to the trough (figures 29 and 30).

Figure 29.—Gold King Mine Level 7 New Adit as it appeared on September 12, 2014, when EPA completed placing backfill over the two new drain pipes. Note that a steep slope was left in place in the mountainside above the drain pipe installation (photograph from EPA project files).

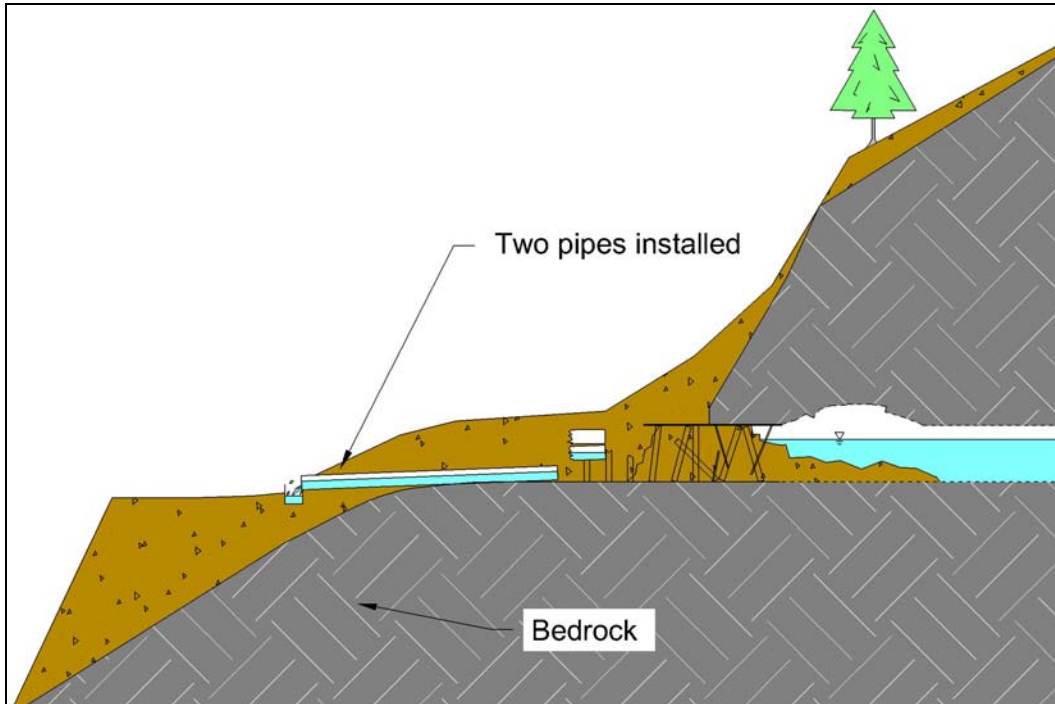
Figure 30.—Cross-section showing the condition of the Gold King Mine Level 7 New Adit in 2014 (water level as assumed by EPA and DRMS), after the installation of the two drain pipes and backfill cover (not to scale).

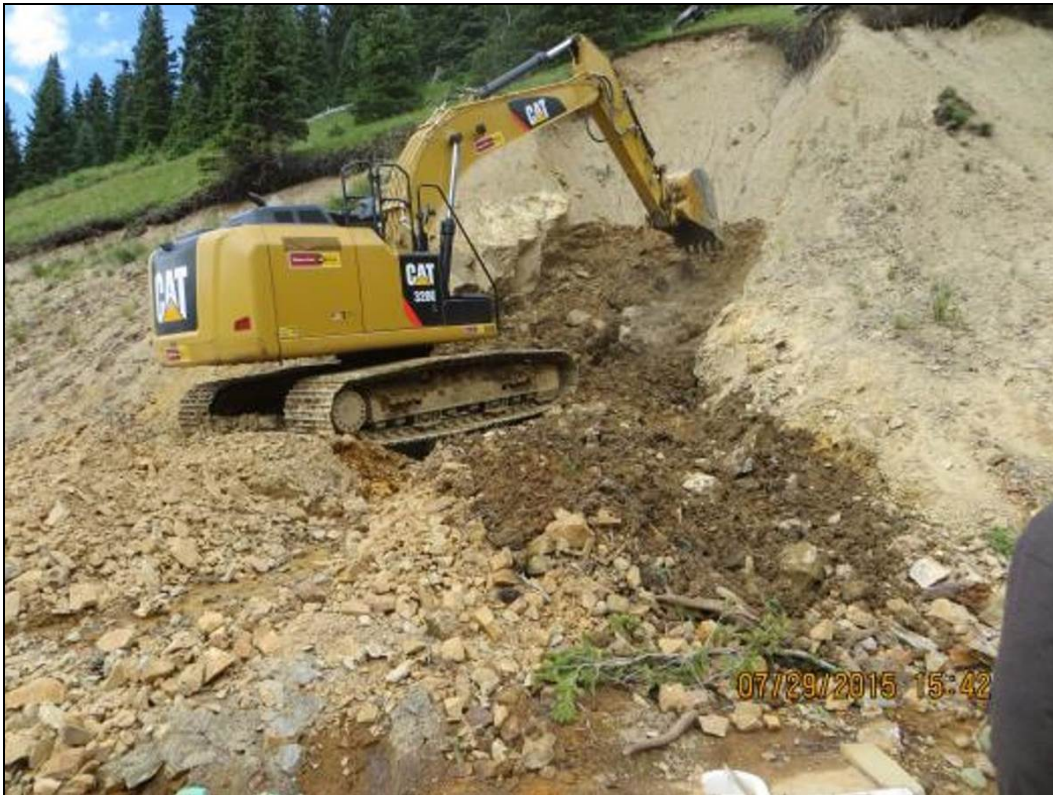
On July 29, 2015, some of the debris that had sluffed down over the winter was excavated from the portal area, and the ends of the pipes were exposed (figure 36). On July 31, 2015, work was begun putting together a manifold piping system that could be used to provide water filtration for the anticipated pump-down of the Gold King Mine.

Figure 36.—Photograph taken on July 29, 2015, showing initial excavation work at the Gold King Mine Level 7 New Adit that was performed to remove the additional accumulation of debris from the eroding slope above the adit (photograph from EPA project files).

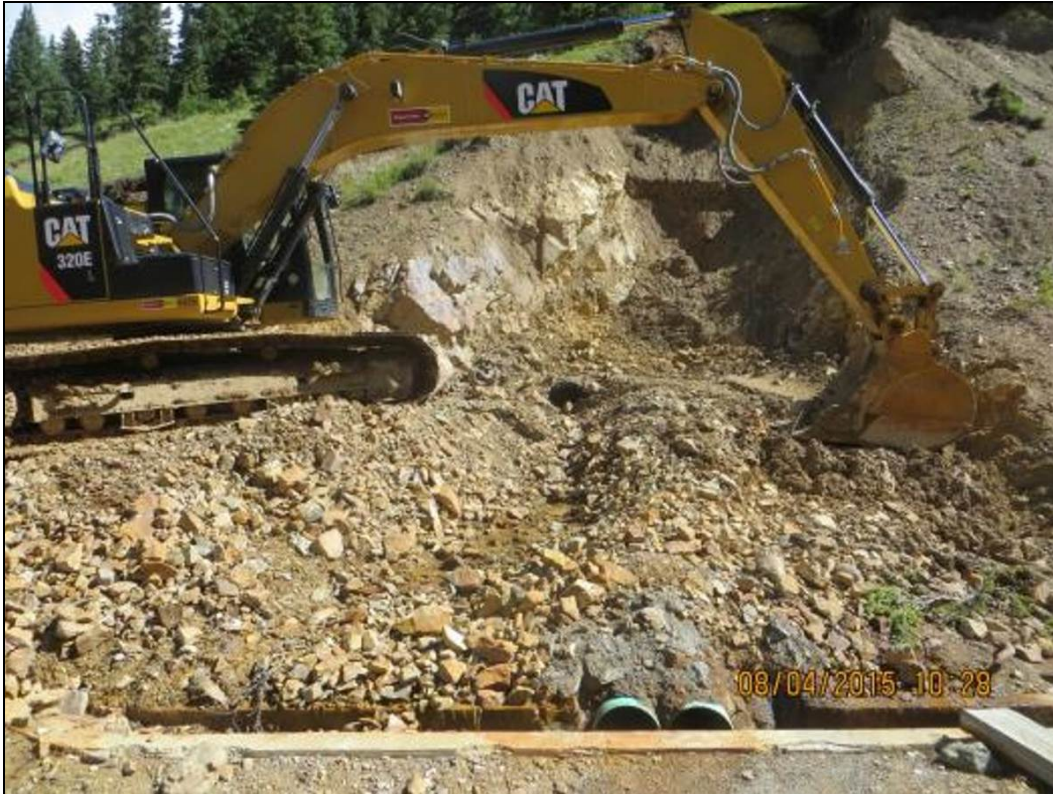
On August 4, 2015, a representative from DRMS was onsite and viewed conditions at the adit. EPA began excavation to examine conditions close to the mine opening similar to what had been done in 2014 (figure 37).

Figure 37.—Photograph showing additional excavation at the Gold King Mine Level 7 New Adit at 10:28 a.m. August 4, 2015 (photograph from EPA project files).

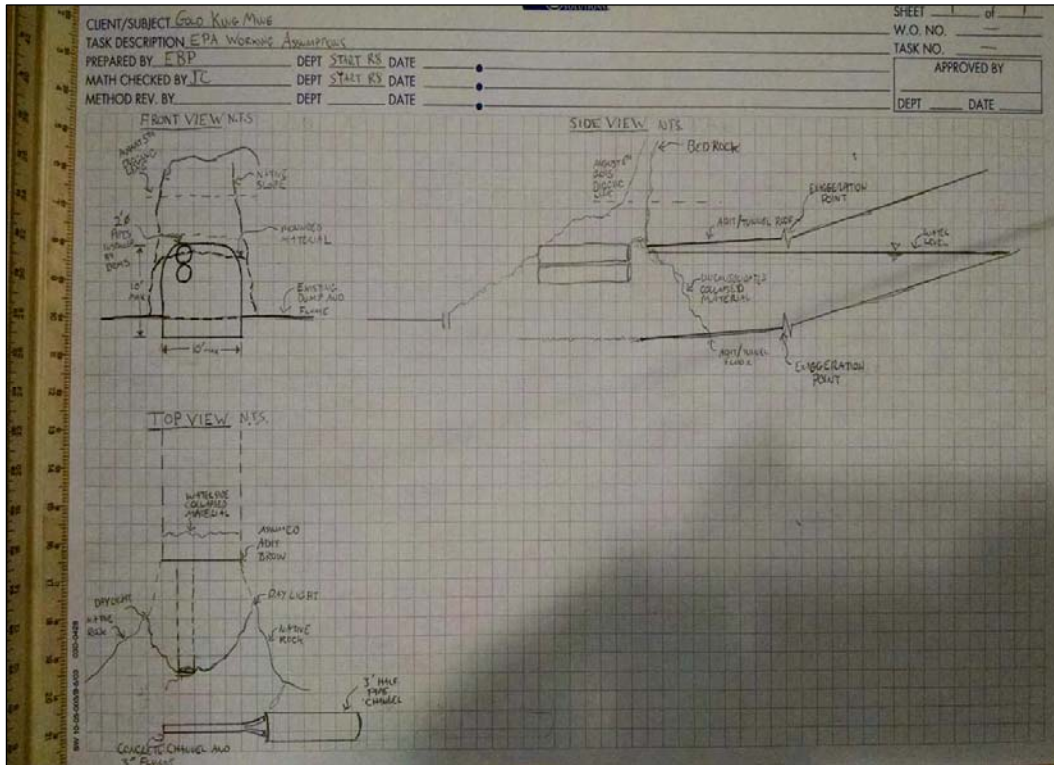
Figure 39 shows a sketch of the plan to open the Gold King Mine Level 7 New Adit portal. To provide a margin of safety, the plan assumes the water was more than 5 feet deep on the upstream side of the blockage, but still below the adit roof.

Figure 39.—Photograph showing the sketch used by EPA to illustrate the conditions at the Gold King Mine Level 7 New Adit portal (photograph from EPA project files).

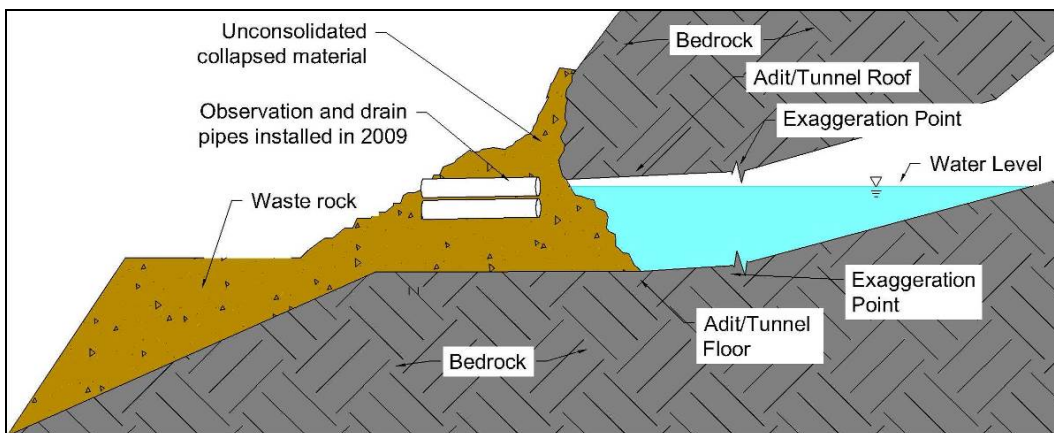
Figure 40.—Cross-section illustration showing the condition of the adit that was assumed by the EPA OSC and the abandoned mine experts from DRMS for use in planning to open the adit (not to scale). The “exaggeration point” means the right side of the drawing has an exaggerated vertical scale in order to show the 1% uphill slope of the adit. If drawn without exaggeration, the uphill slope of the adit would not be obvious on the drawing.

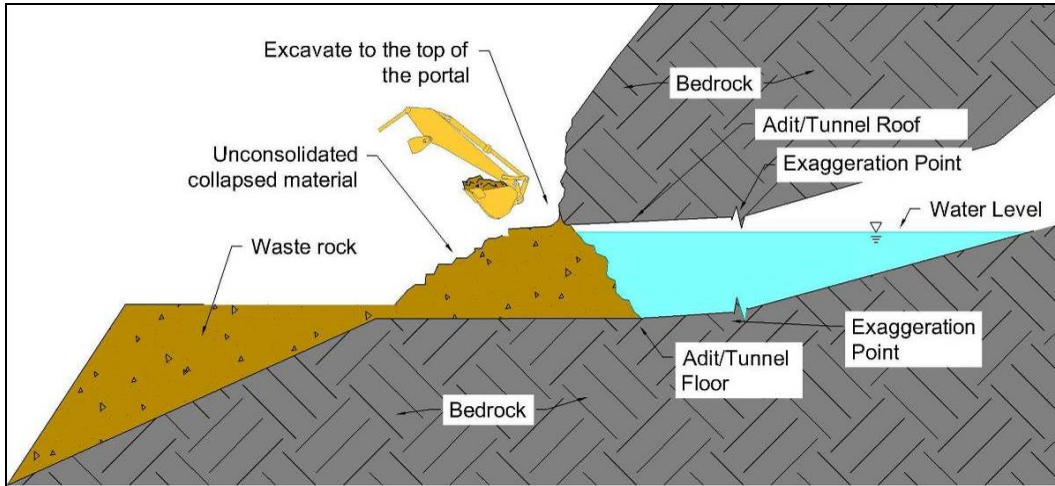
A key aspect of their plan was to only excavate fill lying above the assumed top of the water inside the adit. This method would leave in place the fill holding back the water (figure 41). The next step would push a steel pipe called a “stinger” through the top of the fill to gain access to the mine pool (figures 42 and 43).

Figure 41.—Cross-section illustration showing step 1, the initial excavation to remove the drain pipes and backfill and then carefully excavate the collapsed material to expose the bedrock in the slope above the adit (not to scale).

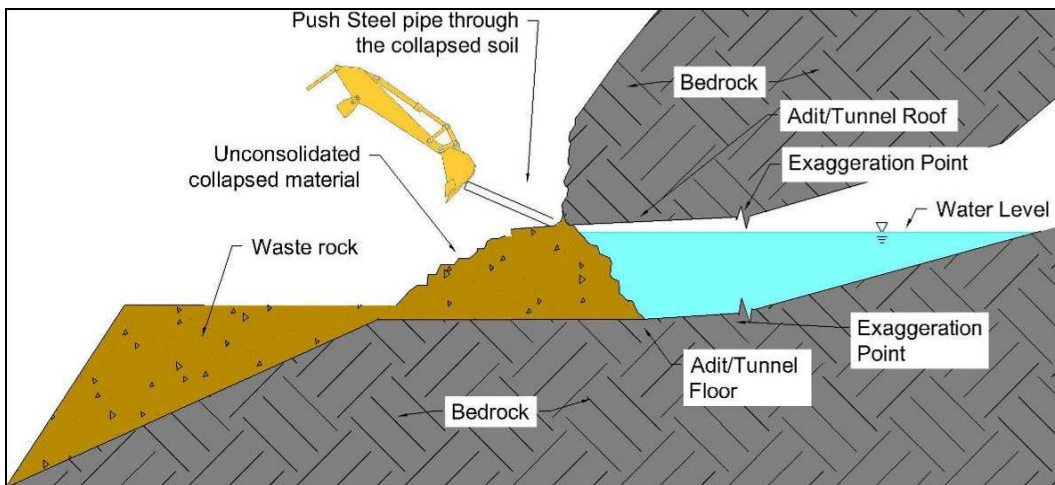
Figure 42.—Cross-section illustration showing step 2 of the plan (not to scale). With the bedrock above the crown of the adit exposed as a guide, a steel pipe called a “stinger” is positioned and pushed into the fill using the bucket of the hydraulic excavator.

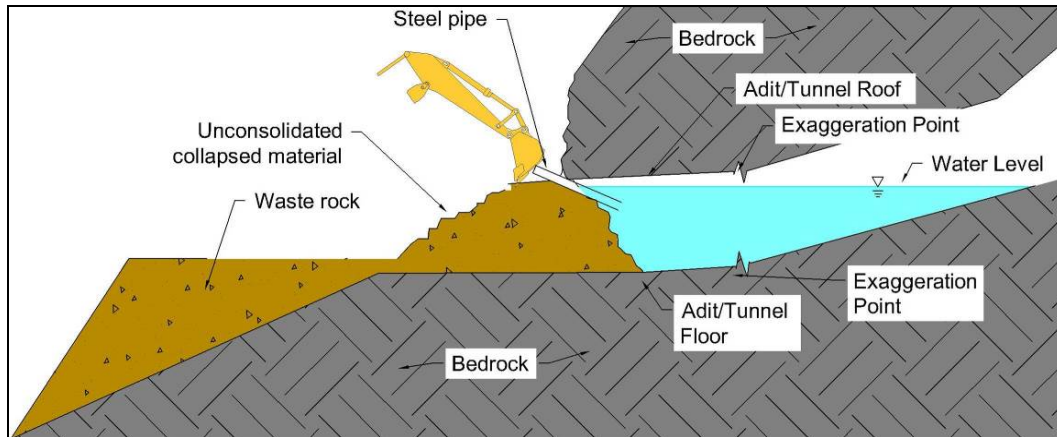
Figure 43.—Cross-section illustration showing step 3 of the plan (not to scale). With the steel pipe fully inserted, contact is made with the water impounded inside the mine.

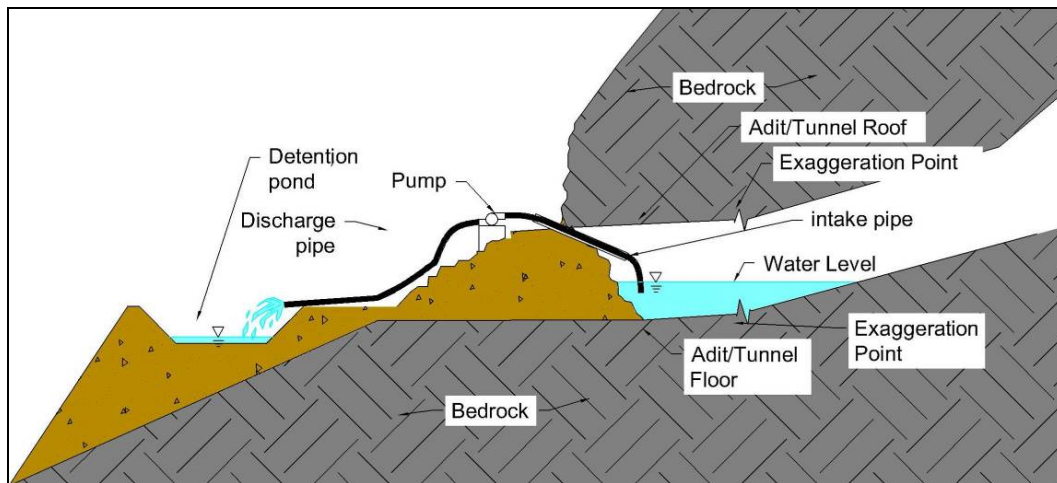
Figure 44.—Cross-section illustration showing step 4 of the plan (not to scale). An intake hose from a pump is inserted into the steel pipe. The pump discharge is taken to a small pond constructed on the waste rock dump. Water from the adit is pumped down. Not shown on this illustration is that the water in the small pond would be continuously removed by another pump and sent to treatment elsewhere on the site.

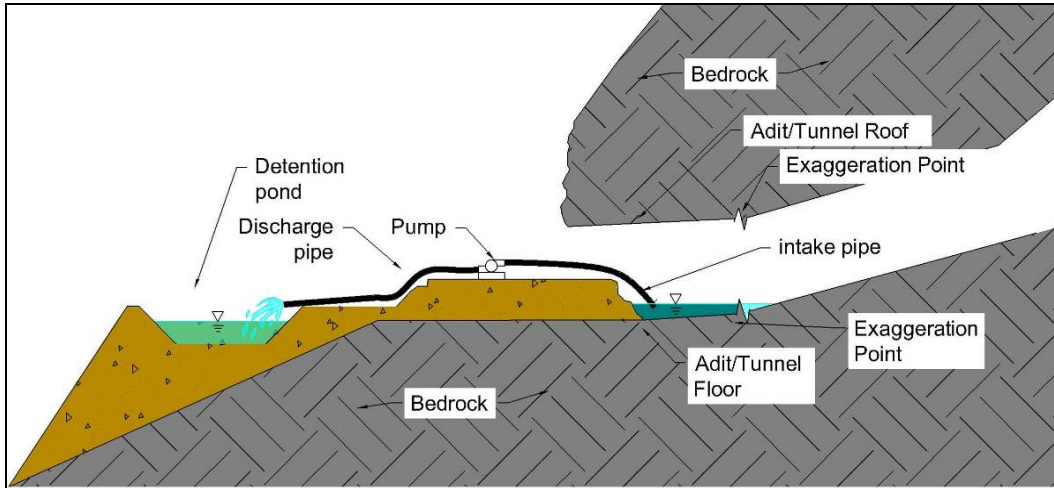
Figure 45.—Cross-section illustration showing step 5 of the plan (not to scale). As the water inside the mine is drawn down by pumping, additional fill from the blockage is excavated and the pump is repositioned to a lower level on the remaining fill. This step is repeated until all the impounded water and the remaining fill is removed; this will establish access to an open adit with the flow freely draining out.

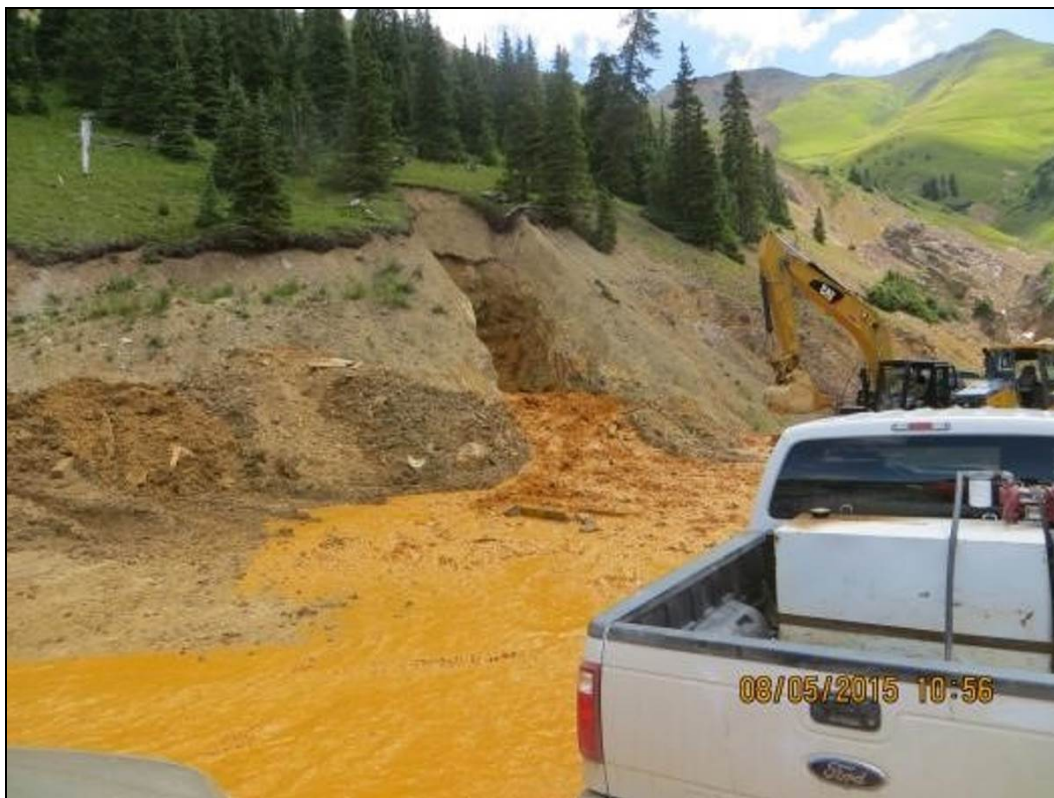
Figure 53.—Photograph showing the blowout at 10:56 a.m. on August 5, 2015 (photograph from EPA project files).

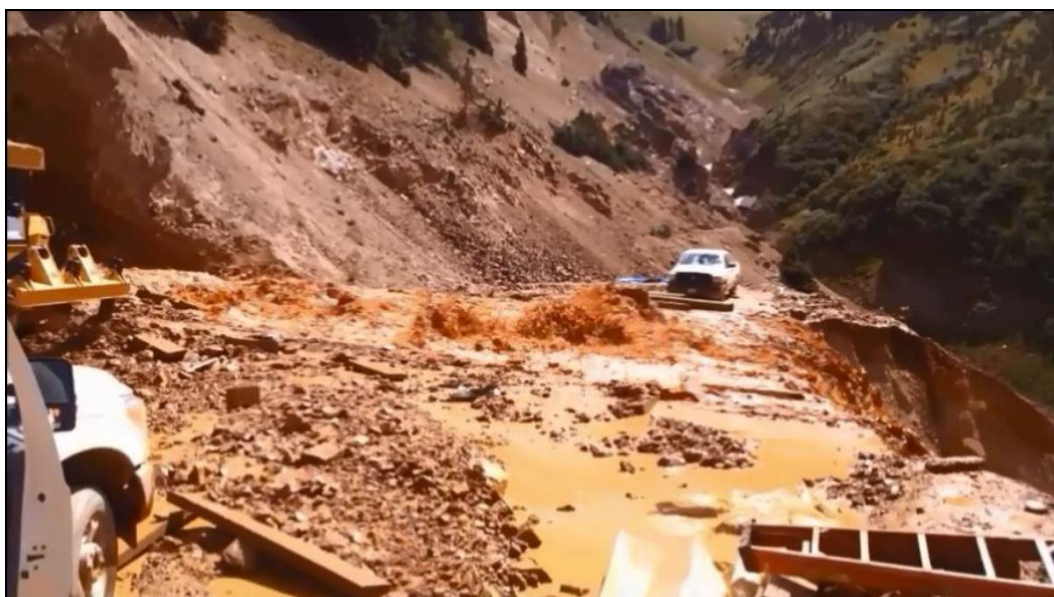
Figure 54.—Photograph showing the peak outflow from the blowout. The waste-rock dump is eroding on the right side of the photograph (still frame extracted from a video taken on August 5, 2015, at approximately 10:57 a.m.).

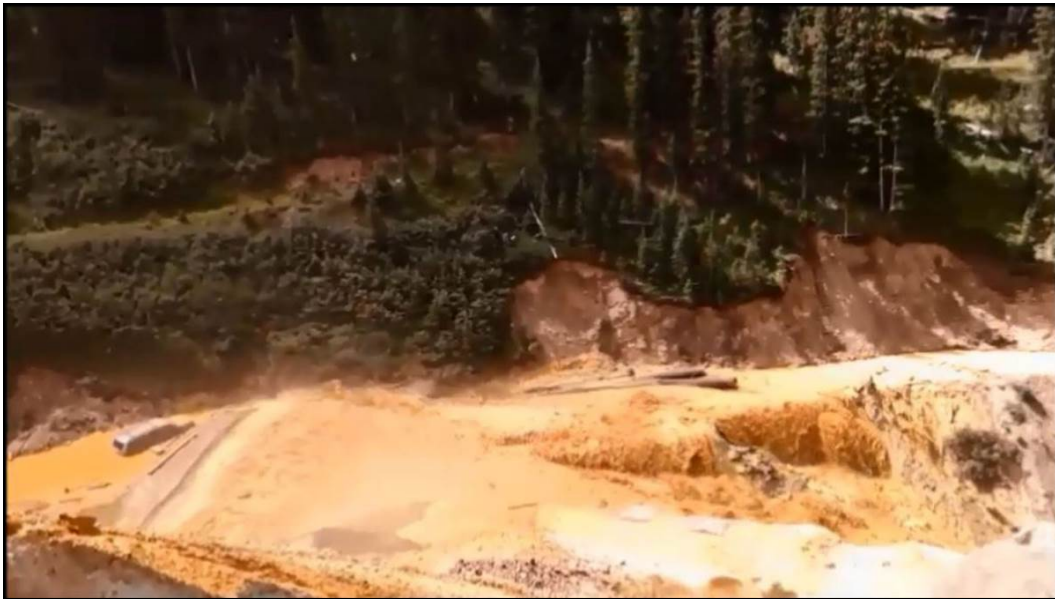
Figure 56.—Photograph showing at left, the inundation of a vehicle parked near the base of the waste-rock dump, and on the right water overwhelming the access road and cascading down into the North Fork of Cement Creek (still frame extracted from a video taken on August 5, 2015, at approximately 10:57 a.m.).

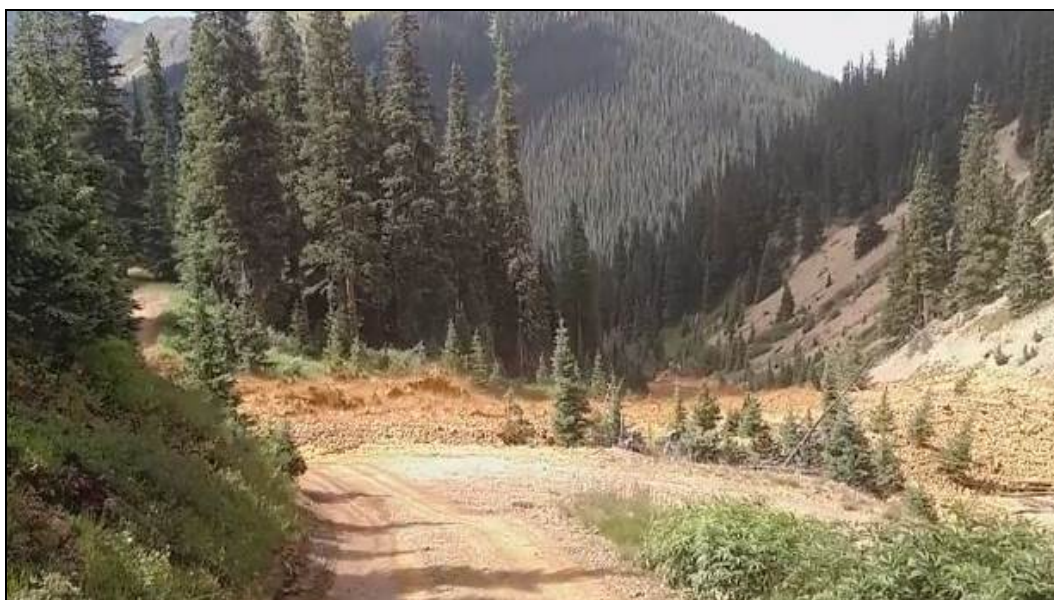
Figure 58.—Photograph looking south along the lower road and Cement Creek showing the blowout flow surging across the lower road and overwhelming Cement Creek (still frame extracted from a video taken on August 5, 2015, at approximately 11:00 a.m.).

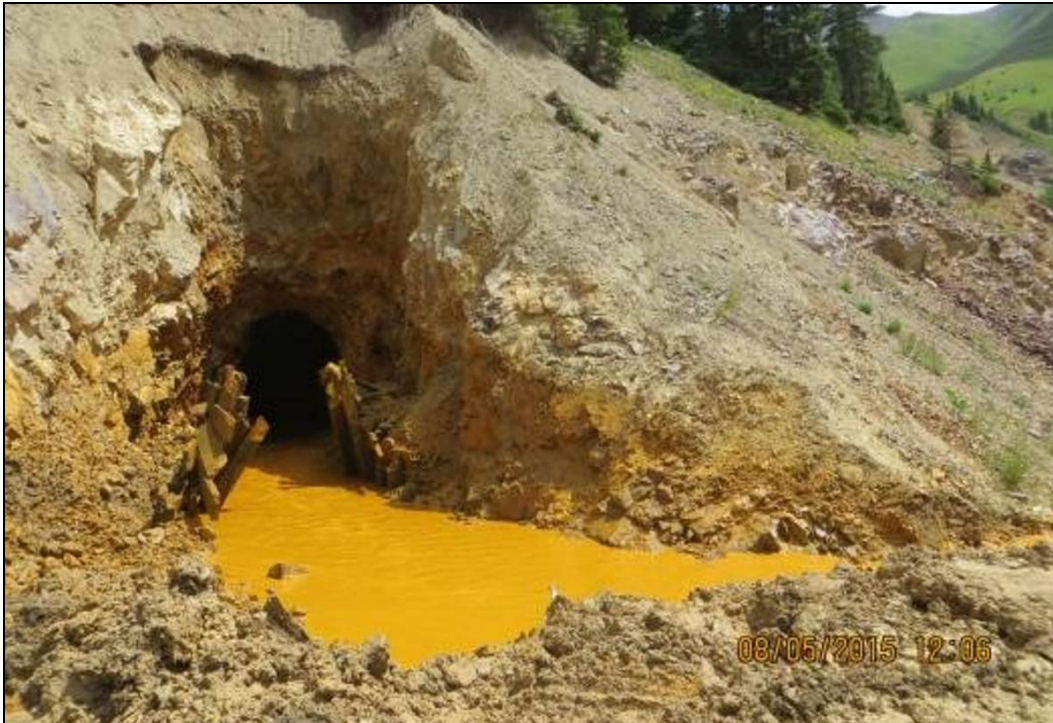
Figure 60.—Photograph showing that the flow had been routed back toward the half-round pipe by 12:06 p.m. on August 5, 2015 (photograph from EPA Project Files).

EPA called down for the roads to be blocked where the stream crosses them, which was promptly accomplished. They also had word passed on to people in Silverton. The details of the notifications made are not a subject of this report. At the site, the top of the waste-rock dump surface was repaired, and the flow was directed back into the remaining bit of the concrete trough and half-round pipe (figure 60). With this accomplished, all but one person left the site by walking down the mountain. One person stayed behind for a few hours to monitor the adit for additional outbursts.

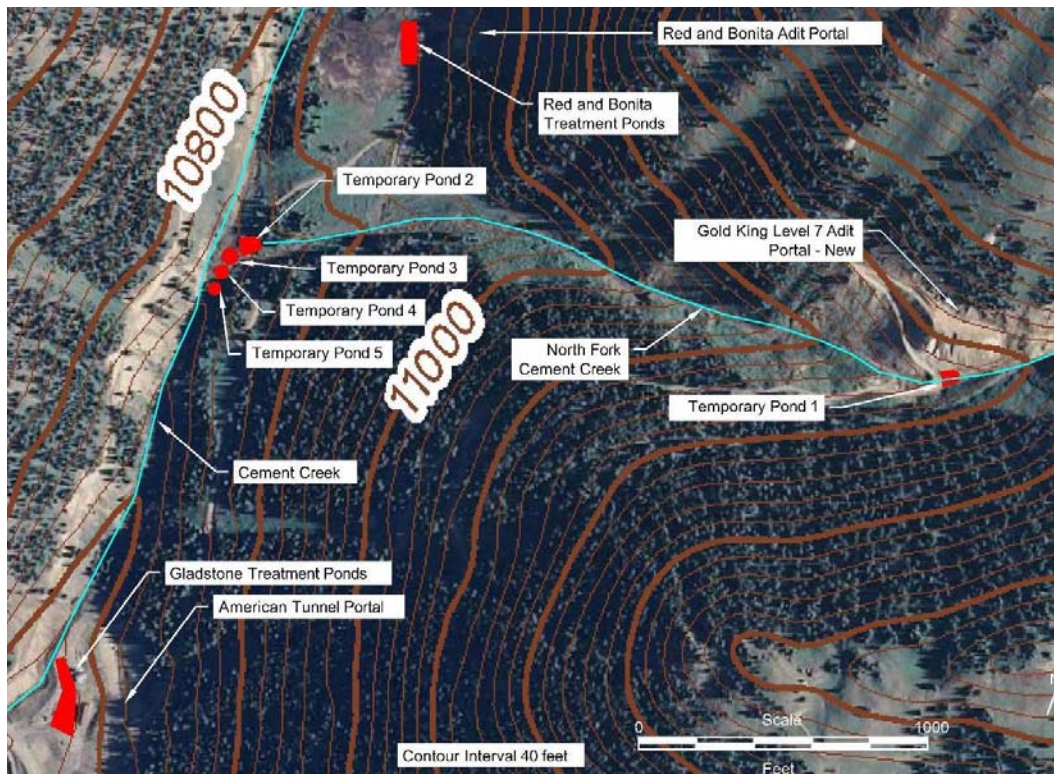
Figure 61.—Illustration showing the location of the temporary treatment ponds that were placed on the North Fork of Cement Creek after the incident.

After notifications were initiated, work began on road repair to reestablish access to the site. This work continued into mid-September. Most of the debris had been deposited in Cement Creek near the confluence with the North Fork of Cement Creek. The debris was removed. Temporary water treatment ponds were constructed on the North Fork using the debris (figure 61). The ponds were immediately put into operation.

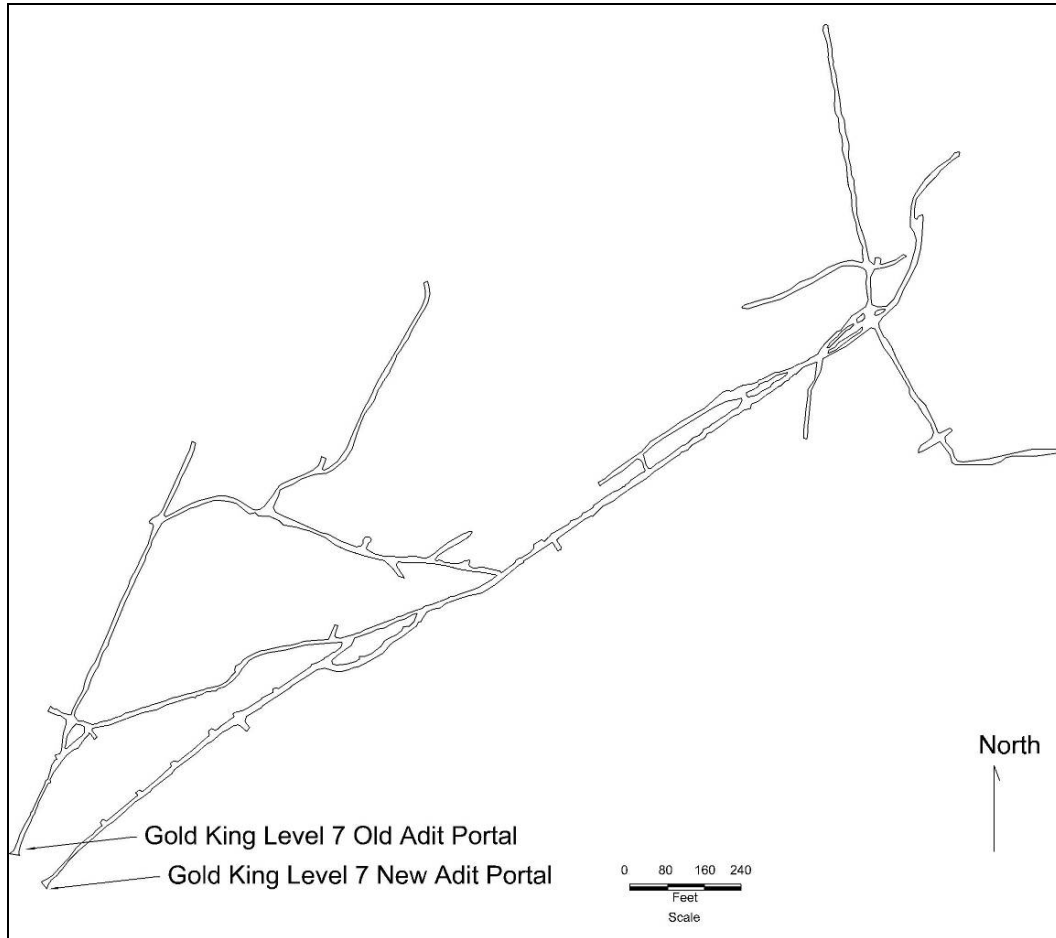
More importantly, because of the gently inclined slope of the new adit to provide drainage, even if the 3 million gallons did not completely fill Level 7 of the mine, it would have completely filled the mine portal area under pressure. The floor of the adit 1,000 feet back in the mine is 10 feet higher than it is at the mine entrance. Even if the water was only 1 foot deep there, the pressure against the portal blockage would have been equivalent to 11 feet of water. The Level 7 adit is estimated to be approximately 2,400 feet long, and therefore it can reasonably be assumed that the water pressure at the portal was significantly higher than that resulting from the water being simply full to the roof at the portal.

Figure 66.—Map showing the extent of the Gold King Mine Level 7 underground workings.

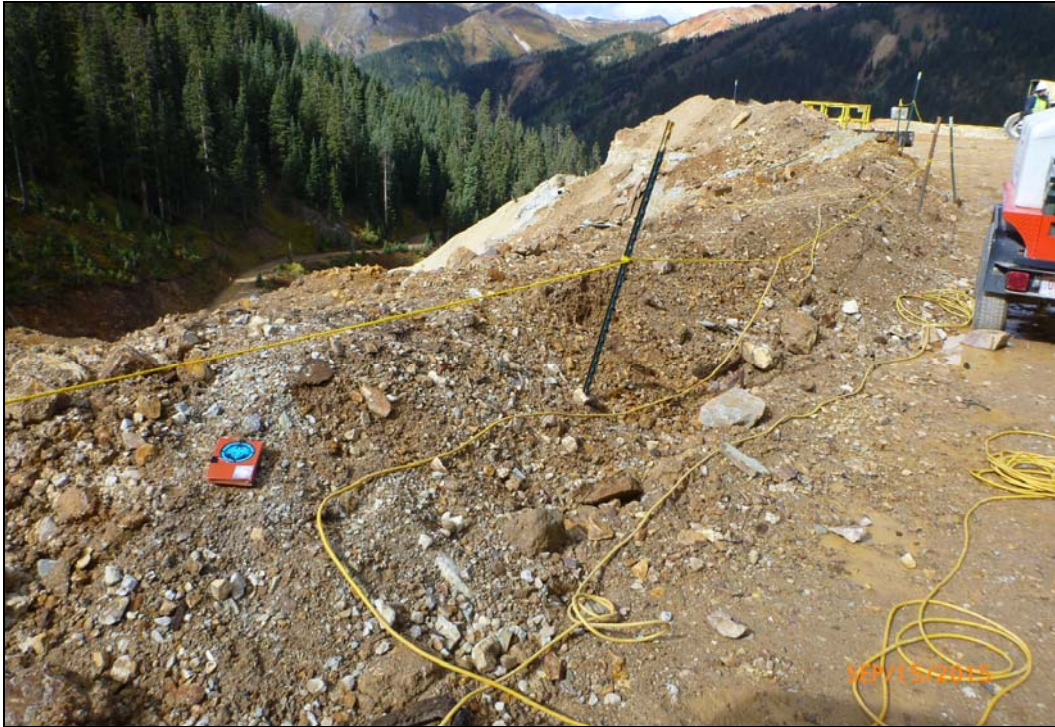
Two samples of the soil from the site were tested (appendix C). Both samples were classified as GC (clayey gravel with sand) with PI (plastic index) values of 13 and 14. Two samples of the clayey gravel were tested for permeability with results of  $3.6 \times 10^{-3}$  cm/s and  $3.4 \times 10^{-4}$  cm/s. This material is not free draining with respect to the observed seepage quantities

Figure C-1.—Photograph showing the safety berm made of soil that was excavated from in front of the Gold King Mine Level 7 New Adit portal. Sample No. 1 consisted of soil sampled from various locations along the safety berm.

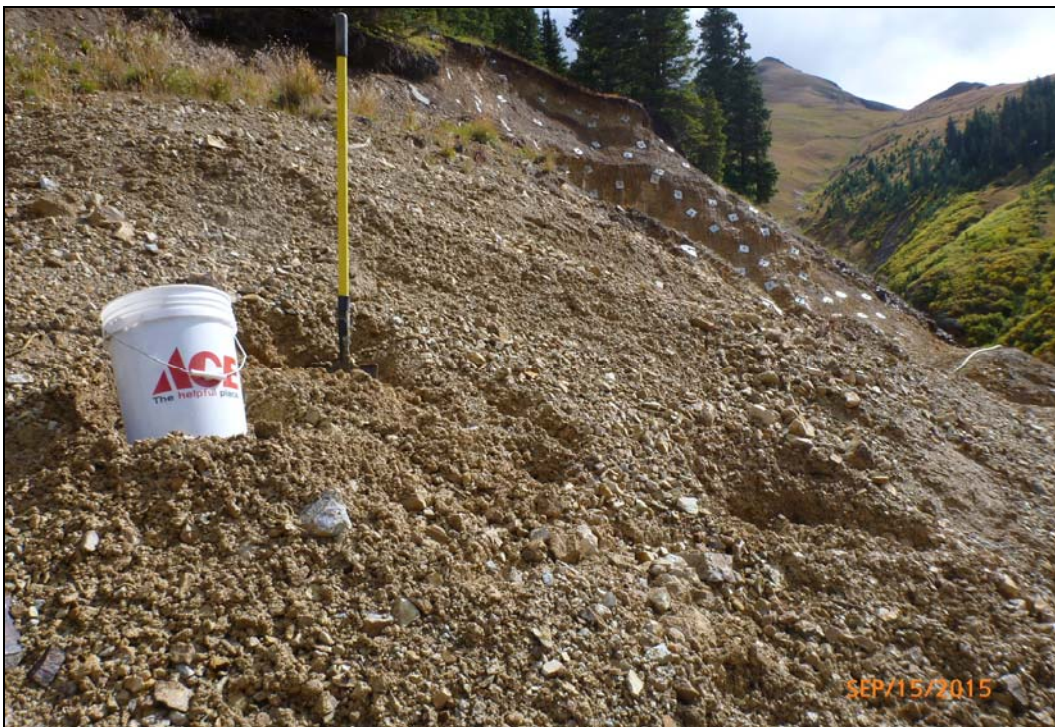
Figure C-2.—Photograph of stockpile where Sample No. 2 was collected. The rock anchors supporting the Gold King Mine Level 7 portal can be seen in the background.
