The Failure of the Aznalcóllar Tailings Dam in SW Spain

Eduardo E. Alonso¹

Abstract

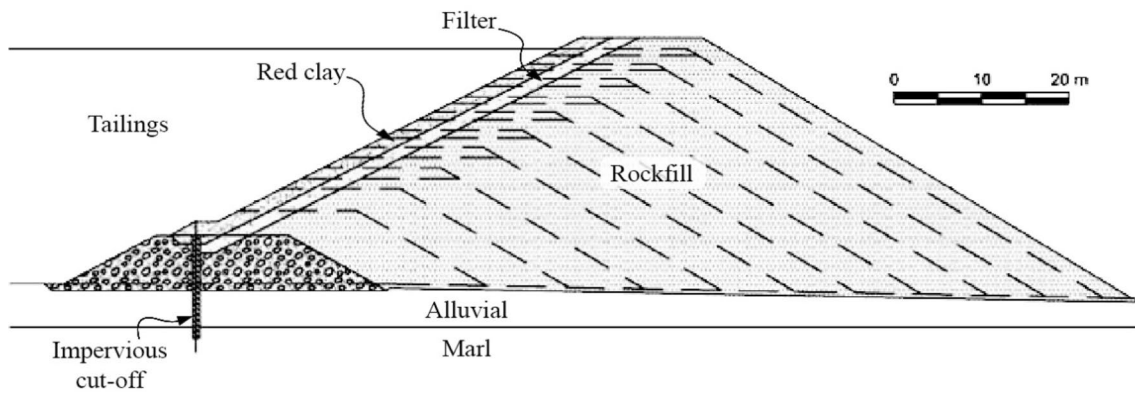
The Aznalcóllar dam was a retention structure for a deposit of saturated pyritic tailings. The dam was a strong rockfill retaining structure built by a downward technique, illustrated in Fig. 1. The figure shows an upstream impervious clay layer, to restrict the water flow, an inner filter, and the rockfill. At the time of failure, the dam was 28 m high and the upper level of the tailings was 2 m below the dam crest. The length of the perimeter dam was 4.5 km. A 600 m long stretch on the southeast side of the dam slid forward, about 50 m, on the 25th of April, 1998. This displacement led to the release of seven million m³ of liquefied

Fig. 1 The original design of the dyke cross section and the specified construction sequence

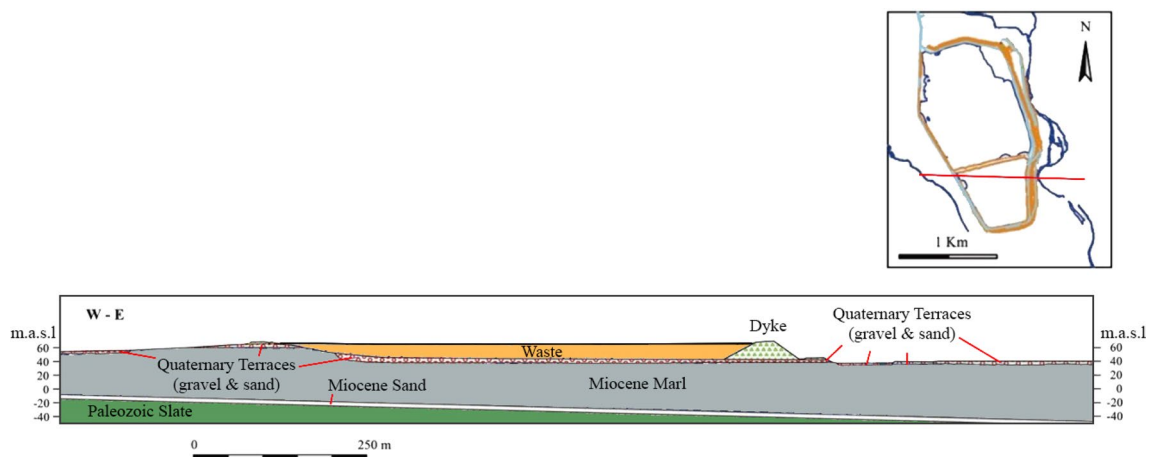
Figure 4 is an illustrative cross section of the southern pond, the one involved in the failure (Alonso and Gens 2006a). The waste was confined by a perimeter dyke,

which had its maximum height on the eastern side. On the opposite western side, a natural hill helped to complete the tailings enclosure. The dyke and the waste rested on an alluvial permeable terrace, 3–4 m thick, which overlaid a 60–70 m thick deposit of over-consolidated brittle marine clays of Pliocene age. A thin aquifer covering a Paleozoic substratum provided the lower boundary for the Tertiary clay, known locally as the Guadalquivir blue clay.

Fig. 4 Representative geological profile

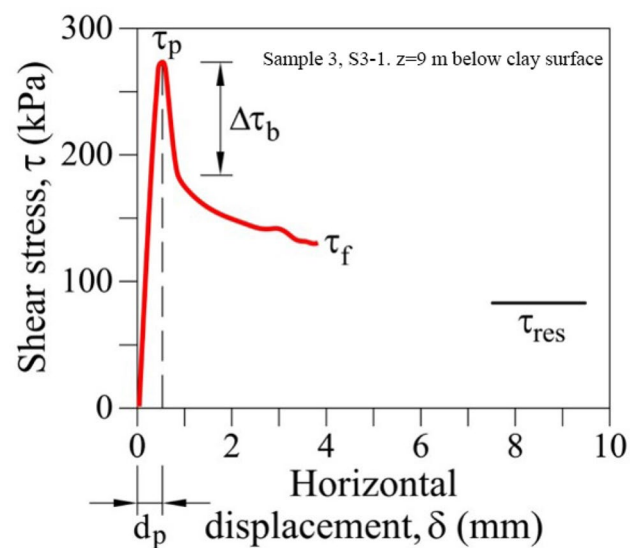
Fig. 8 A drained direct shear test of a 50 mm diameter sample of blue clay under a normal effective stress of 400 kPa. Figure 5 shows the position of boring S3-1

The clay deposit is very homogeneous, a condition accepted in all stability calculations. Drained direct shear tests provided good information on the clay’s brittleness. Figure 8 shows the shear stress-displacement record for a sample recovered at a depth of 9 m below the upper clay surface.

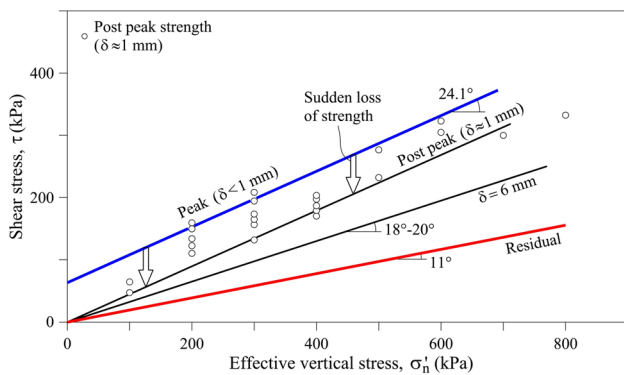
The set of shear tests performed were also used to determine the shear strength envelopes (Fig. 9). An effective cohesion of 64 kPa and a drained friction angle of 24.1° characterizes peak conditions for very small relative shear displacements ($< 1 \text{ mm}$). Further deformation leads to a progressive softening. The residual friction for relative shear displacements in excess of 10 mm was 11°.

Fig. 9 Strength envelopes of Guadalquivir blue clay based on direct shear tests

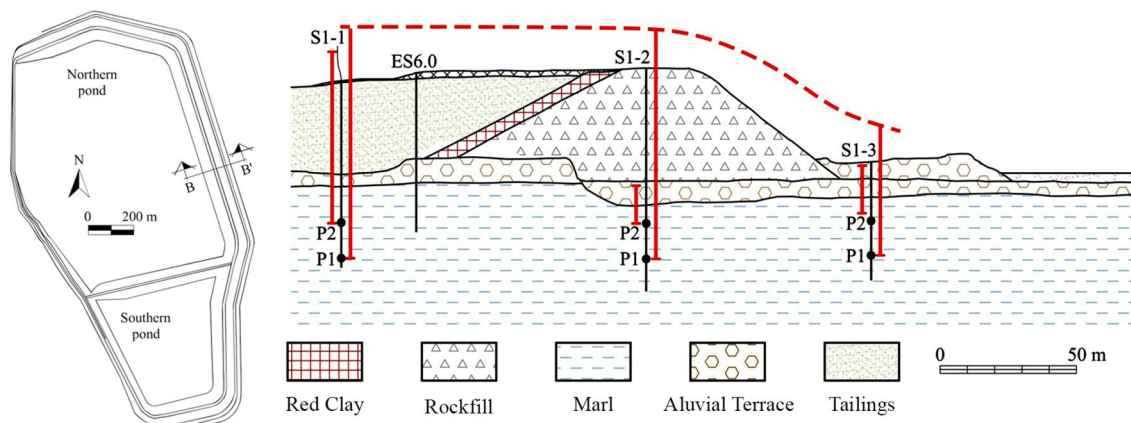
A key aspect of the failure was the pore pressure measurements in the foundation blue clay in locations not directly affected by the landslide. The northern dyke, which did not fail, was a convenient choice to install a few vibrating wire piezometers because its geometry and construction history was identical to conditions of the failed southern dyke. Figure 10 shows some measurements taken more than a year after the failure. Despite the time elapsed without any further raising of the dam and the partial unloading of the tailings weight, the pore pressures a few meters below the upper clay boundary were still very high, due to the low, homogeneous clay permeability. This information was the starting point for a simplified analytical procedure to determine the evolution of stresses and pore pressures on the foundation clay during the entire construction history of the deposit. Alonso and Gens (2006a) and Gens and Alonso (2006) provide details of this analysis, which relied on the following assumptions:

Fig. 10 Measured pore water pressure profile in northern dyke after failure of the southern dyke, October 1999. (The length of the red segments, at the scale of the figure, provides the piezometric head at the considered point)

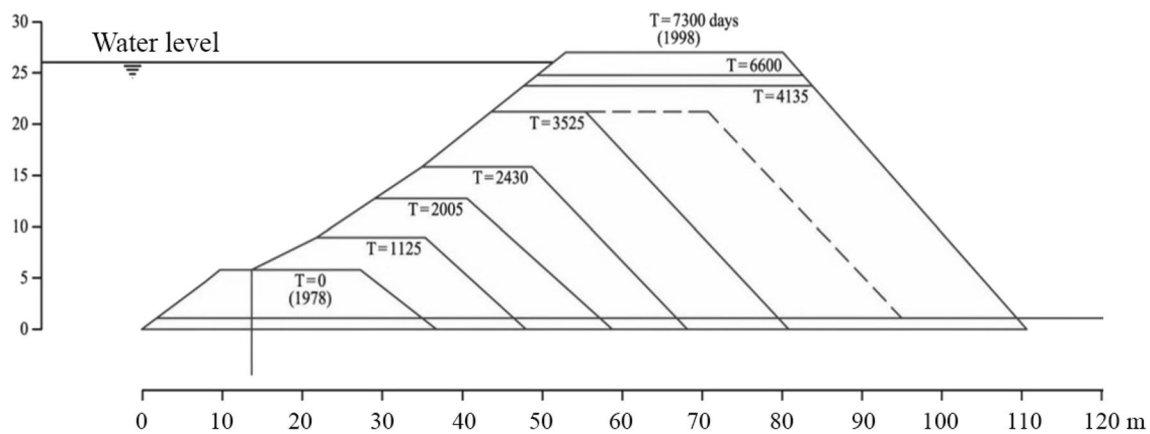
This procedure provided a good indication of the process of progressive failure experienced by the foundation clay during the forward construction of the dike. Figure 11 shows the actual sequence of dam construction.

Fig. 11 The evolving geometry of Aznalcóllar dam

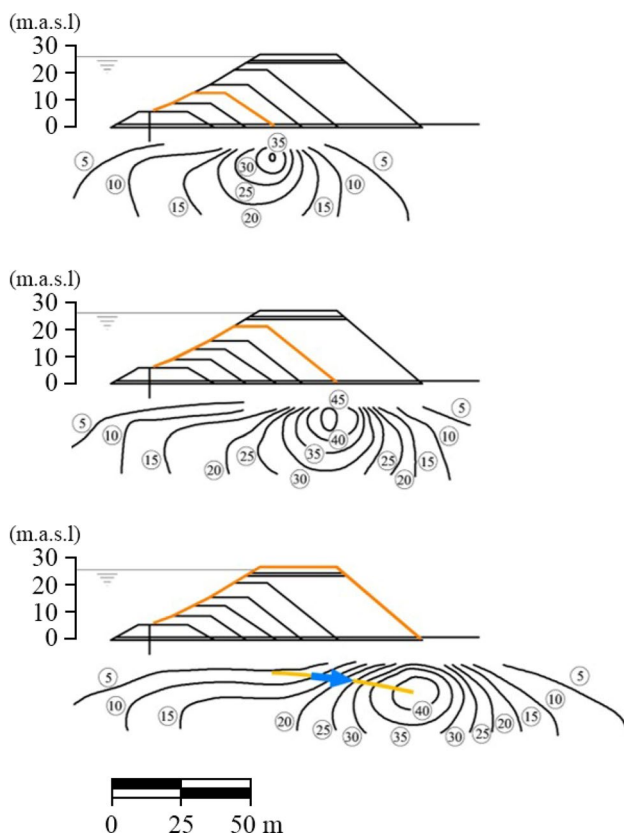
Fig. 12 Mobilized stress ratio in the clay foundation during dam construction

Figure 12 shows the theoretical mobilized friction angles in the clay foundation at three instants of the pond and dam construction. The maximum mobilized friction values occur below the downstream toe of the dam. They are high enough to exceed the peak strength and to trigger progressive failure. An indication of the position and development of a failure surface is plotted by an arrow line in Fig. 12.

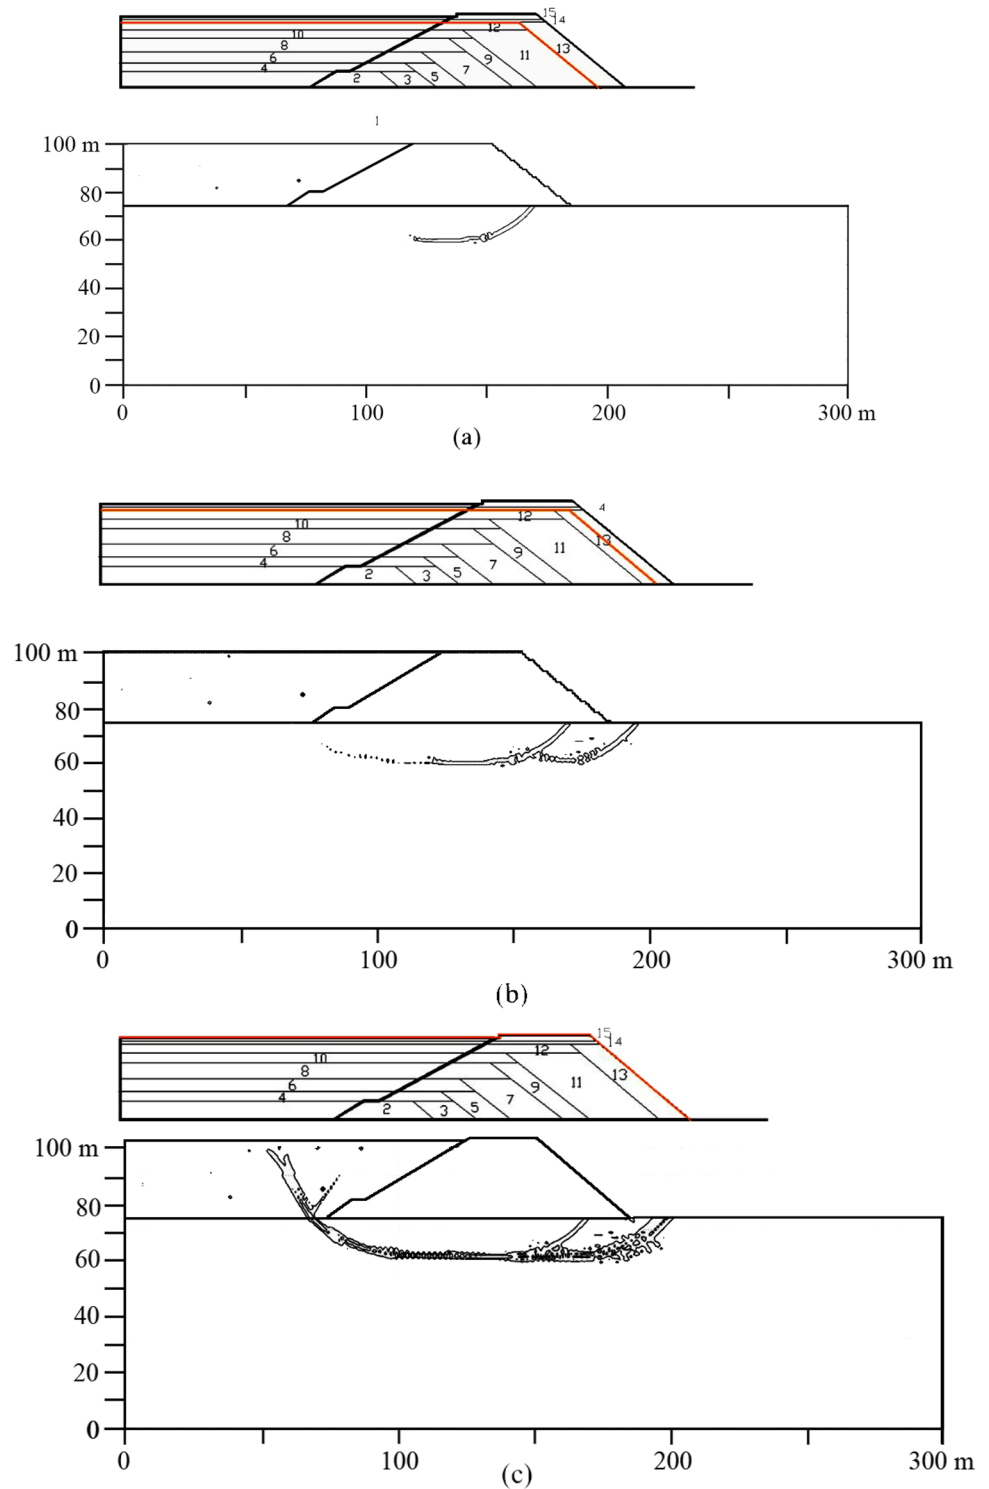
Figure 13 shows the calculated evolution of the shear band for four instants of the dam construction. The model indicates that the first confined shear band developed at an advanced state of construction, about 4 years before the final failure. The model faithfully reproduced the position of the failure surface and its planar geometry. Also, the results were sensitive to the initial state of stress. The best agreement with the observations occurred at an at-rest coefficient of $K_0 = 1$, which is consistent with a moderately overconsolidated clay.

Fig. 13 a–c Development of the sliding surface for the final stages of dam construction. Plots indicate the contours of plastic deviatoric strain (1% and 5%). At rest coefficient: $K_0 = 1$

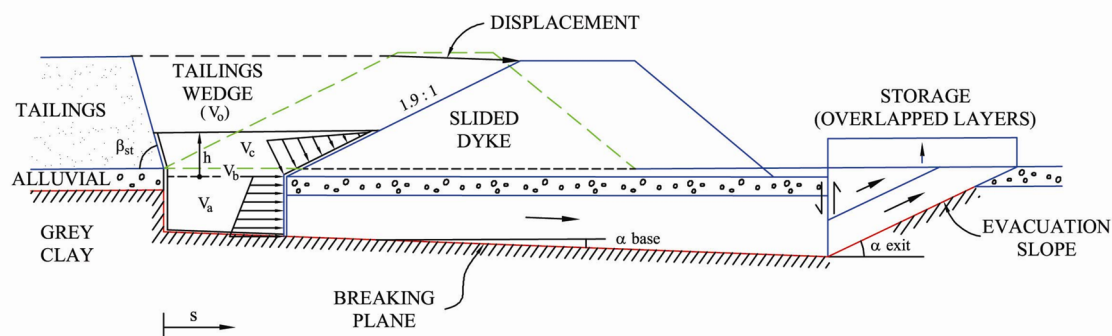
The third point was analysed in more detail. Figure 15 is a “free body” diagram of the slide. The stiff rockfill dyke move forward as a solid body without apparent distortion. A layer of clay and the alluvial terrace also moved forward sliding on a well-defined shearing surface which was, most likely, a sedimentation plane. This layer deformed in a passive manner at the toe of the slide.

A static equilibrium analysis of the dam, foundation soils, and tailings at the time of failure ($s=0$ in Fig. 15) is consistent with an average drained friction angle of 18° operating

Fig. 15 Free body diagram of the forward motion of the dam and its foundation

on the sliding clay surface. As the dam accelerated and was displaced, the friction angle dropped to 11° along the entire failure surface (Alonso et al. 2010). Alonso and Gens (2006b) provides the details.

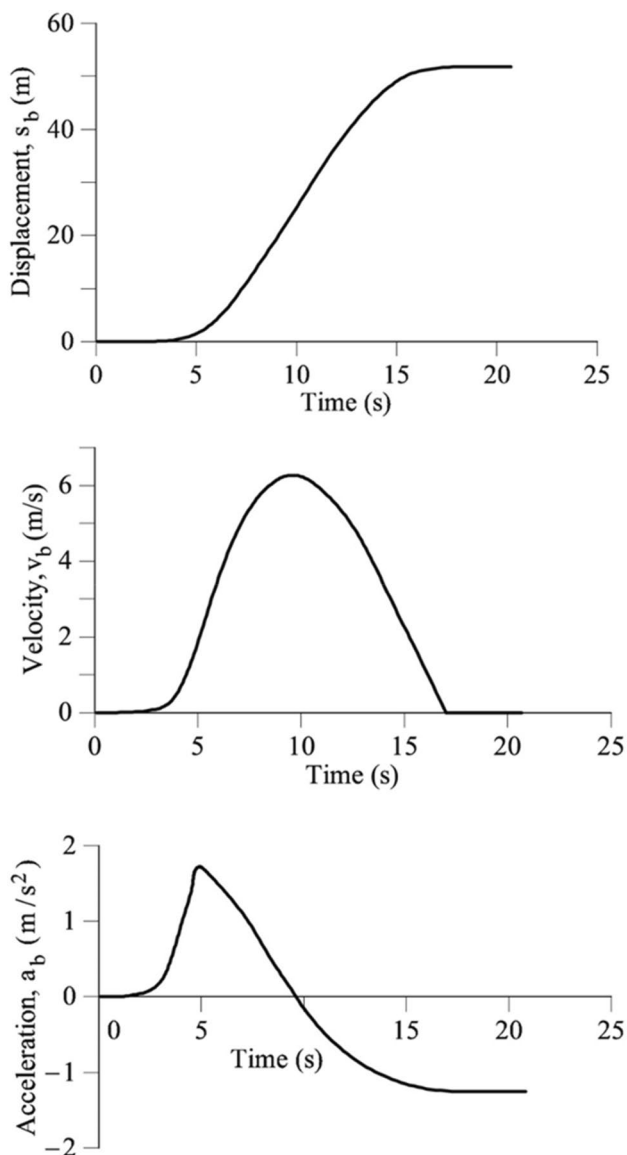
Figure 16 shows the calculated evolution of displacement, velocity, and acceleration of the dam. The calculated displacement matches the observations well. The passive wedge developing at the frontal part of the motion increased in resistance, but the main factor controlling the entire motion was the continuous reduction of tailings level pushing the dam. The calculated maximum velocity (Fig. 16) was slightly over 6 m/s (20 km/h) and the peak acceleration was 1.8 ms^{-2} . Overall, the estimated duration of the slide was 17 s.

Fig. 16 The motion after failure: displacement, velocity, and acceleration records

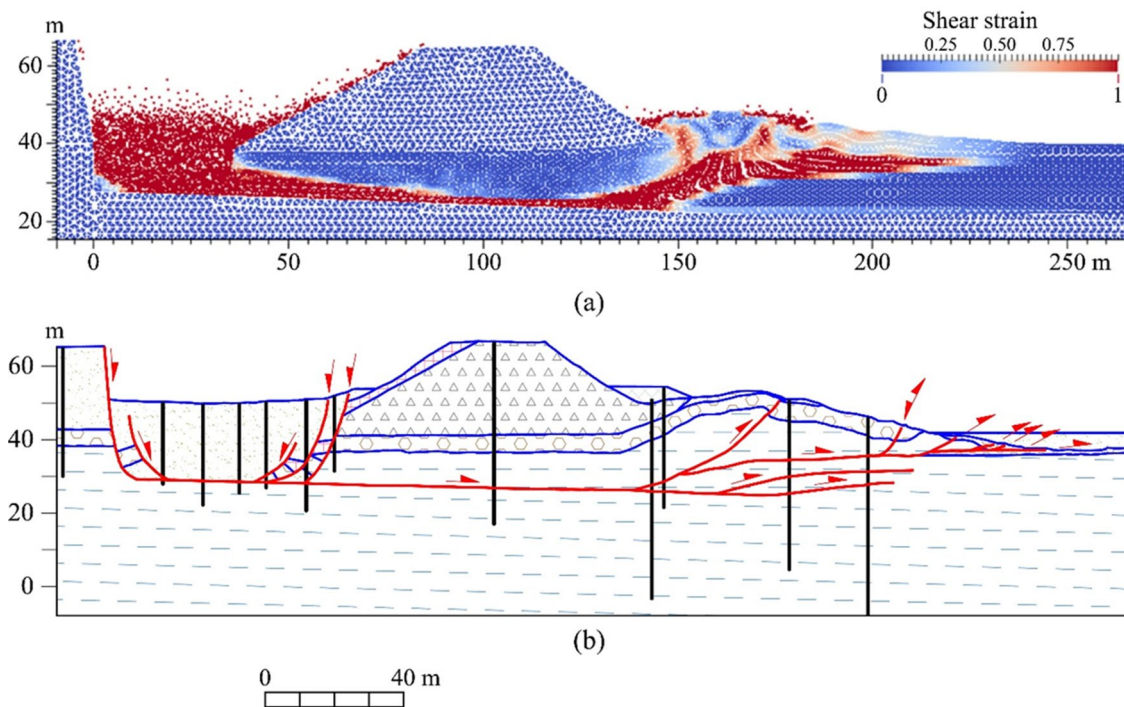
More recently (Alonso 2020), an MPM analysis provided further insight and validation of the procedure outlined, using a strain-softening Mohr–Coulomb model to represent the blue clay foundation. Figure 17a shows the development of internal shearing strains when the slide came to rest. This result may be compared with the pattern of sliding surfaces observed in situ (Fig. 17b).

Fig. 17 **a** MPM analysis of Aznalcóllar failure. Shear strains contours. **b** Sliding surfaces identified “in situ”

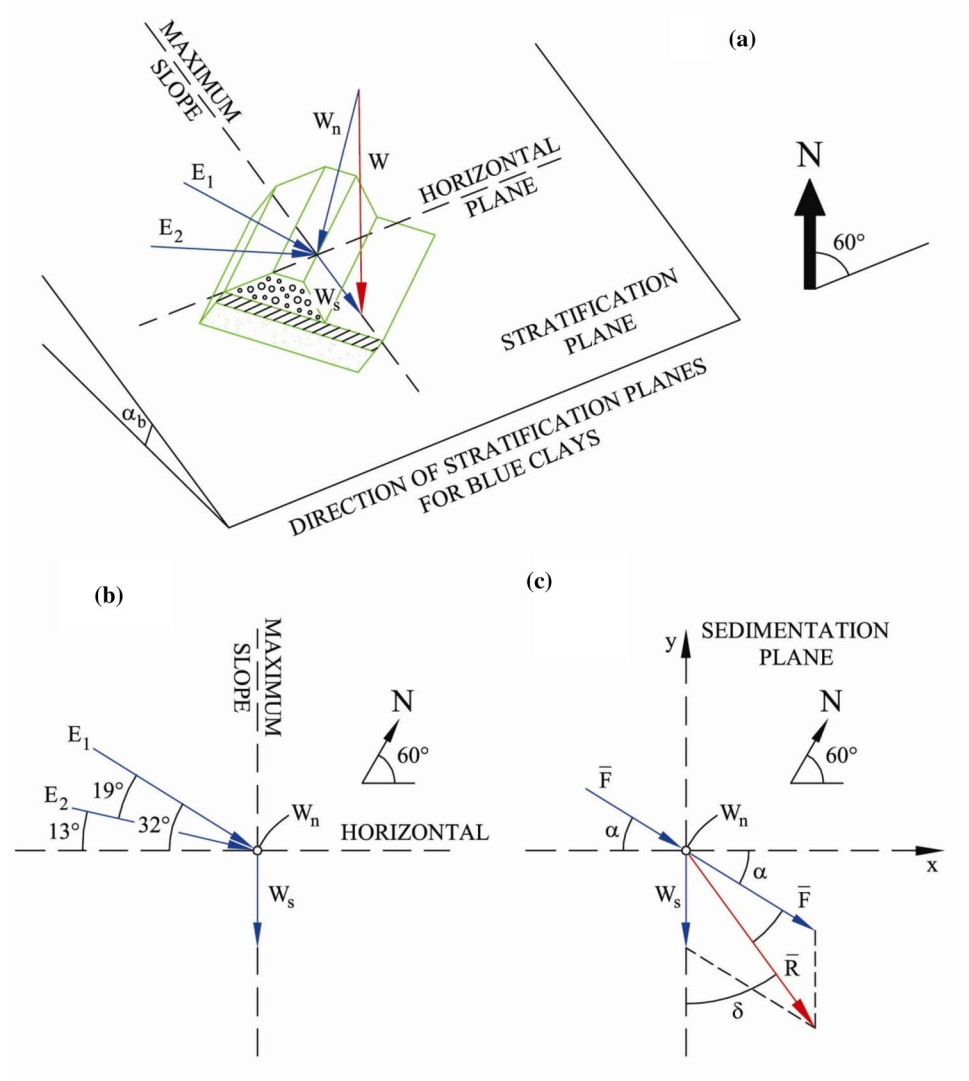
Consider this situation in Fig. 18. Figure 18a shows the moving dyke and accompanying material slab resting on the stratification plane which is, potentially, the failure surface. The plot shows the weight W and its two components: normal to the failure plane (W_n) and in the direction of maximum slope (dip direction of clay strata; W_s). If the tailings thrust is perpendicular to the direction of the dykes, the figure also shows the force vectors E_1 and E_2 of the south and north basins of the pond, respectively. Note that E_1 , if compared with E_2 , is closer to the dip direction of the clay strata. Figure 18b and c show, in the stratification plane, the thrust vectors, the weight component W_s , and their resultant, \bar{R} . The angle α defines the direction of the force vectors E_1 and E_2 .

In a limiting situation, the force vectors in Fig. 18b and c should be in equilibrium with the friction force generated in the sliding plane. This friction is proportional to the effective normal weight (W'_n) of the moving mass. The calculation of (W'_n) requires information on the pore pressures acting on the sliding surface, which was known because of the previous analysis.

Fig. 18 **a** Scheme of a slice of the dam and its foundation soils sliding on a bedding plane; **b** forces acting on the slice; **c** resultant force

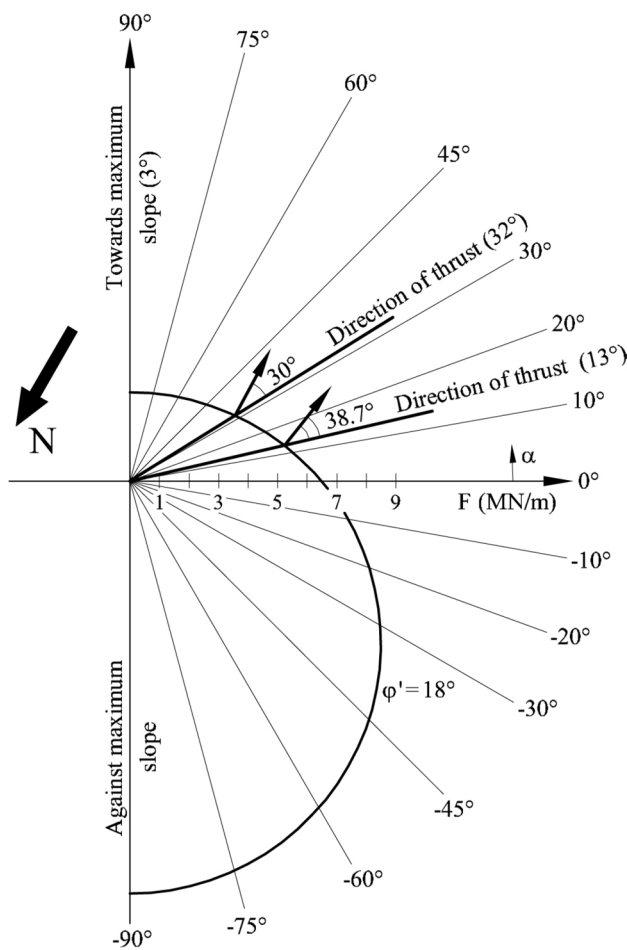
Figure 19 shows the solution of Eq. (4). It provides the intensity of the force F in terms of the angle α in a polar diagram. The thrust against the southern dyke (the one that failed) has an angle $\alpha = 32^\circ$ with respect to the horizontal direction of the sedimentation planes. The limiting force per unit length of the southern dyke is $E_1 = 420$ t/m (4.2 MN/m). A significantly higher force, $E_2 = 538$ t/m (5.38 MN/m) for $\alpha = 13^\circ$ would have been required for the northern dyke to fail, because the tailings thrust of the northern basin “sees” the stratification planes with an effective dip angle close to 0.5° , while the southern dyke “sees” an inclination of the sliding plane of 2° . Figure 19 also shows the very significant change in the necessary force to trigger the instability when the pushing forces go against or in favour of a sliding surface dipping only 3° .

The polar plot in Fig. 19, which is a circle, is interpreted as the yielding surface in the two dimensional plane of forces F (for a given normal force W_n). In this plane, the direction normal to the circle represents the predicted direction of the displacement. The figure also shows this. The southern dyke rotated slightly towards the south during the motion. The preceding comment explains this field observation.

Fig. 19 Polar diagram showing the forces that induce dam sliding as a function of the direction of the thrust ($\alpha = 13^\circ$ for the northern dyke; $\alpha = 32^\circ$ for the southern dyke). The direction of motion (arrows normal to the force function) is also indicated

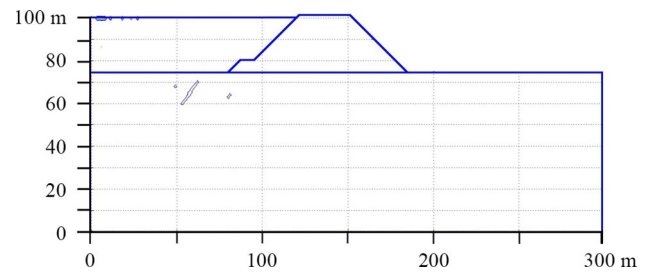
Case 2 leads to a perfectly stable situation despite the measured brittle behaviour of the Guadalquivir blue clay. Figure 20 shows the calculated contours of shearing deformation (0.1–1%) at the end of construction. The small confined shear band shown in the figure indicates stability.

Fig. 20 Case 2. Dam built in a single step. Slow application (7300 days) of loading. Brittle blue clay cohesion drops from 64 kPa to 0. Friction drops from 24° to 11°. Contours of plastic shearing deformation of 0.1% and 1% at the end of construction

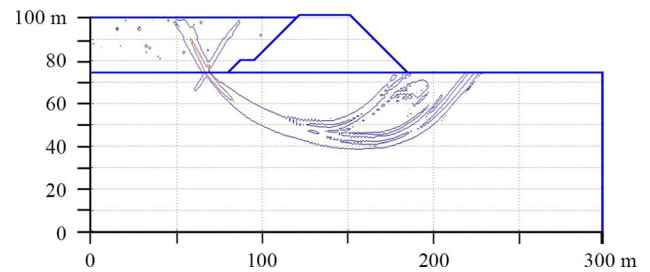
Case 3 (Fig. 21) shows a fully developed failure surface, as expected, but its geometry is a “circle” failure, as also found in limit equilibrium in homogeneous soils. Case 4 (Figs. 22, 23) shows a tendency to develop a flattened rotational failure at an intermediate stage of construction, but at the final dyke height, the dominating shear band reproduces a circular failure.

Fig. 21 Case 3. Actual staged construction. Constant strength parameters of blue clay: $c' = 0$, $\alpha' = 17^\circ$. Contours of plastic shearing deformation of 1% and 5% at the end of construction

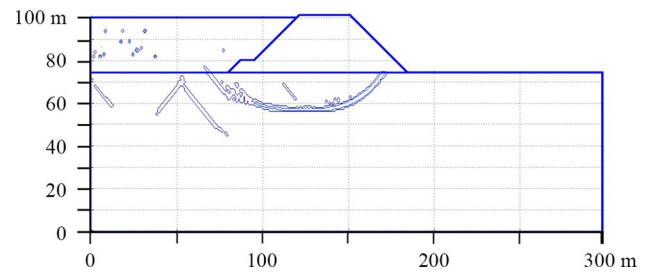
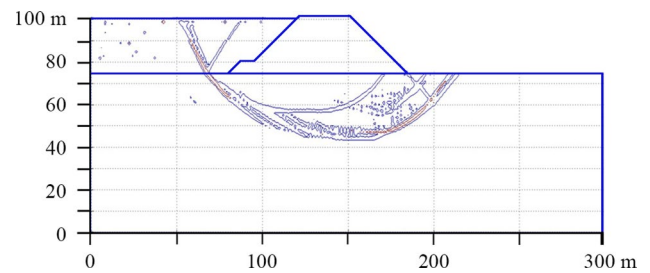
Fig. 22 Case 4. Actual staged construction. Strain softening of cohesion and constant friction: c' drops from 64 kPa and $\alpha' = 17^\circ$. Contours of plastic shearing deformation of 0.1% and 1% at an advanced stage of construction

Fig. 23 Case 4. Actual staged construction. Strain softening of cohesion and constant friction: c' drops from 64 kPa and $\alpha' = 17^\circ$. Contours of plastic shearing deformation of 1% and 5% at the end of construction

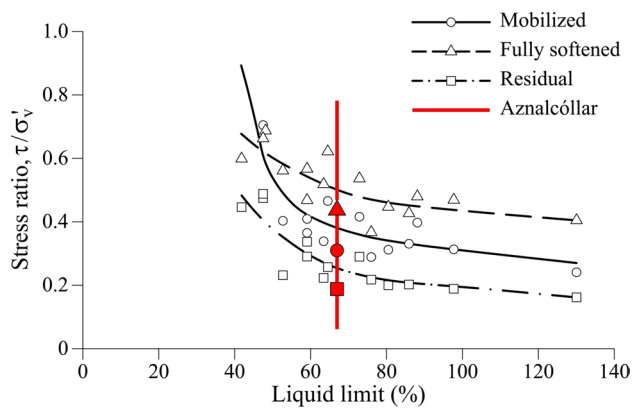
Fig. 24 Operating average stress ratio. Mobilized, fully softened and residual stress ratio from field case histories (Stark and Eid 1994). The Aznalcóllar case is also shown

The friction ratios are shown to decrease with the plasticity of the clay involved in the failure. The figure shows that the mobilized strength for the Aznalcóllar case is at the mid-point between the peak and residual friction angles. A similar trend was found by Potts and Zdravkovic (2001) when analyzing slope failures in brittle clays. However, this is not a theoretical result and the averaged mobilized strength depends on all the aspects mentioned previously when discussing the geometry of the failure surface.
