**THE LOCATION, HAZARD ASSESSMENT AND SEALING OF  
UNSAFE MINE OPENINGS IN THE CENTRAL  
WITWATERSRAND GOLD MINING BASIN**

A dissertation submitted to the Faculty of Engineering and the Built Environment, University of the Witwatersrand, in fulfilment of the requirements for the degree of Master of Science in Engineering by research only

Johannesburg, 2009

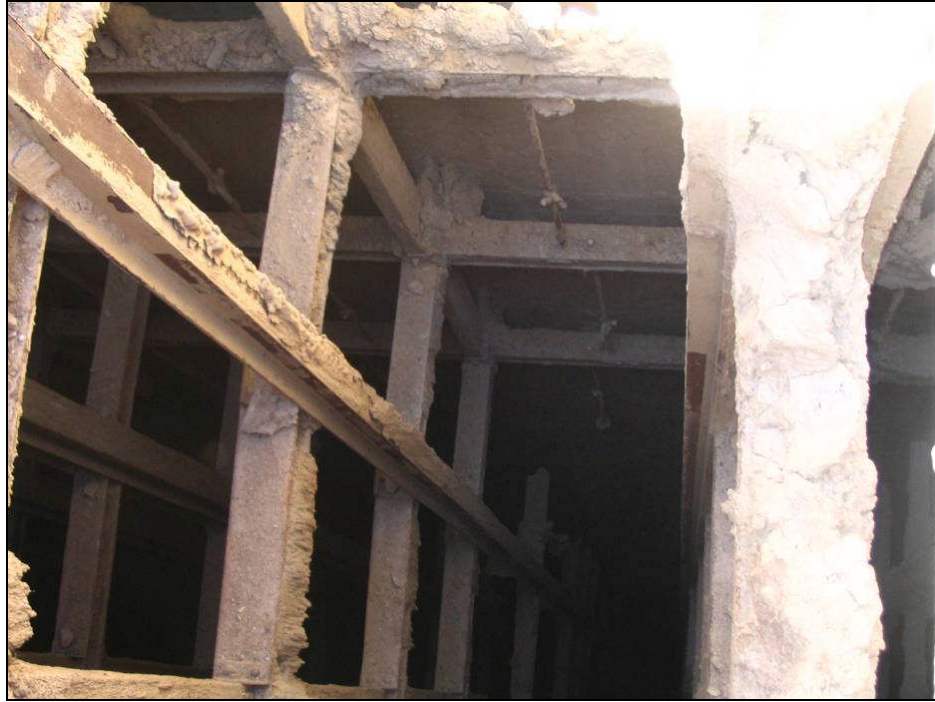
Figure 1.6 Steel framework within an abandoned, vertical mine shaft (Rand Leases Mine, Roodepoort)

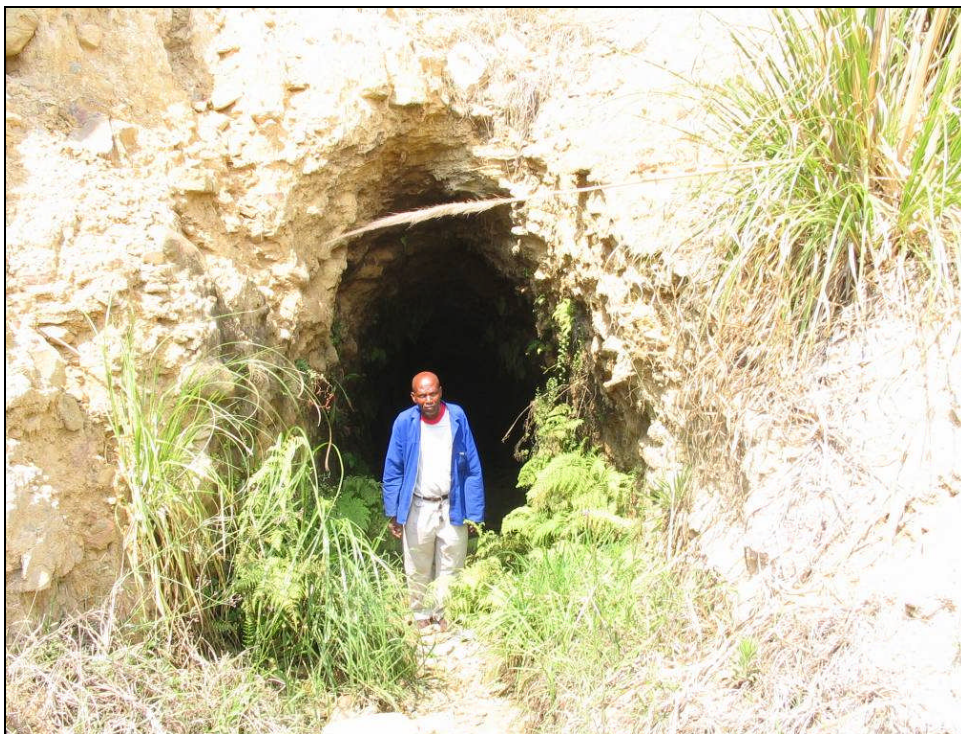
Figure 1.7 Typical example of an abandoned inclined mine shaft, Ekurhuleni

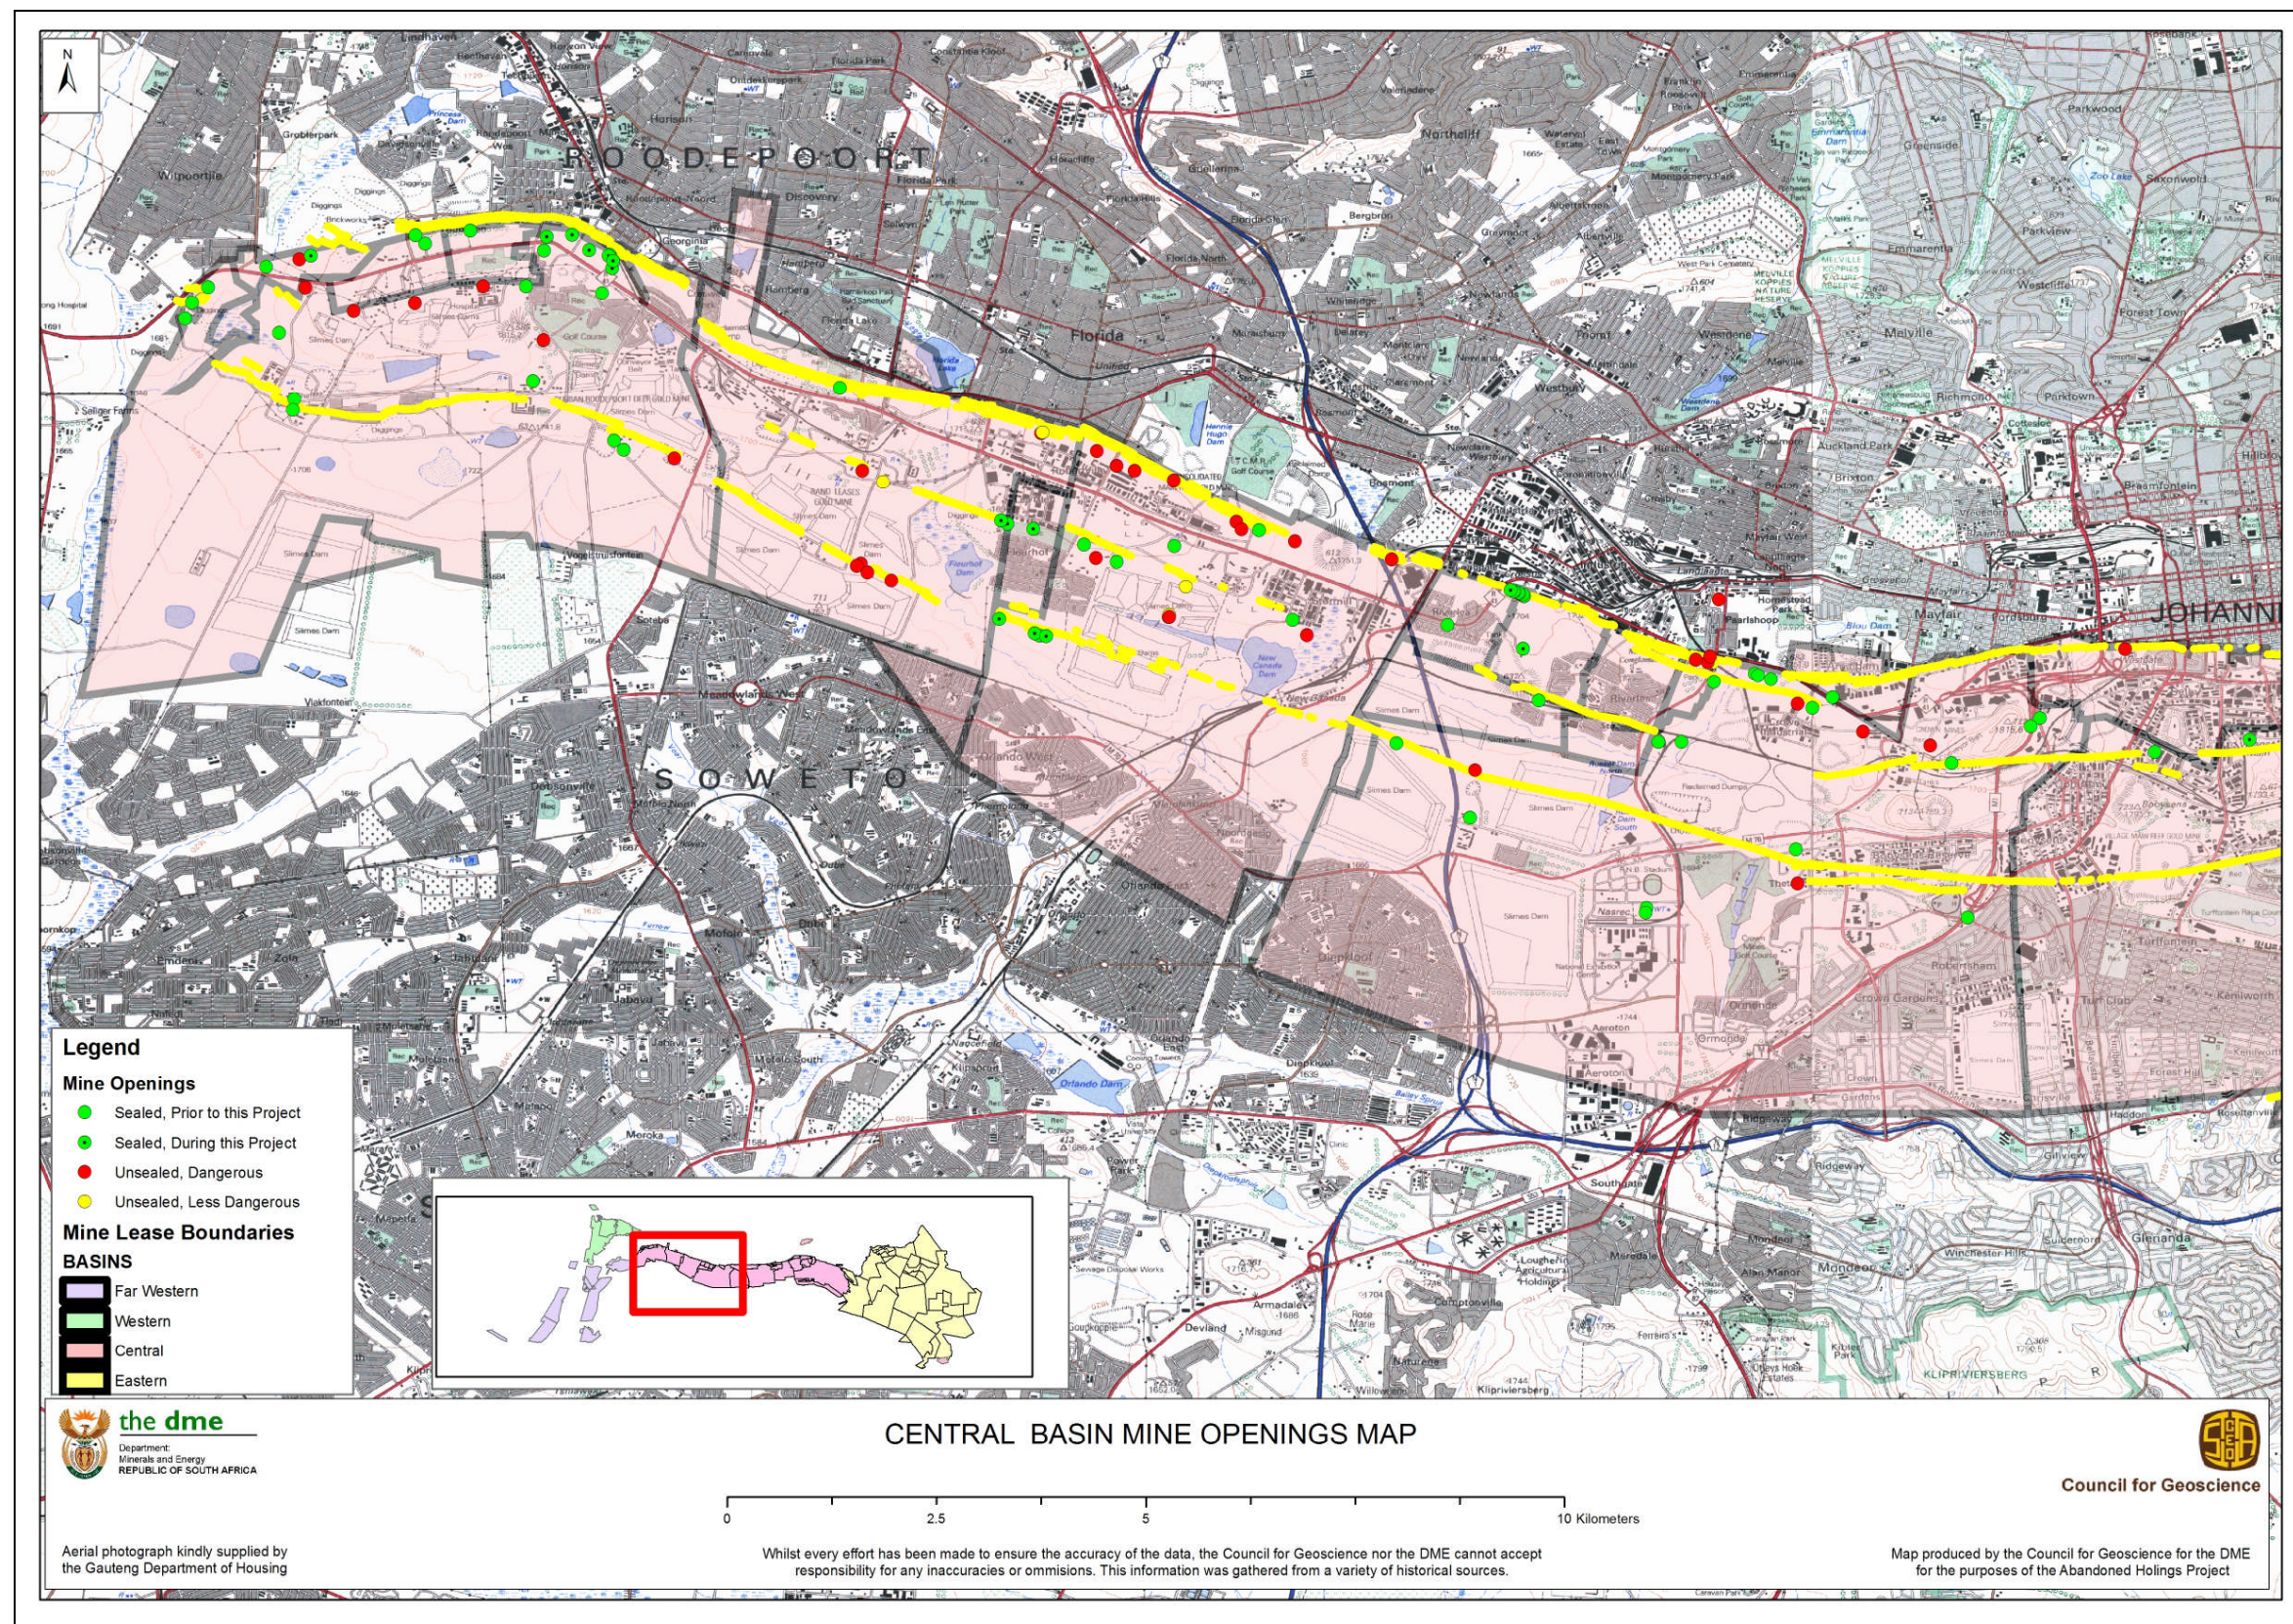
Figure 3.1. Central Basin Mine Openings

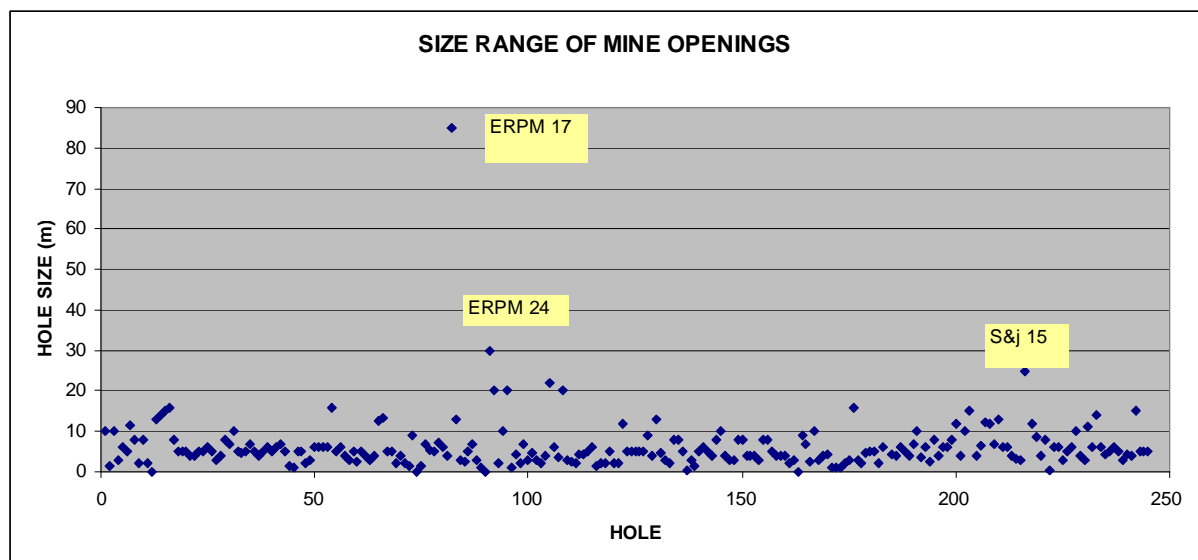
The range of the largest dimension of the mine openings in the Central Witwatersrand Mining Basin varies from 1-85m with an average of 6,22m, Figure 3.4. For the most part the largest dimension of these openings is <10m which is typical of the shafts that make up the majority of the holes that were encountered.

Figure 3.4. Size range of mine openings

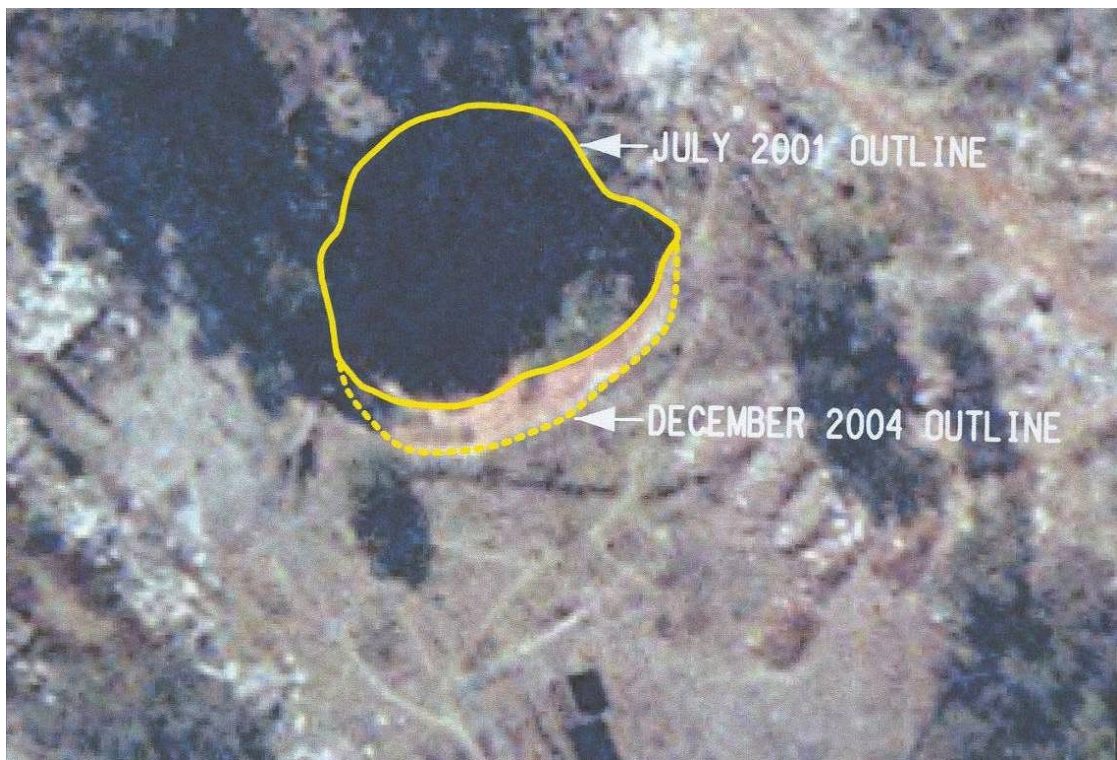
Besides its size, approximately 27 000m<sup>3</sup>, S&J15 (Figure 3.7) on the former Primrose Gold Mine property also illustrates how quickly subsidence can occur. Up until 1999 this area was a working gold mine, with a working headgear positioned over an inclined shaft. Yet by 23 October 2002, the date of a site visit by L. Croukamp (pers. com), a massive subsidence was present which presumably had developed sometime within this period i.e three years. This appears to be indicative of the illegal removal of steel supports from the abandoned shaft which led to collapse of the hanging wall and eventually surface collapse, Figure 5.16.

Figure 3.8. Aerial extent of growth of S&J 15

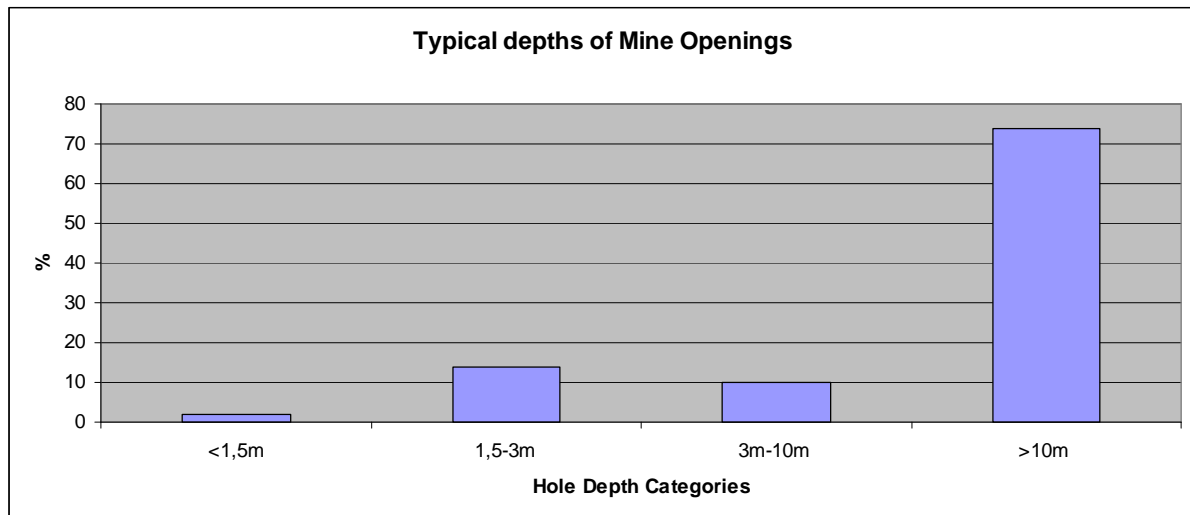
During this study, the exact depth of each mine opening was considered to be only of limited interest, as anything deeper than 10m was considered to be extremely hazardous and certain to result in a fatality. Thus exact depths were not recorded. The percentage of these very deep holes compared to the shallower categories of holes (defined earlier in Table 2.3) is shown in Figure 3.9 with the majority of the holes (74,5%) being greater than 10m deep.

Figure 3.9. Typical depths of mine openings

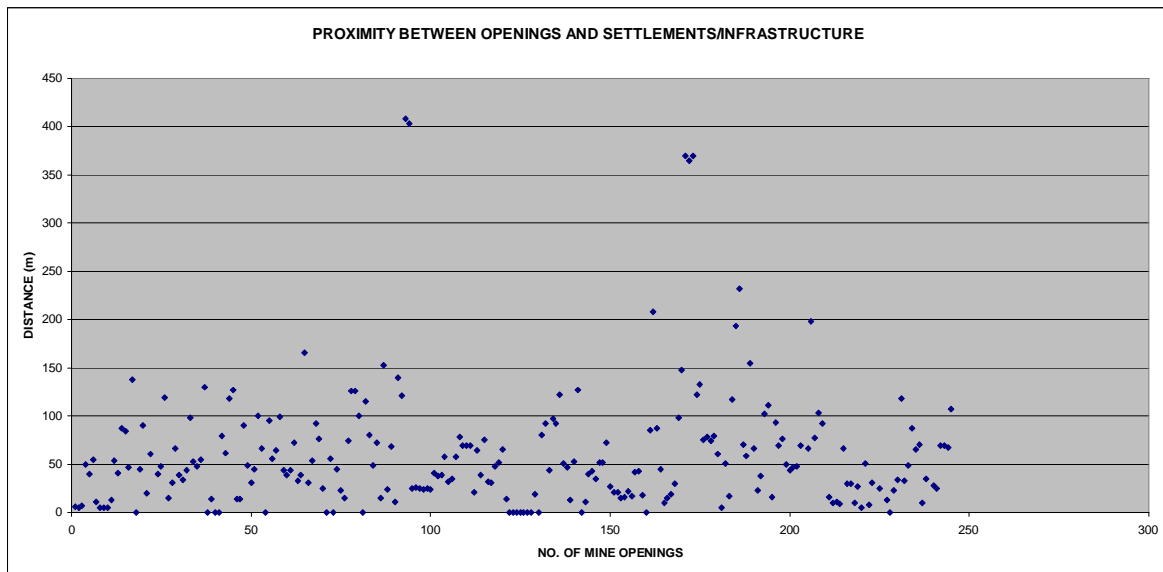
In general the majority of the 244 holes in this basin were found within 100m (average 59,8m) of such settlements (Figure 3.10). At least 11% of the holes were found surrounded by such settlements i.e people were living around the collars of such openings (Figure 3.11). While some of these openings had been permanently sealed and hence posed little or no danger, others only had temporary barricades (such as barbed wire fences etc.), indicating that perhaps people were not aware of the danger posed by such mine openings. At least eight holes (ERPM 32-38, Appendix D) were found in the small loop of land that separates Main Reef Road and the N3 Highway, former Geldenhuys Mine (Figure 3.2). On a much smaller scale, Hole R61 was located within a metre of a major footpath that leads from the Meadowlands Men's Hostel (Soweto) to Main Reef Road, a thoroughfare that is more than likely used at night. The arbitrary 1000m which was initially chosen as being the dividing line between 'near' and 'far' proved to be too coarse when used in this Basin.

Figure 3.10. Proximity between mine openings and settlements/ infrastructure

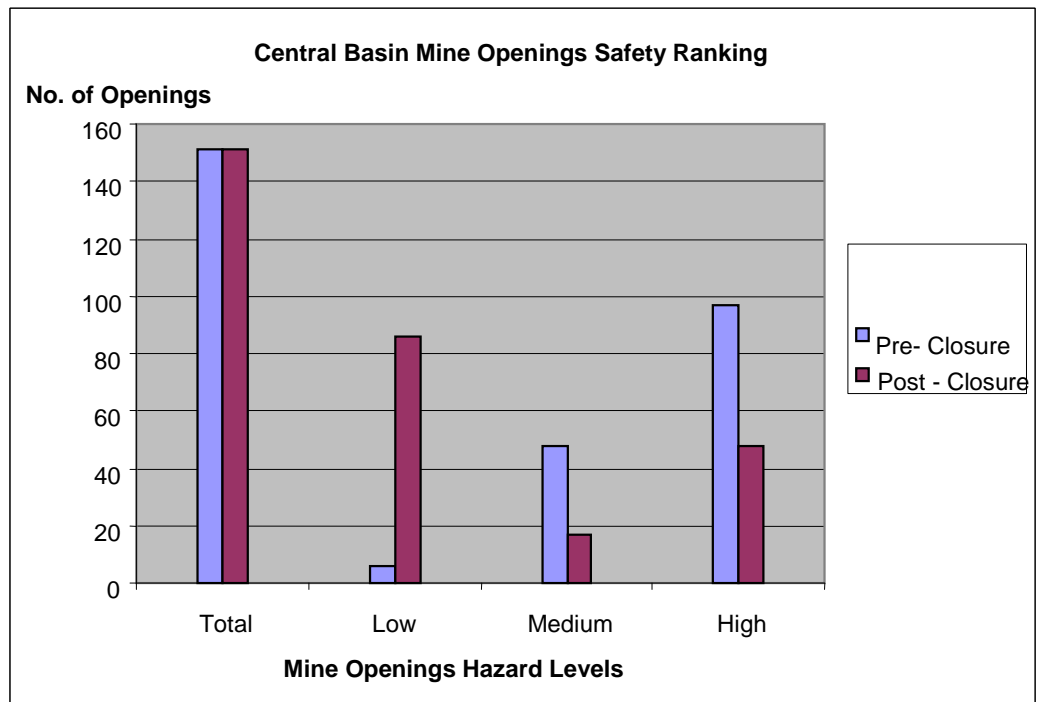
Using this system as a guideline, 49 high risk (50,5%) and 31 moderate risk holes (64,5%) were selected for closure, a total of 80. This resulted (Figure 3.12) in a reduction in risk due to the sealing of these medium and high risk openings. Prior to closure, the majority of the holes were considered to be a 'high' risk (64,2%) which after sealing reduced the number of high risk unsafe holes to 48 (29%). Similarly the holes with a medium risk (31,7%) were reduced to 18 i.e 11,9 %. Consequently the number of holes with a low risk risk increased because of the addition of the 80 newly sealed holes.

Figure 3.12: Simplified grouping of hazardous mine openings

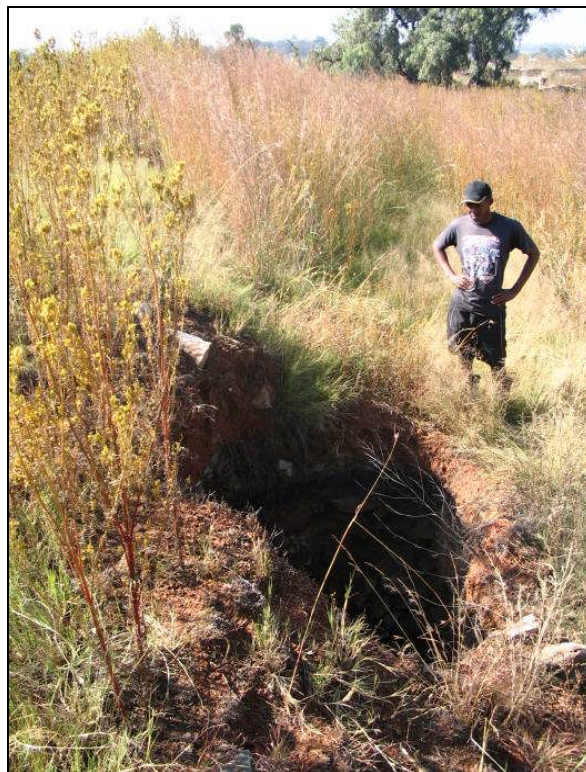
Figure 5.2 Hole 19A, Ekurhuleni

This test was undertaken on the 19/5/2004 at a small abandoned ventilation shaft (Hole 19A) situated in the Balmoral informal settlement, Ekurhuleni, Figure 5.1 and Figure 5.2, as an urgent solution was required to eradicate this community hazard. PUF was considered because of its proven reliability in the United States where its efficacy, reliability and ease of installation had already been proven.

This shaft is rectangular in shape being 2,6m (long), 1,7m (wide) and 11m (deep), Figure 5.3. It has the following profile consisting of an overlying layer of loose to moderately dense fill (3,2m deep), followed by a 2,4m thick layer of moderately hard, weathered quartzite before slightly weathered,

hard rock quartzite is encountered at a depth of 5,6m.

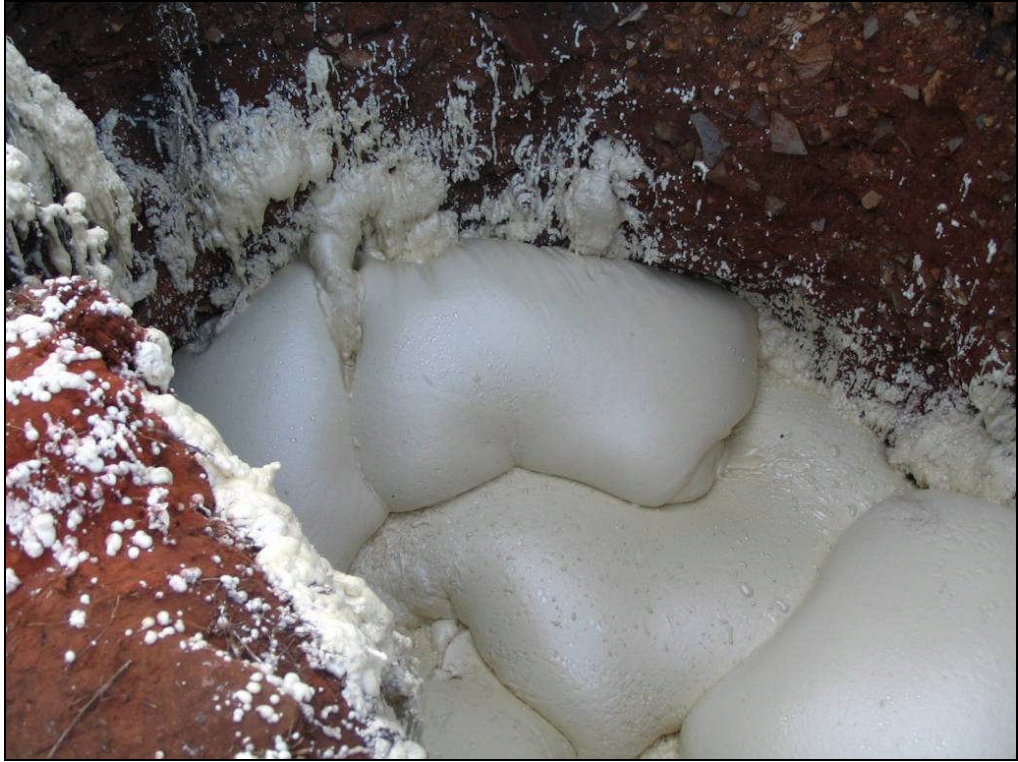
Before the initial foam layer could bond with the sidewalls, the base of the formwork slipped 0,5m to a depth of 6,1m. According to the foam thickness required as stated in the U.S specifications (Table 4.3), the plug thickness required had to be adjusted to 4,7m for a hole of these dimensions. A theoretical volume 20,77 m<sup>3</sup> of PUF was thus required to create a plug of this thickness at this depth. According to the contractor's records however, 800 kg of chemicals (components A and B) were used which should theoretically have generated 26,6 m<sup>3</sup> of rigid foam, at a density of 30 kg/m<sup>3</sup> which indicates that the PUF did not foam to the expected volume.

Figure 5.6: Layers of expanding foam

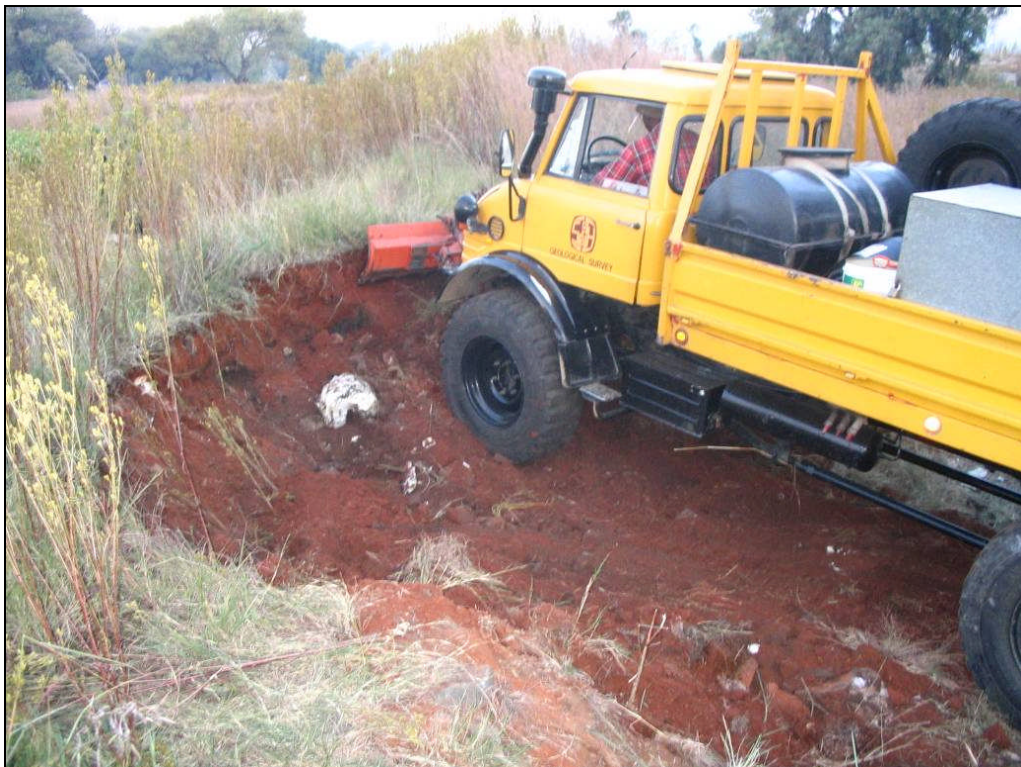
Figure 5.7: Placing covering material over PUF filled shaft

Once the upper layer of the foam had set reasonably hard in the hole/ shaft it was then backfilled with soil (Figure 5.7) so that it could be protected from potentially damaging sunlight and from curious residents who may have wanted to take samples of the foam. The time taken for this whole process was approximately 6 hours. A survey peg was also installed, so that any settlement could be monitored which to date (3 years) indicates that no noticeable settlement nor deterioration of the foam has taken place.

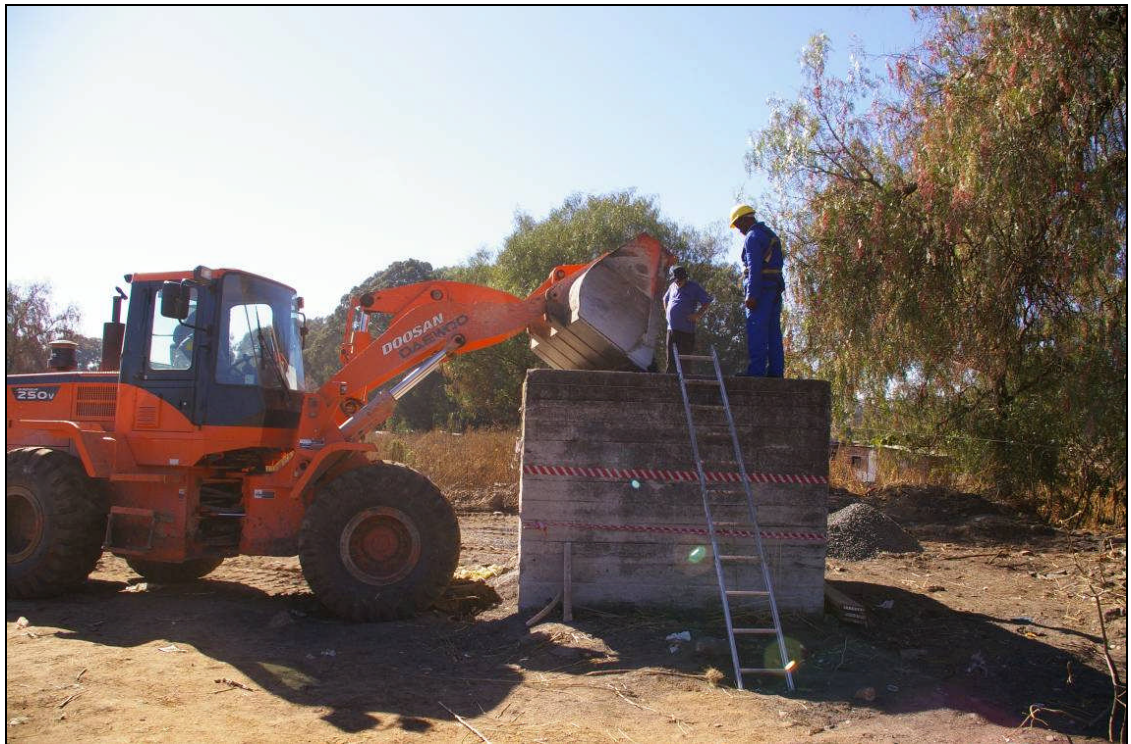
4. It was initially hoped to use water to load the foam plug but a watertight seal could not be achieved so concrete gravel (19mm) was used instead. A front end loader was used to place the stone in the shaft (Figure 5.10). Care had to be taken when placing the gravel with the front end loader not to drop it from height and cause damage to the foam which is vulnerable too puncturing. A thin layer of gravel was thus initially hand placed before using the front end loader.

5. Measured amounts of gravel were then continually added to induce failure. However even after the loading of a total of 36m<sup>3</sup> of gravel i.e a layer 2,8m thick and weighing 80tonnes, it was decided that the test be halted as failure had still not taken place.

Figure 5.10. S & J 15B: Gravel load being placed on PUF plug

6. As the PUF was only being used here on a test basis, the Consulting Engineer felt it prudent to seal this shaft with a 1,5m thick concrete plug which was placed in the upper portion of the shaft.

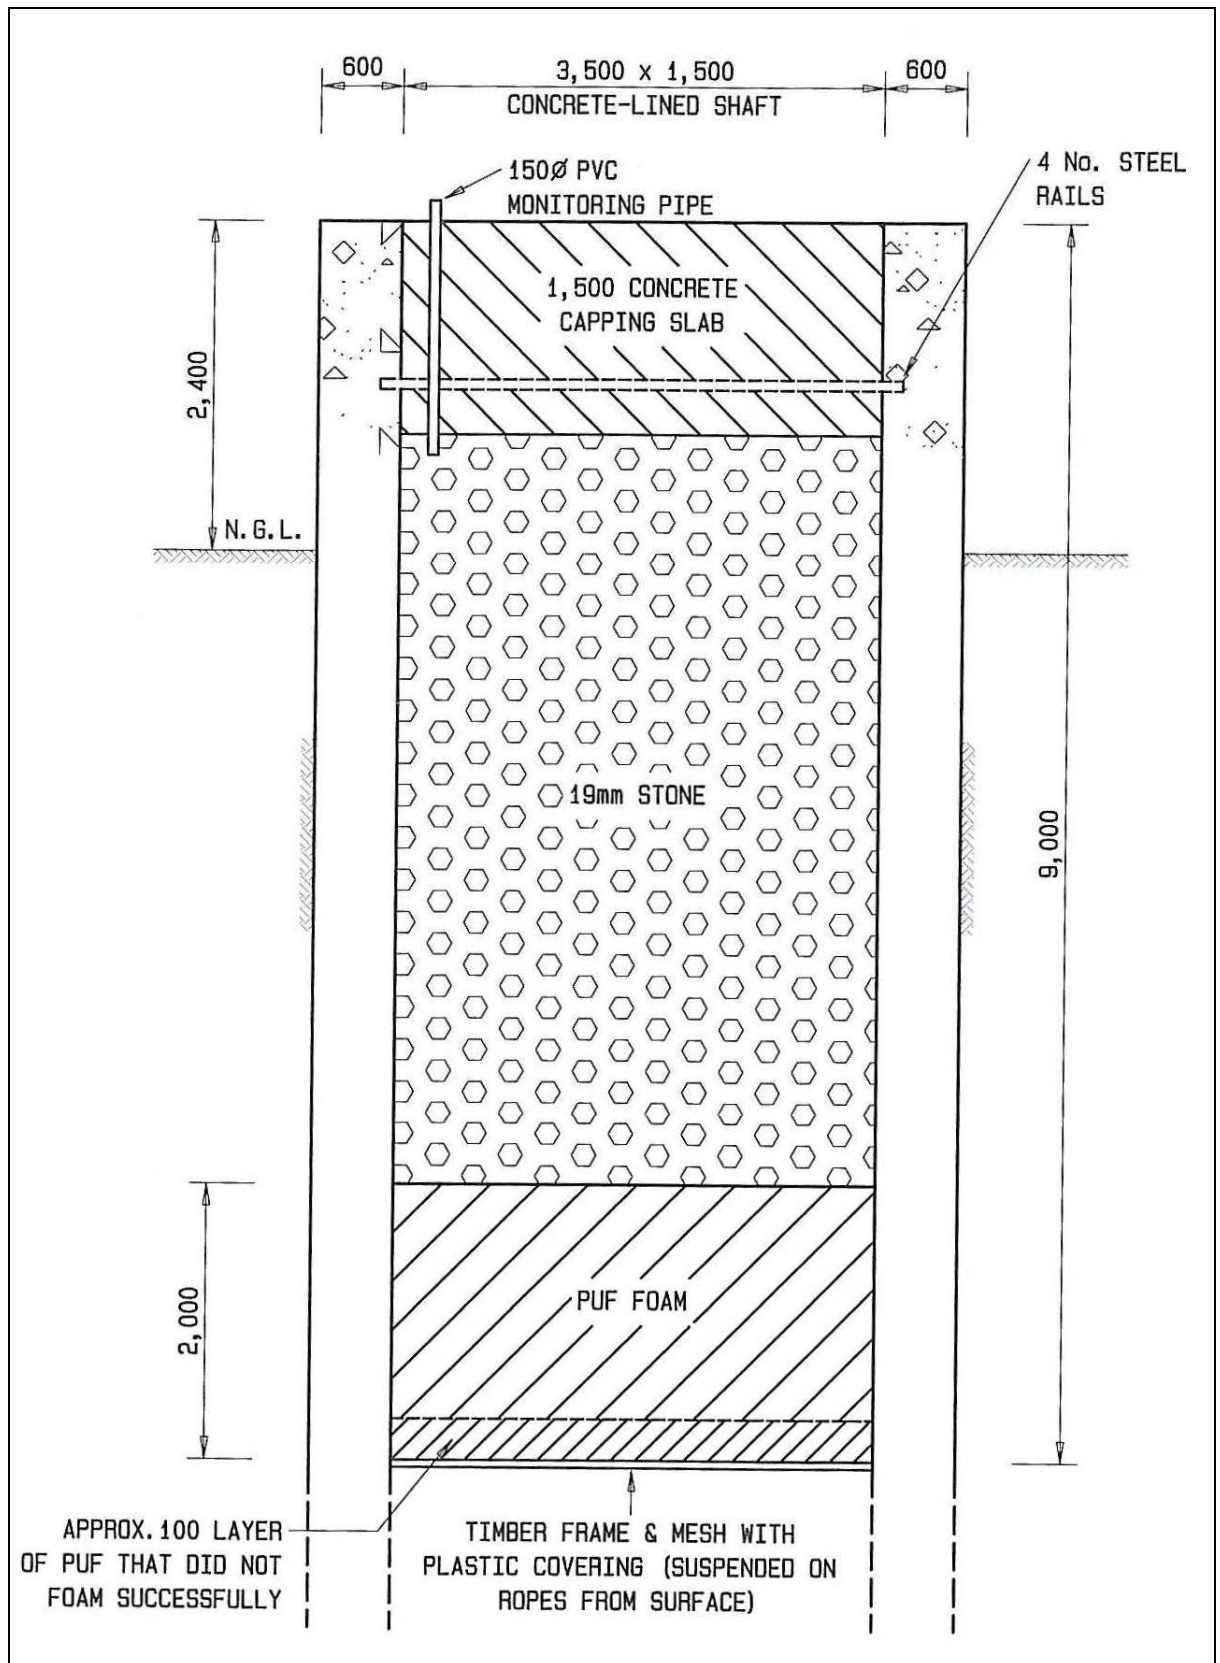
Figure 5.11. Field test: Hole S & J 15B, Ekurhuleni (Council for Geoscience, 2008)

The initial intention of this field test of the bearing strength of the PUF was to test various thicknesses of PUF plugs to failure. An initial plug thickness of 2m (Figure 5.11) was thus chosen which was based on the dimensions of the hole. Such a plug thickness is substantially thinner than the Colorado Division of Mines and Geology (2002) recommended PUF plug thickness (5,5m) for a shaft of these dimensions (3,5m x 1,5m). After loading the plug with 57 tonnes of gravel however, failure was not achieved. Therefore it would appear, that even such a PUF plug is able to carry a significant load perhaps equivalent to that of a house.

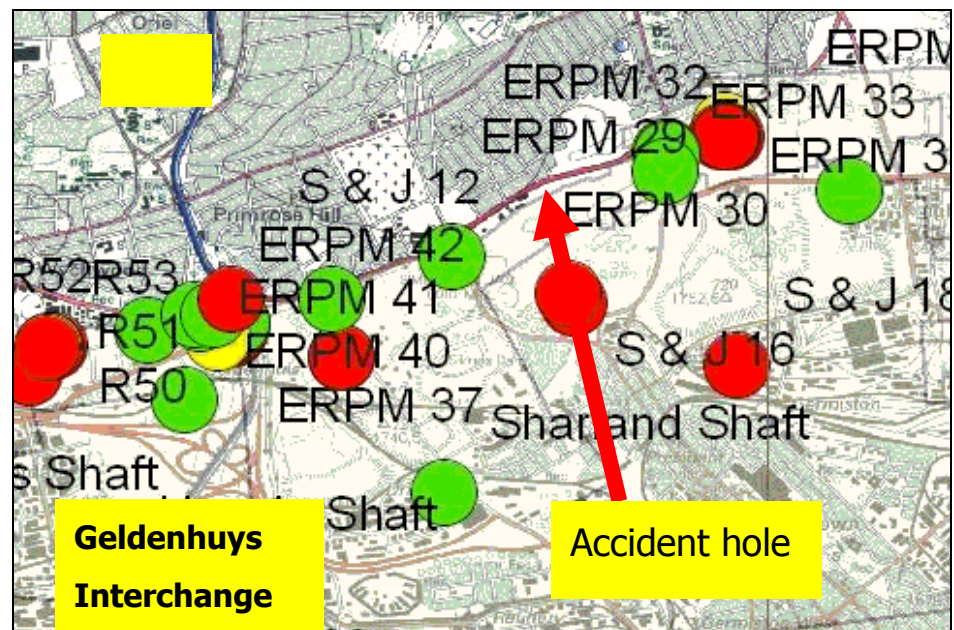
This hole is situated in the proclaimed mine lands 100m south of Main Reef Road (R29), Ekurhuleni (Figure 2). It is approximately 0,5m x 0,5m wide and 20m deep and is hidden in long grass in this open piece of veld. This hole is a few metres from a well worn footpath.

While the hole is narrow at the surface (0,5m) it widens immediately underground. At a depth of 20m the hole inclination changes from vertical to steeply inclined where, the original stopes are encountered, and continues for at least another 50m.

This area was a former open cast mining operation, overlying mining stopes, that has been backfilled with a variety of materials. It appears that it was formed by the loosening and collapse into the underlying void of these unconsolidated materials. This process appears to have occurred by a process of backwards collapse until the void reached the surface. It is thus by definition a 'subsidence' and not a 'shaft'.

Figure 2: Location of accident hole plus location of other known abandoned mining holes/shafts.

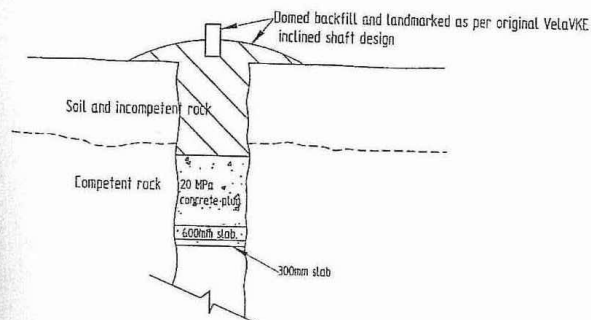
Figure 2: Plug configuration in vertical shaft without shaft lining.

The proposed alternative entails the in-situ construction of a monolithic parallel sided concrete plug in the shaft (Figure 2). The plug will consist of un-reinforced 20 MPa in-situ cast concrete. The plug will be located in competent rock and will be constructed as follows. The rock sidewalls will be barred down and cleaned at the plug site. Shuttering will be suspended from surface onto which a 300 mm thick concrete slab will be cast. This slab will be allowed to cure until a cube strength of no less than 25MPa is reached where after a 600 mm thick slab will be cast onto it and allowed to cure until a cube strength of 25MPa is reached. A mass concrete plug will be cast onto the hardened concrete slabs. These slabs will be able to carry up to 3 m of wet plug mass concrete. The shaft will then be backfilled above the plug to surface with soil.

Both the 300 mm and 600 mm slabs will be reinforced to ensure strength during subsequent construction phases

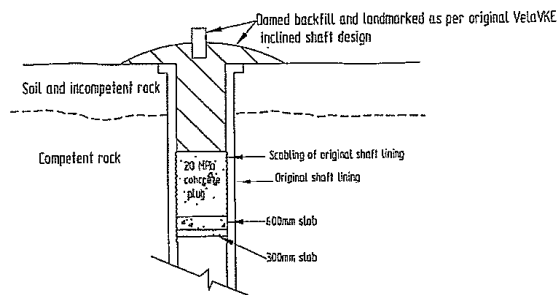
Figure 3: Plug configuration in vertical shaft with shaft lining.

In cases where the vertical shaft has been fitted with a shaft lining, the plug will be keyed into the original shaft lining provided that the shaft liner is able to transfer the self weight of the plug and imposed loads to the surrounding rock or soil (Figure 3).
