# Institute of Geological Sciences

Report No. 75/10

THE ROCKFALLS OF JAMES VALLEY, ST HELENA.

A PRELIMINARY REPORT GIVING A SUMMARY OF RECOMMENDATIONS.

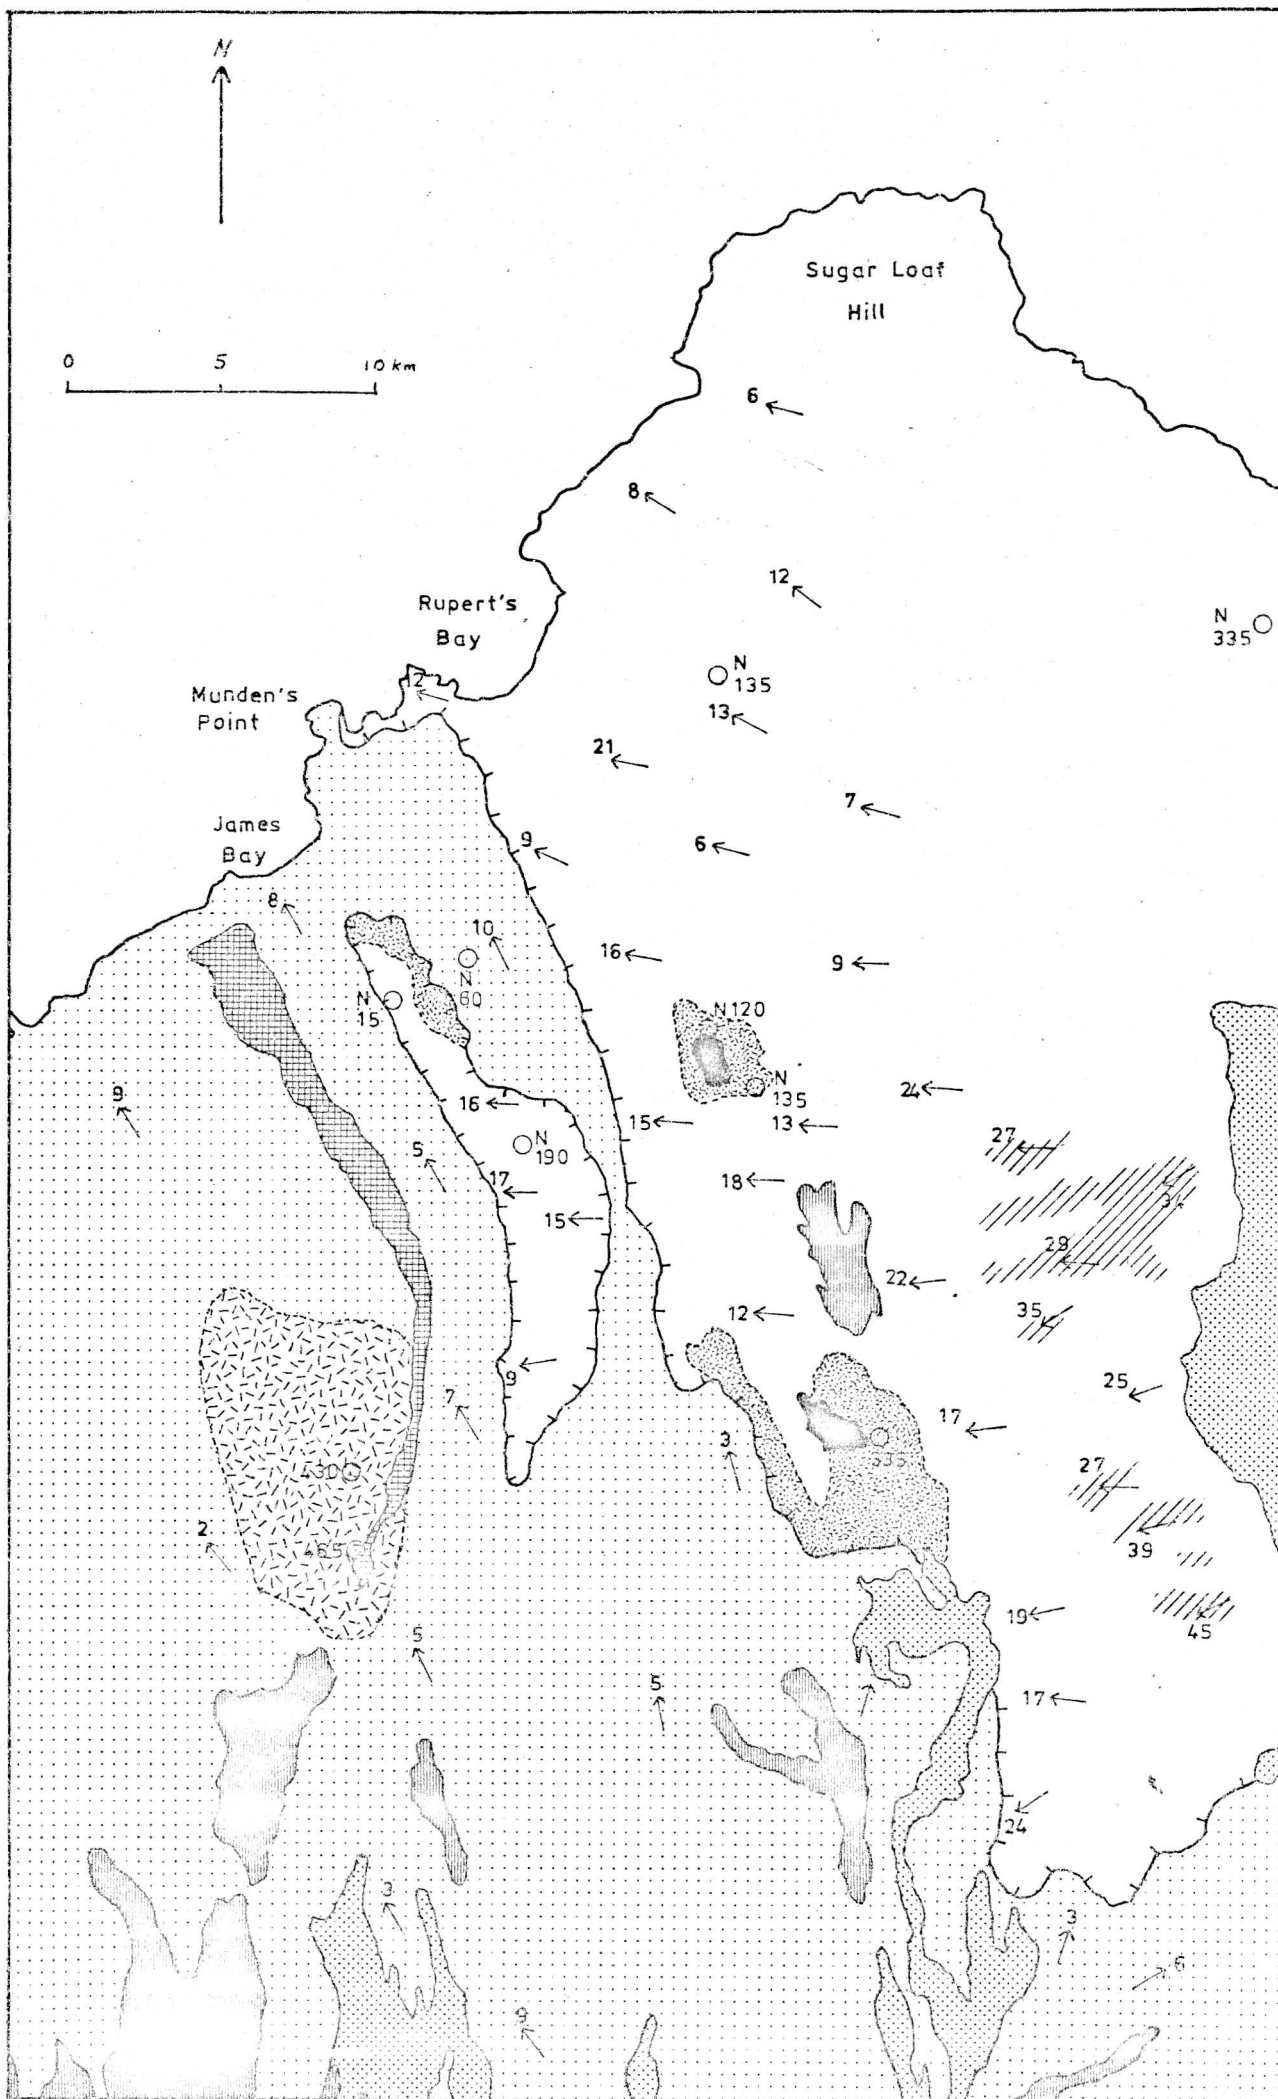
FIGURE 1 Geological Map of the Jamestown Area

In James Valley rocks of the N.E. volcano are only exposed in an 'erosional window' in the bottom of the valley and on the eastern valley side above the hospital (see Figure 1). These rocks are nowhere involved in the rockfalls in the valley and can be distinguished from the later rocks
