Bajtoš P, Pramuka S, Rapant S (2012) Impact of mineral extraction on the environment – Report for 2011, Report № ČMS Geological Factors 04–207–2012. Ministry of the Environment of the Slovak Republic | Section of Geology and Natural Resources | Dionýz Štúr State Geological Institute | Regional Centre Spišská Nová Ves, Spišská Nová Ves, 61 p

#### 4.8 Nižná Slaná R8 site

The occurrence of signs of subsidence – cave-ins, sinkholes and ground subsidence at the Kobeliarovo deposit – was limited in 2004 to a section of the deposit measuring approximately 200 x 200 m. According to information that has not yet been verified, surface subsidence in the Kobeliarovo deposit area, on the north-western edge of the village, has been occurring since the mid-1990s. According to data from Siderit, s.r.o. Nižná Slaná, the first collapse occurred in 1995. From August 2002, repeated field surveys and detailed photographic documentation were carried out in the collapse zone, initially of the nine collapses that existed at that time, and later, at the end of the monitoring period (August 2004), of up to 19 collapses that had gradually occurred in the collapse zone. Due to the high safety risk resulting

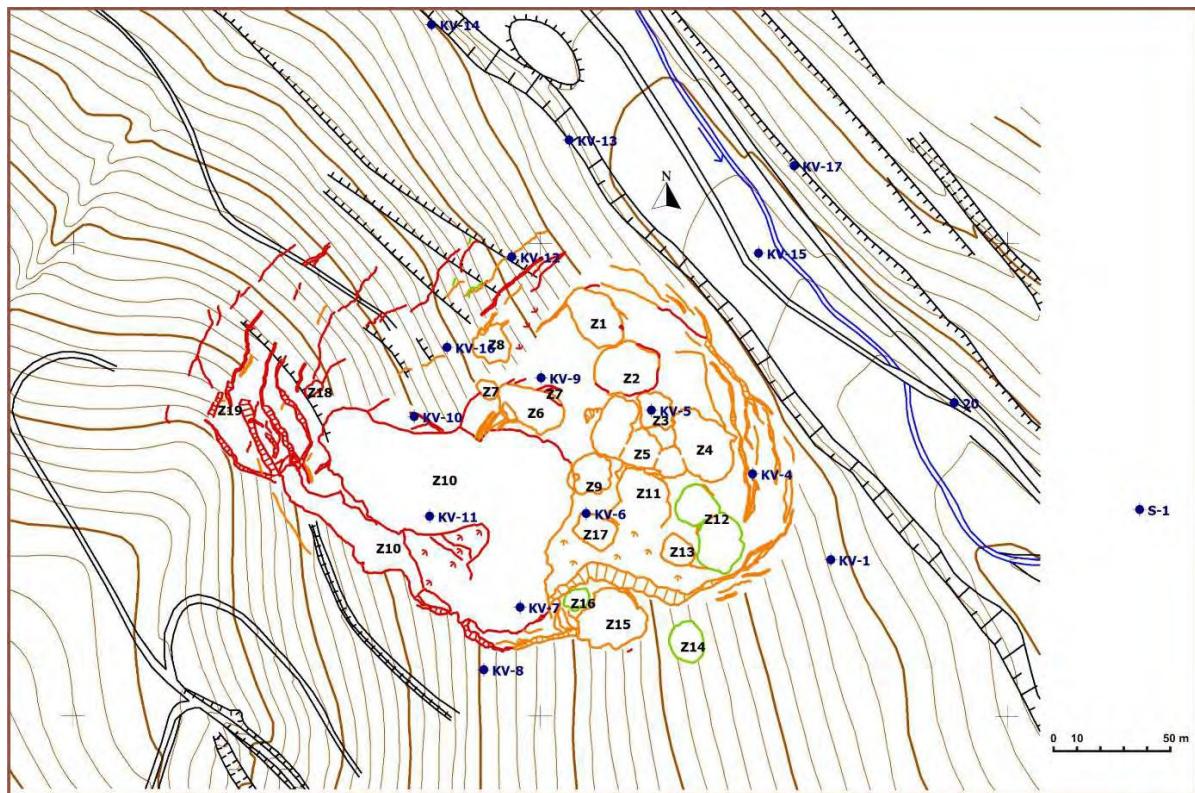
Fig. 26: Location of monitoring points (topographic base Ščuka et al., 1982).

In the past, more accurate methods of monitoring the development of slope deformations due to mining activity consisted only of monitoring fixed measuring points (Fig. 26). These points were mainly installed in the central and eastern parts of the current area of subsidence and in the wider vicinity to the south and east. Tabular data on the height measurements of these points are provided in the appendix to the report by Vrana (2005). The analysis of these data, the temporal development of the landslides and our own observations reveal the following facts. Height measurements of the measuring points began in October 1996. A large part of the points ceased to be measured in height after a short time – by June 1997, partly due to the collapse of the points (KV-5, KV-6) into emerging collapses or for reasons unknown to us (KV-4, KV-9, KV-16). Some points were probably not even initially surveyed due to their collapse into the cave-ins (points KV-7 and KV-11). Of the other points that were continuously monitored over a longer period, elevation measurements are available until September 2001 (points KV-1, KV-12, KV-13) as well as points 4 and 5. However, it has not yet been possible to determine the positional situation for these points.

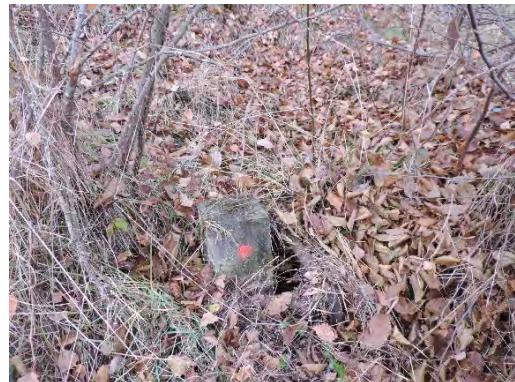
Fig. 28: Observation measuring point KV-4.

Due to the difference in the monitoring period and the absence of measuring points in the western part of the monitored area, it is not possible to determine the prognosis for the subsidence of the area. Only two measuring points have been found so far during the reconnaissance of the terrain, namely KV-4 (Fig. 28) and KV-8 (Fig. 29).

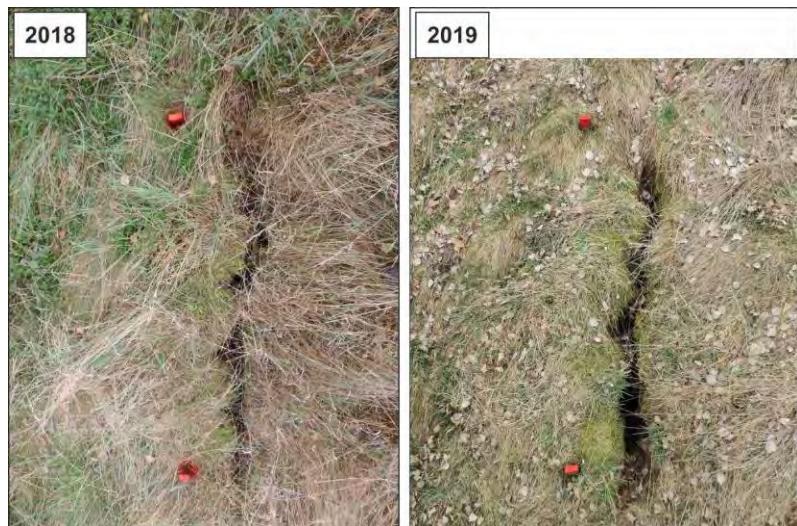
c)

No observable changes in geodynamic activity were detected in the further eastern to south-eastern course of the edge of the collapse zone (collapses Z3, Z4, Z12, Z13, Z14, Z15 and Z16). Near collapse Z15, an active tensile crack with a width of approximately 10–15 cm and a continuous length of approximately 1.8 m has been observable for a long time. Comparative imaging of this crack from location F3 shows no visually observable changes in its dimensions (Fig. 44c). Comparison of images of crack branching from location F4 showed no signs of observable activity (Fig. 44d).

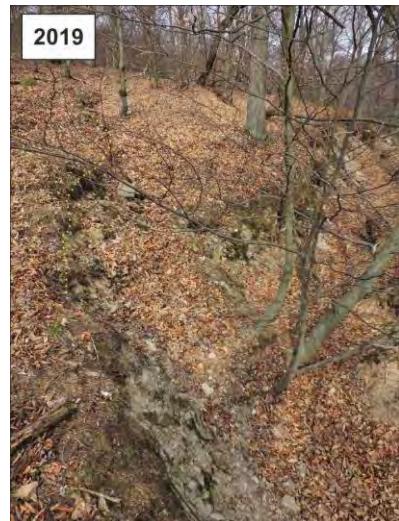
g)

An active subsidence-tension crack was photographed from location F6, and a comparison of the images from 2018 and 2019 (Fig. 44f) shows that there has been no observable change in the activity of the crack. During reconnaissance in 2019, a new tensile-subsidence *crack 4* was observed and documented (Fig. 41). The crack connects a significant subsidence crack and a less significant tensile-subsidence crack in the V-Z direction. The degree of subsidence is approximately 0.2–0.4 m (Fig. 44g). Its openness is also observable intermittently. Another imaging station marked F6A (Fig. 41) was set up to monitor this crack. Comparative imaging of the tensile-

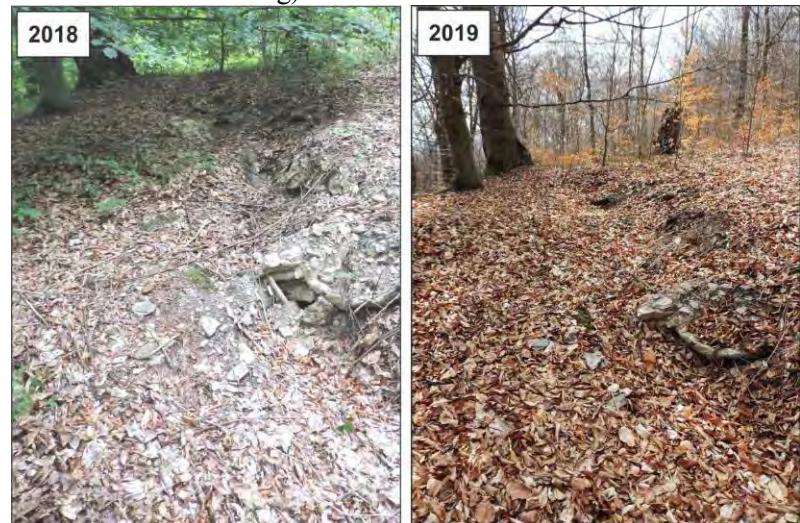
h)

- The subsidence crack from location F7 (Fig. 46h) did not show any observable activation. Comparative imaging was performed at site F8 of a significant subsidence-tension fracture with presumed active character (Fig. 44i) with a subsidence rate of approx. 1–2 m and a width on the terrain surface of up to approx. 1 m (from the opposite direction of its course as from site F6). The terrain

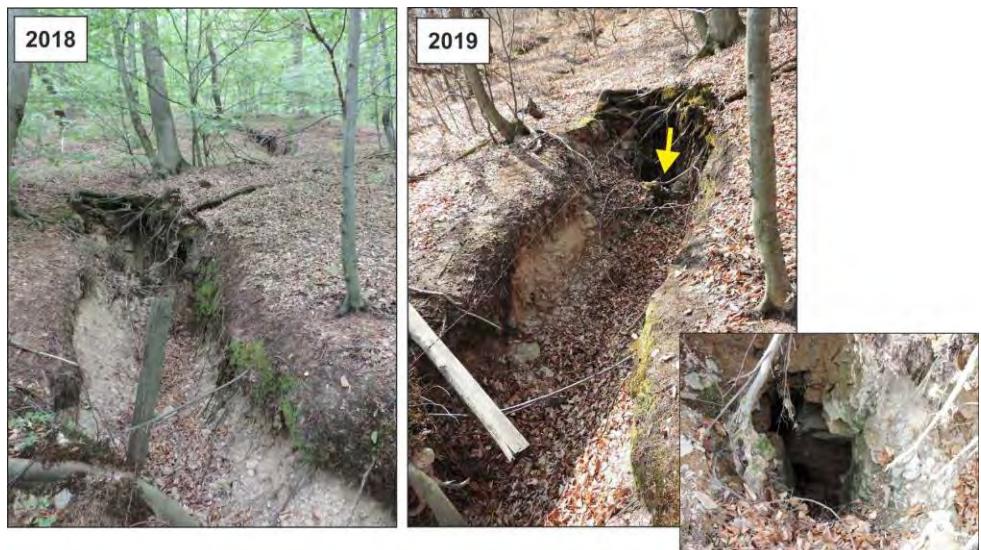
Fig. 44: Comparative photographs of the landslide zone in Kobeliarovo from 2018 and 2019 from the following locations: a) F1 with the location of debris fall marked, b) F2, c) F3, d) F4, e) F5, f) F6, g) F6A, h) F7, i) F8, j) F9, k) F10, l) F11 marking the location of the crack opening and detail, m) F12, n) F13, o) F14, p) F15.
