Influences of Tailings Particle Size on Overtopping Tailings Dam Failures

Abstract

Keywords Physical test · Numerical simulation · Undercut erosion · Surface scouring

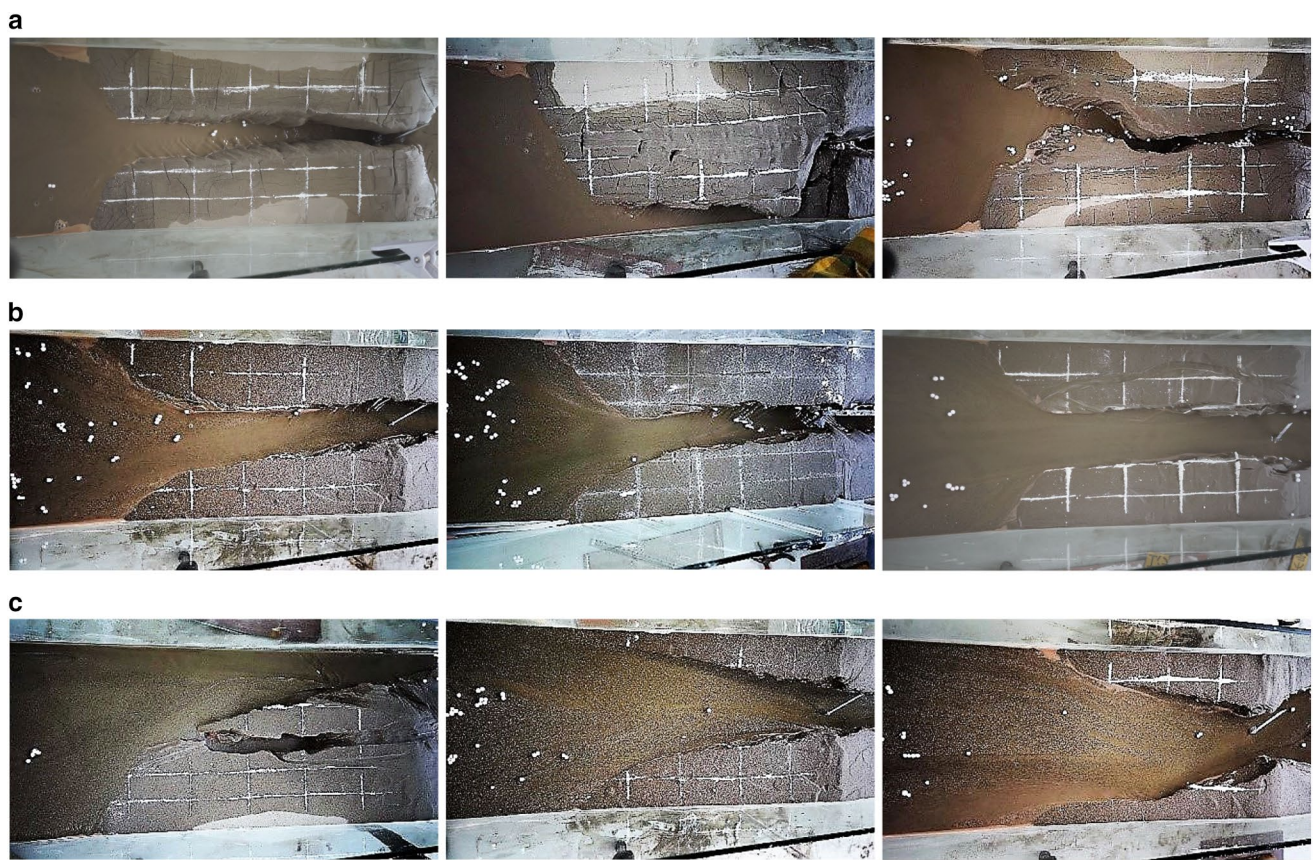
Fig. 5 Comparison of the results of an overtopped dam break **a** tailings < 0.074 mm in repeated tests; **b** tailings between 0.074–0.25 mm in repeated tests; **c** tailings between 0.25–0.5 mm in repeated tests

Each tailings dam experiment (for each particle size) was repeated three times. Figure 5 compares the states after overtopping failure for each experiment. It can be seen that although the form of the gully was slightly different in the repeated experiments, the dam morphology was basically the same. Therefore, in this paper, one of each group of repeated experiments with different sized tailings was selected as a typical analysis object.

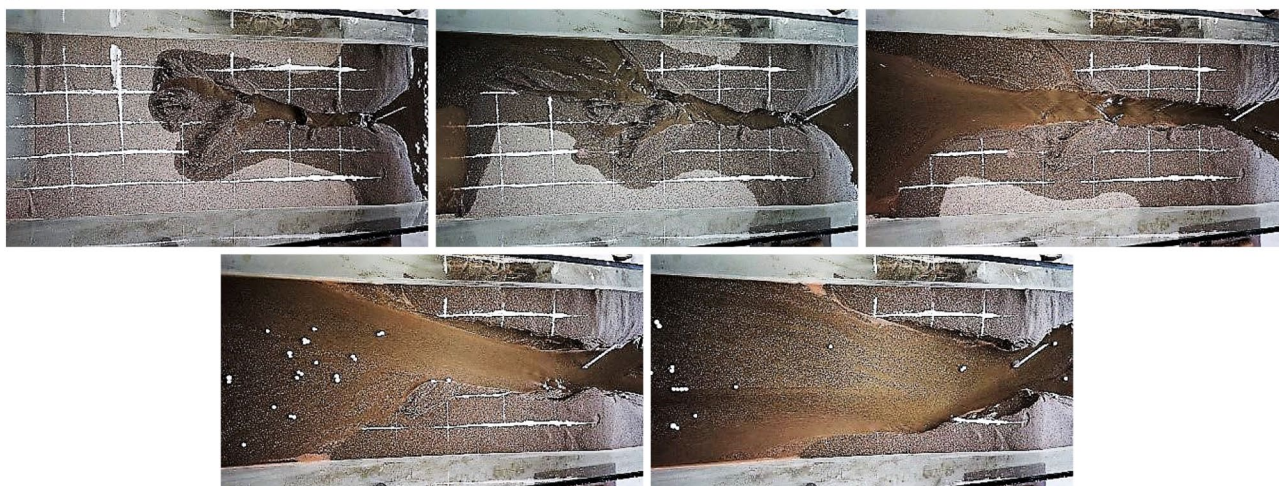
Fig. 7 Failure process for a tailings dam subjected to overtopping **a** with tailings < 0.074 mm; **b** with tailings between $0.074 \sim 0.25$ mm; **c** between $0.25 \sim 0.5$ mm

After the water level in the reservoir rose to a certain height, the water began to flow over the top of the dam. During the overtopping, a dam body generally experiences several stages: Phase I. Water over the top; Phase II. Initial gully formation; Phase III. Emergence of multi-stage scarps; Phase IV. Widening of the breach until Phase V. Complete failure (Wahl 1998), as shown in Fig. 6. Overtopping failure processes from tests with different tailings sizes are shown in Fig. 7.

We found that for tailings < 0.074 mm, the flow speed of the water was the fastest, the flow was straight, and the wetted area around the flow was relatively small in Phase I, when the water flows over the top of the dam to the toe. In Phase II, the initial gully formed at the toe of the dam started to collapse, but the water surface on the dam body surface was wide, and gully formation was not initially obvious. The

For the $0.074 \sim 0.25$ mm tailings, the permeability of the dam body was enhanced by the larger diameter of the tailings particles, so the wetted area around the water flow increased, and the water surface on the dam body surface was narrower. It took a long time for the water to reach the foot of the dam in Phase I, but the water flow was still straight. As the overtopping water flowed along the dam surface, a small erosion gully formed during Phase II. The middle part of the tailings dam collapsed as the gullies deepened. The surface of the $0.074 \sim 0.25$ mm tailings dam had steep ridges, but the gullies formed in Phase III were wider and shallower (Fig. 8).

The still larger tailings particles ($0.25 \sim 0.5$ mm) weighed more, so as the water flowed, it formed a scour, and the tailings moved down the dam surface for a short distance and then settled on the surface of the dam, which continuously changed the water's flow path, and increased the time for the flow to reach the toe as well as the wetted area. The gully at the top of the dam began to develop as water flowed down the dam surface with difficulty, and there was a continuous collapse where the water flowed through. The water flow path continuously changed until a stable gully formed; as the erosion gully at the top of the dam developed further, the depth increased, and the widest, shallowest gully was produced. The $0.25 \sim 0.5$ mm dam did not show steep ridges.

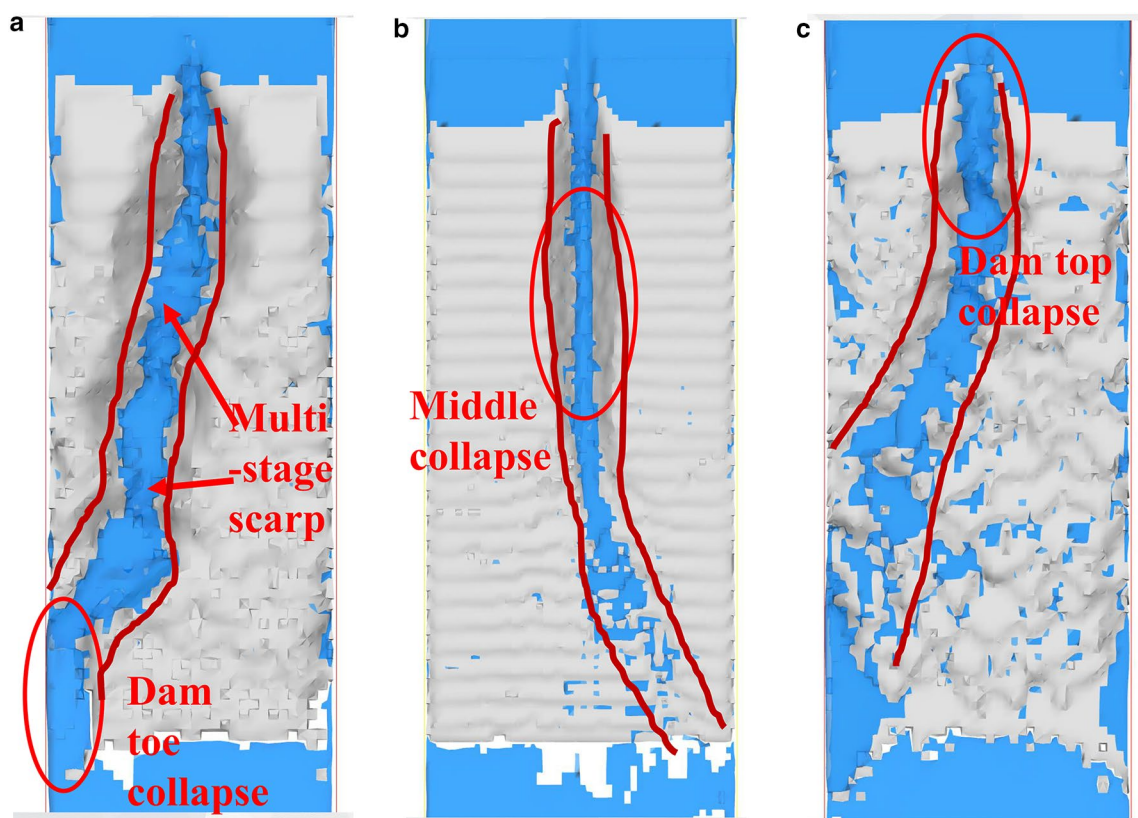
Fig. 13 Breakage morphology from numerical simulation with different particle sizes **a** < 0.074 mm; **b** $0.074 \sim 0.25$ mm; **c** $0.25 \sim 0.5$ mm

The post-processing part of FLOW-3D was used to describe the dam-break process form (Fig. 13). When the initial gully formed, the collapse began at the foot of the dam body with tailings < 0.074 mm, and a collapsed form of a multi-stage scarp appeared in the gully, which is similar to what occurred in the physical model. For tailings of $0.074 \sim 0.25$ mm, the dam body developed a breach in the middle, while the top and toe were not obviously damaged, the breach width was small, and the collapse trend was relatively straight. The $0.25 \sim 0.5$ mm dam first formed an obvious gully from the top of the dam, and there was a little erosion and accumulation of tailings on the surface of the dam body, while the gully form was roughly like a trumpet, similar what was observed in the model test. However, by default, the tailings have no viscosity in FLOW-3D, so the breach had an inverted triangular cross section, which is inconsistent with the shape of the breach cross section in the physical experiment. Overall, though, the results obtained by numerical simulation and physical experiment were basically similar.
