Insights from the Compilation and Critical Assessment of Breach and Runout Characteristics from Historical Tailings Dam Failures: Implications for Numerical Modelling

Abstract

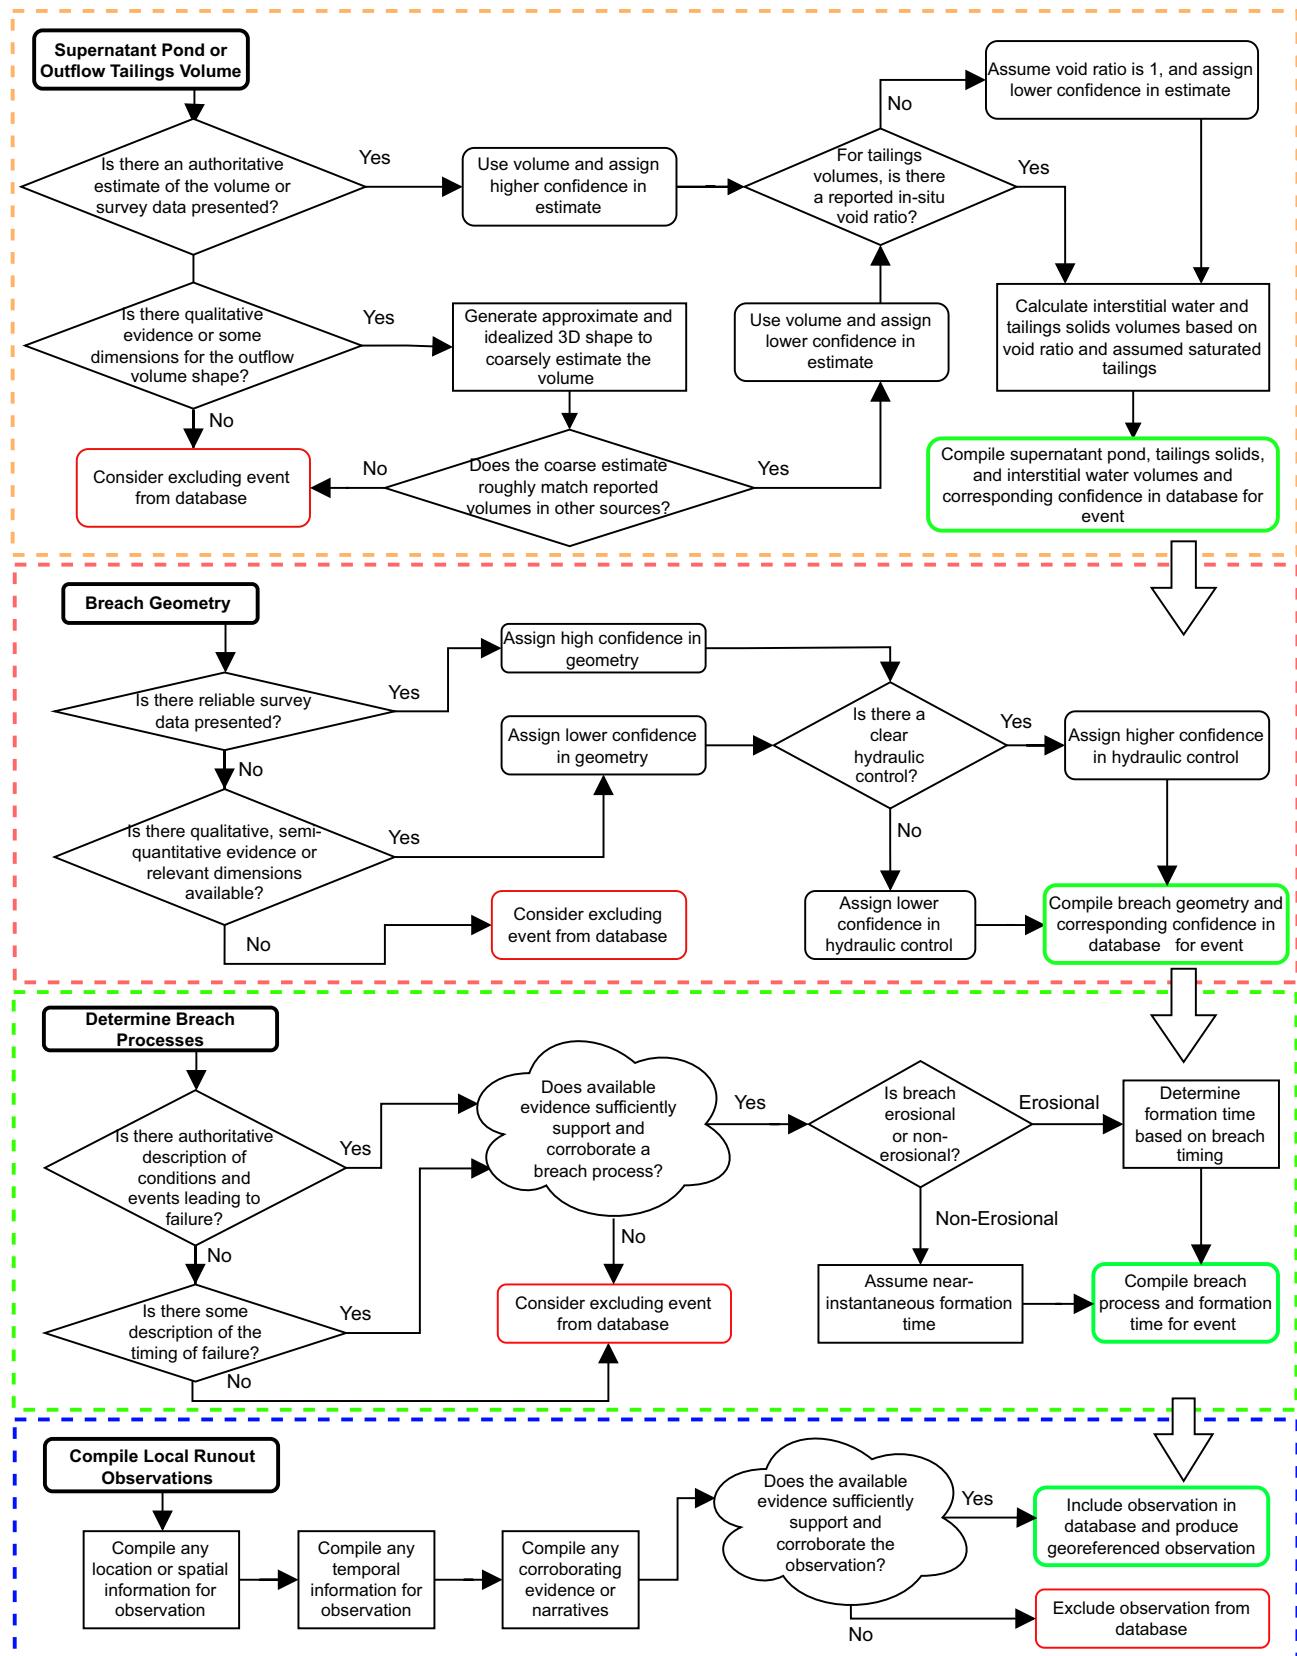
Fig. 1 Summary methodology for data compilation

The tailings dam breach events considered in the database are listed in Table 1. A flowchart is shown in Fig. 1 that demonstrates the simplified methodology to compile the various data. The events were chosen primarily based on the data availability for the breach characteristics, and therefore the amount of runout observations varies by event in this database. The various parameters are briefly defined in the following subsections, before the details, context, and insights

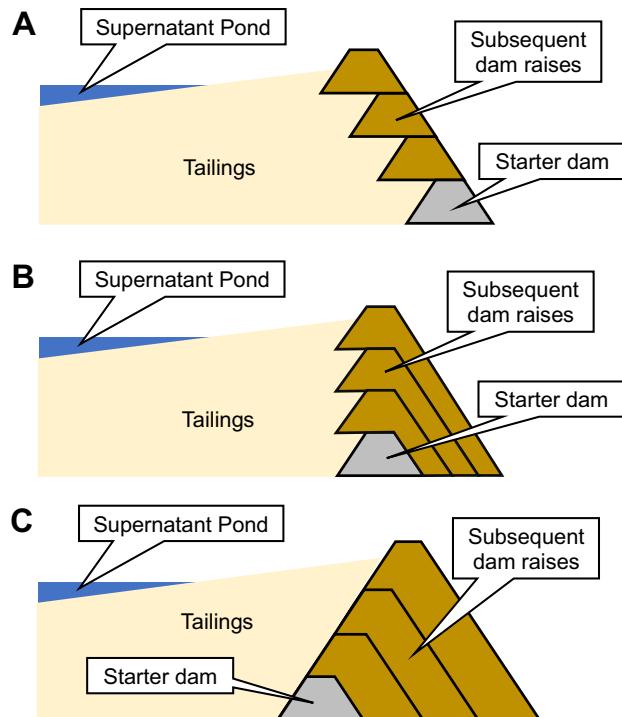
Fig. 2 Schematic of tailings dam cross sections for different construction raises. **a** Upstream construction, **b** centreline construction, and **c** Downstream construction

centreline, or downstream raises (Vick 1990), as shown in Fig. 2. The arrangement of the facility can be a ring-dyke, side-hill, or cross-valley (Blight 2010), as shown in Fig. 3. Ponds may exist on top of the tailings, either as part of operations or after flood inflows. The tailings may be liquefiable due to numerous static or dynamic triggers, including the breach event itself (CDA 2021; Small et al. 2017). Hard and soft rock type tailings can also have different geotechnical and rheological attributes (Ghahramani et al. 2020; Rana et al. 2021a; Small et al. 2017).

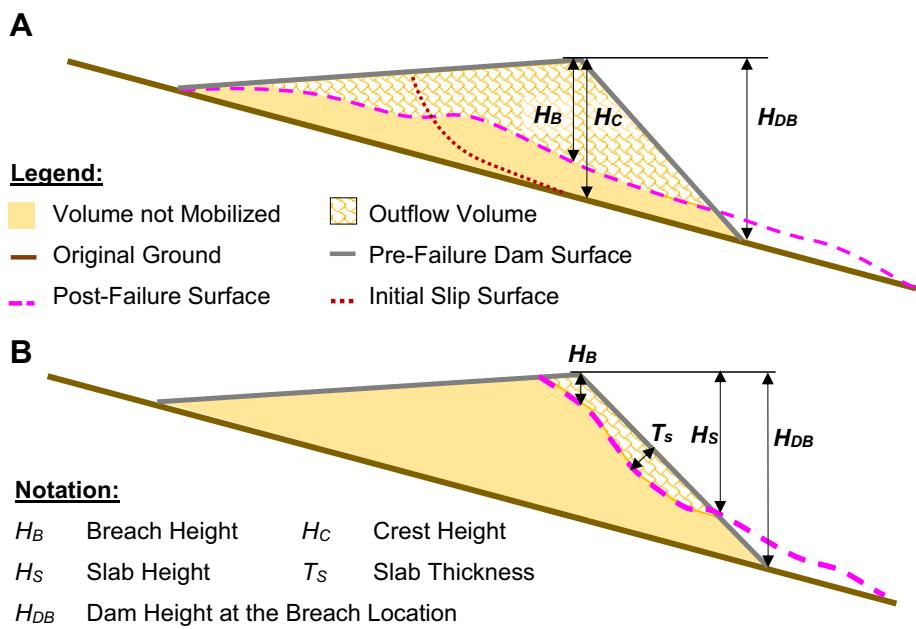
Fig. 5 Height conventions and dimensions. **a** Standard breach geometry, and **b** Avalanche breach geometry

Confusion regarding these possible height definitions was found to be prevalent in reporting. Consequently, four separate parameters are explicitly defined here: maximum dam height, dam height at the breach location, crest height at the breach location, and breach height. The maximum dam height corresponds to the ICOLD definition, and may be useful for regulatory or classification purposes, whereas the breach height is most relevant to the hydraulic control and actual outflow. The crest height at the breach location is approximately the maximum potential breach height. These definitions are shown visually in Fig. 5a.

maximum thickness of the tailings outflow volume measured normal to the average post-failure surface slope was larger than the breach height, the event in question was considered using a different convention. This scenario is shown schematically in Fig. 5b. This distinction was made as the hydraulic control was assessed to be at the breach toe in these failure events (e.g. the 2010 Kayakari event, Ishihara et al. 2015). The source area for this scenario is visually similar to slab avalanche source areas as defined by UNE-SCO (1981). Consequently, the tailings dam breach events that meet this criterion are termed 'avalanche events'. This convention was developed, as it was found that the geometry at the breach toe was better suited as the hydraulic control, rather than at the setting-out-line.

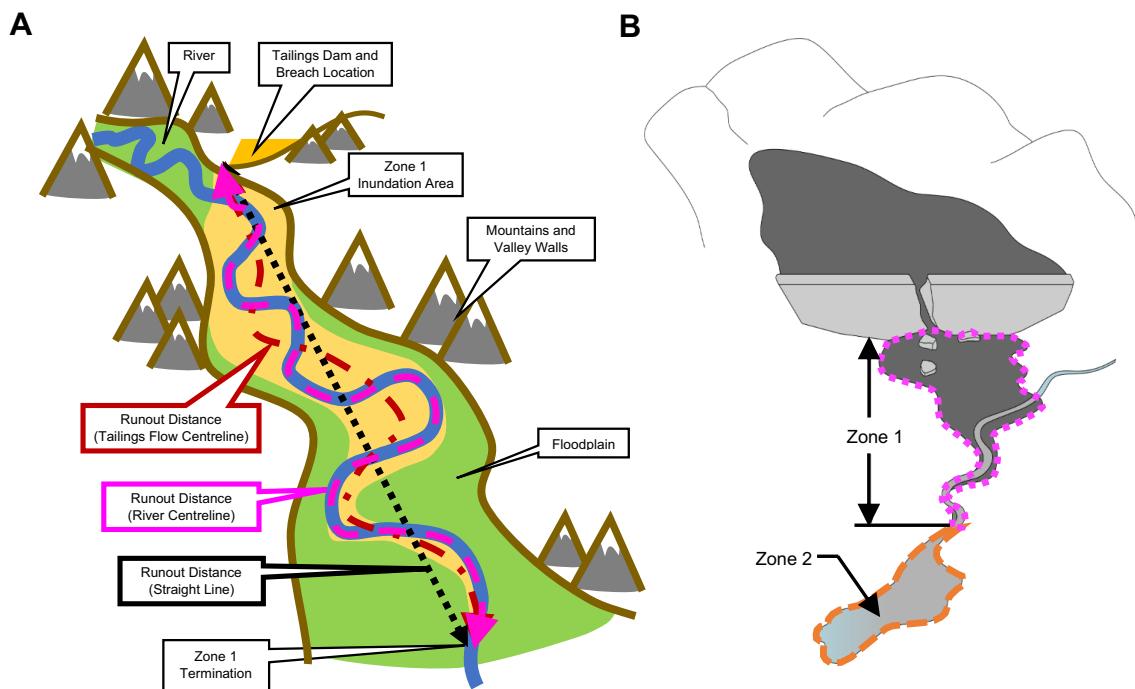
Fig. 7 Tailings runout conventions. **a** Various runout distance conventions, and **b** the Zone 1 and Zone 2 impact area convention from Ghahramani et al. (2020)

The convention for measuring runout distance has not been defined in previous databases (e.g. Concha Larrauri and Lall 2018; Ghahramani et al. 2020; Rico et al. 2008). It can be measured along the river centreline or thalweg, along the centreline/streamline of the tailings flow (i.e. not necessarily the river centreline), or along the shortest straight-line distance. These conventions are shown conceptually in Fig. 7a. It appears that all three conventions have been used in previous databases, and sometimes even within the same database.

Ghahramani et al. (2020) established a convention for separating the impacted area into two zones to improve consistency in reported runout characteristics, as shown in Fig. 7b. Zone 1 is the primary impact zone, defined as the extent of the main solid tailings deposit, which is characterized by remotely visible or field-confirmed sedimentation, above typical bankfull elevations if extending into downstream river channels. Zone 2 is the secondary impact zone, defined as the area downstream of Zone 1 that is further affected by the tailings flow in some way. Secondary impacts may include flood or displacement wave impacts (i.e. fluid impacts above typical downstream water levels) and sediment plume impacts (i.e.
