# Numerical Simulation of Water Flow from the Coal Seam Floor in a Deep Longwall Mine in China

**Abstract** The study of groundwater flow from the coal seam floor is critical to safe mining operations in China. We developed a numerical simulation model to describe flood water pathways during mining, using the field conditions present at the no. 4196 west work face in the Panxi longwall coal mine, Shandong Province, China. Groundwater flow analysis revealed unusual values for the failure depth of the coal seam floor. The high ground stress and underground pressure, excavation length, width of working face, poor mechanical properties of aquitards, and expansion of fractures by groundwater infiltration all contribute to groundwater flow into the mine. The modeling results predict the time and longwall locations associated with the maximum likelihood of flood occurrence. Such results can be used by decision makers to improve mine design and safety.

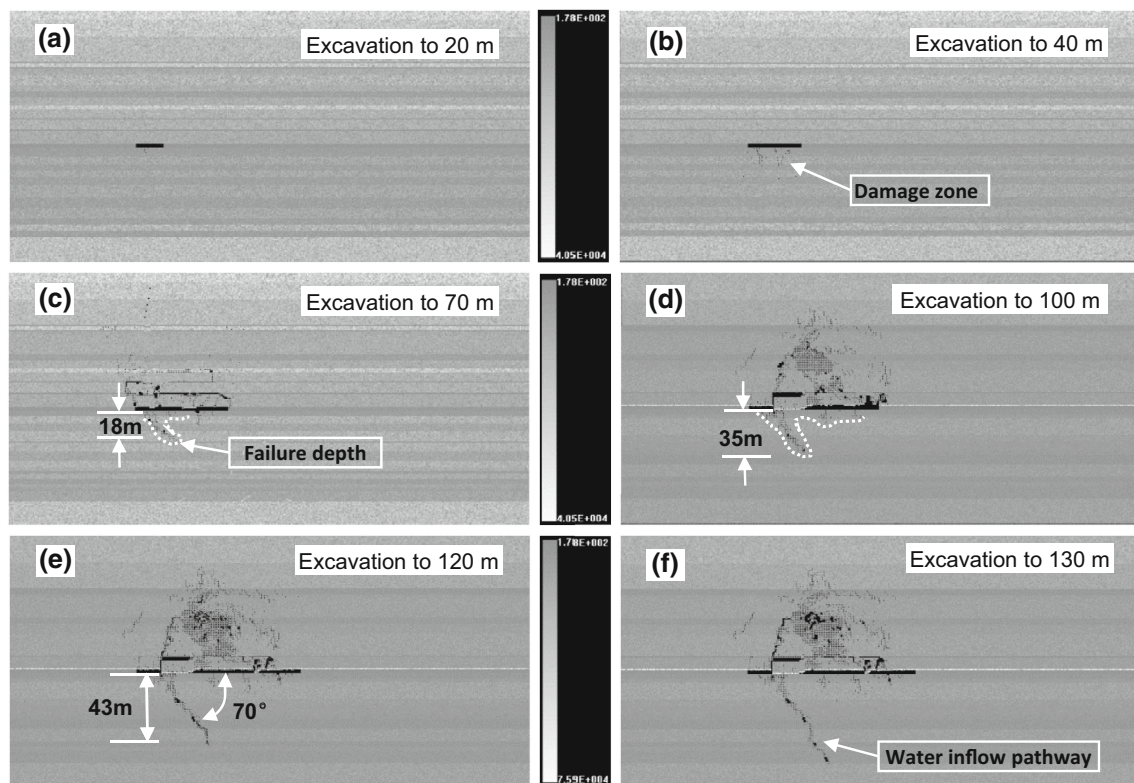
**Fig. 7** Elastic modulus patterns of the roof and floor strata

Similar to the floor strata, the roof strata also underwent deformation, fracture, damage, and collapse (Fig. 7). Before the 7th step, the immediate and main roof hardly generated fractures due to their thick and strong nature. When the excavation was 70 m long, the immediate roof began to cave and upward-extending cracks began developing in the main roof. In addition, a bed-separation zone appeared between the immediate roof and the main roof because of differential subsidence (Fig. 7c). At the 10th step, the mine face had advanced 100 m, the main roof has caved completely, and fractures continued to develop upward to a height of  $\approx 45$  m (Fig. 7d). When the excavation was 120 m long, the roof's failure length increased to  $\approx 65$  m.
