Potential for Retrofitting STD

Submarine tailings disposal (STD) systems have been retrofitted, designed, or appear to be possible at several existing or abandoned coastal and island mines. At Atlas Copper Mine, the Philippines, the system is somewhat different from the norm: a 500-m pipe pier, with a discharge point just below the surface, extends offshore to 30-m water depth. Little environmental information is in the public domain, but there appears to be some nearshore turbidity and deposition. A system was designed for the Toquepala and Cuajone mines, Peru, but was not implemented. The discharge depth was to have been at 20 m to a sloping offshore bank, with low-oxygen water and sediments. The Marcopper Mine, the Philippines, elected for nearshore disposal, but extended this by causeway to surface discharge over deeper water. Reviews of potential STD sites showed at least three locations with apparently suitable depth and slope close to shore. At Bougainville Copper Mine, Papua New Guinea, the tailings disposal option was to a river with flow westward to the sea. Nearshore deep water beyond a fringing reef in an easterly direction was closer to the mine and could have been in

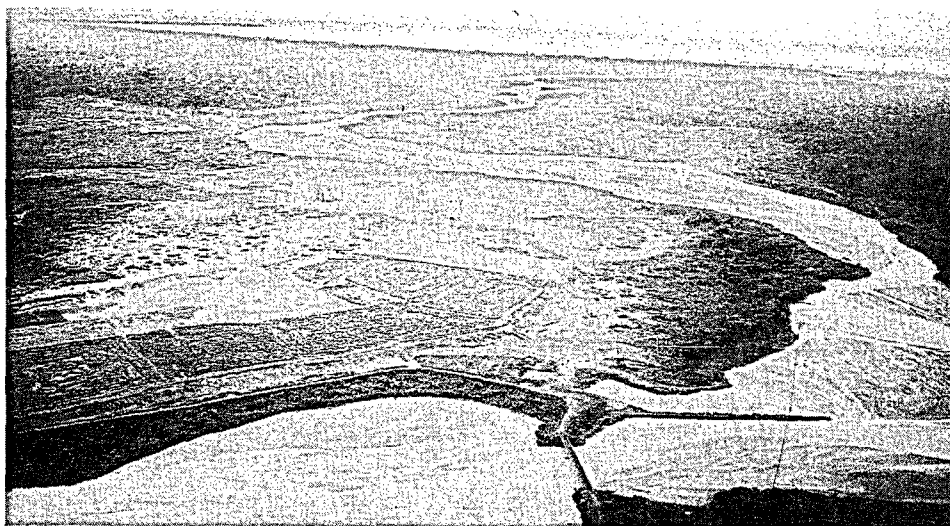
Figure 17. Tailings from the Bougainville Mine filling the channel of the Jaba River and flowing to the west coast. Tailings deposition from flooding is being reclaimed.

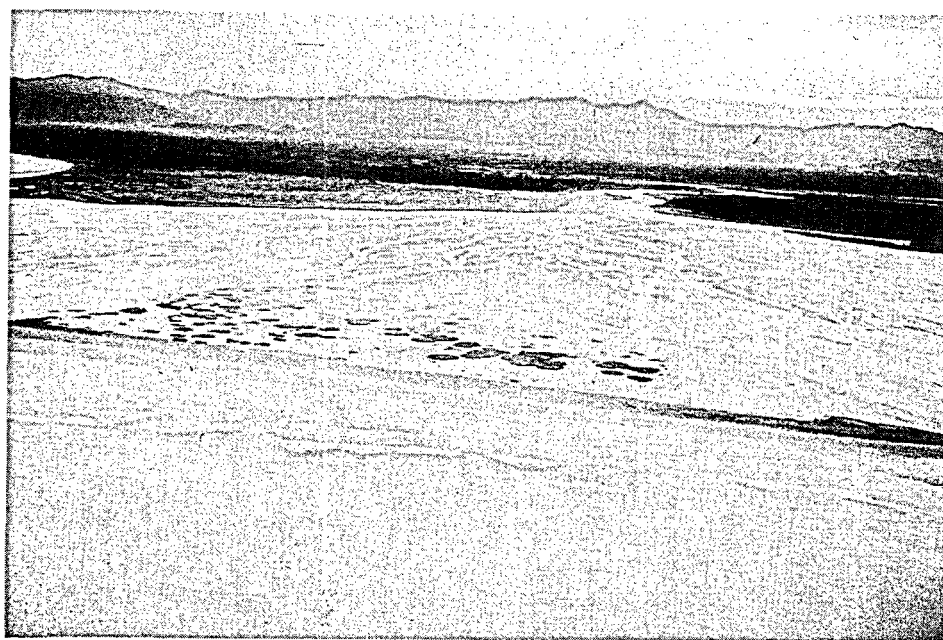
Figure 18. Tailings from the Bougainville Mine form a delta in Empress Augusta Bay after flowing down the Jaba River.

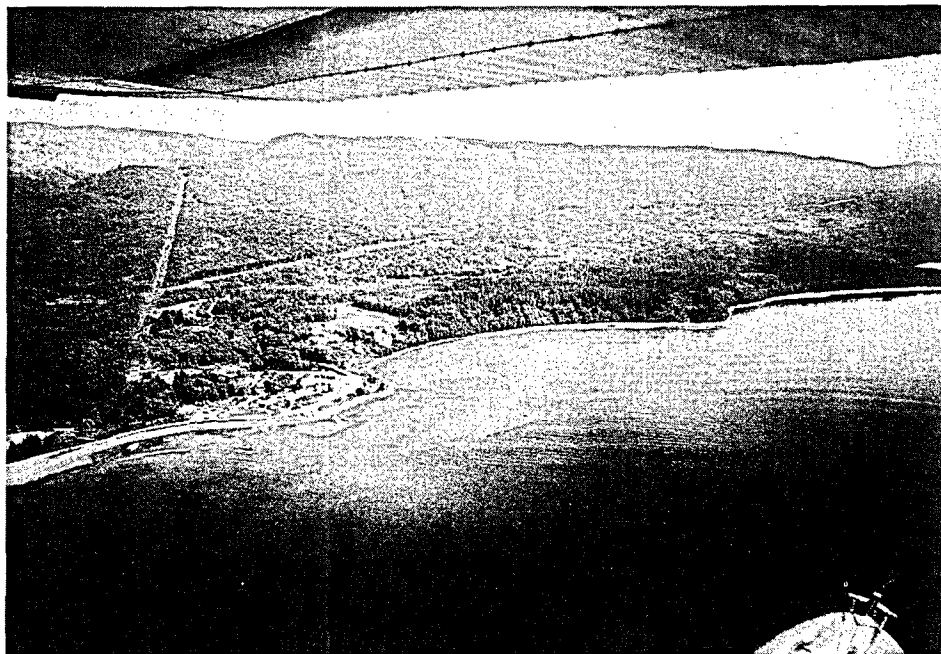
Figure 22. A surface plume of tailings from the Jordan River Mine close to the intended discharge point.

In 1962 reserves were evaluated as approximately 1 million tons of 1.54% copper and approximately 750,000 tons of 1.14% copper. The mill was placed underground and the tailings were pumped through a 15-cm line to tidewater, presumably at Outfall Point (Figure 22). Initially the tailings were the consistency of very fine sand, with 79.4% particles < 0.074 mm (minus-200 mesh), 11.2% > 0.074 mm (minus-200 mesh), and < 0.10 mm (plus-200 mesh); and 8.5% > 0.10 mm (plus-200 mesh) and < 0.15 mm (plus-100 mesh) (Kilby, 1991).

tailings were estimated to deposit, with the balance suspended and dispersing (Littlepage, 1973). Figure 22 shows a surface plume from the original terminus, and Figure 23 an onshore drifting plume from a nearer-shore breakpoint. The latter was the discharge point from soon after operations started to closure, i.e., for about a year and a half.
