A CASE STUDY OF A LARGE OPEN PIT URANIUM AML PROJECT GAS HILLS, WYOMING ¹

Abstract:

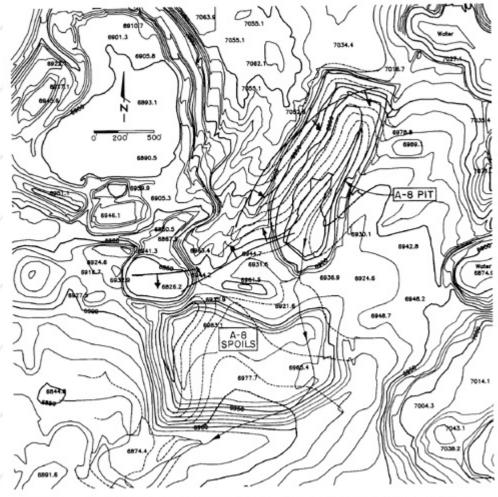
Figure 1. Site map of the A-8 Project as located in the East Gas Hills region of Central Wyoming.

The A-8 open pit uranium mine as shown in Figure 1, was abandoned in the early 1970's, without any reclamation measures. Reclamation activities now are in progress to control hazards and further environmental degradation. Approximately 3.5 million cubic yards of backfill will be placed in the pits. Surface drainage channels will be constructed and cover soils placed to control Radium 226 emissions and to assist with revegetation.

The reclamation plan selected for implementation is represented in Figure 1. It reflects the general finished grading and surface drainage plan. The estimated construction cost is \$4,180,000. Construction is scheduled to occur between June, 1990 and November, 1991.
