D8 motorway Dobkovičky landslide: the case history and repair options

Petr Kycl

Czech Geological Survey, Czech Republic

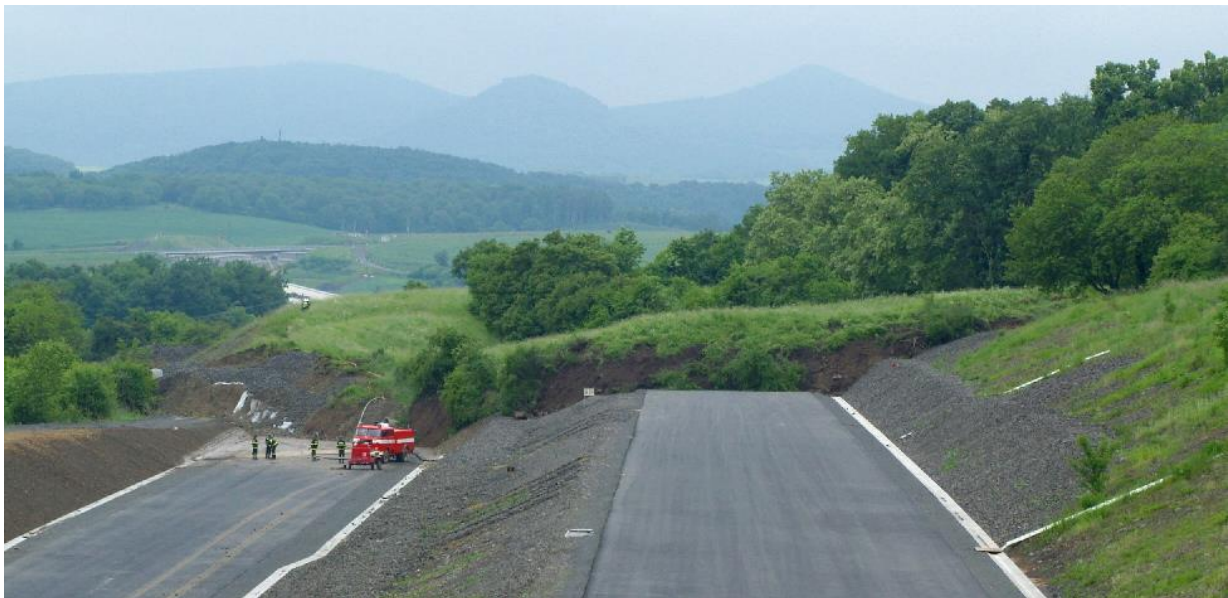
On Friday, June 7th 2013, the works were interrupted and the motorway under construction was damaged when heavy rains triggered a landslide near village Dobkovičky (km 56.3–56.5: fig. 1).

Fig. 1: Damaged motorway D8 which was under construction at the time of landslide.

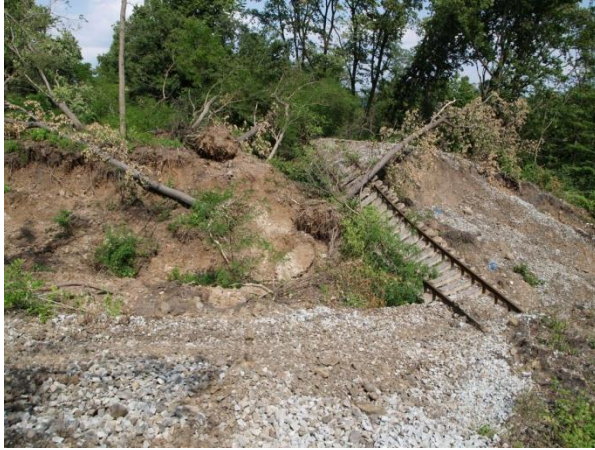
The damage was not restricted only to the motorway (fig. 1) but also affected the single-track railway Lovosice – Teplice between the stations Dobkovičky and Radejčín (fig. 2). The railway was completely destroyed in the length of 200 m, including a 6 m high embankment.

Fig. 2: Destroyed railway.

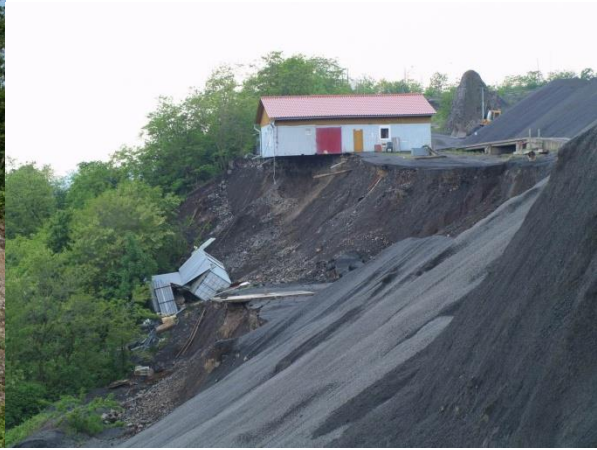
Fig. 3: Damages in the Dobkovičky quarry.

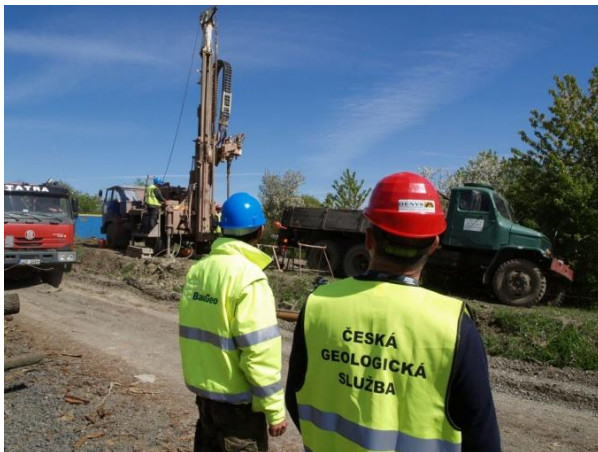
The site investigations of the landslide lasting for two months and carried out by the AZ Consult Company began at the end of April 2014 (fig. 4). The survey comprised 15 boreholes (of which 4 were inclinometric, 6 hydro-geological and 5 engineering geological) complemented with 2 dug holes and 7 geophysical profiles. The aims of the investigations were to determine surface of rupture (fig. 5), geotechnical properties of the soils and rocks necessary for the stability calculating, effect of the superficial and underground water and finally to create the geotechnical model of the landslide.

Fig. 4: Site investigation – borehole HV103.

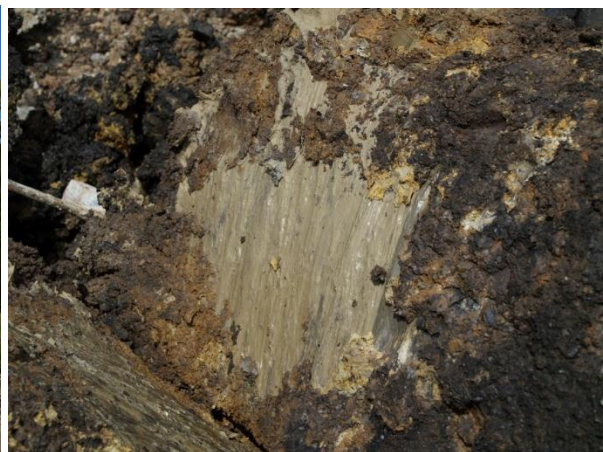
Fig. 5: Surface of rupture in dug hole KS-1.

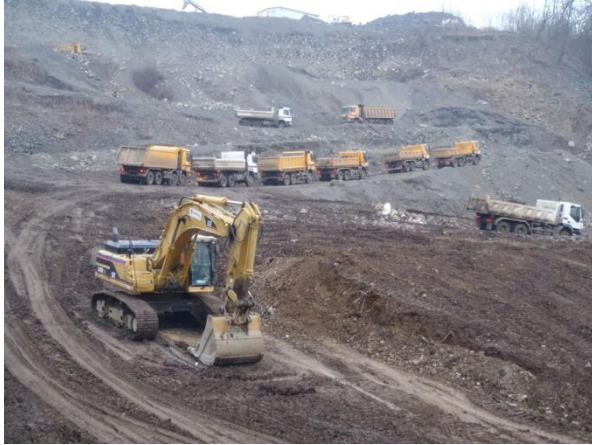
Fig. 6: Excavation of 80.000 m³ in the upper part.

Finally, the remediation works started on November 18th 2014. The first phase comprised excavation of 80.000 m³ of the slid masses from the upper part of the landslide. At the same time, superficial drainage channel has been realized. When measurements confirm the landslide is stable, the II. phase can be approached.

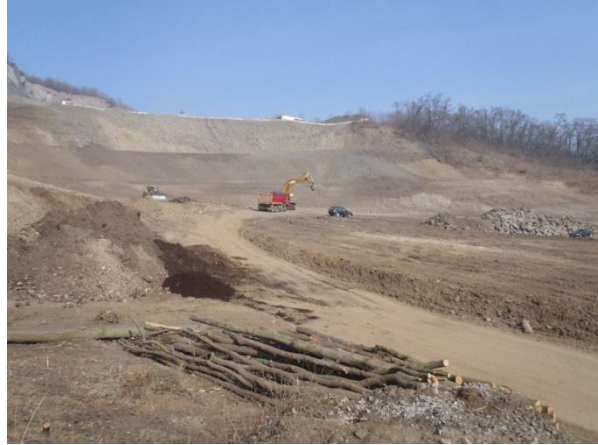
Fig. 7: Final form of landslide in the upper part.

The tender for the project of the II. phase has been actually announced. The II. phase will include deep drainage and static elements in the line above the motorway. The static elements will be probably based on the underground piles or wall segments (“T elements”). The start of the II. phase is expected for the turn 2015/16. Finally the landslide accumulation from the motorway can be excavated, and reconstruction of the asphalt surface and drainage of highway will follow. December 2016 is the actual deadline for opening of the D8 motorway.
