Idaho Department of Water Resources

## Open File Report

# FLUORESCENT DYE TRACER TESTS AT THE MALAD GORGE STATE PARK

September 30, 2009

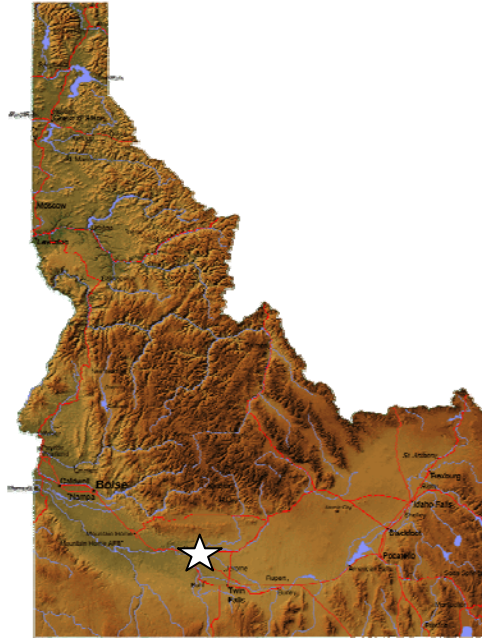
Figure 1. General location of the dye tracer test at the Malad Gorge State Park.

The Malad Gorge State Park is located approximately 90 miles southeast of Boise (Figure 1) and starts near where Interstate 84 crosses the upper part of the Gorge in Gooding County at T6S R13E, southern section 25 and northern section 36 (Figure 2). The elevation of the park picnic area well head is 3,273 feet determined from 100 post processed readings using a Trimble GeoXT 2005 set on the highest precision option and NAD83. On March 20, 2009 the depth to water in the well was 191.76 feet or 3,081 feet elevation. The river and spring discharge elevations range from 3,030 to 3,040 feet elevation using the same technique. The Gorge in this area is about 225 feet deep with vertical walls of basalt and talus slopes. Formation of the Gorge is attributed to cataract retreat of flood waters from the Bonneville Flood. No major landslides are located in this part of the Gorge. However, a bench about 20 feet higher than the river within a section of the talus slope may be the remnants of an old landslide.

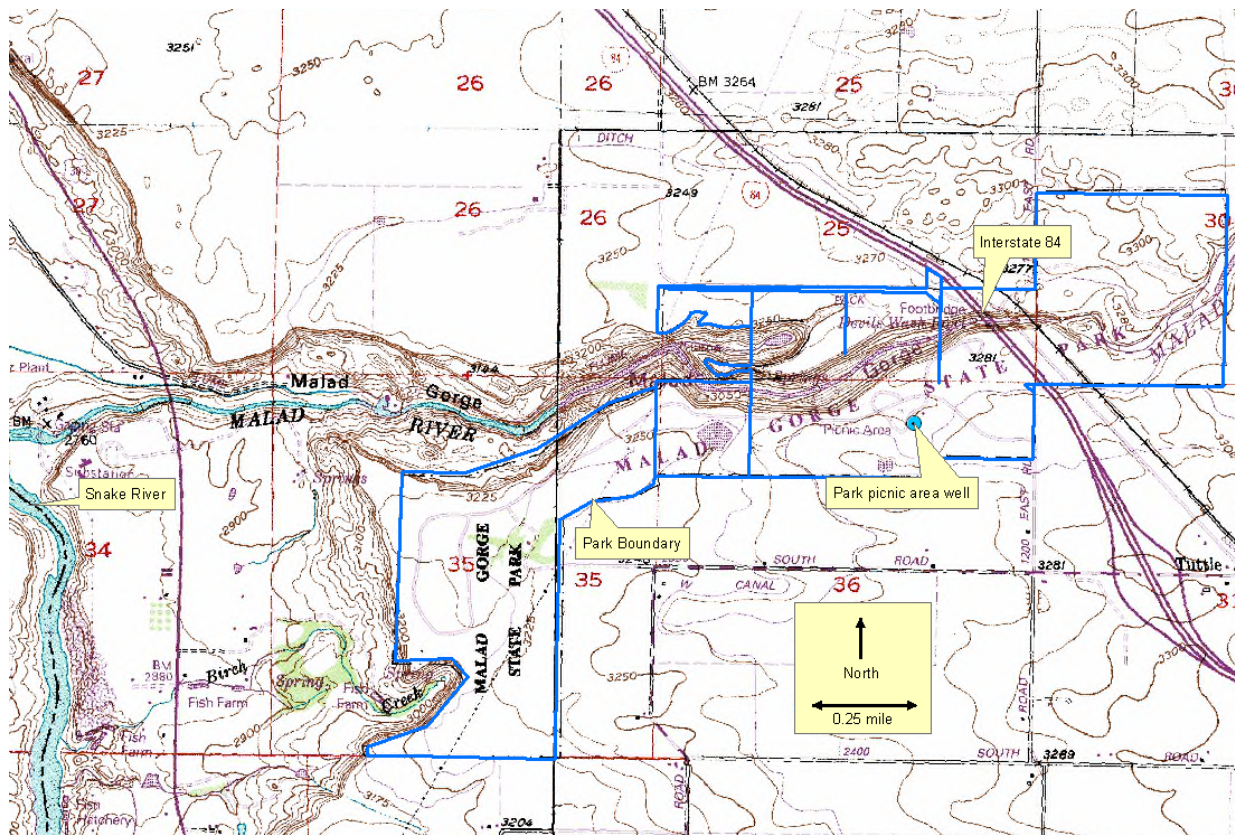
Figure 2. USGS topographic map of the site showing the park boundary as the blue colored line.

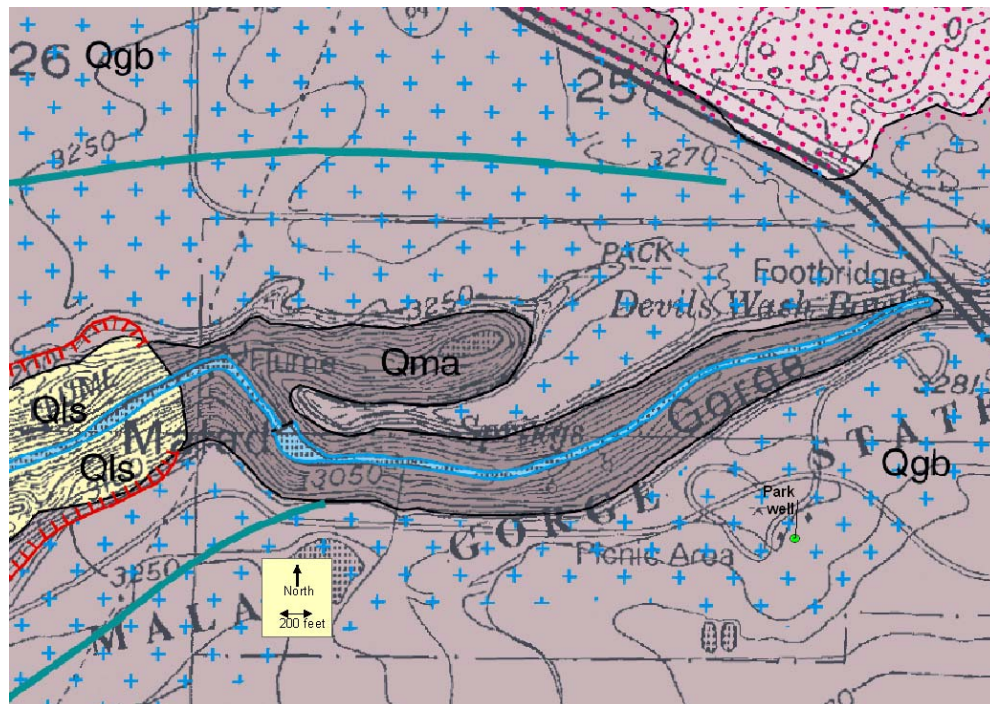
Figure 3. Geologic map showing the upper section of Malad Gorge Pleistocene age basalts Madson (Qma) and Gooding Butte (Qgb) (Gillerman et al, 2005). See Appendix A.

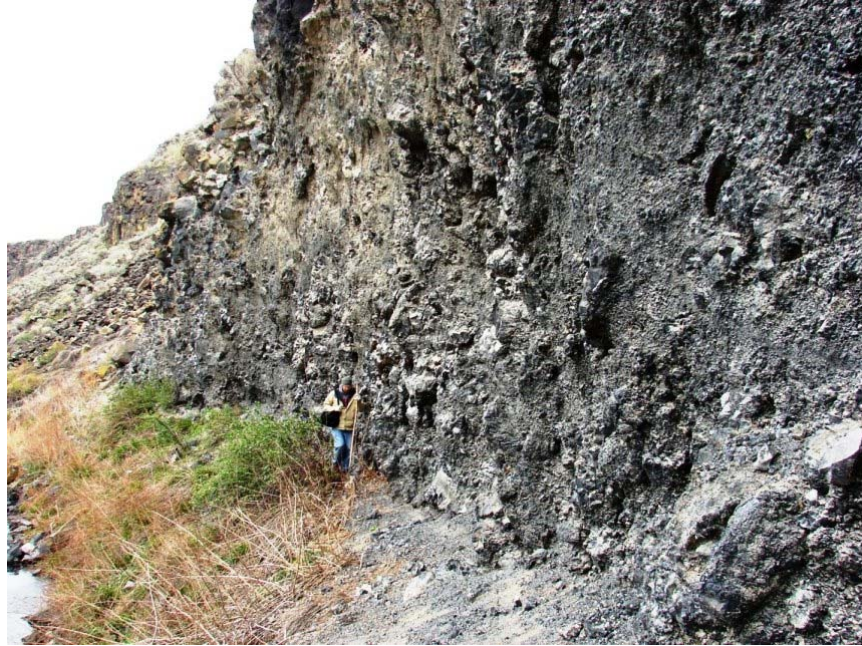
Figure 4. Thick layer of pillow basalt with groundwater discharge located at Idaho Power Company's upper diversion dam.

Located near Idaho Power's upper diversion is an in-situ outcrop of pillow lava exposed in the canyon wall that is at least 30 feet thick, although the base is not exposed (Figure 4). The location of Cross-section A-A' is shown in Figure 5 noting some relevant geologic outcrops and the deepest wells in the area. The elevation of this pillow zone correlates to the inferred contact between the GFF and overlying Madson (Qma) basalt based on additional information in well logs of the Park Office and Hooper wells and L. Woody borehole (Figure 6). Individual logs can be found in Appendix B. Note the close elevation correlation between the pillow outcrop, site MG-7 and the lowest geologic notation for the park picnic well as 'broken basalt'. Groundwater flows from the base of the brecciated pillows which is similar to other spring locations in the Hagerman Valley with exposed pillows and groundwater discharge. Field inspection at several nearby spring sites show a geologic pattern of a massive 'cap' of basalt overlying a pillow/brecciated rubble zone typically with groundwater discharging from it, and underlying the pillows is the GFF. This general geology has been observed at the Curren Tunnel, Three Springs, Big Springs, an outcrop 1 mile south of Rangen (dry), and at Spring Creek. All four well logs note "broken basalt" at this contact and it is interpreted to be the pillow/rubble deposit. Pillows and associated rubble are highly permeable and capable of transmitting or discharging large volumes of ground water.

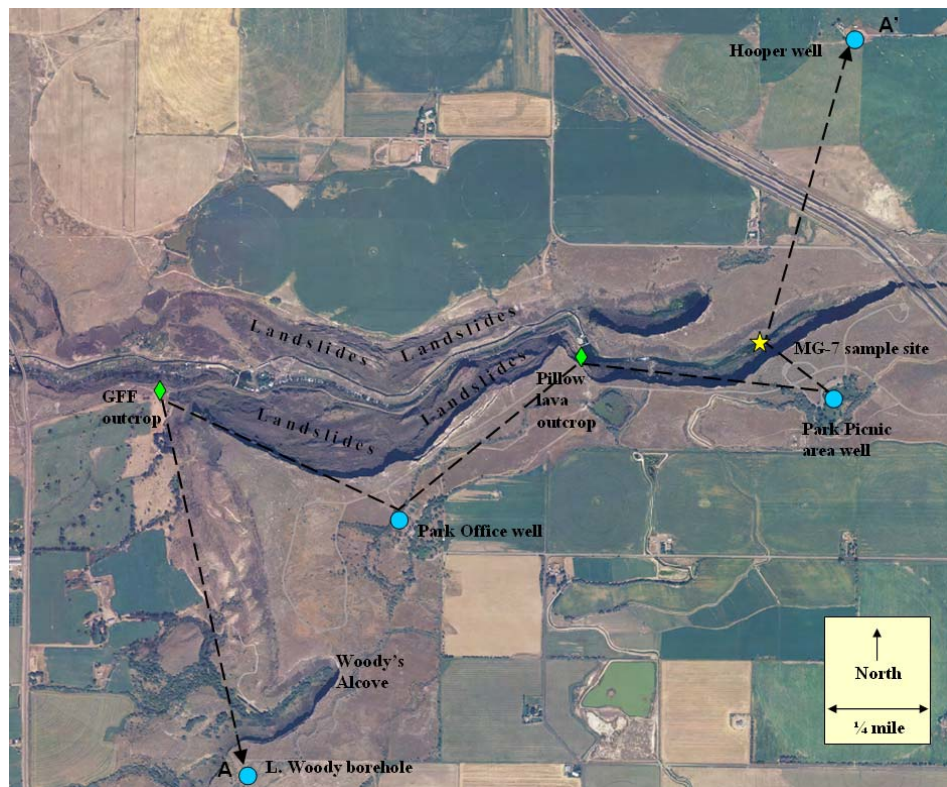
Figure 5. Location of geologic cross section line A-A' with wells noted as blue circles, outcrops as green diamonds and sample site MG-7/Malad River as yellow star.

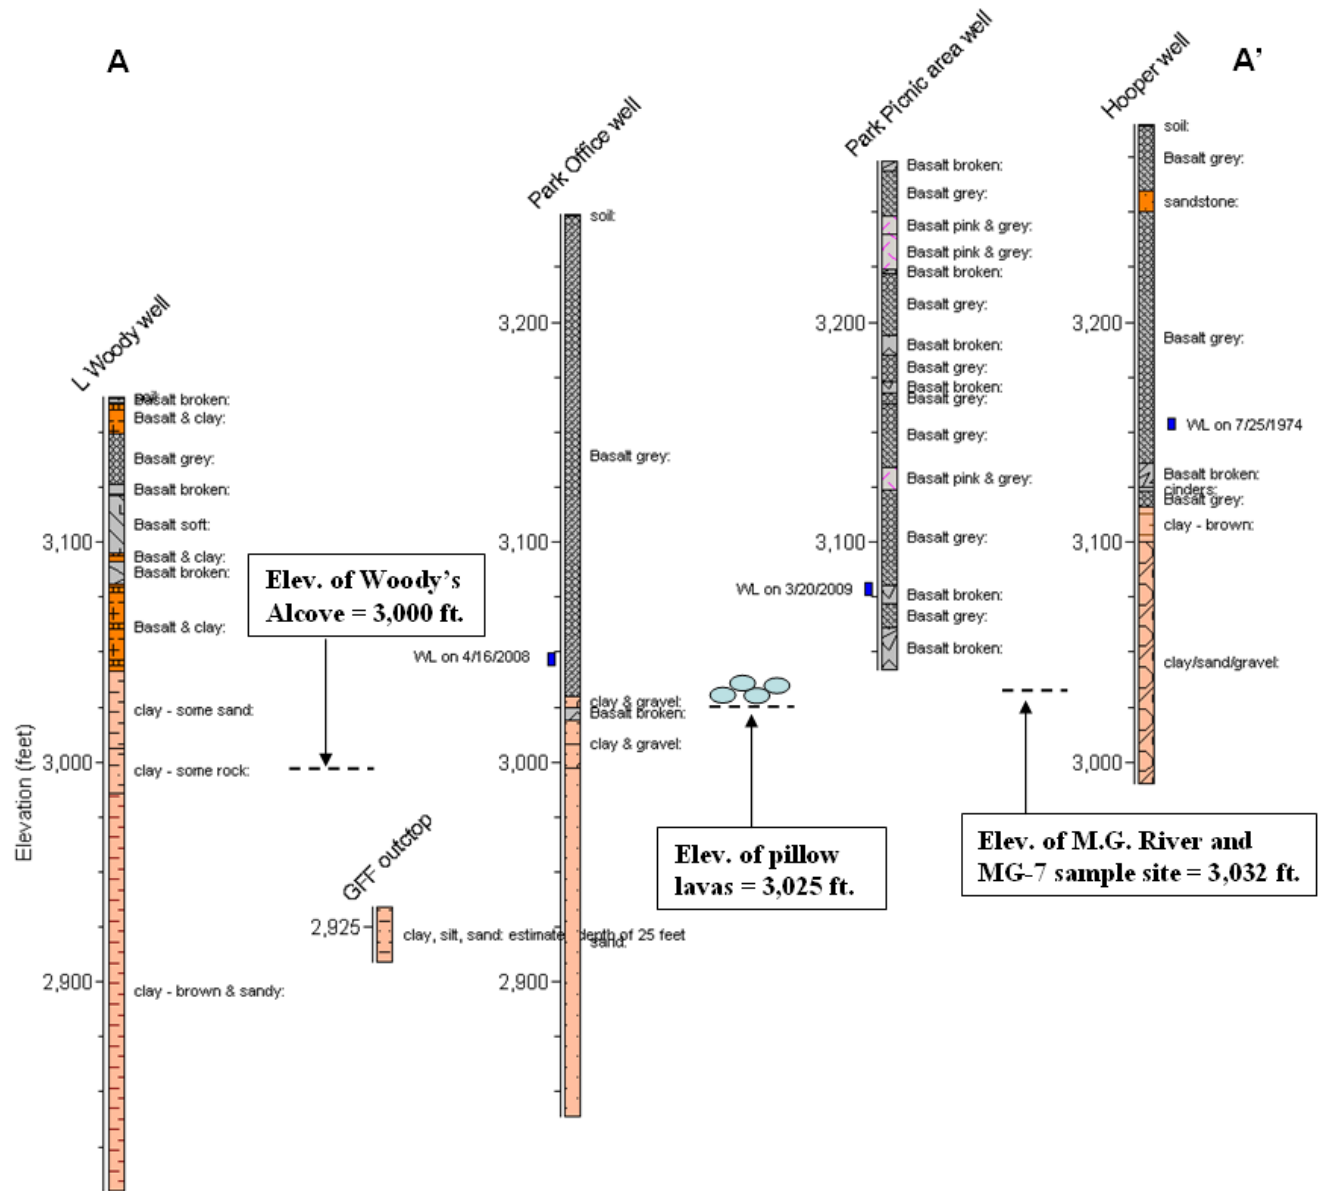
Figure 6. Geologic cross section A-A' noting sediments as orange colored background and basalt related rock type as grey colored background patterns. Elevations of Woody's Alcove, pillow basalt outcrop and the Malad Gorge River/sample site MG-7 are also shown. Tick marks are every 25 feet. Well water levels are shown with dates.

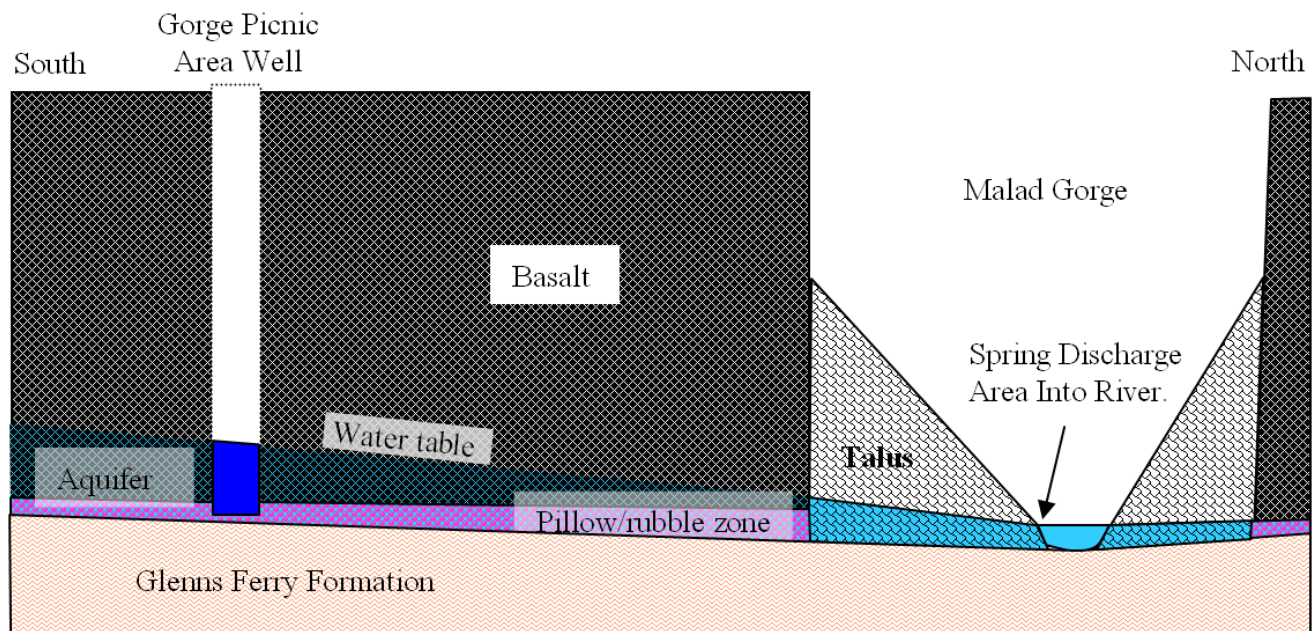
Figure 7. General conceptual cross section geologic model for the tracer test area (not to scale).

An idealized vertical cross section model is shown in Figure 7 that is not to scale, and the exact subsurface geologic architecture is not well defined. The units, contacts and orientation are inferred from outcrops, mapping and well logs. Numerous well logs and outcrops indicate the GFF contact appears to rise in elevation both north and south of this area and there is an approximately 47 foot elevation change from the water level in the well to the river/spring elevation in the Gorge.

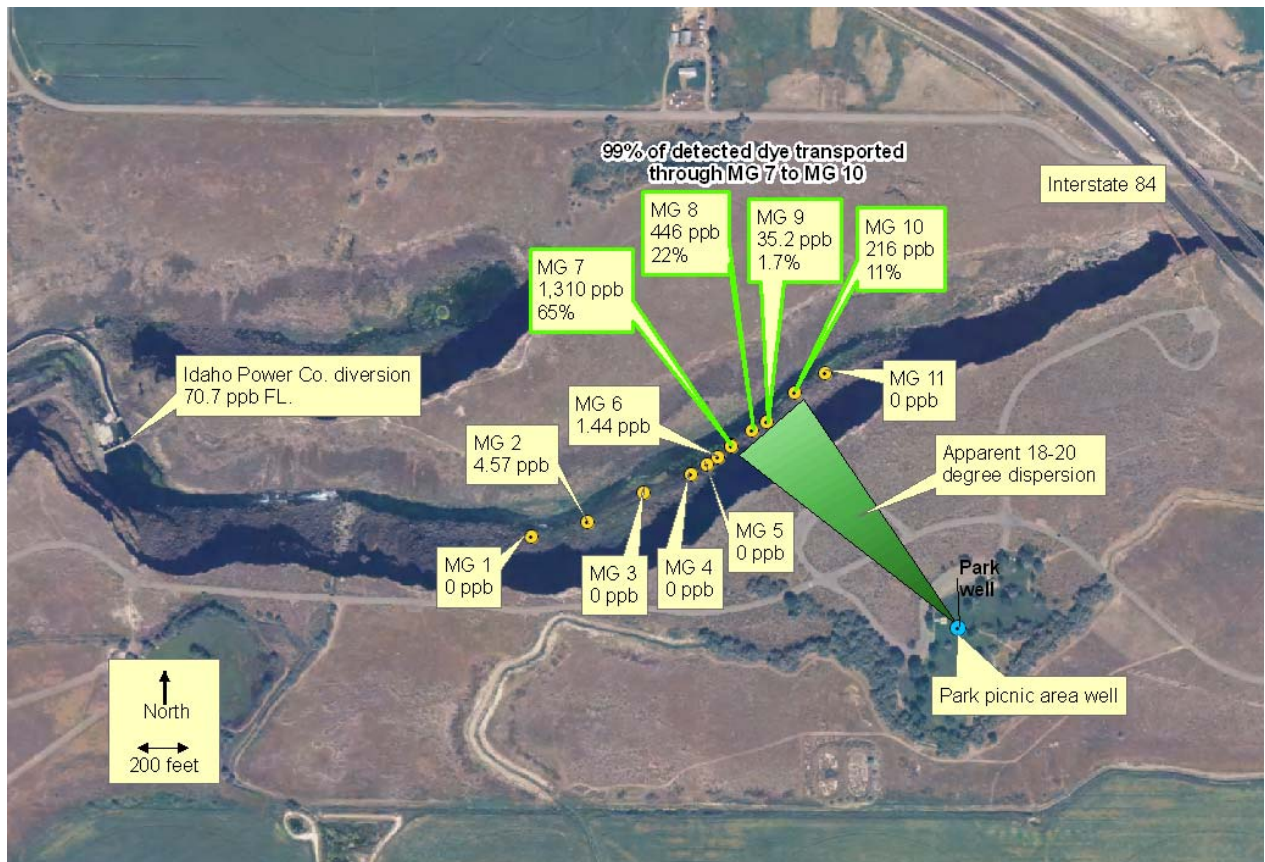
Figure 8. Air photo showing Fluorescein tracer test sample sites with yellow circles and the dye injection well in the Park picnic area with a blue circle. The majority of the detected Fluorescein dye passed by sites MG 7, 8, 9 and 10.

Fluorescein dye was injected in phase I with charcoal packets used as dye collectors along with 50 mL water samples. Figure 8 shows the location of the sample sites as yellow circles and noted as MG-1 through MG-11. They were placed at high spring/groundwater discharge flowing into the river. Ground water discharge was observed at other locations but at reduced rates. It was anticipated that the dye would discharge at MG-4, 5, and 6 and that is why there is a slightly higher density of sample sites. Coconut shell charcoal packets purchased from Ozark Underground Labs (OUL) were deployed at each sample site in the spring water and also at the Idaho Power diversion. Charcoal packets serve as ‘sentries’ that are constantly immersed in water and will absorb dye as it passes through the packet during the test period. This means the information gained from the charcoal packets is integrative over the test period.

Results from Phase 1 Fluorescein test demonstrate that 99% of the detected dye in charcoal packets passed by sample sites MG-7, 8, 9, and 10 with a minor amount at MG-2 and MG-6 (Figure 8). Site MG-7 received the highest concentration of dye of 1,310 ppb (from the charcoal packet) or 65% of the detected dye and therefore it is assumed this site has the best hydraulic communication with the well. MG-8 received the next highest charcoal packet concentration of 446 ppb or 22% of the detected dye. Sites MG-9 and MG-10 also received high dye concentrations. MG-3, 4, 5, and 11 did not receive any dye and only a small amount (1.44 ppb) at MG-6. This pattern indicates the dye was well constrained between MG-7 through MG-10 with little or no lateral migration of dye into adjacent sites of MG-6 or MG-11. The horizontal spatial dimension was delineated from the ‘spread’ of the dye cloud with a cone of dispersion measured at approximately 18-20 degrees. Taken as a whole (sites MG-7 through MG-10), the distribution apparently indicates a high level of homogeneity in the aquifer at this scale and location. This might be attributable to the highly broken, fractured and rubble nature of the pillow zone which diffuses the flow more than a non-pillow zone. The caveat to this is that each individual site may have multiple flow paths which is supported by Phase II of the test. The main flow path is based on the azimuth between the well and MG-7 which is nearly due northwest at 310 degrees. Dye was also detected at about 71 ppb from the charcoal packet located at the Idaho Power diversion and appears to have been diluted by both the Malad River inflow as well as other groundwater springs flowing into the river with no dye.

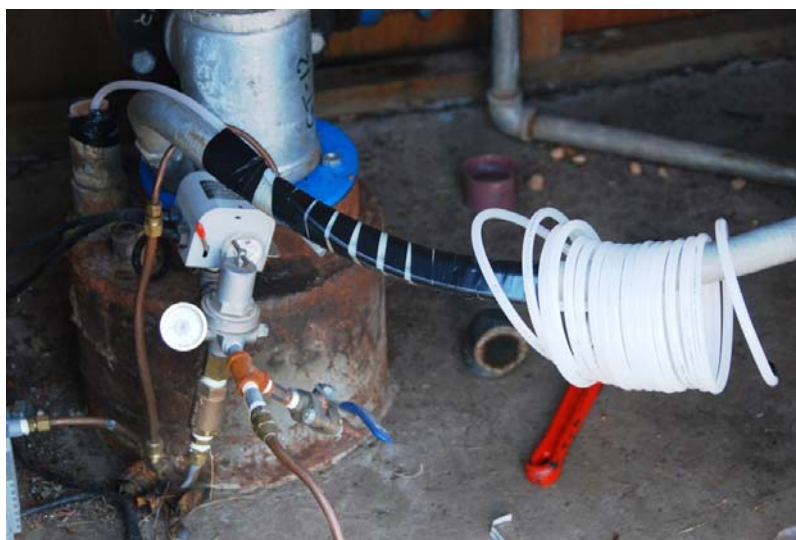
Figure 9. Polyethylene tubing deployed down well to the 213 foot level.

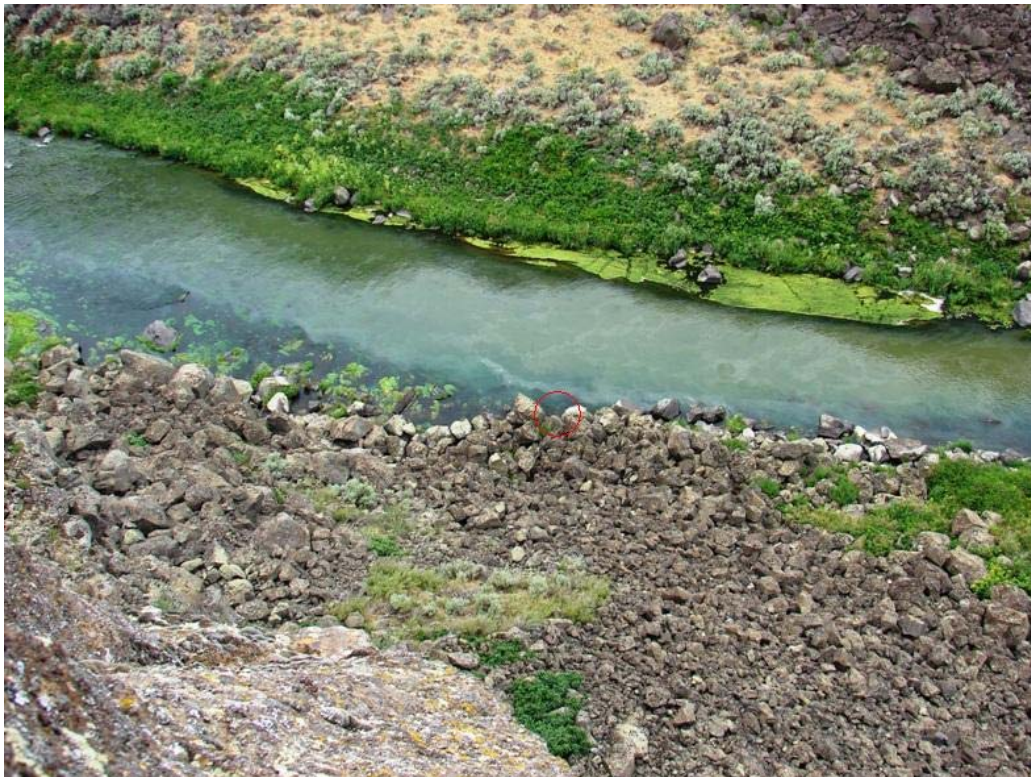
Figure 10. Location of sample site MG-7 in the red circled area as viewed from the canyon rim. Note the boundary of clear groundwater discharging into murky Malad River water.

The SCUFA unit was calibrated using deionized water and 4.0 ppb RWT solution, and it measures the water concentration of dye directly. The SCUFA also measures and records turbidity. The unit was inserted into 3-inch diameter black plastic pipe with holes drilled at an angle to allow water to flow through but block sunlight. Direct sunlight on the optics can produce noise and erratic readings. The unit was secured under a rock in a shady area of high flow at MG-7 (see following photos).

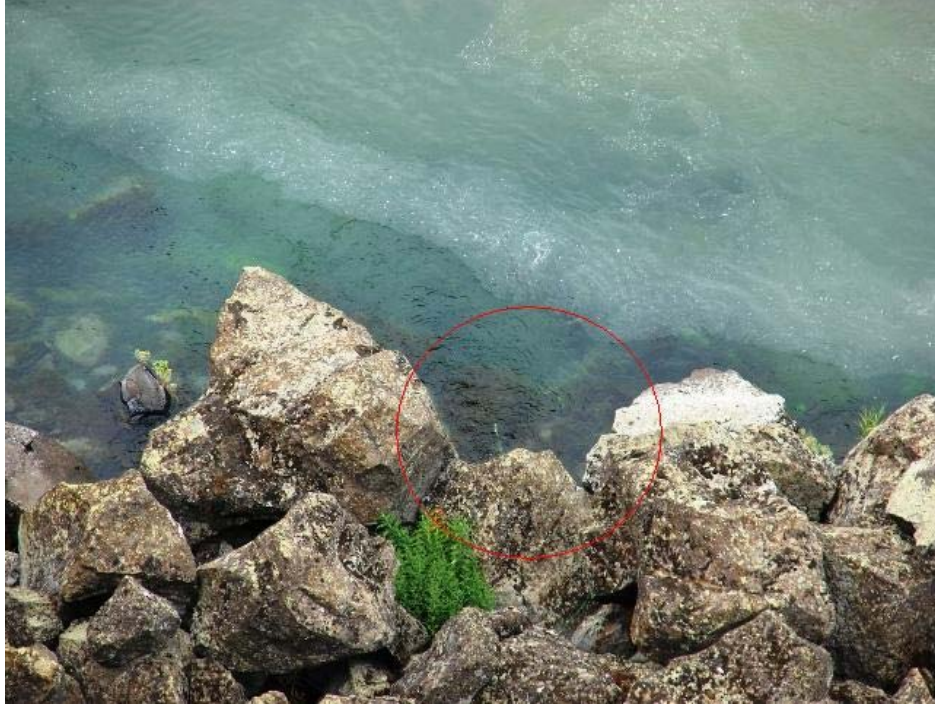
Figure 11. Closer view of MG-7 showing the high flow out into the river.

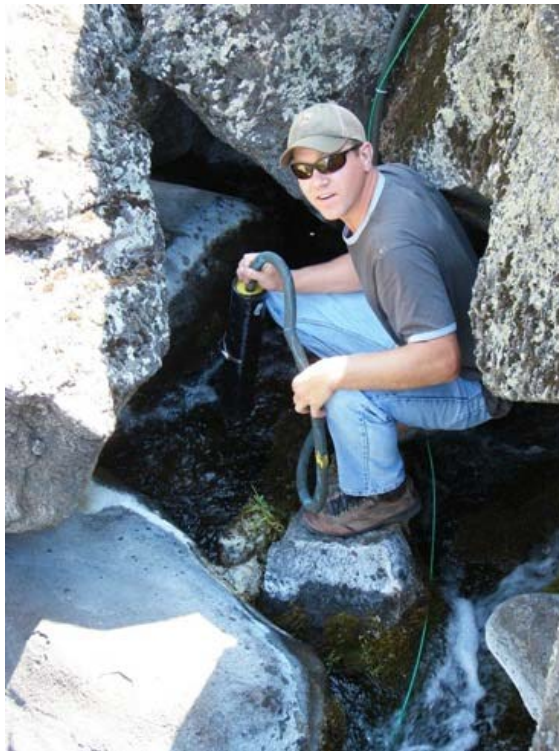
Figure 12. IDWR staff, Dennis Owsley, assisting with deployment of the SCUFA. Note the strong current from the spring discharge.

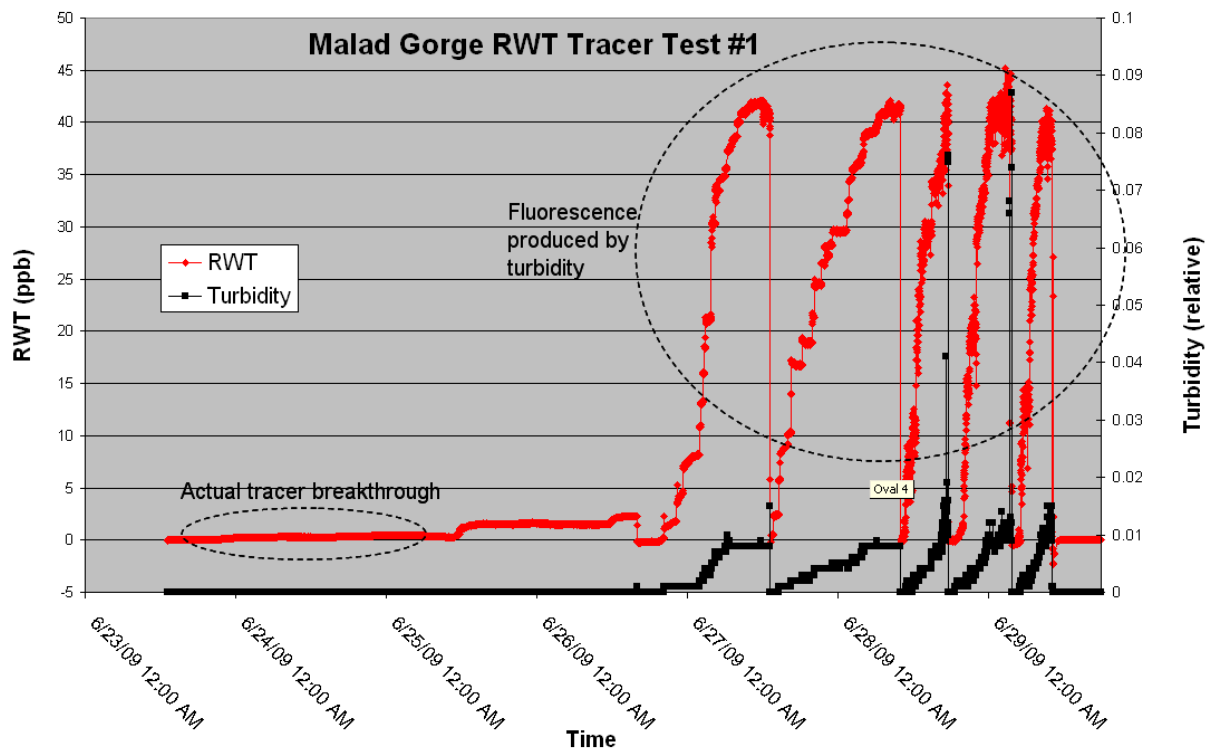
Figure 13. RWT test #1 concentration breakthrough curve from SCUFA. Fluorescent spikes correlate to turbidity spikes.

Prior to and after the June 23<sup>rd</sup> deployment of the SCUFA, cool wet weather occurred and farmers stopped diverting irrigation water. High return flows into the Malad River and increased sediment load resulted. On the 23<sup>rd</sup>, the pool level of the river rose about 6 inches but may have been even higher at other times. It is unknown if this had any effect on the spring flows or water quality, but there were some unusual cycles in the fluorescent data recorded by the SCUFA (Figure 13) that correlate to turbidity.

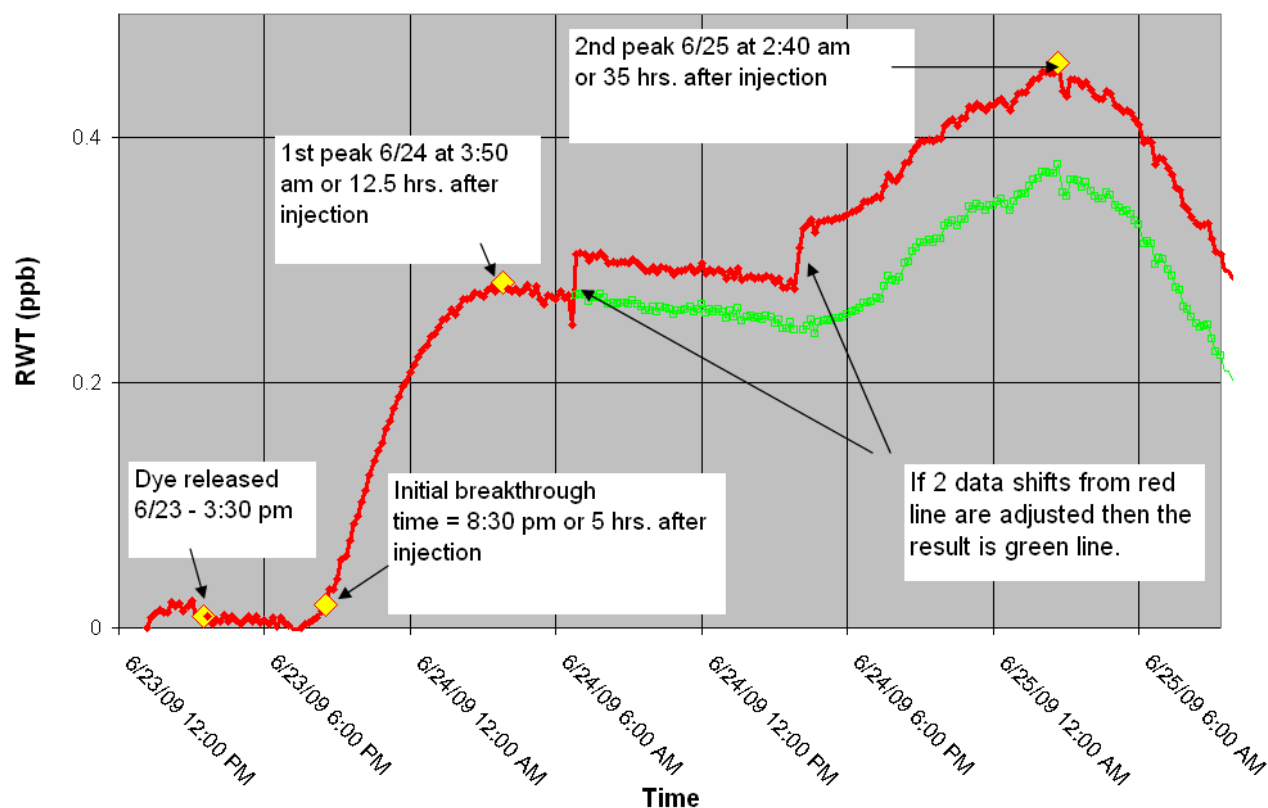
Figure 14. Expanded view of the oval shaped circled data in Figure 13 concentration breakthrough curve. Note the two peaks and temporal pattern for comparison with the second RWT test. Two data shifts occurred and if adjusted then the green line would be the resultant curve.

Figure 15 shows a classic, nearly ‘text book shaped’, RWT concentration breakthrough curve with a sampling frequency of 10 minutes. In comparing Figures 14 and 15, it is evident, that the initial breakthrough, first peak and second peak are all within 1 hour of the each other. With a more complete recession curve, it was possible to calculate the center of mass of the dye at about 30 hours after injection. The two peaks can be explained by a simple ‘double flow path’ model

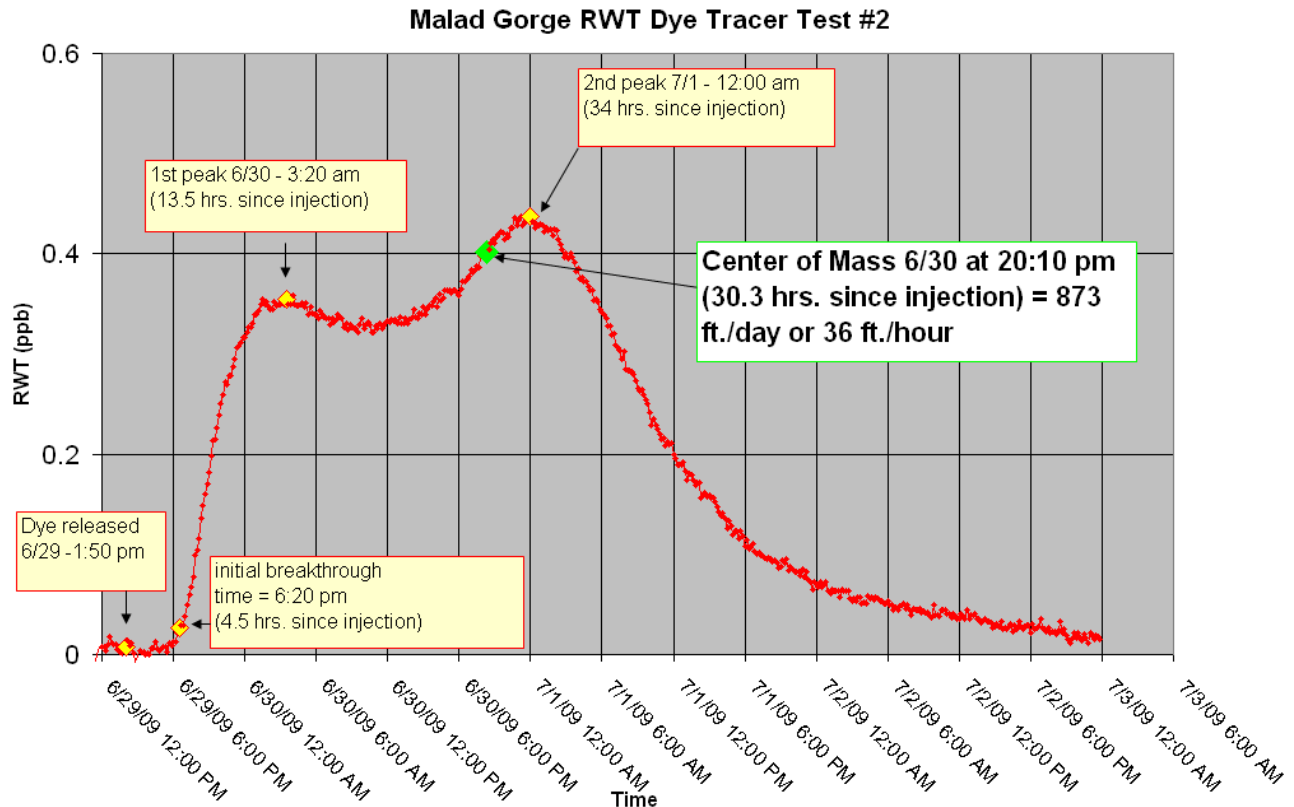
Figure 15. Dye concentration breakthrough curve for 2<sup>nd</sup> RWT test. Note the same two peak pattern as in test #1 confirming reproducibility.

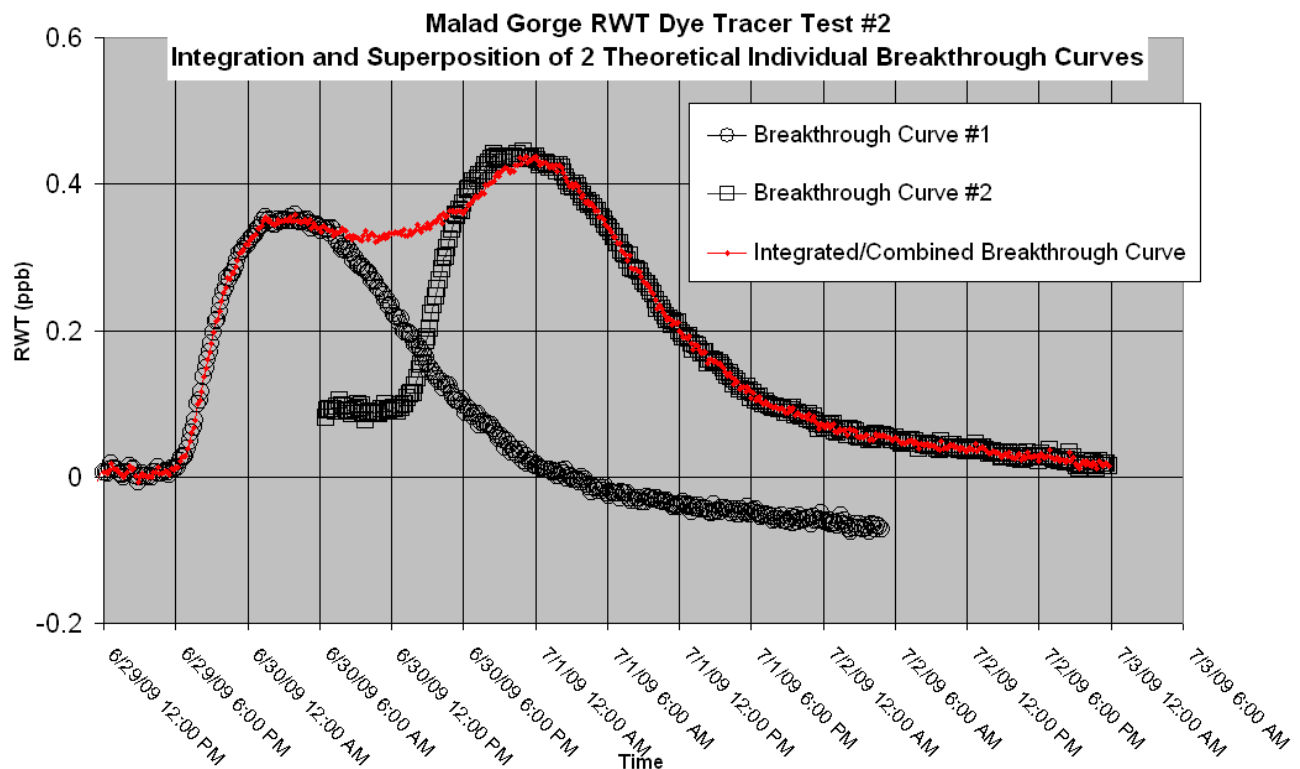
Figure 16. A general combination of two individual conceptualized concentration breakthrough curves noted in black with circles for Curve #1 and squares for Curve #2. The integration of these two black symbol curves would have the shape of the red symbol line.

for this specific site with each path having its own unique breakthrough curve as conceptualized in Figure 16 as black circles and squares. The two flow paths are combined or integrated at sample site MG-7 as one graph (Figure 15) as the red symbol line. The first peak demonstrates relatively higher hydraulic conductivity in the flow path but received slightly less dye. The second peak demonstrates a slower flow path that received slightly more dye. The double peak may have been initiated within the well from the slug injection which was not evenly mixed within the borehole water column. A mixing pump placed within the water column may have eliminated this pattern. In order to deploy a mixing pump, it would have been necessary to pull the supply pump at a cost of \$500 while further delaying the use of the pump for park water supply.

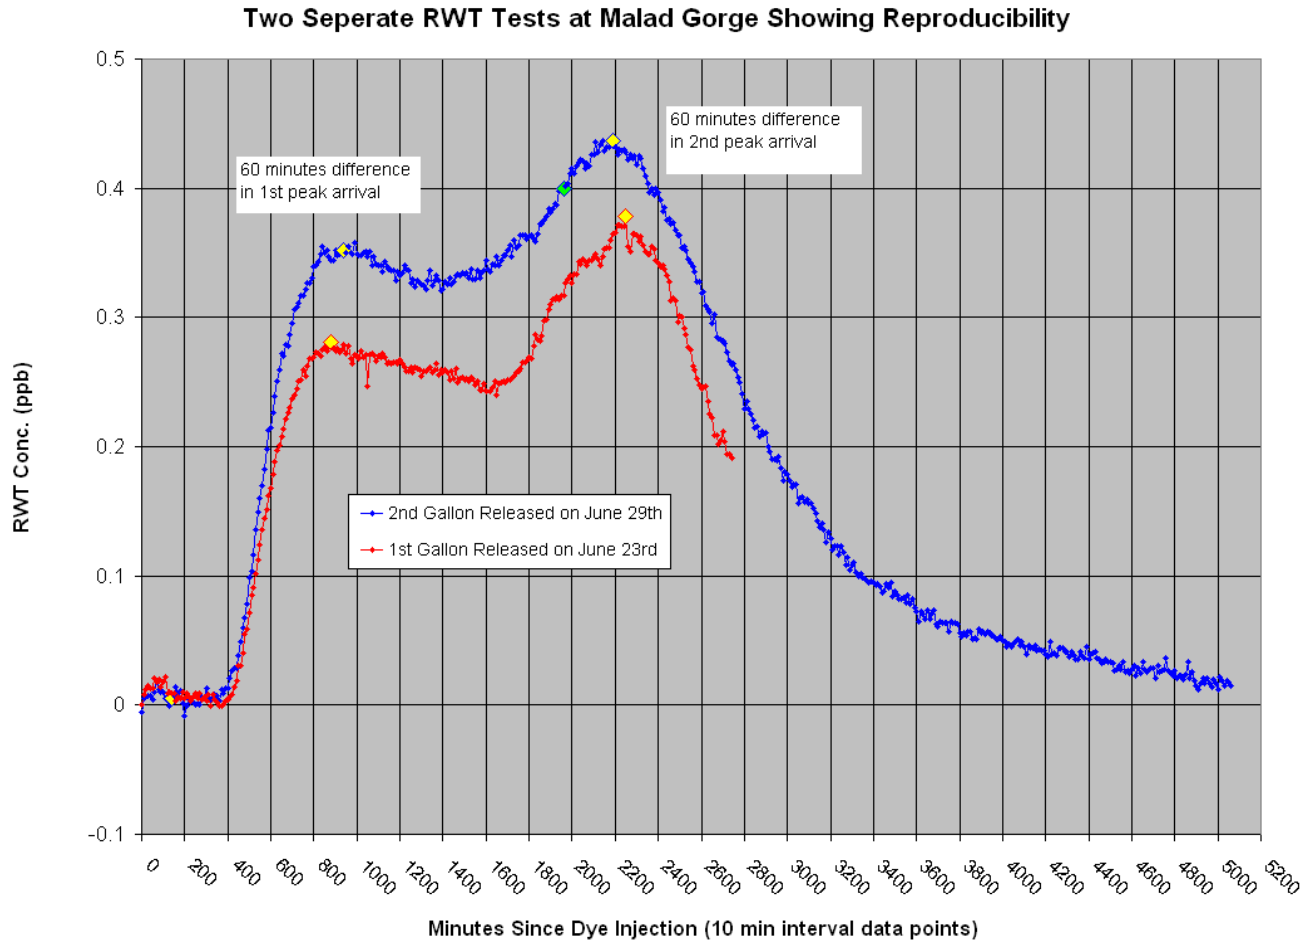
Figure 17. Reproducibility of both RWT tests demonstrating similar patterns with a strong correlation.

Figure 17 shows a plot of both tests on the same relative time axis starting with the dye injection. The data shifts from the first test were adjusted to produce a consistent line colored red which allows for a better visual comparison of the two breakthrough curves. The curves show a consistent pattern between both tests with essentially the same slope angles on the rising limbs and recession limbs as well as the timing of the peaks. The vertical difference between the two graphs is probably from the calibration of 4 ppb for the first test and 25 ppb for the second test causing a slight change in the measured values. The horizontal shift of the peaks of about 1 hour may be due to slightly different water levels in the well and resulting in different flow hydraulics. The water level in the well on March 20<sup>th</sup> was 191.76 feet below T.O.C. and at the time of injection for the first RWT test on June 23 it was 191.06 feet below T.O.C. Unfortunately, a water level was not collected during the second RWT test on June 29<sup>th</sup>.
