A LARGE SINKHOLE IN THE VERCHNEKAMSKY POTASH BASIN IN THE URALS

ABSTRACT

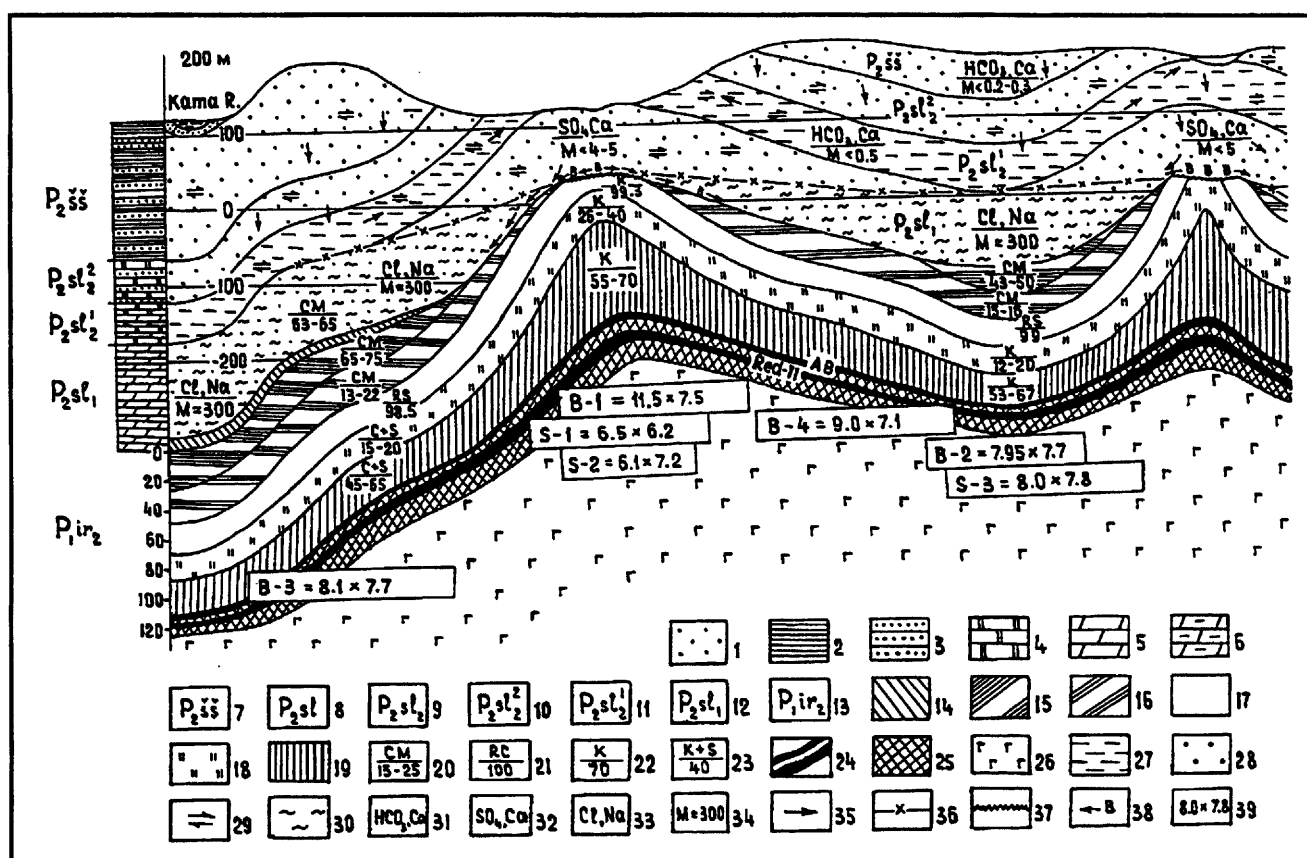
Figure 1. Geological conditions of mining in the Verchnekamskoe salt deposit (From Kopnin, 1991). The arrow indicates the 3rd Bereznikovskiy potash mine. KEY: 1-quaternary deposits; 2-argillites; 3-aleurolites, sandstones; 4-dolomites; 5-marls; 6-clay marls. Lithological complexes: 7-strata capping the parti-coloured complex; 8-the parti-colored complex; 9-carbonate complex; 10-limestone-sandstone complex; 11-limestone marl complex; 12- clay-marl complex; 13-evaporites. Waterproof complex (WPC), upper zone: 14- lower part of clay-marl complex with two rock salt beds; upper transitional zone; 15- marl-salt rocks; 16-salt rock. Middle zone of WPC: 17-salt caprock; 18-halite carnallite rocks with potassium beds G, Z, I, K. Lower zone of WPC: 19-carnallite rocks with potassium beds B, H, D, E. Content of rock salt (%): 20- clay, marl; 21- rock salt; 22-carnallite; 23-carnallite and sylvite. 24-working beds AB and Red-II; 25-sylvite zone; 26-rock salt. Hydrogeological conditions: Aquifers: 27-relatively homogenous; 28-very heterogeneous. Water exchange zones: 29-active; 30-labored. Chemical type of water: 31- CaHCO_3^- ; 32- CaSO_4 ; 33- NaCl . 34-mineralization of underground water (total dissolved solids), g/L; 35-water movement; 36-water borderline; 37-salt karst mirror; 38-movement of NaCl brines, 39-sampling points.

At the location of the collapse, mines were located at a depth of 425-435 m (Figure 1). Above the

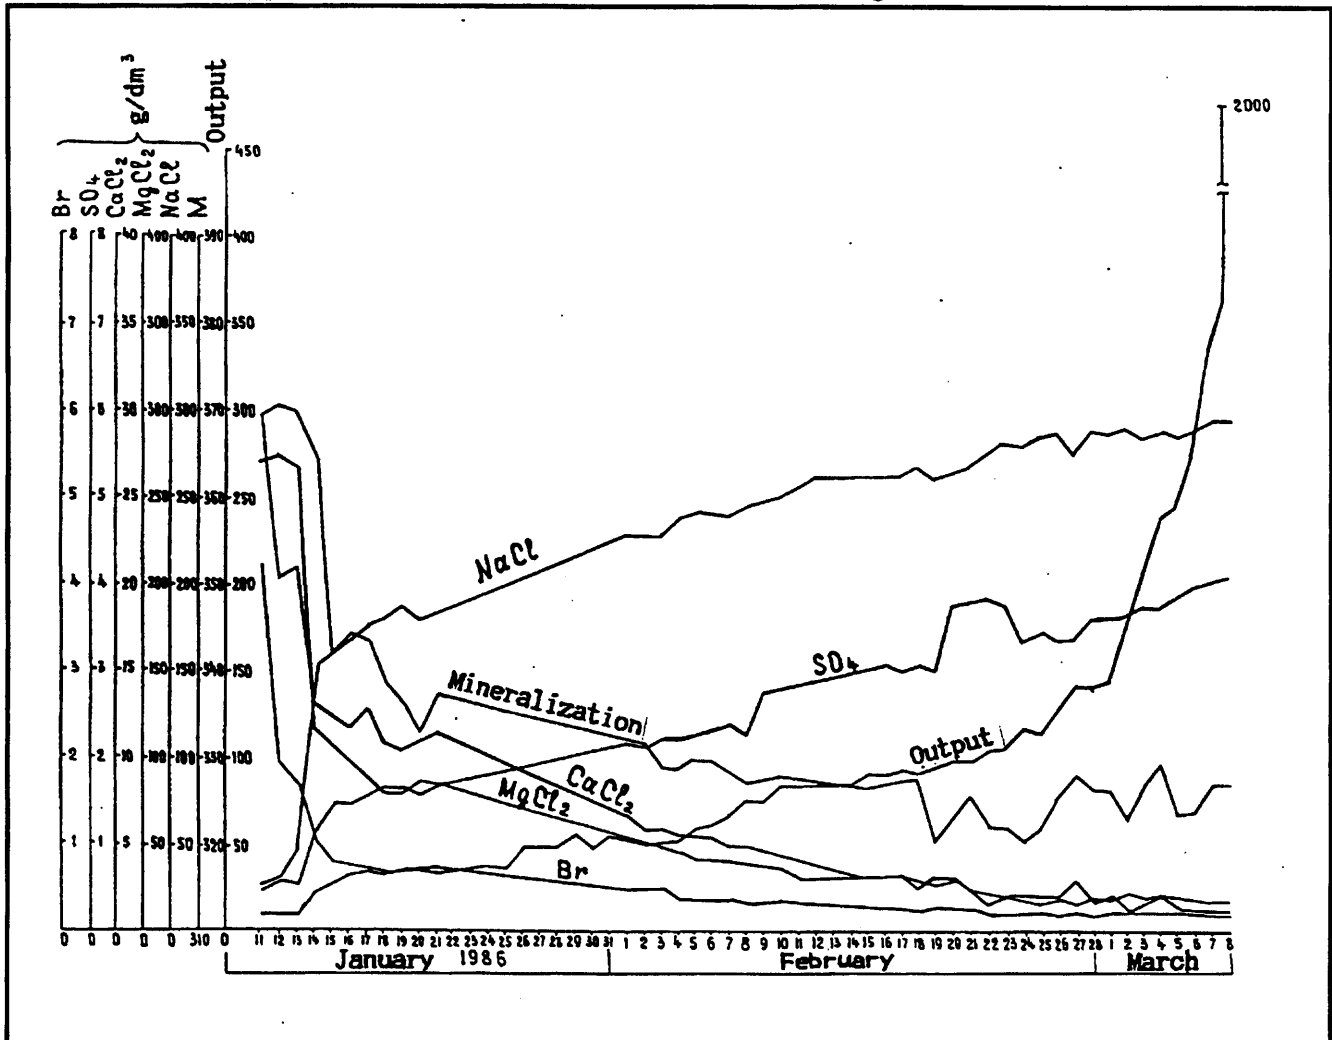
Figure 3. The dynamics of brines composition and water inflow in block 8 during January-March 1986.

1. From 11 to 15 January: relatively steep rise of water inflow (from 10 to 30 m³ per hour), sharp drop of brine mineralization (from 370 to 343 g/dm³) rapid increase of content of NaCl (from 25 to 160 g/dm³), SO₄²⁻ (from 0.5 to 1.6 g/dm³) and decrease of MgCl₂ (from 270 to 115 g/dm³), CaCl₂ (from 30 to 13 g/dm³) and Br (from 4.2 to 0.9 g/dm³).

2. From January 16 to February 20-23: comparatively gradual rise of water inflow (from 30 to 100 m³ per hour), relative slow lowering of mineralization or total dissolved solids (from 345 to 323 g/dm³) and content of MgCl₂ (from 115 to 25 g/dm³), CaCl₂ (from 13 to 2 g/m³), Br (from 0.9 to 0.3 g/dm³) and increased concentrations of NaCl (from 160 to 270 g/dm³) and SO₄ (from 1.6 to 3.9 g/dm³).
3. From February 21-24 until March 8: sharp increase of inflow (from 100 to 350 and more m³ per hour), and fluctuations in mineralization (between 323-333 g/dm³) and chemical composition.

The nature of these discharges caused immediate concern, and as a result, were closely monitored from January 11 until March 8, when the inflow of water sharply increased. On March 9, all miners were safely brought to the surface, though the mining equipment had to be left underground. Figure 3 displays the dynamics of the water inflows and their chemical composition. Analysis of the water-inflow behavior, mineralization and chemical composition curves indicate that the inflows had three distinct phases, apparently associated with what was occurring in the strata above the mines.

We can see that the first and the third periods are relatively short (5 and 13-14 days) and the second period is longer (35-37 days). The first two periods share a decisive relationship between mineralization, chemical composition and the volume of water inflow. During the third period, this relationship becomes less significant, though to some extent it can still be seen during the sharp fluctuations that occurred.

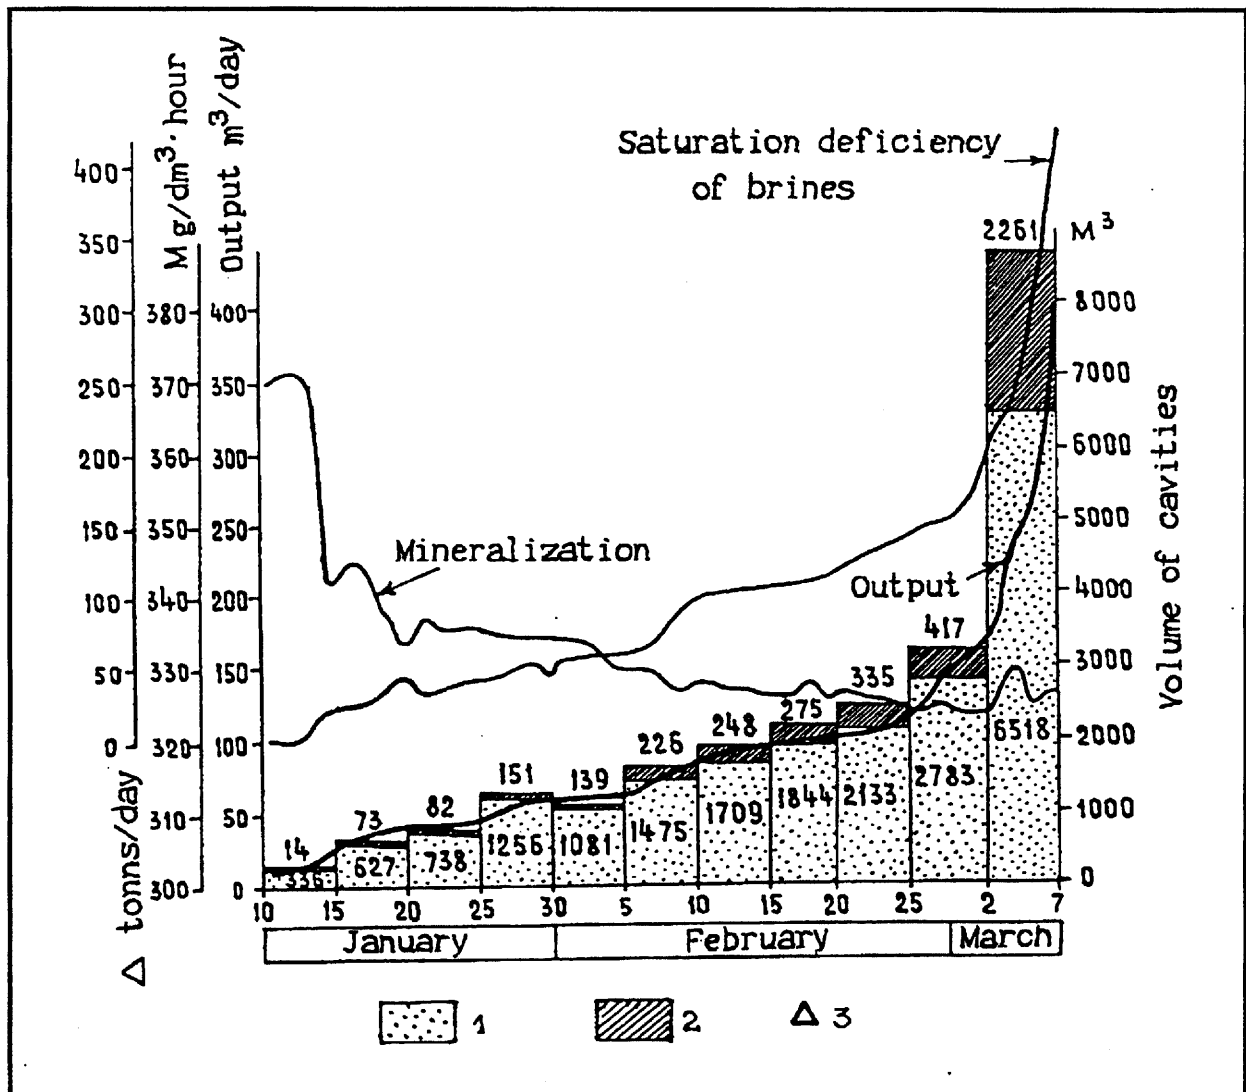
Figure 4. Salt dissolution and cavity formation in water-inflow zone of mine from January 11 to March 8, 1986: KEY: 1. The volume of cavities formed above mines owing to leakage; 2. The volume of cavities formed on the mines level owing to saturation deficiency of brines; 3. Saturation deficiency of brines that came into the mines.

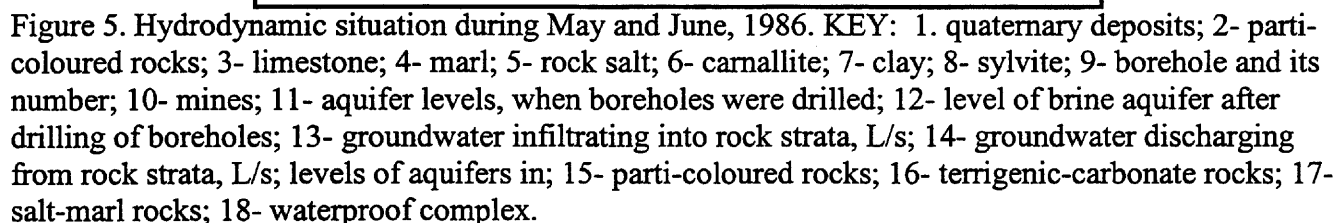
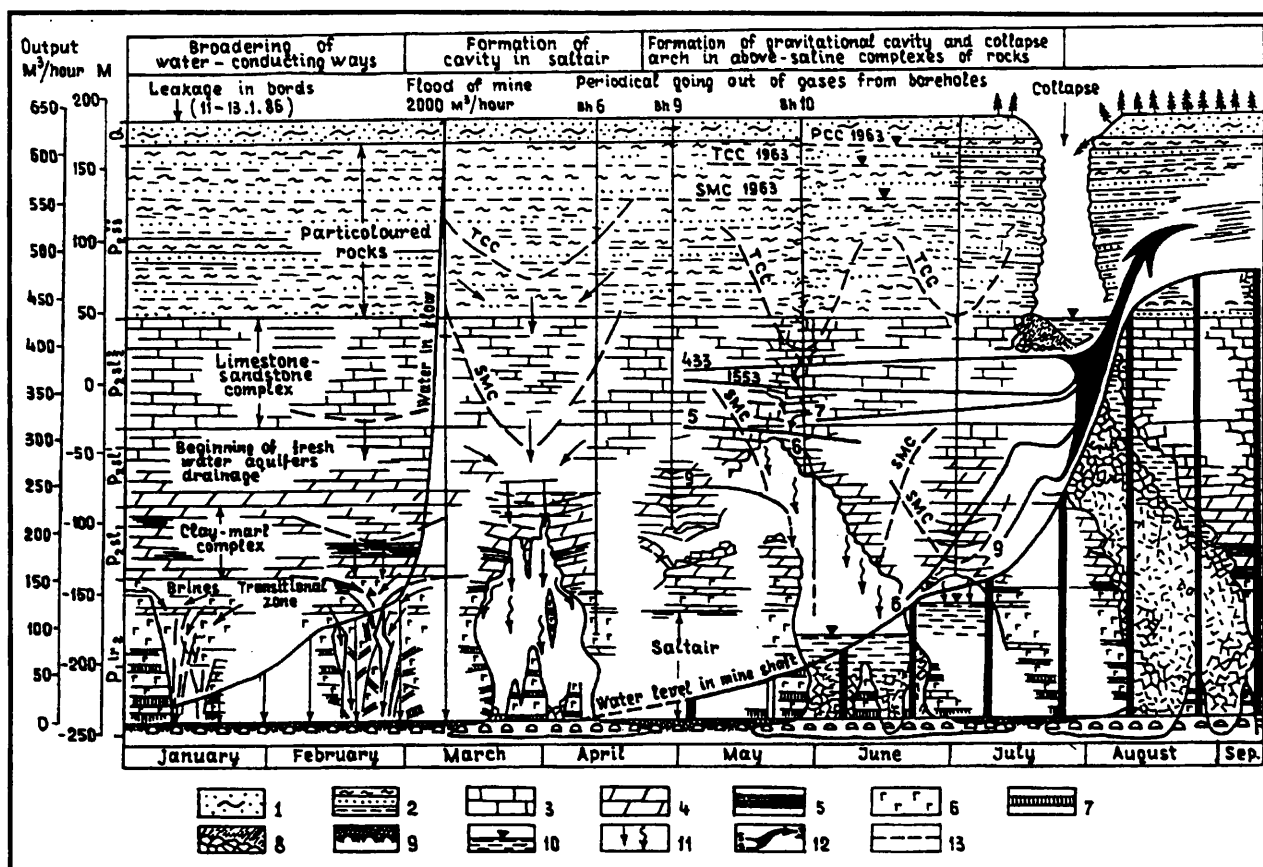
Figure 6. Development of events during January-August, 1986. KEY: 1- sand, loam; 2- sandstone, aleurolite, argillite; 3- limestone; 4- marl; 5- clay; 6- rock salt; 7- carnallite; 8- breakdown material; 9- mines; 10- water level in cavity; 11- underground drainage of aquifers; 12- exchange of aquifers water level; 13- water levels. The term "saltair" refers to the evaporite beds.

Figure 6 defines more exactly the temporal succession and graphically presents the main events. For example, the process described above corresponds with the period beginning in March and extending to late April. That one-and-a-half month period was a critical phase in the formation of the large

Assuming that the flooded mines, evaporite cavity and mine shafts are hydrodynamically connected, the water level in the mine shafts should correspond to the cavity water level. As can be seen in Figure 6, the cavity appears to have flooded rather slowly. From April 15-20 until the beginning of July (about 80 days), the water level had gone only to the level of the first salt bed of the transitional complex (upper border-line of corrosion cavity). Such a long period of cavity filling (1-1.5 million m³ in 80 days compared with 15 million m³ of mines during the 40 days before!) is most likely due to either (or both) continued enhancement of the cavity volume, and/or a decrease in water inflow. The drilling of boreholes at the location of the future sinkhole confirmed the fact that by the summer, the fresh-water aquifers were significantly drained. The borehole NIO, which was bored in the end of May, established the absence of underground waters in the lower half of the above-saline lithological complexes (Figures 5 and 6). Consequently, from the end of April to the end of May, the output of water inflow was sharply lowered, and in the beginning of the summer it became very small. We have assumed therefore that the evaporite bed cavity volume remained fairly stable with dissolution and erosion approximately balanced with deposition of breakdown material at the bottom of the cavity. Thus, the volume of the initial cavity in salt may be estimated, as before, to be 1.0-1.3 million m³.

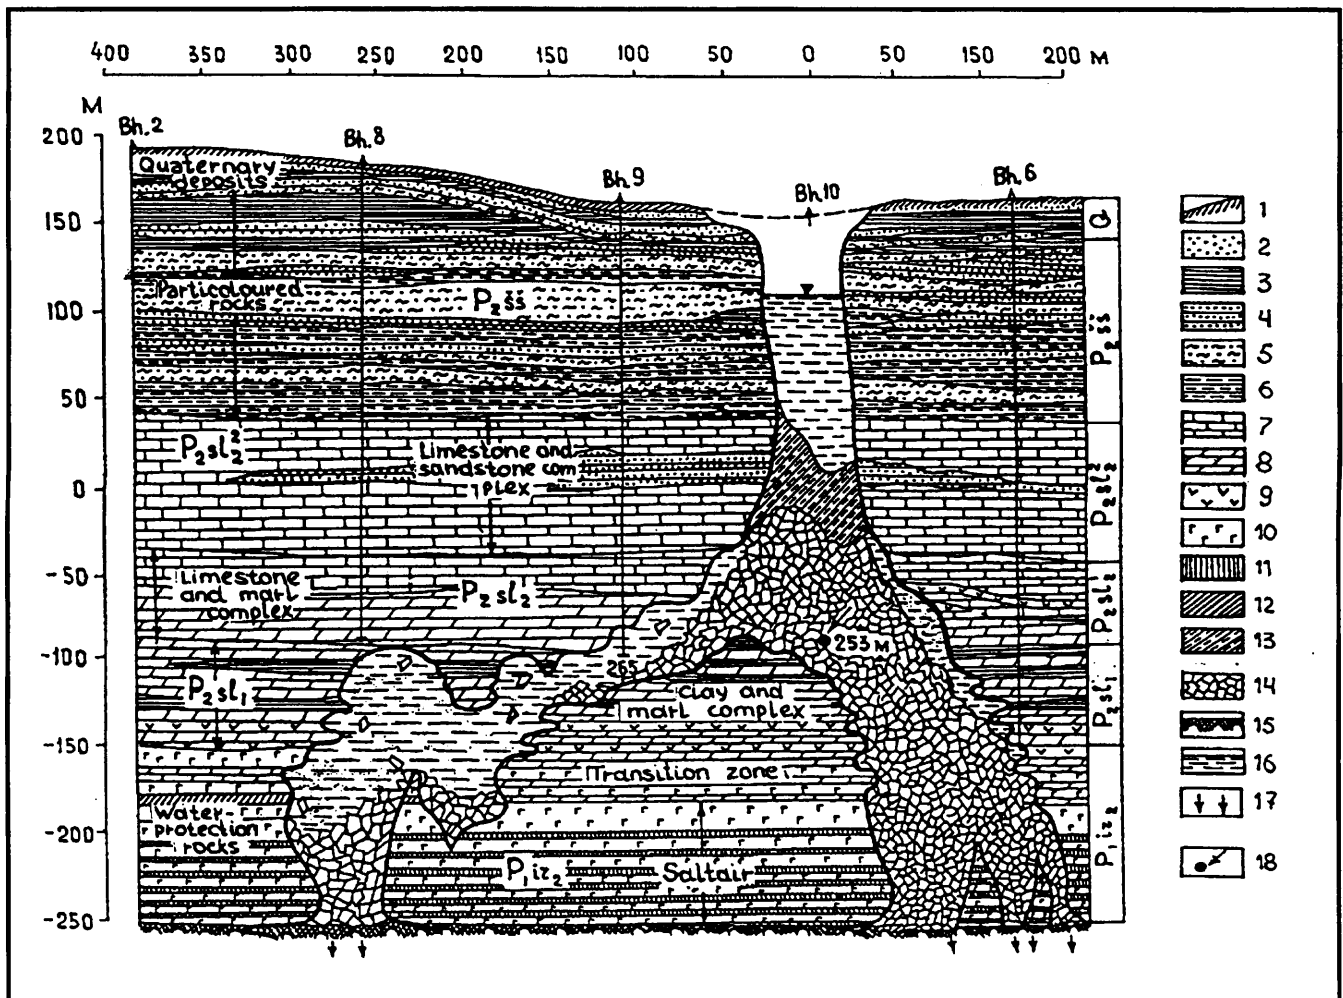
Figure 7. General view of the corrosional and gravitational system of cavities in the vicinity of the sinkhole just after sink formation. Key: 1-salt; 2-sand; 3-clay; 4-sandstone; 5-aleurolite; 6-argillite; 7-limestone; 8-marl; 9-gypsum; 10-rock salt; 11-carnallite; 12-sylvite; 13-loam, sandy loam; 14-collapsed material; 15-mines; 16-water; 17-places of brines infiltration in January 1986; 18-points of borehole tube break.

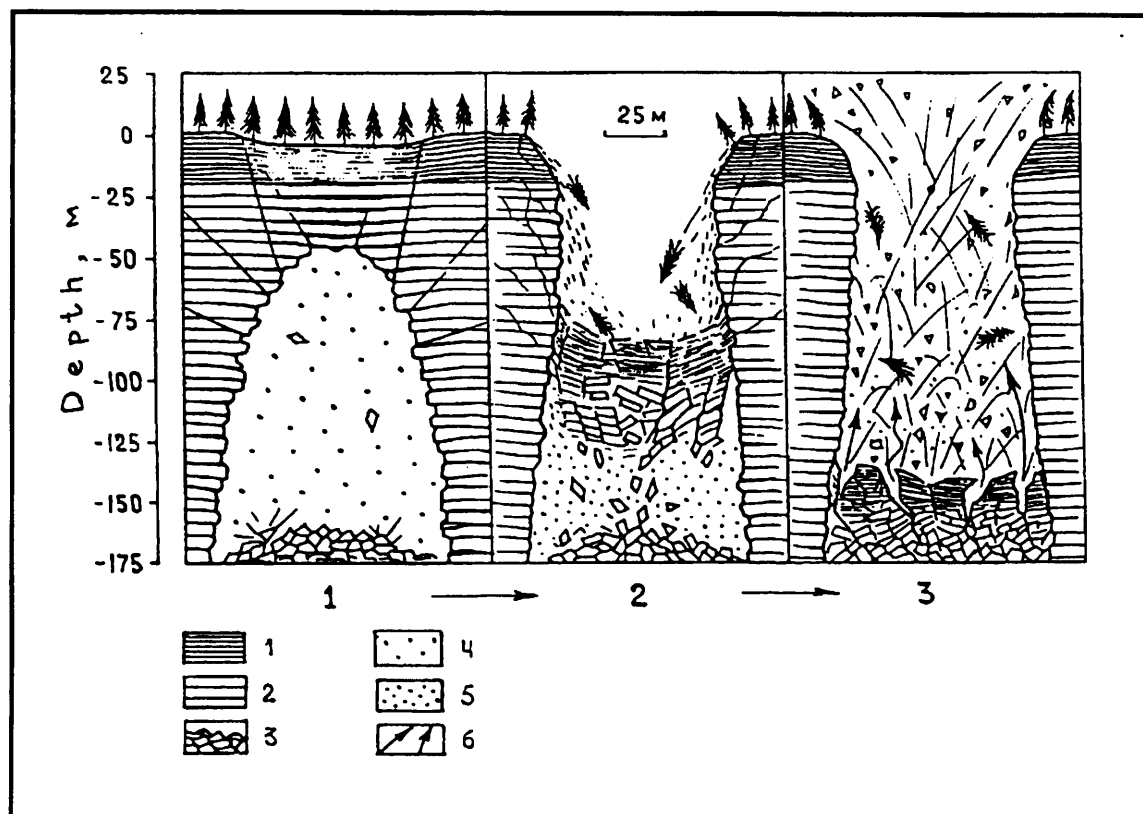
Figure 8. Arch collapse of isolated gravitational cavity and expulsion of rock fragments. KEY: 1- quaternary deposits; 2- parti-coloured rocks; 3- collapsed material; 4- gas mixture; 5- compressed gas mixture; 6- directions of gas spurts.

In this hypothesis, the piston effect compressed the explosive gases and promoted the burst. As a result, the total power of the burst proved to be sufficient to throw out not only small clay and sand particles
